PHASES I & II MONITORING YEAR 0 BASELINE REPORT

MILLSTONE CREEK MITIGATION SITE

Randolph County, NC
Cape Fear River Basin
HUC 03030003

DMS Project No. # 204
NCDEQ Contract No. 6741
USACE Action ID No. 2018-01788
DWR Project No. 16-1200

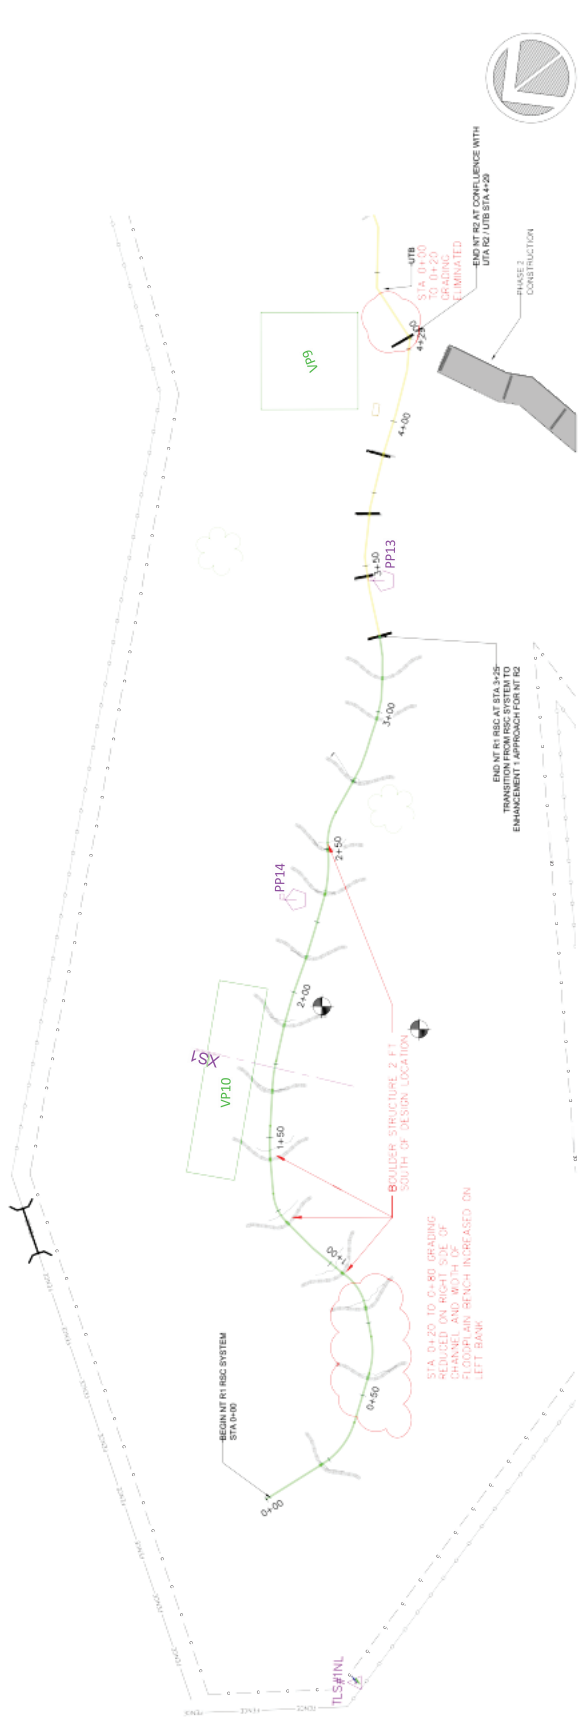
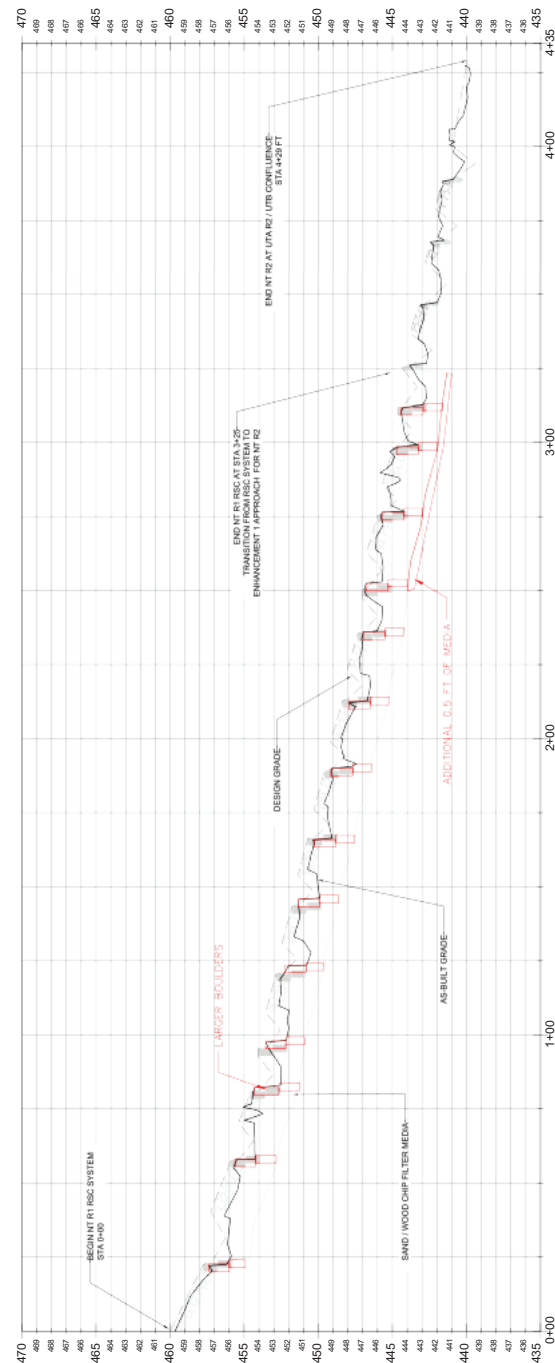
- NOTES:
1. DEVIATIONS FROM THE DESIGN WILL BE SHOWN IN RED
 2. BOULDERS ARE LARGER THAN SPECIFIED AND EXTEND TO THE BOTTOM OF THE MEDIA TRENCH AN ADDITIONAL 0.5 FT OF MEDIA WAS ADDED FROM STA 2+50 TO STA 3+25 TO COMPENSATE FOR THE LOSS IN MEDIA VOLUME DUE TO THE LARGER BOULDERS

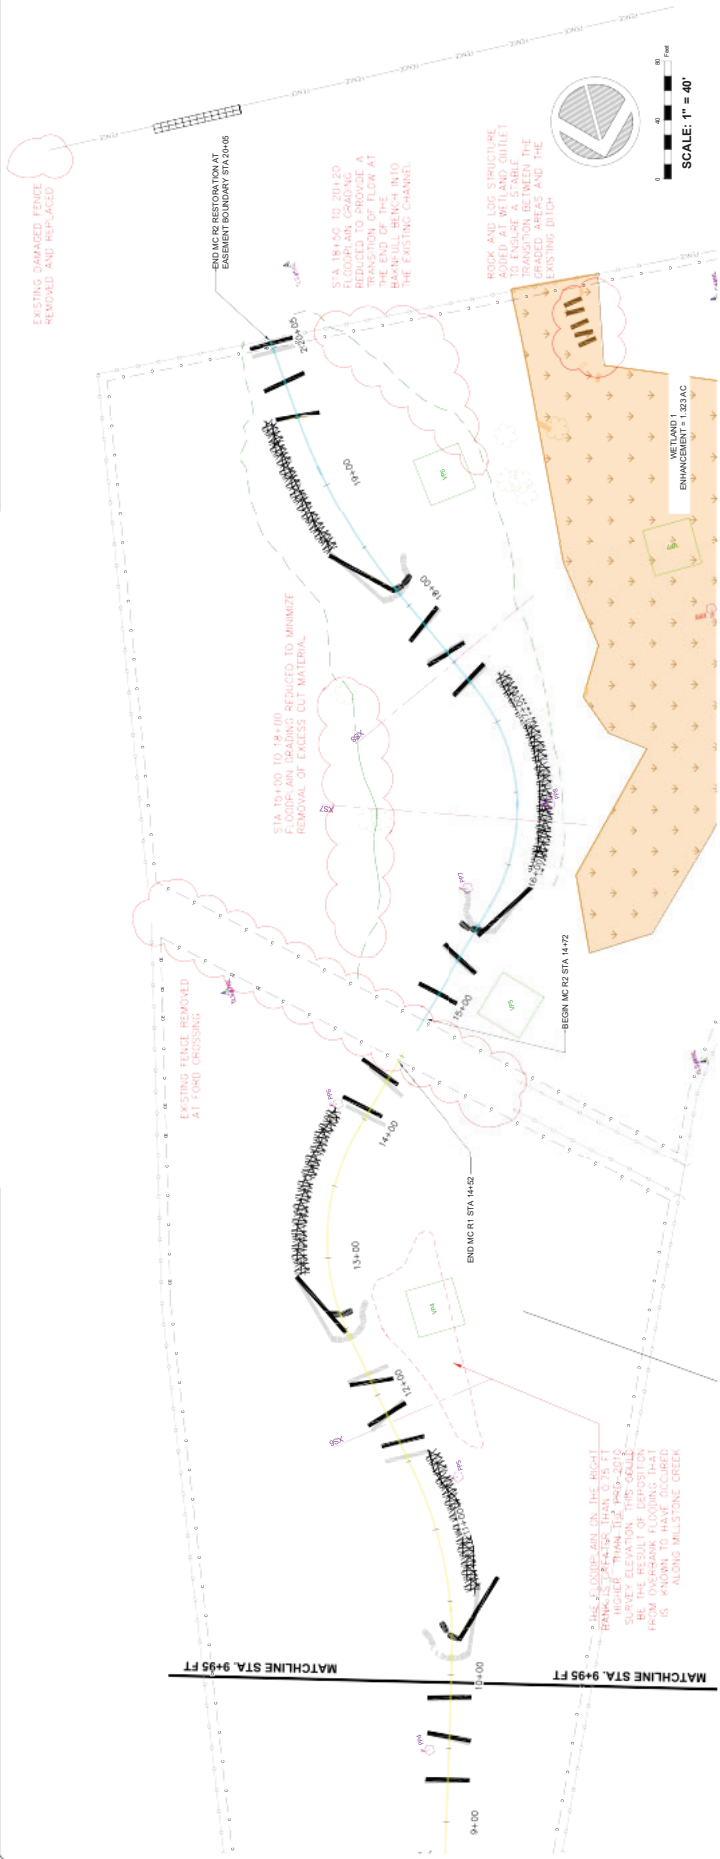
- NOTES:
1. DEVIATIONS FROM THE DESIGN WILL BE SHOWN IN RED.
 2. ALL J-HOOKS WERE LOCATED AND ORIENTED ACCORDING TO THE DESIGN DETAIL NOT THE PLAN VIEW.
 3. ALL POOL DEPTHS WERE MODIFIED TO BE TWO (2) FT BELOW THE UPRISING FOR THE PRESENCE OF RUNNING SAND.
