**Moccasin Creek Buffer & Wetland  
Restoration, Enhancement &  
Preservation  
Wake and Franklin Counties  
North Carolina**

**2nd Year Monitoring Report  
February 14, 2008**

Rummel, Klepper & Kahl, LLP  
900 Ridgefield Drive  
Suite 350  
Raleigh, NC 27609

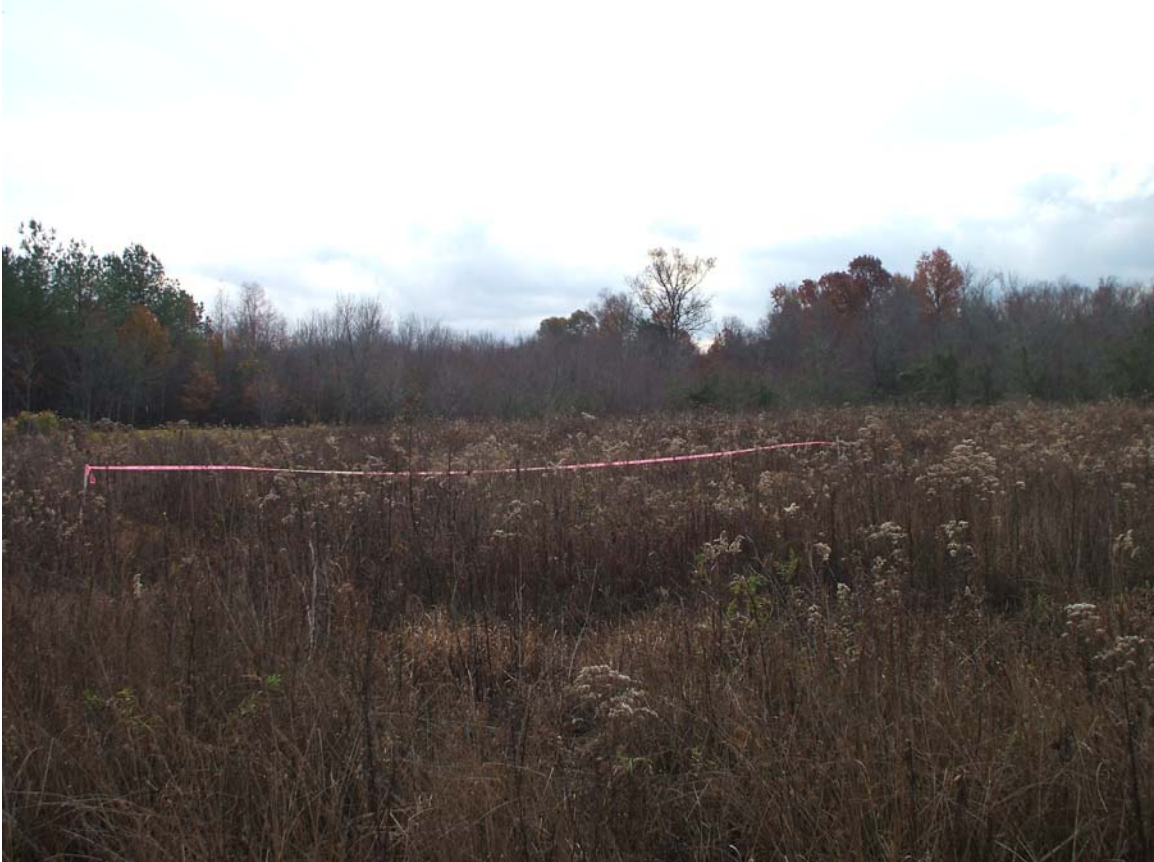
Vegetation Plot Photographs, Zone 1, Plot 1

Year 2 Result- 687 stems/acre

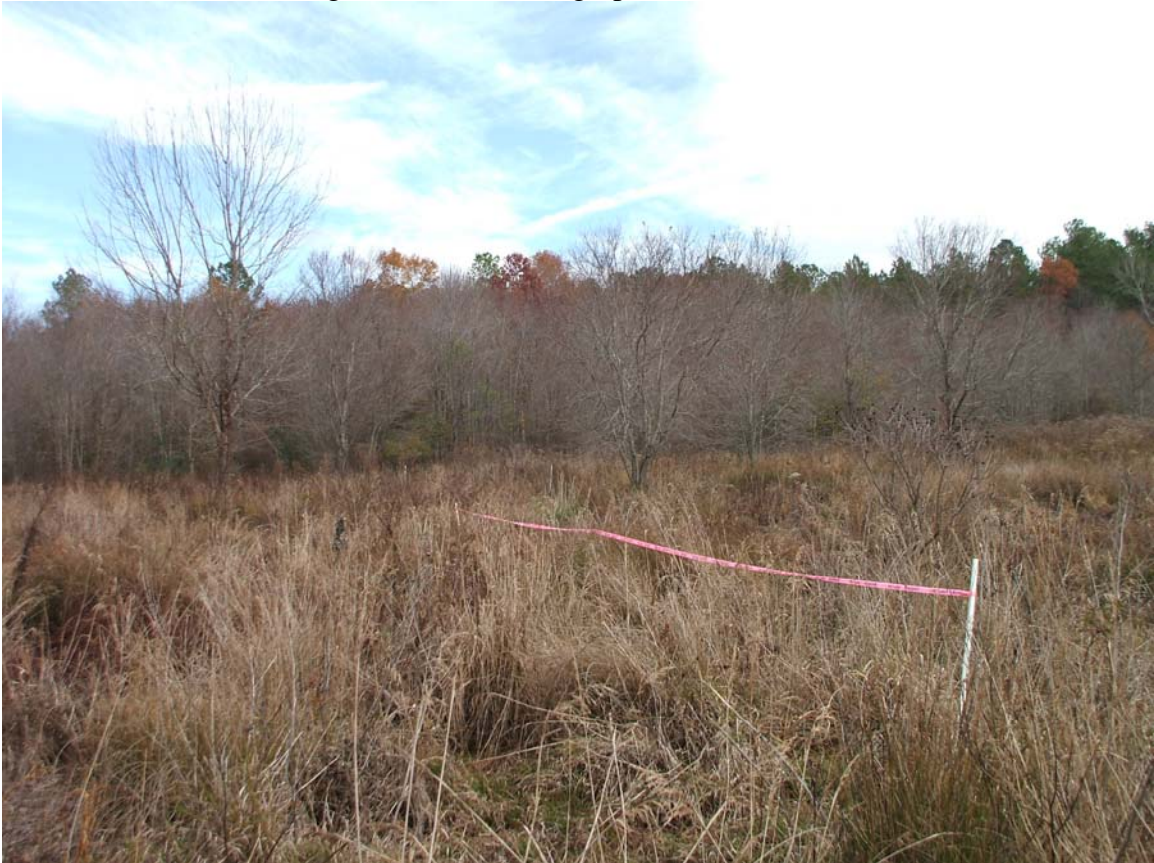
Vegetation Plot Photographs, Zone 1, Plot 2

Year 2 Result-161 stems/ acre

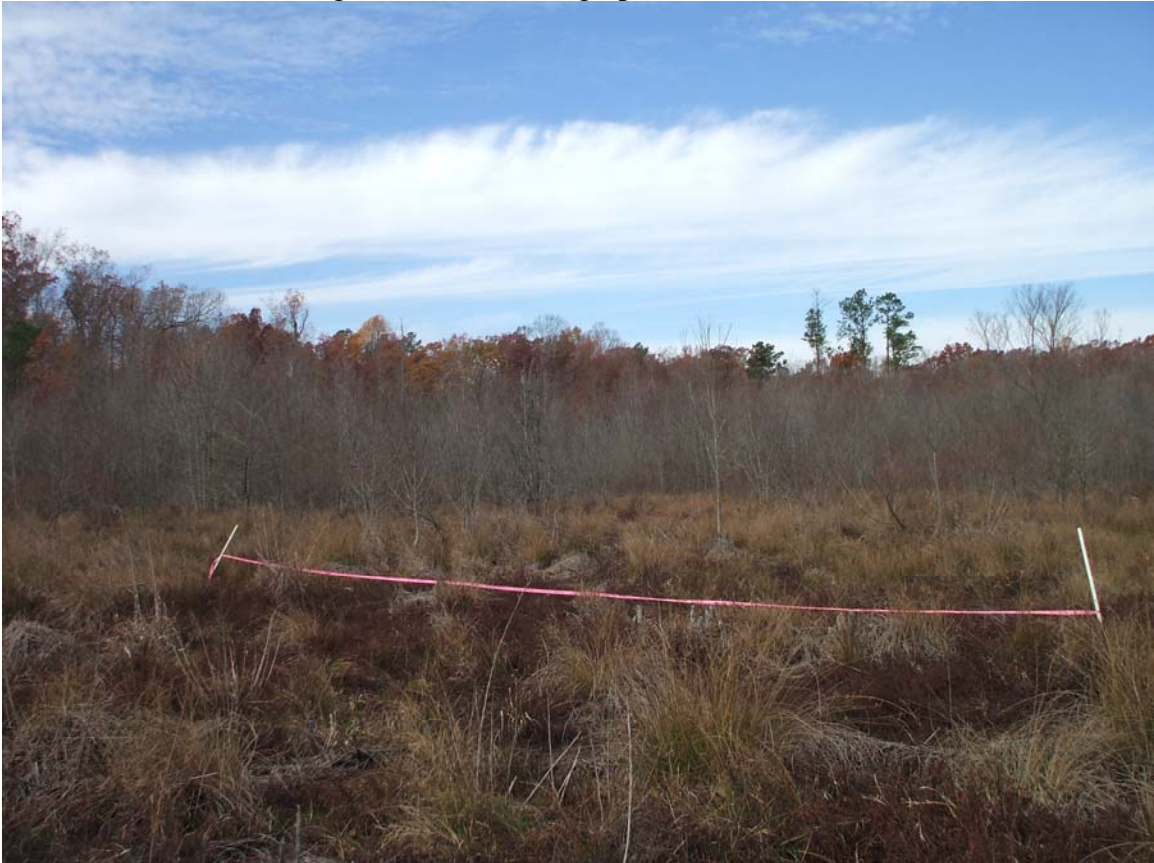
Vegetation Plot Photographs, Zone 1, Plot 3

Year 2 Results-202 stems/ acre

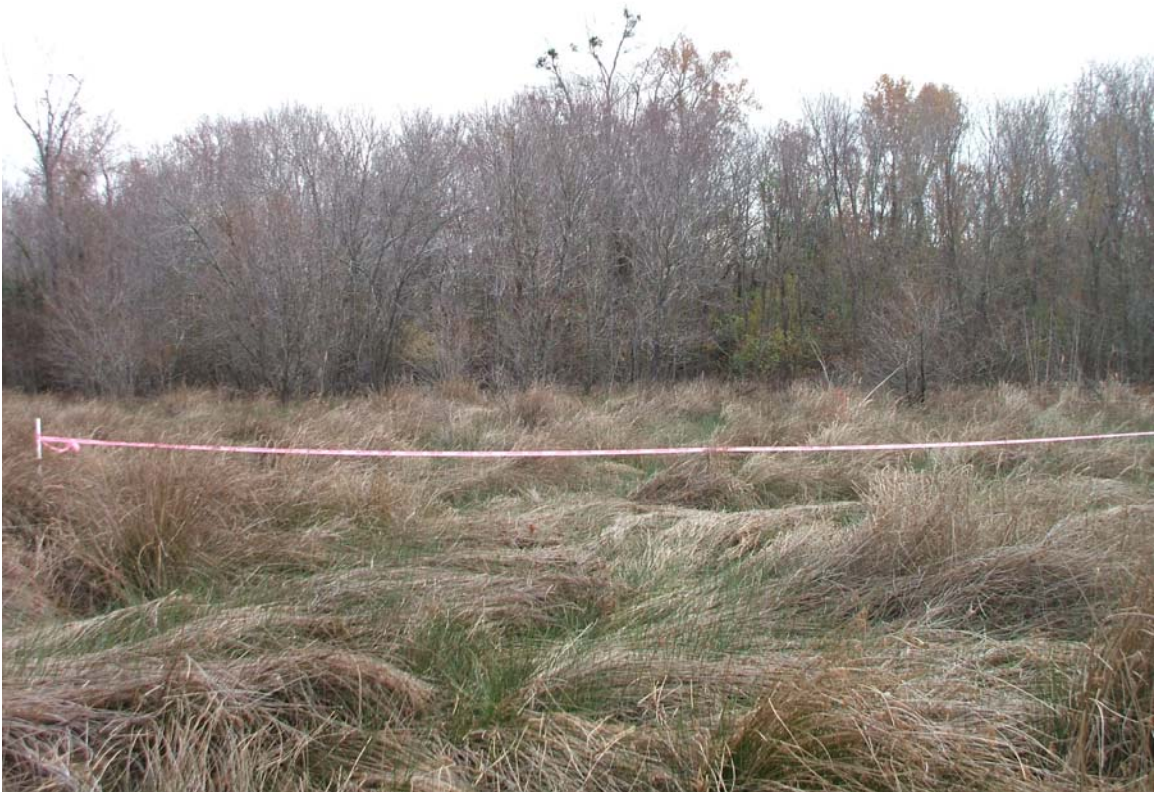
Vegetation Plot Photographs, Zone 1, Plot 4

Year 2 Results-0 stems/ acre

**Zone 1:** (5.12 acres) The average density for Zone 1 is below the required 320 stems/acre. Plot 1 had a density of 687 stems/acre, which is 367 above the required 320 stems/acre while Plot 2 (161 stems/acre), Plot 3 (202 stems/acre), and Plot 4 (0 stems/acre) each were below the minimum success criteria of 320 stems/acre. “Blackberry”, *Rubus* sp., is a threatening competition to the planted trees in Plot 1 of Zone 1 and will need herbicidal treatment. *Polygonum sagittatum*, marshmallow, *Juncus* are outcompeting the tree species in Plot 4.

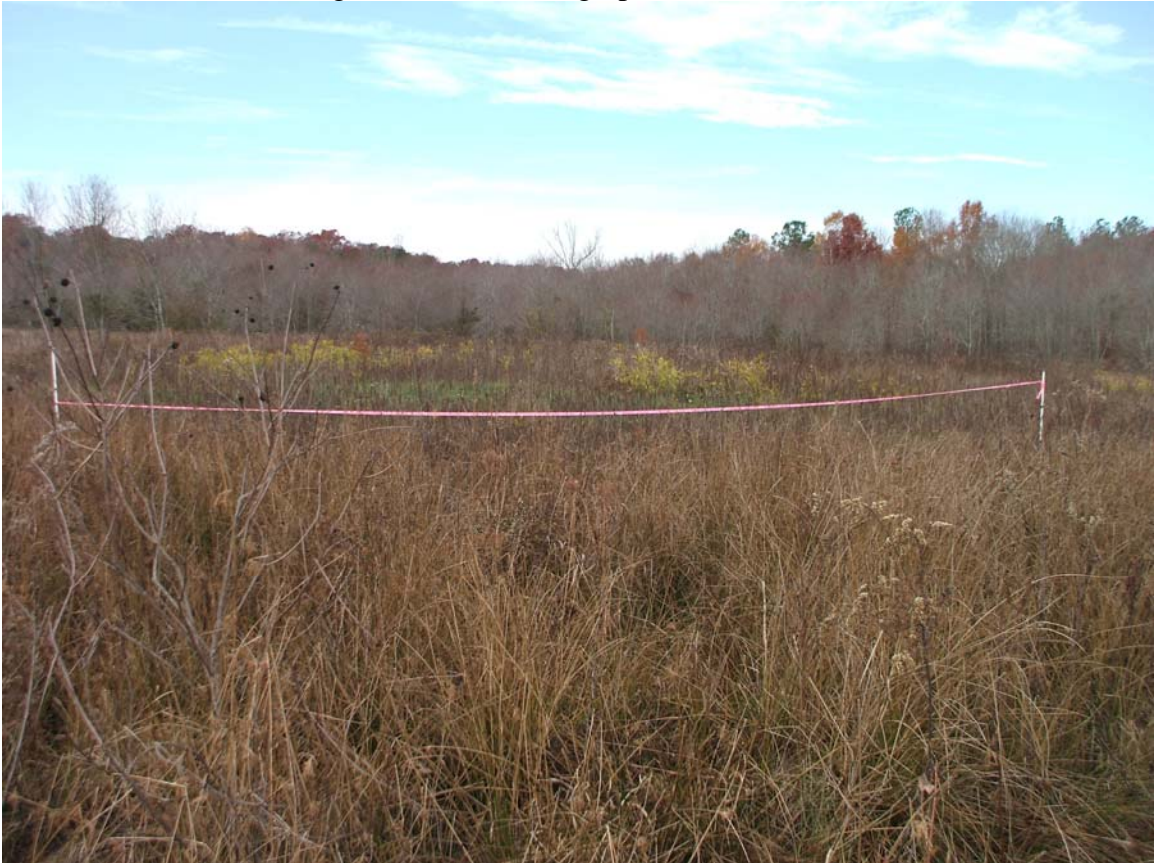
Vegetation Plot Photographs, Zone 2, Plot 1

Year 2 Results-485 stems/ acre

**Zone 2:** (0.6 acres) The sycamore tree, *Platanus occidentalis*, was not successful within Plot 1 of Zone 2 having a survival rate of 11%. The willow oak, *Quercus phellos*, had a survival rate of 73%. Overall this zone had met the requirements with 485 stems/acre. No shrub species were observed within this zone.

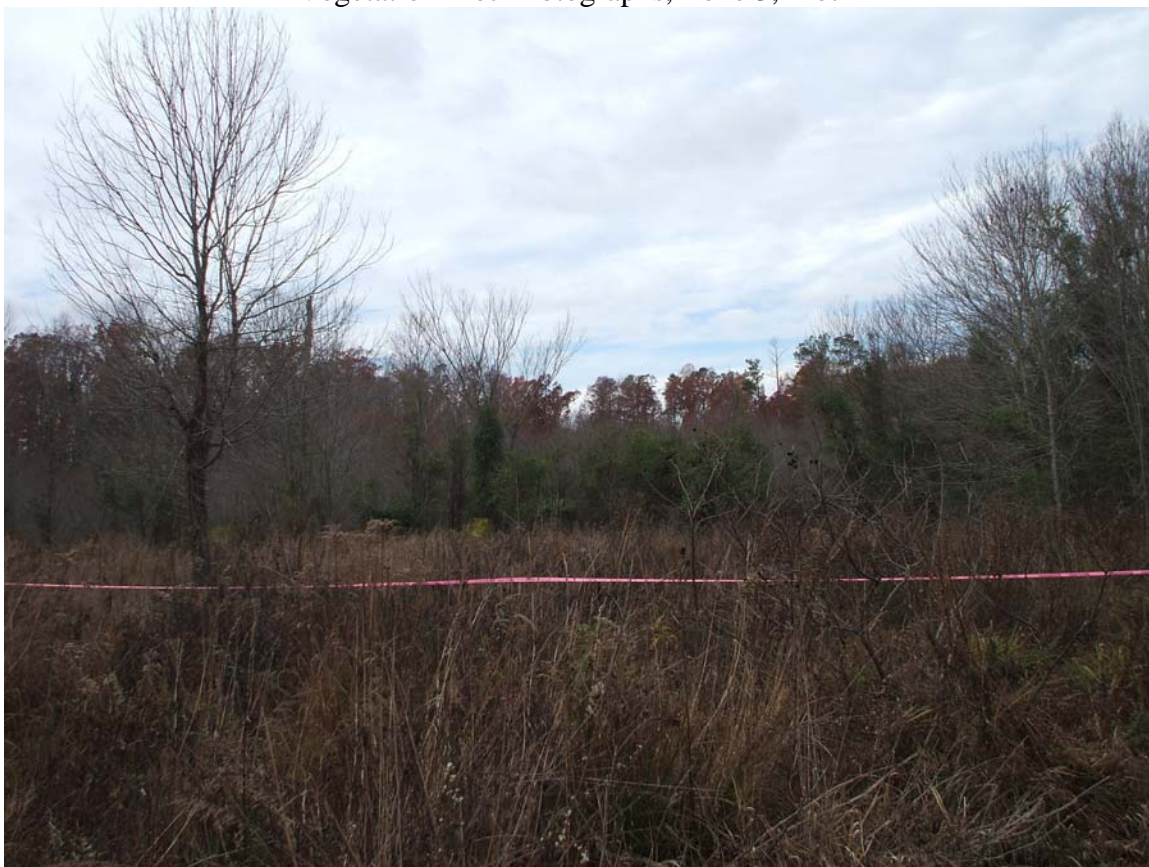
Vegetation Plot Photographs, Zone 3, Plot 1

Year 2 Results-121 stems/ acre

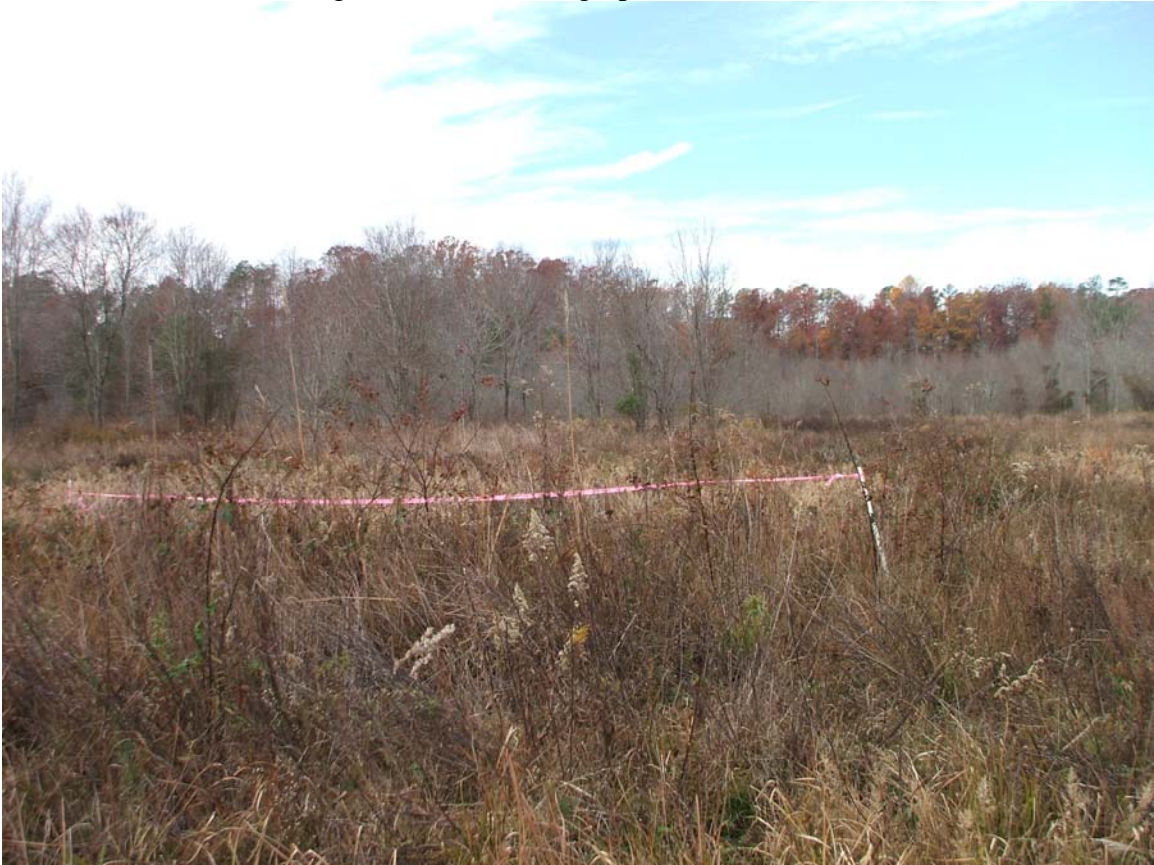
Vegetation Plot Photographs, Zone 3, Plot 2

Year 2 Results-202 stems/ acre

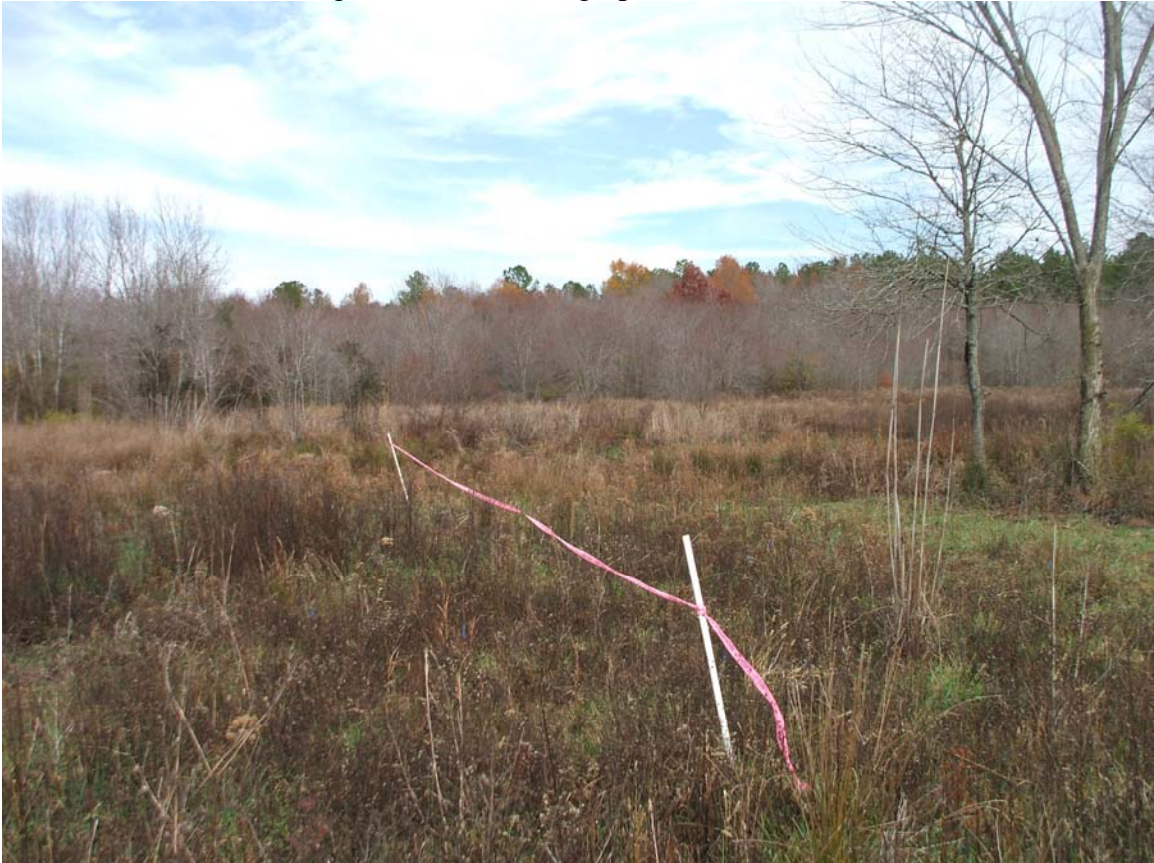
Vegetation Plot Photographs, Zone 3, Plot 3

Year 2 Results-404 stems/ acre

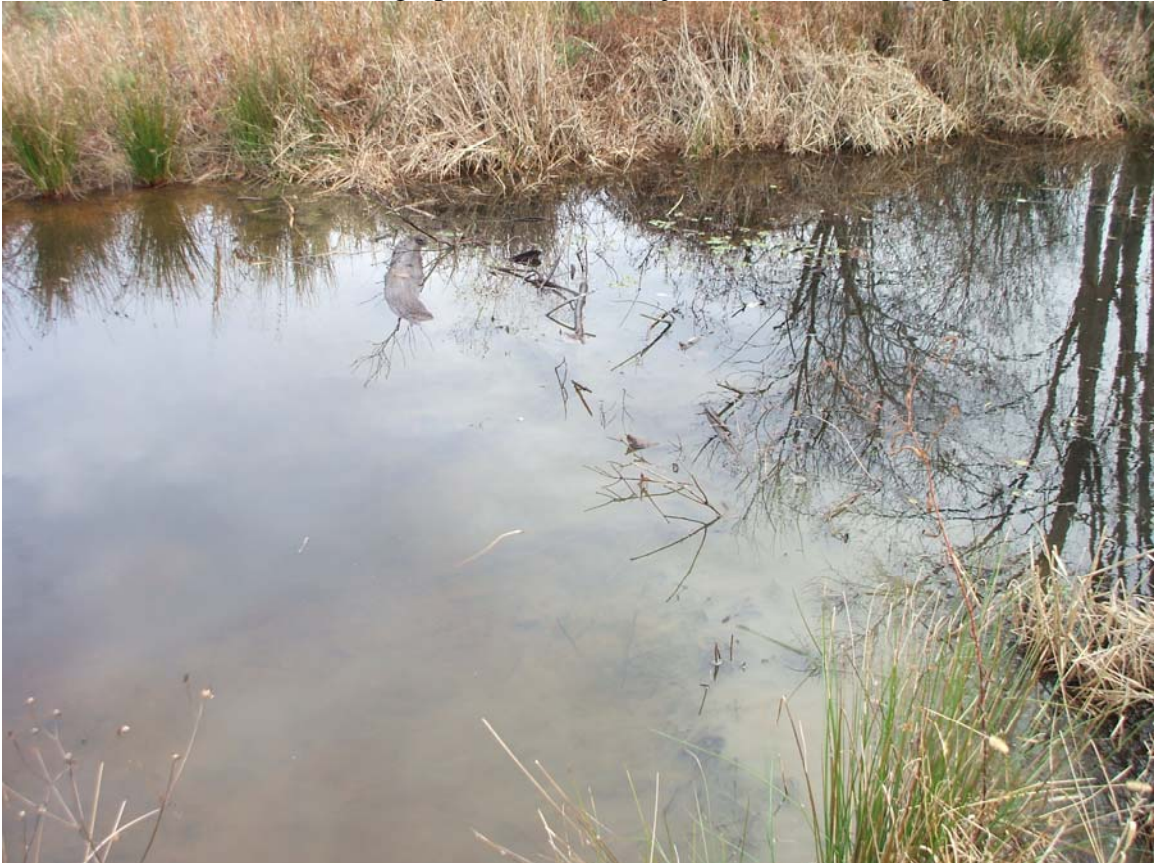
The areas of repair were examined and it was determined that there has been no damage since construction. There are, however, beaver dams downstream of the repair area on Moccasin Creek that have raised the water level, making it difficult to see the channel bottom. All beaver dams are scheduled to be removed in early 2008.

Moccasin Creek Photographs, Beaver Dam just downstream of repair area

The four stream repair sites are all doing well. The vegetation is doing well and the banks are stable. The beaver dams located directly downstream of the repair area on Moccasin

Creek need to be removed to ensure that the site conditions do not become too wet for plant survival.
