**Moccasin Creek Buffer & Wetland
Restoration, Enhancement &
Preservation
Wake and Franklin Counties
North Carolina**

1st Year Monitoring Report

December 26, 2006

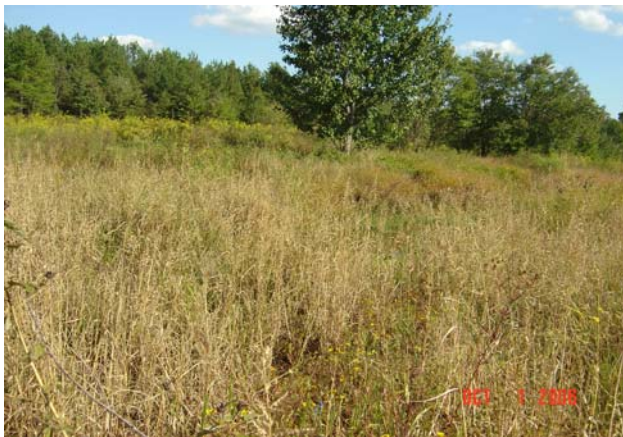
The site has abundant successional herbaceous vegetation that is out-competing many of the planted tree species. The small trees are being shaded out and dominated by the taller herbaceous vegetation. The vegetation success rate has been met this year. There is a concern however; that if the planted tree species continue to decline at the current rate the

Abundant Successional Herbaceous Vegetation

number of remaining trees after the five-year monitoring period is complete will be less than the requirements. It is recommended that larger tree species be planted at a minimum size of 1 gallon container grown trees at a rate of 320 stems/acre.

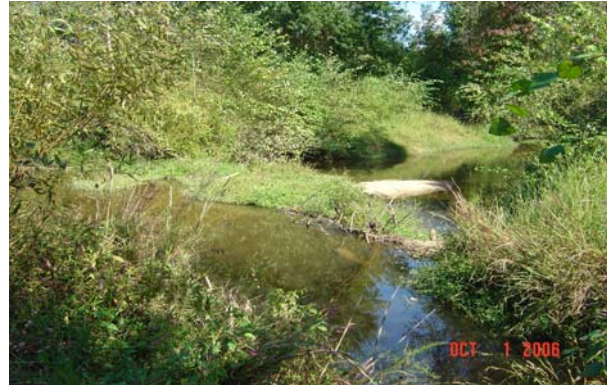
herbicidal treatment. It is recommended that the site be traversed in the spring when the new growth appears to identify patches more effectively. A beaver dam is located on Moccasin Creek approximately 30 feet downstream of the old road crossing. This may have had an effect on the survival rate of the newly planted trees from prolonged periods of inundation.

The four stream repair sites are all doing well. The vegetation is doing well and the banks are stable. The beaver dams located directly downstream of the repair area on Moccasin Creek need to be removed to ensure that the site conditions do not become too wet for plant survival.

Beaver Dam

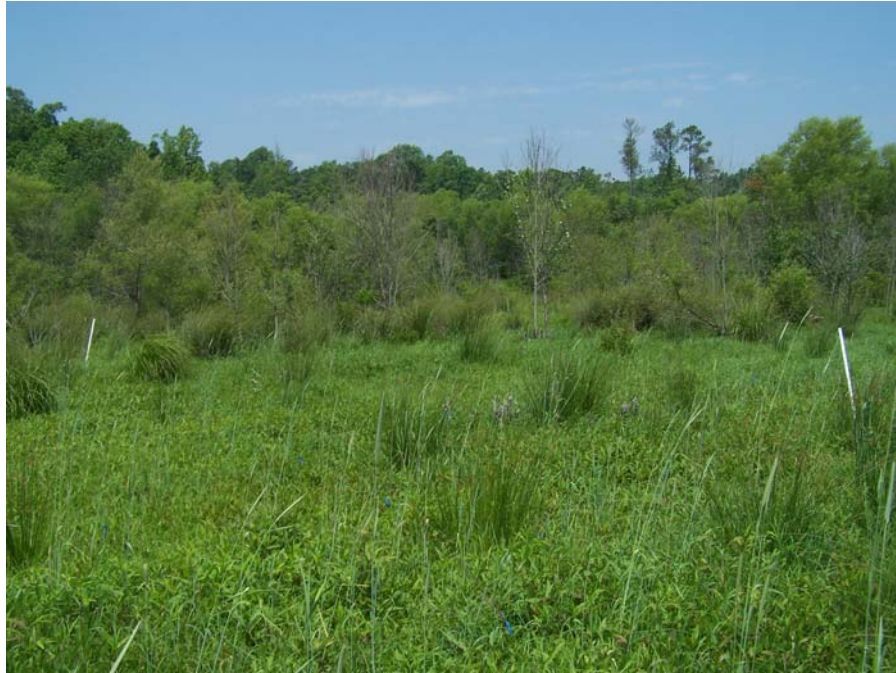
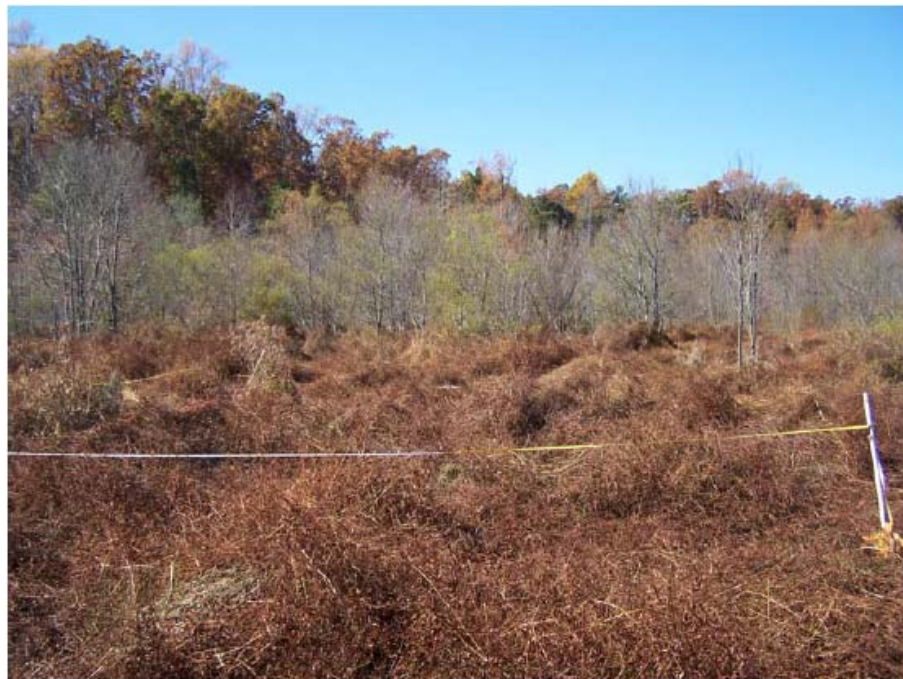
Vegetation Plot Photographs, Zone 1, Plot 3

Zone 1: (5.12 acres) Although the average density for Zone 1 meets the required 320 stems/ acre, Plots 3 and 4 has a stem density lower than the requirements. Plot 3 had a density of 242 stems/ acre, which is 78 below the required 320 stems/ acre, and Plot 4 had a stem density had 194 stems/ acre, which is 126 stems below the required 320 stems/ acre. “Blackberry”, *Rubus* sp., is a threatening competition to the planted trees in Plot 1 of Zone 1 and will need herbicidal treatment. *Polygonum sagittatum*, marshmallow, *Juncus* are outcompeting the tree species.

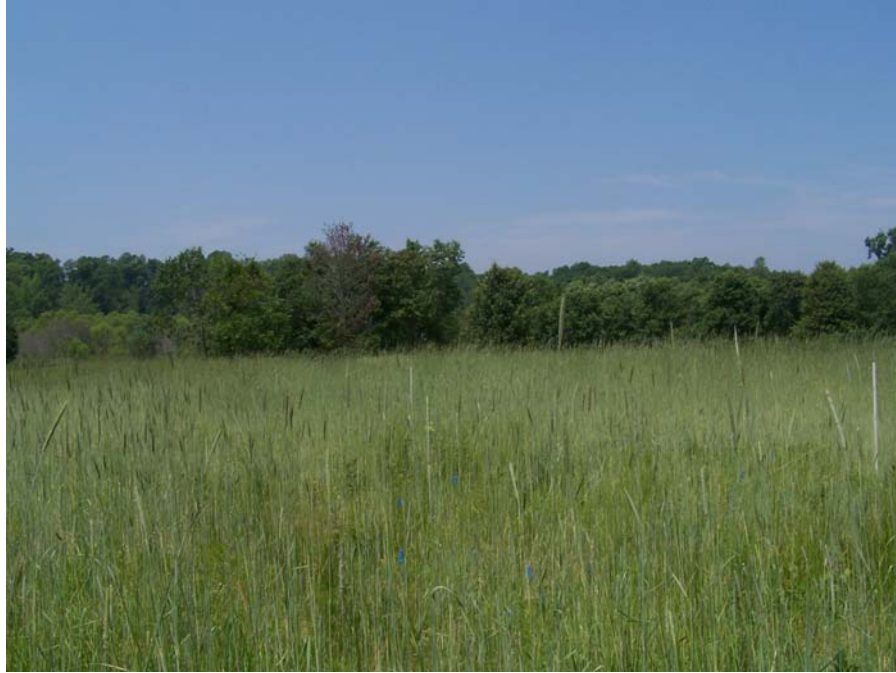
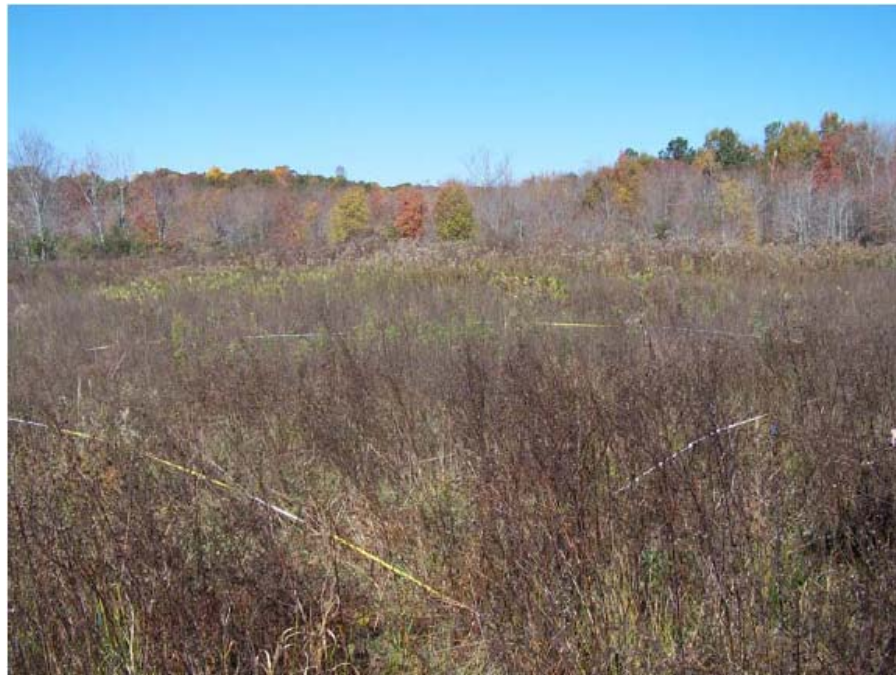
Vegetation Plot Photographs, Zone 2, Plot 1

Zone 2: (0.6 acres) The sycamore tree, *Platanus occidentalis*, was not successful within Plot 1 of Zone 2 having a survival rate of 11%. The willow oak, *Quercus phellos*, had a survival rate of 75%. Overall this zone had met the requirements with 484 stems/ acre. No shrub species were observed within this zone.

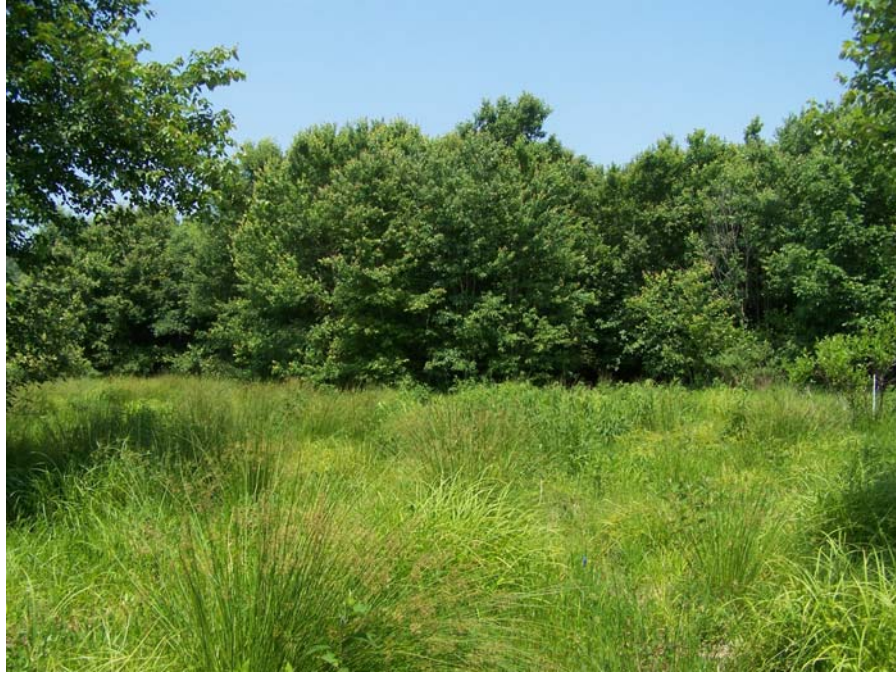
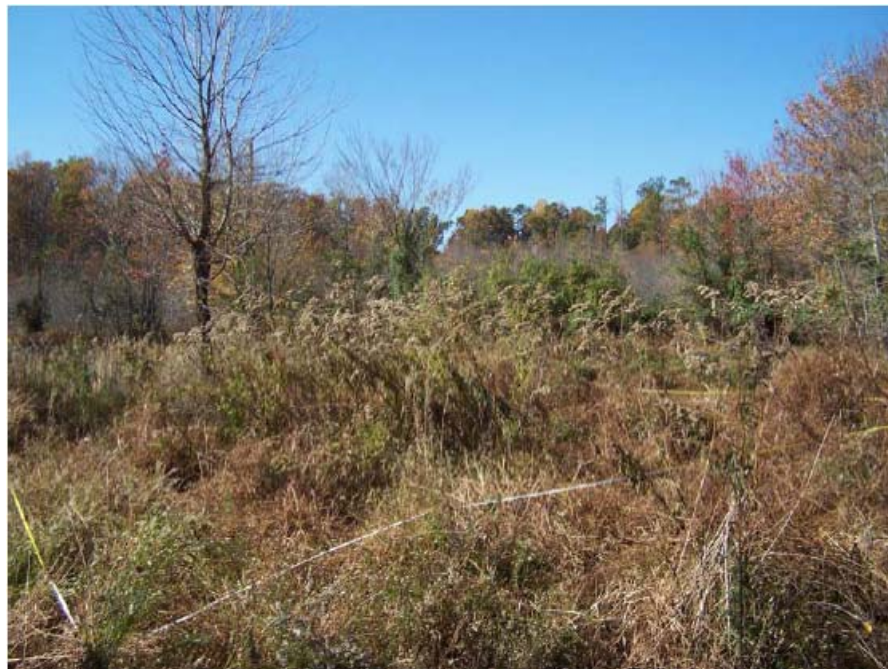
Vegetation Plot Photographs, Zone 3, Plot 1

Zone 3: (3.56 acres) Although the average density of Zone 3 meets the required 320 stems/ acre, Plots 1 and 2 each has 145 stems/ acre, which is 175 stems below the requirement. The tree species within these two plots, the Swamp black gum, and bald cypress have failed to compete with volunteer herbaceous species mainly composed of *Polygonum sagittatum*, *Juncus effusus*, and *Carex* sp.

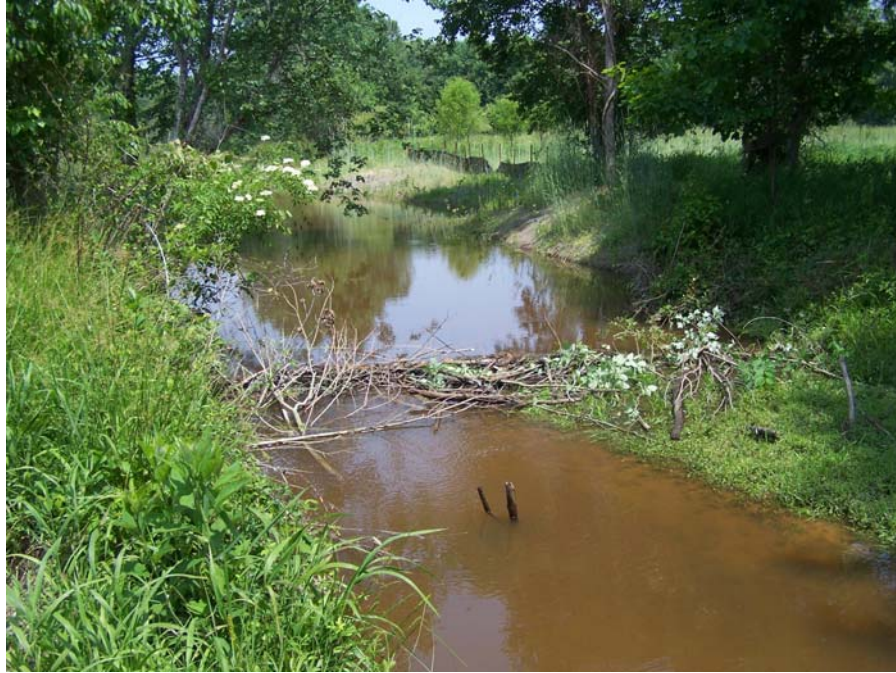
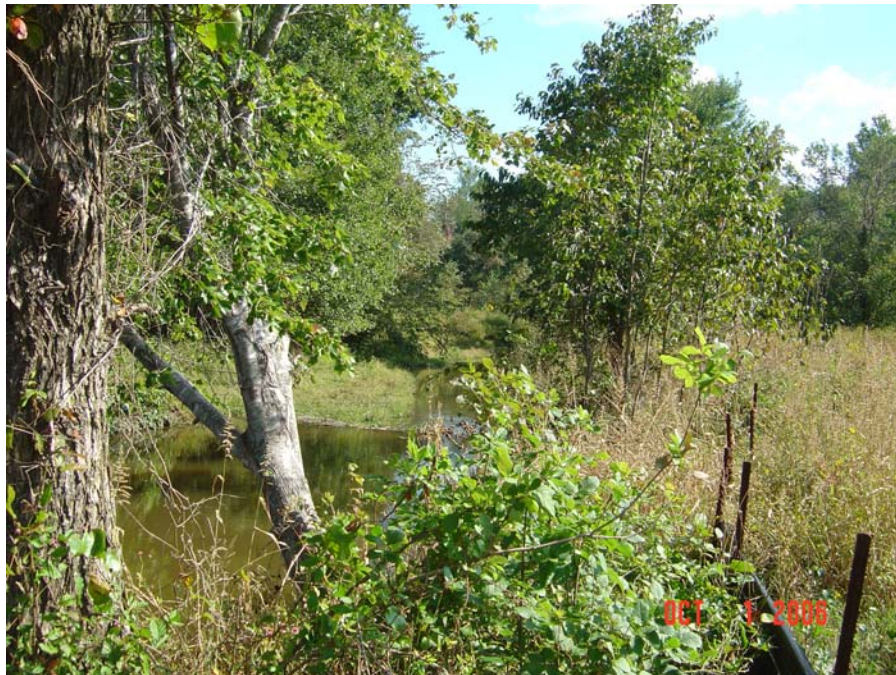
The areas of repair were examined and it was determined that there has been no damage since construction. There are, however, at least two beaver dams downstream of the repair area on Moccasin Creek that have raised the water level, making it difficult to see the channel bottom. These dams should be removed.

Moccasin Creek Photographs, Beaver Dam just downstream of repair area

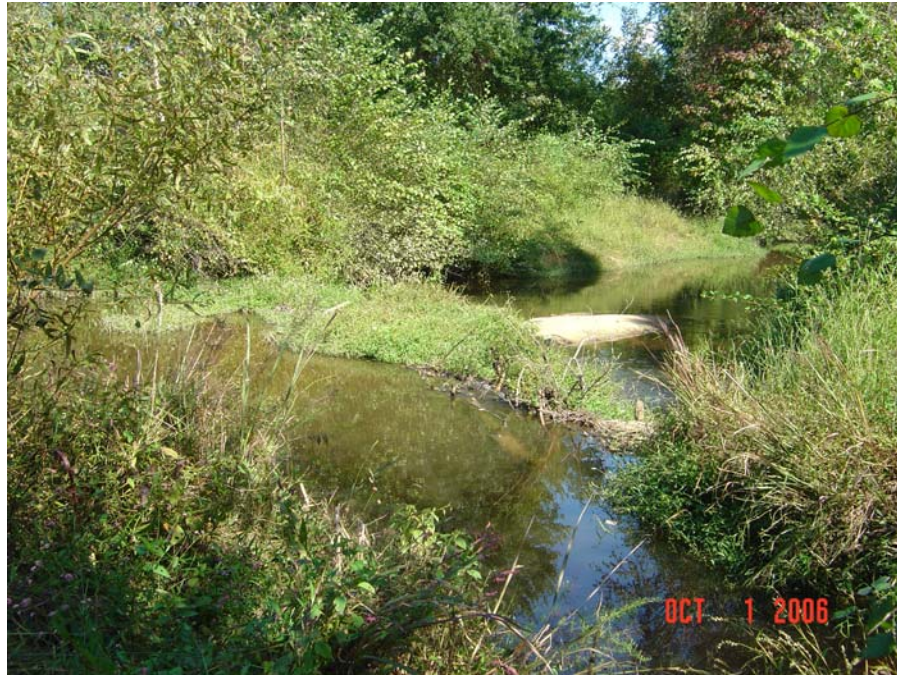
Moccasin Creek Photographs, Beaver Dam just above the confluence with Wolf Creek

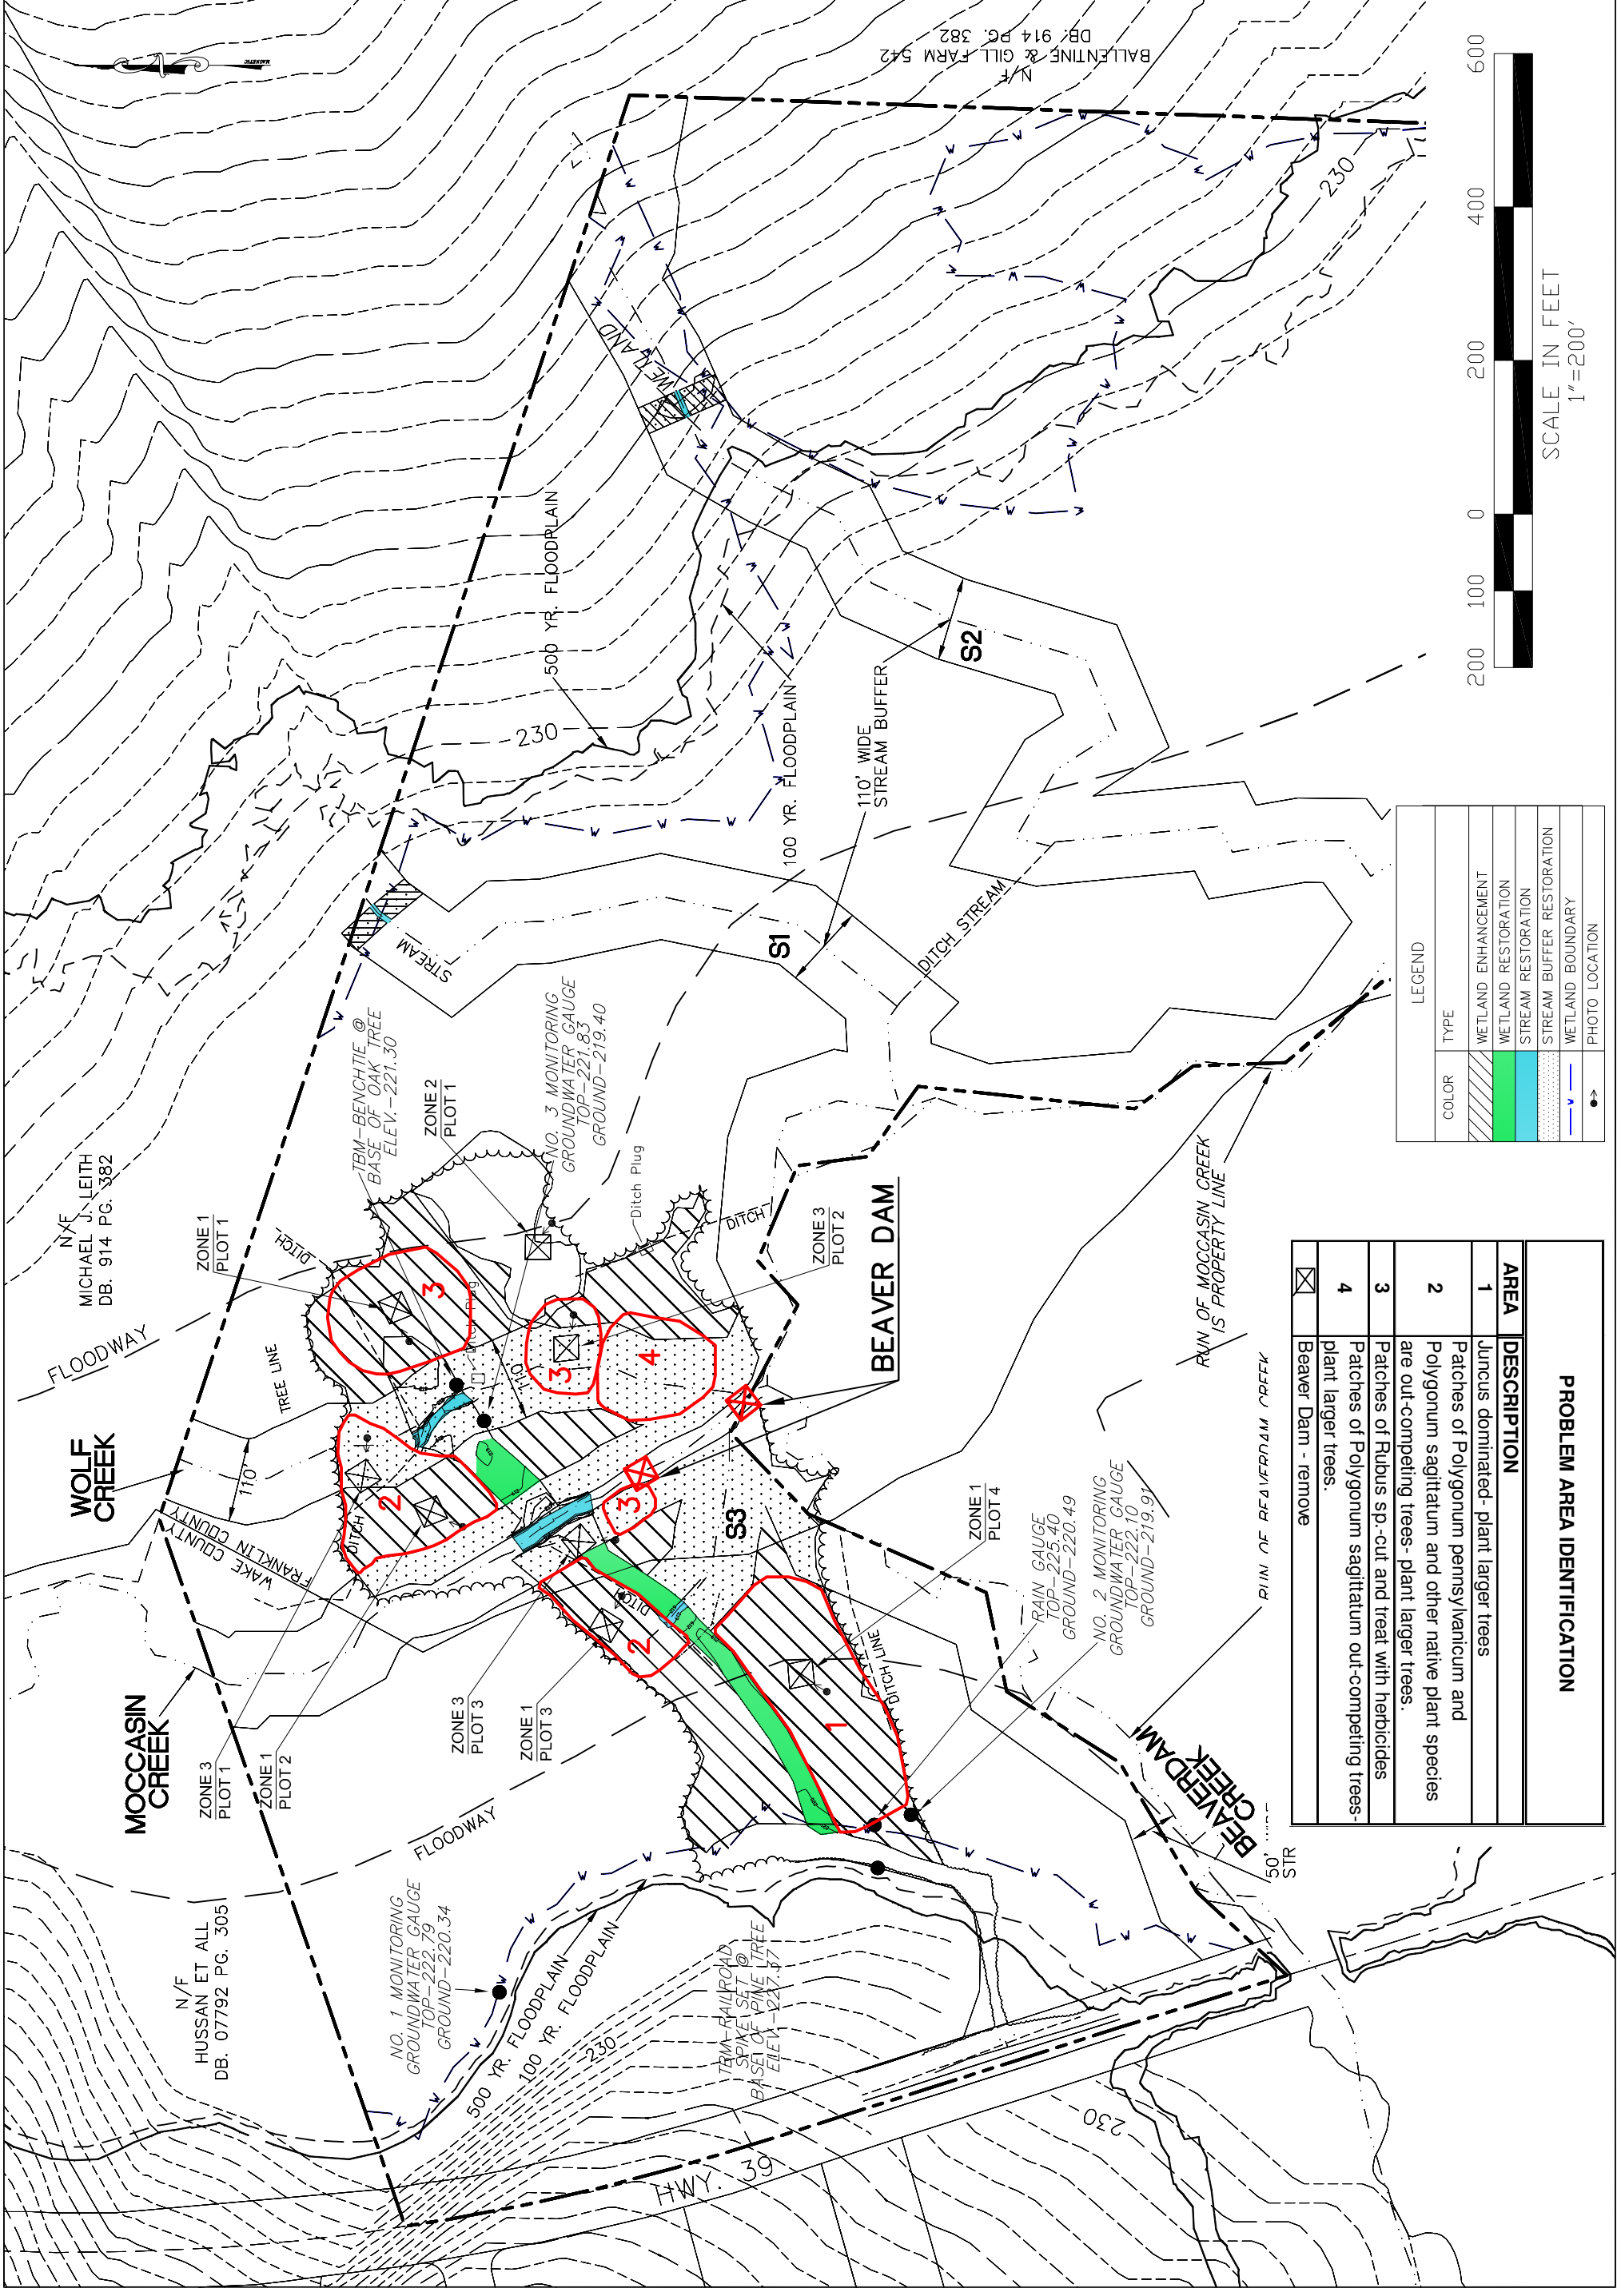
MOCCASIN CREEK
 AS-BUILT OVERALL SITE
 PROBLEM AREA PLAN

PROBLEM AREA IDENTIFICATION	
AREA	DESCRIPTION
1	Juncus dominated - plant larger trees
2	Patches of Polygonum pennsylvanicum and Polygonum sagittatum and other native plant species are out-competing trees - plant larger trees.
3	Patches of Rubus sp.-out and treat with herbicides
4	Patches of Polygonum sagittatum out-competing trees - plant larger trees.
[X]	Beaver Dam - remove
