Year 2 Monitoring Report

MOCKINGBIRD SITE

NCDMS Project # 100021 (Contract # 7185)
USACE Action ID: SAW-2017-01505
DWR Project #20171040

February 2023

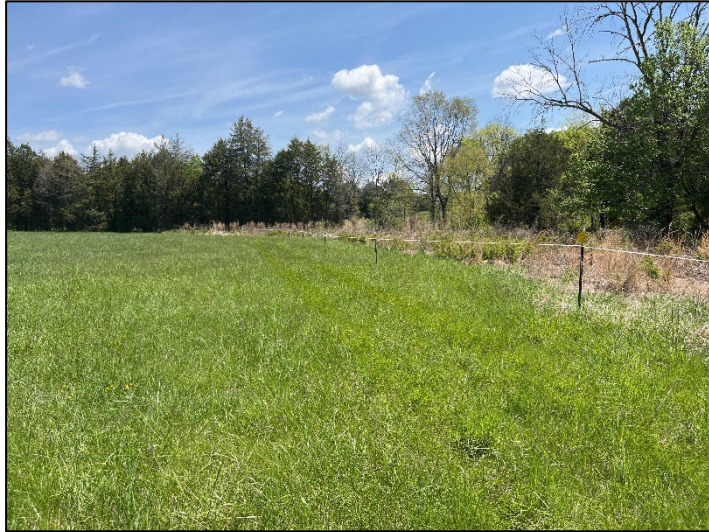
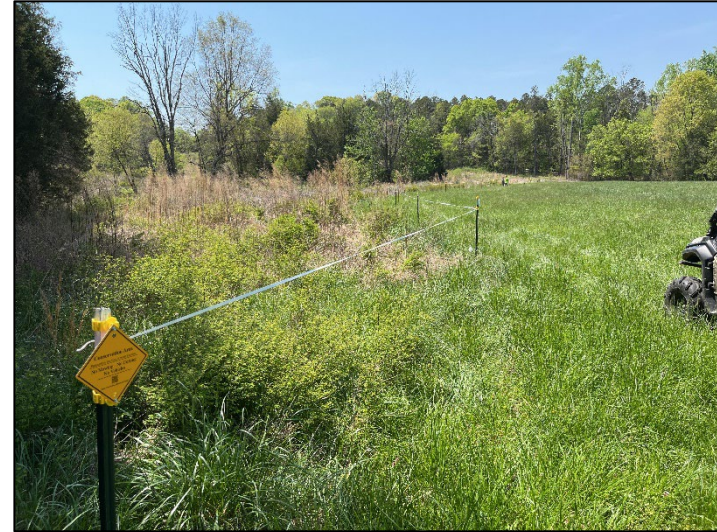
TP-3 Easement Boundary (4/22/2022)

Areas around TP3 and HC2-B are no longer having any encroachment and/or scalloping issues. These areas were marked heavily with additional t-posts and horse tape to clearly define the easement boundary on April 22nd, 2022. Since then, these areas have been checked for encroachment several times. Photos of these areas can be seen in Appendix B. Additional photos can be provided in MY3. Small areas if scalloping were noted along the easement edge directly north of XS9/10, this will be addressed in MY3.

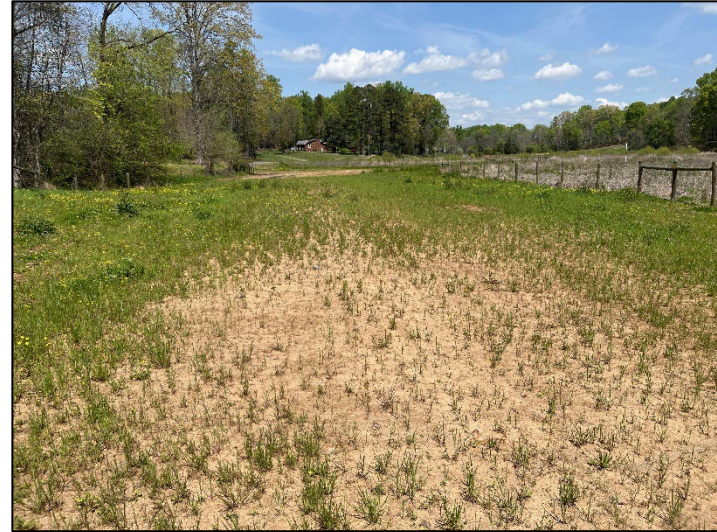
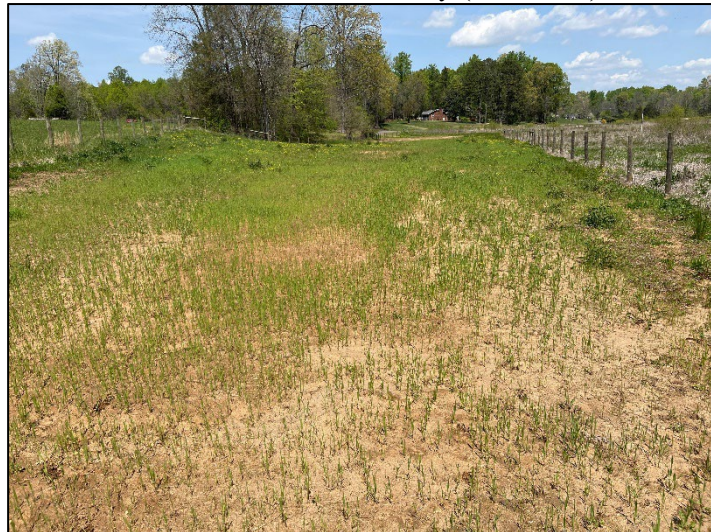
Regrading Area (4/22/2022)

The hydrologic trespass area noted near NM2 was regraded so that the field would have positive drainage. The field was regraded on December 8th, 2021 to help with the standing water. RES believes that these actions have resolved the hydrologic trespass. The area of regrading has been called out on the CCPV. Some photos are included in Appendix B and updated photos can be included in MY3.

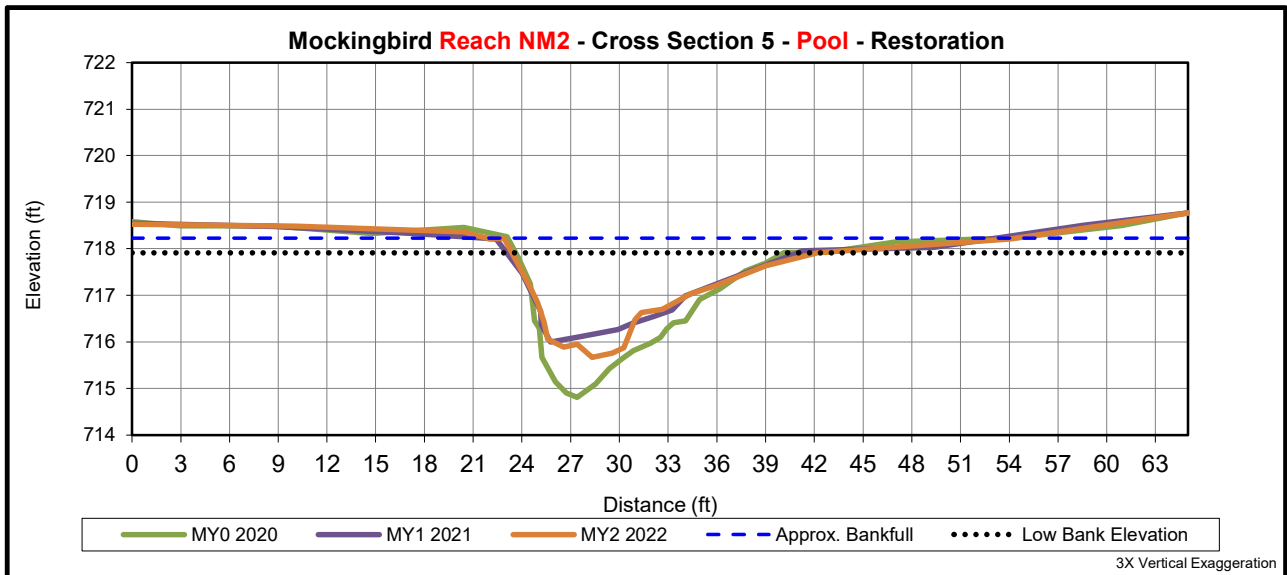
Cross section 5 and 17 only showed minor variations between MY0 and MY1. The MY2 conditions are stable and should continue to function properly.

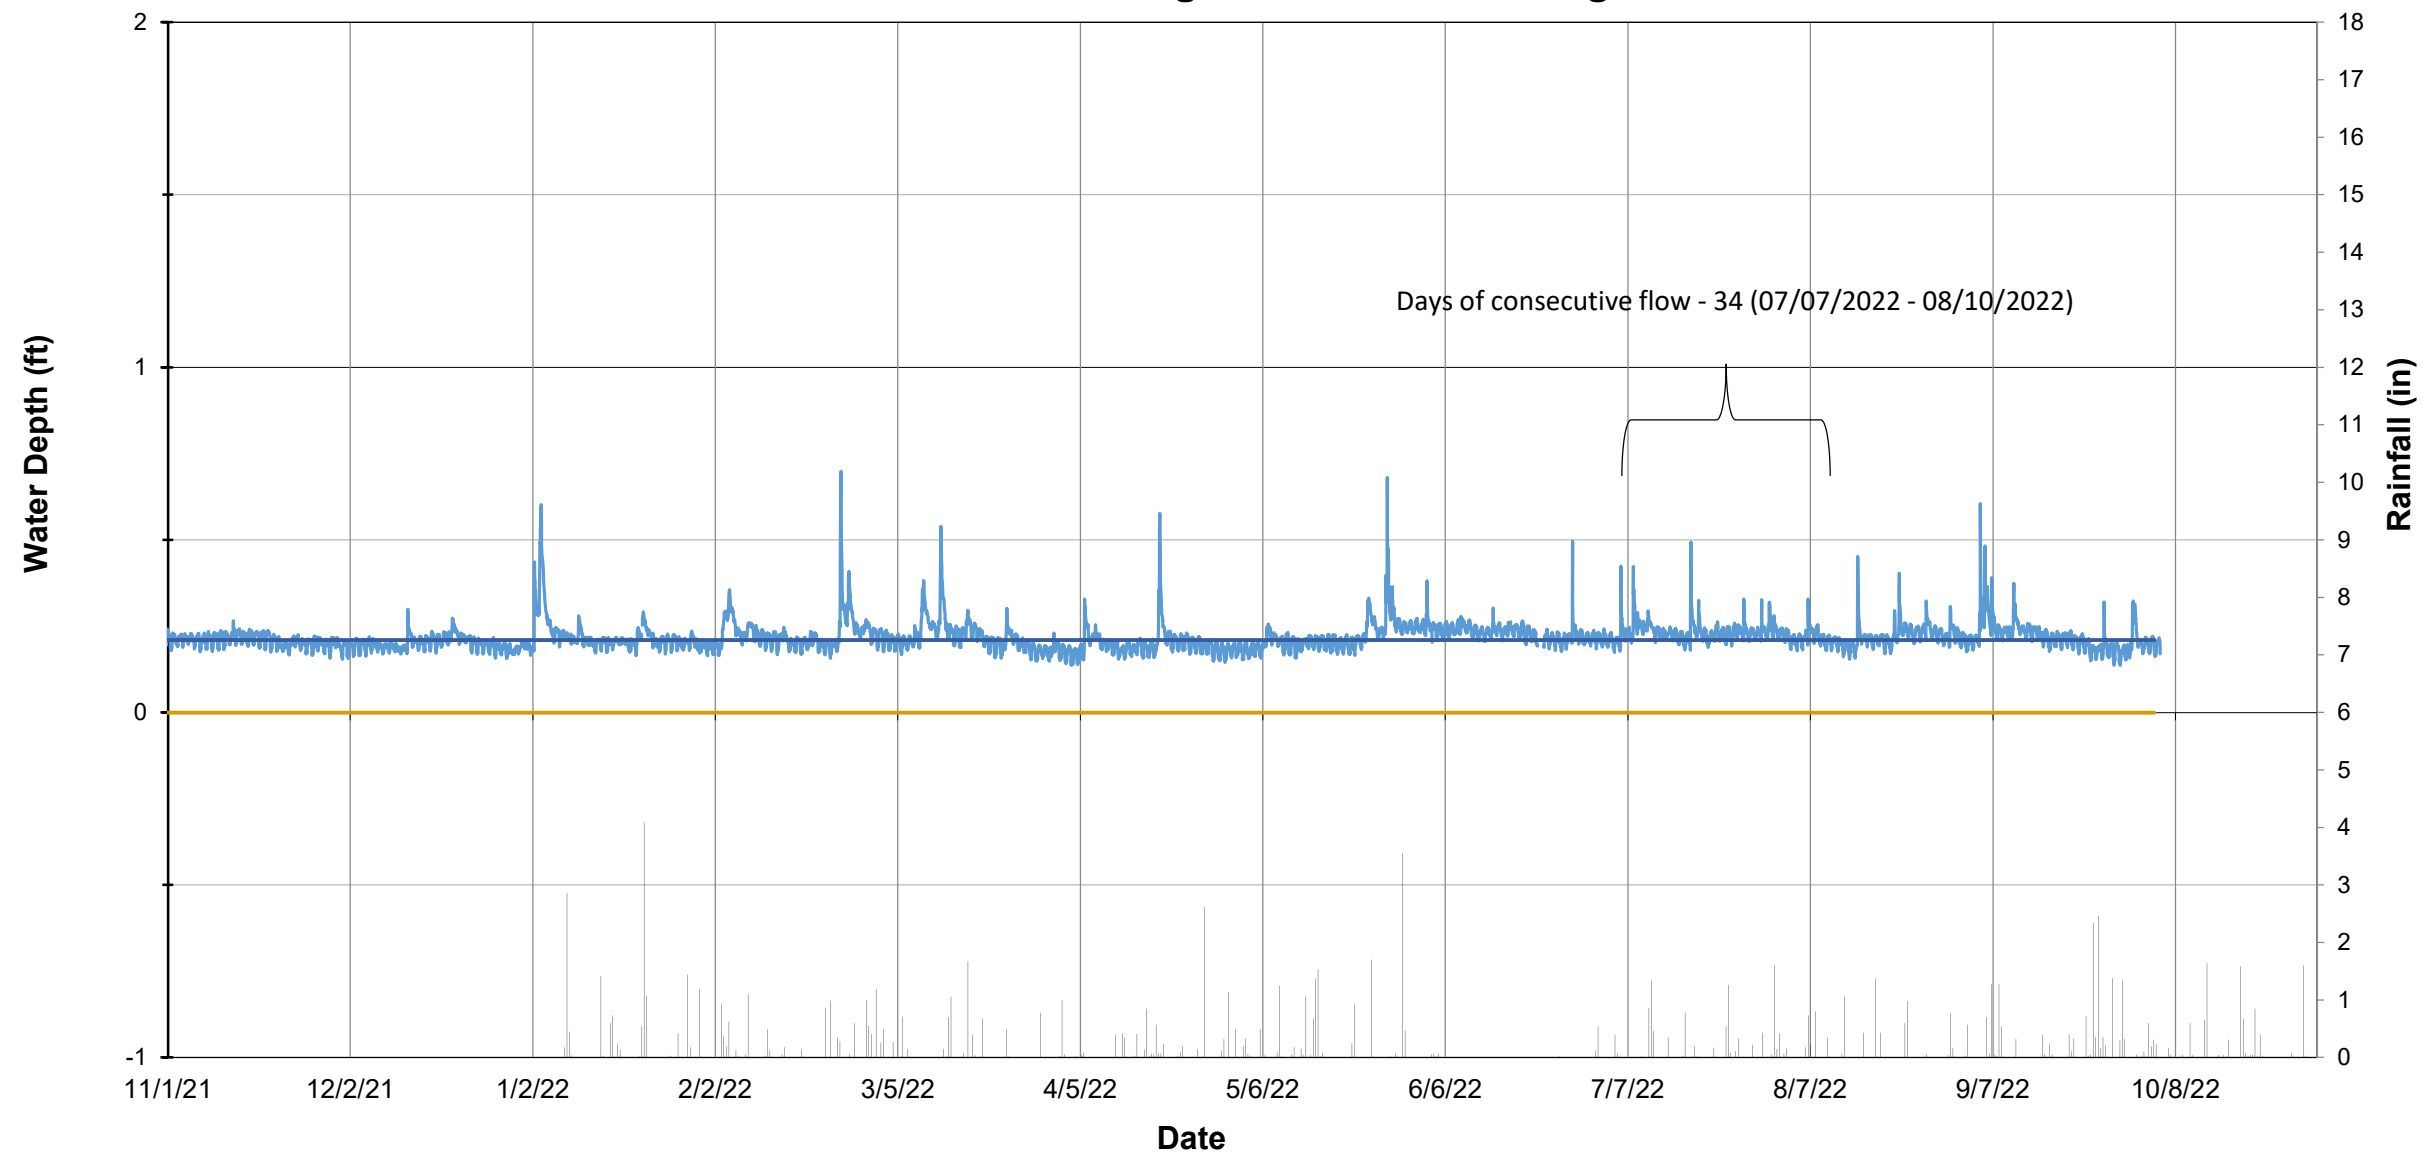
MY2 2022 Mockingbird NM1 Flow Gauge

Days of consecutive flow - 34 (07/07/2022 - 08/10/2022)
