Year 3 Monitoring Report

MOCKINGBIRD SITE

NCDMS Project # 100021 (Contract # 7185)

January 2024

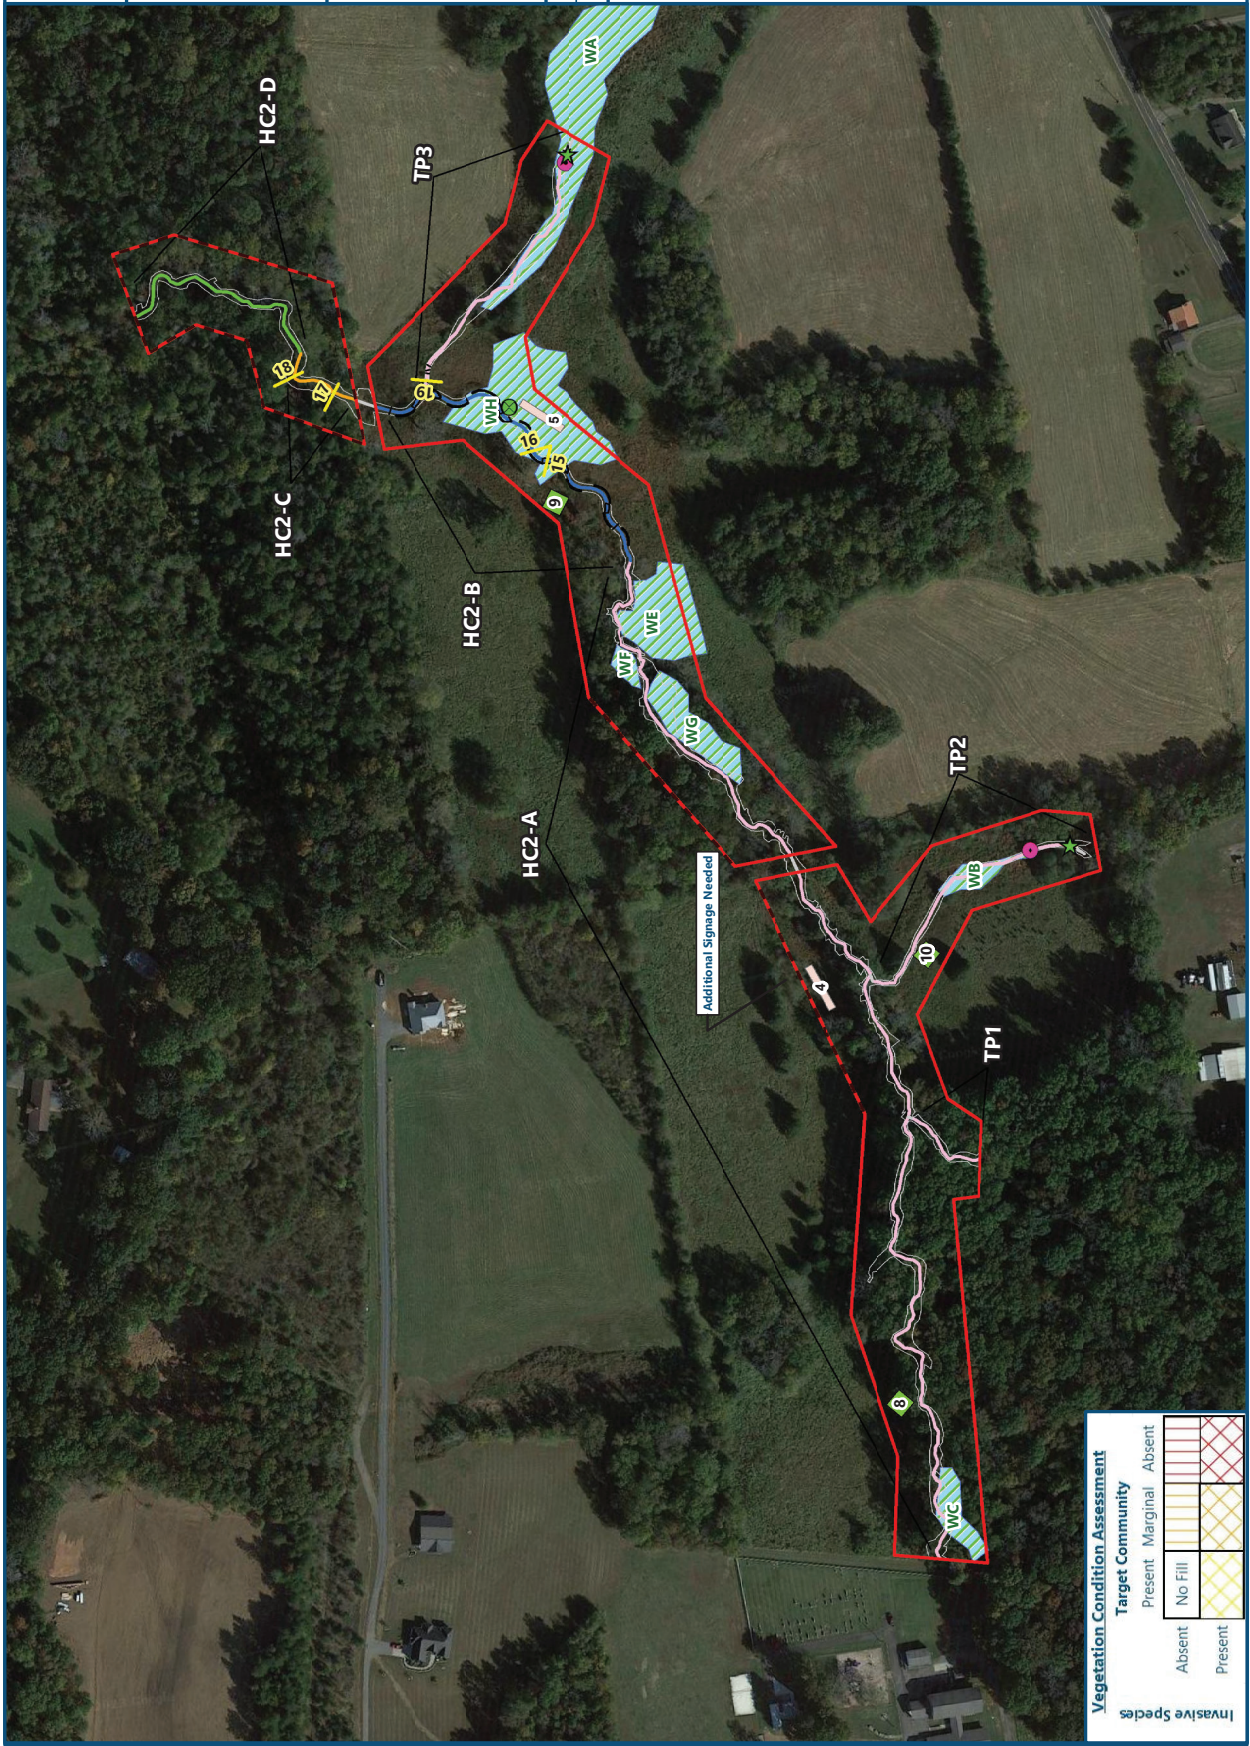
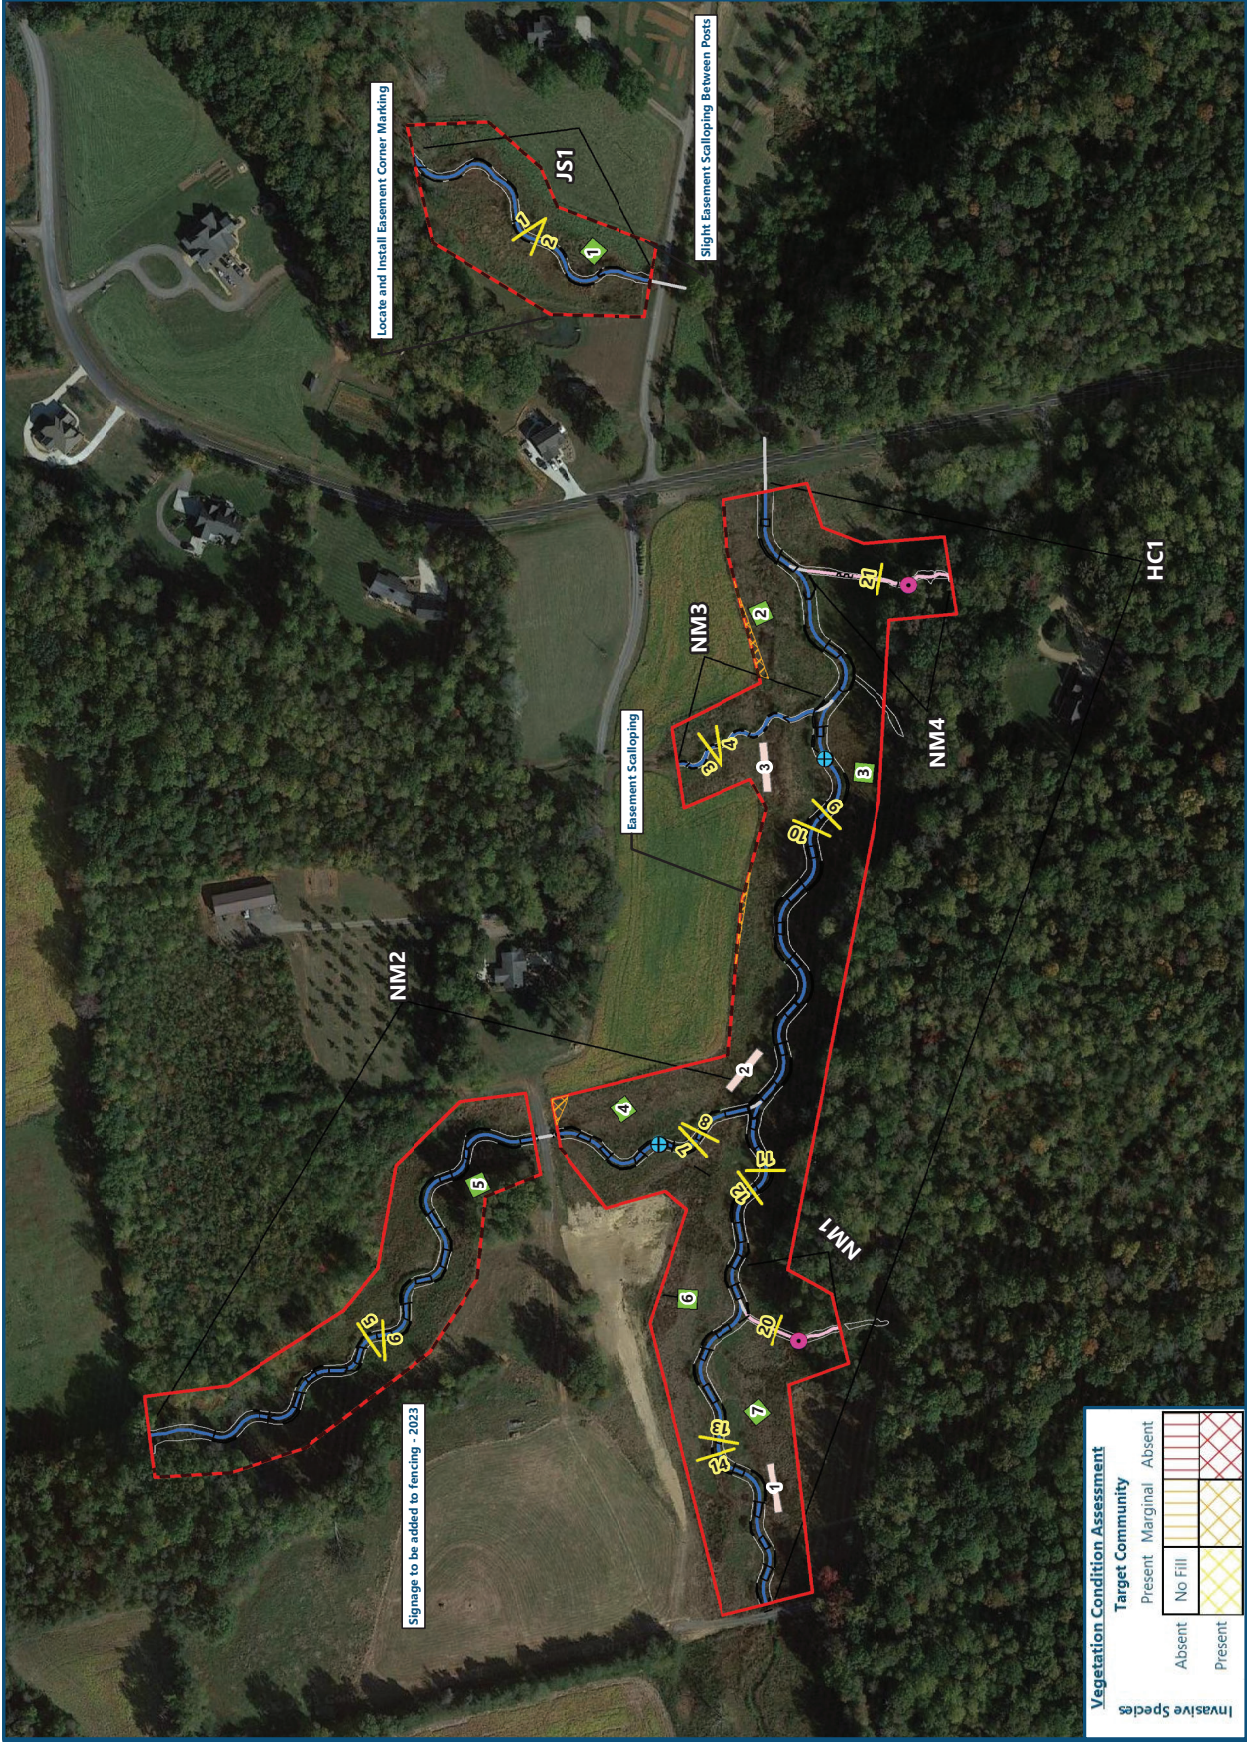
Visual assessment of vegetation outside of the monitoring plots indicates that the herbaceous vegetation is becoming well established throughout the project. A small scattering of Chinese privet, autumn olive, and multiflora rose was observed throughout the easement, these areas will be treated in 2024. No polygons of invasive species greater than 1000 ft² were found on site. Several areas around the easement have insufficient boundary marking however only a few small areas of easement encroachment are located around the site (< 0.1 acres), these areas are called out in **Figure 2** of **Appendix B**. RES is working currently to solve all easement issues found on the site and will remain in contact with NCDMS to rectify the situation. Photos of crossings can be found in **Appendix B** and appear to be functioning as designed.

- When the site is treated for scattered invasives in 2024, please remember to map the treated areas in the MY4 (2024) report.
[RES will include the treated invasive polygons in the MY4 CCPV figure.](#)

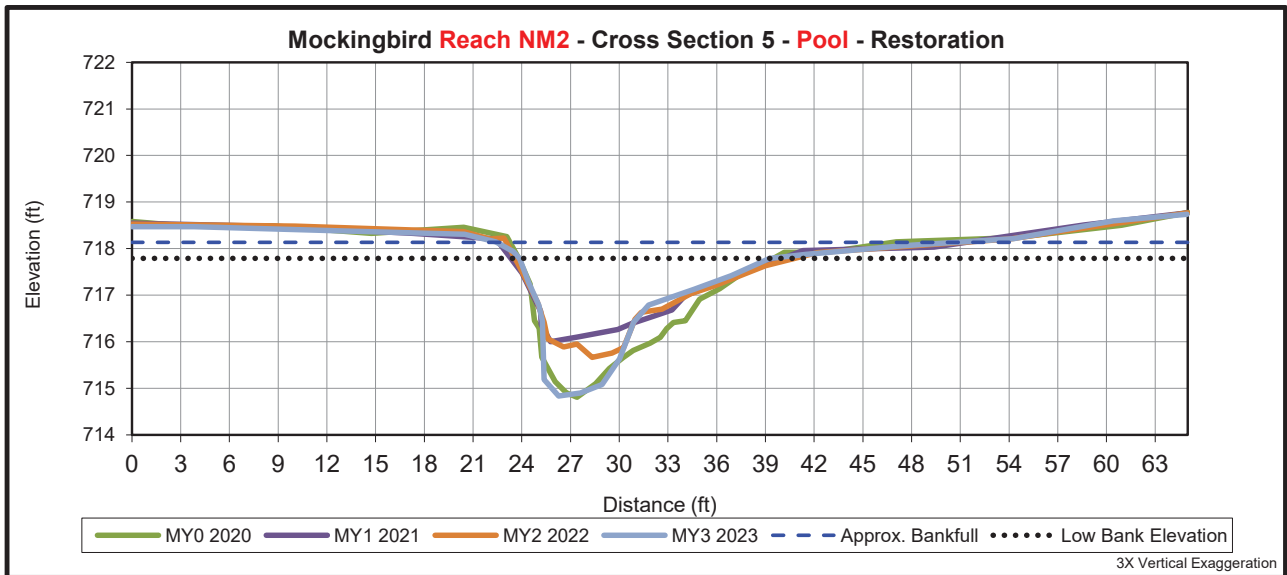
Cross Section 5 (Pool)						
	MY0	MY1	MY2	MY3	MY5	MY7	MY+
Bankfull Elevation (ft) - Based on AB-XSA¹	717.92	718.3	718.2	718.1			
Bankfull Width (ft) ¹	-	-	-	-			
Floodprone Width (ft) ¹	-	-	-	-			
Bankfull Max Depth (ft) ²	3.1	2.0	2.3	3.0			
Low Bank Elevation (ft)	-	718.0	717.9	717.8			
Bankfull Cross Sectional Area (ft ²) ²	25.8	19.3	19.8	20.4			
Bankfull Entrenchment Ratio ¹	-	-	-	-			
Bankfull Bank Height Ratio ¹	-	-	-	-

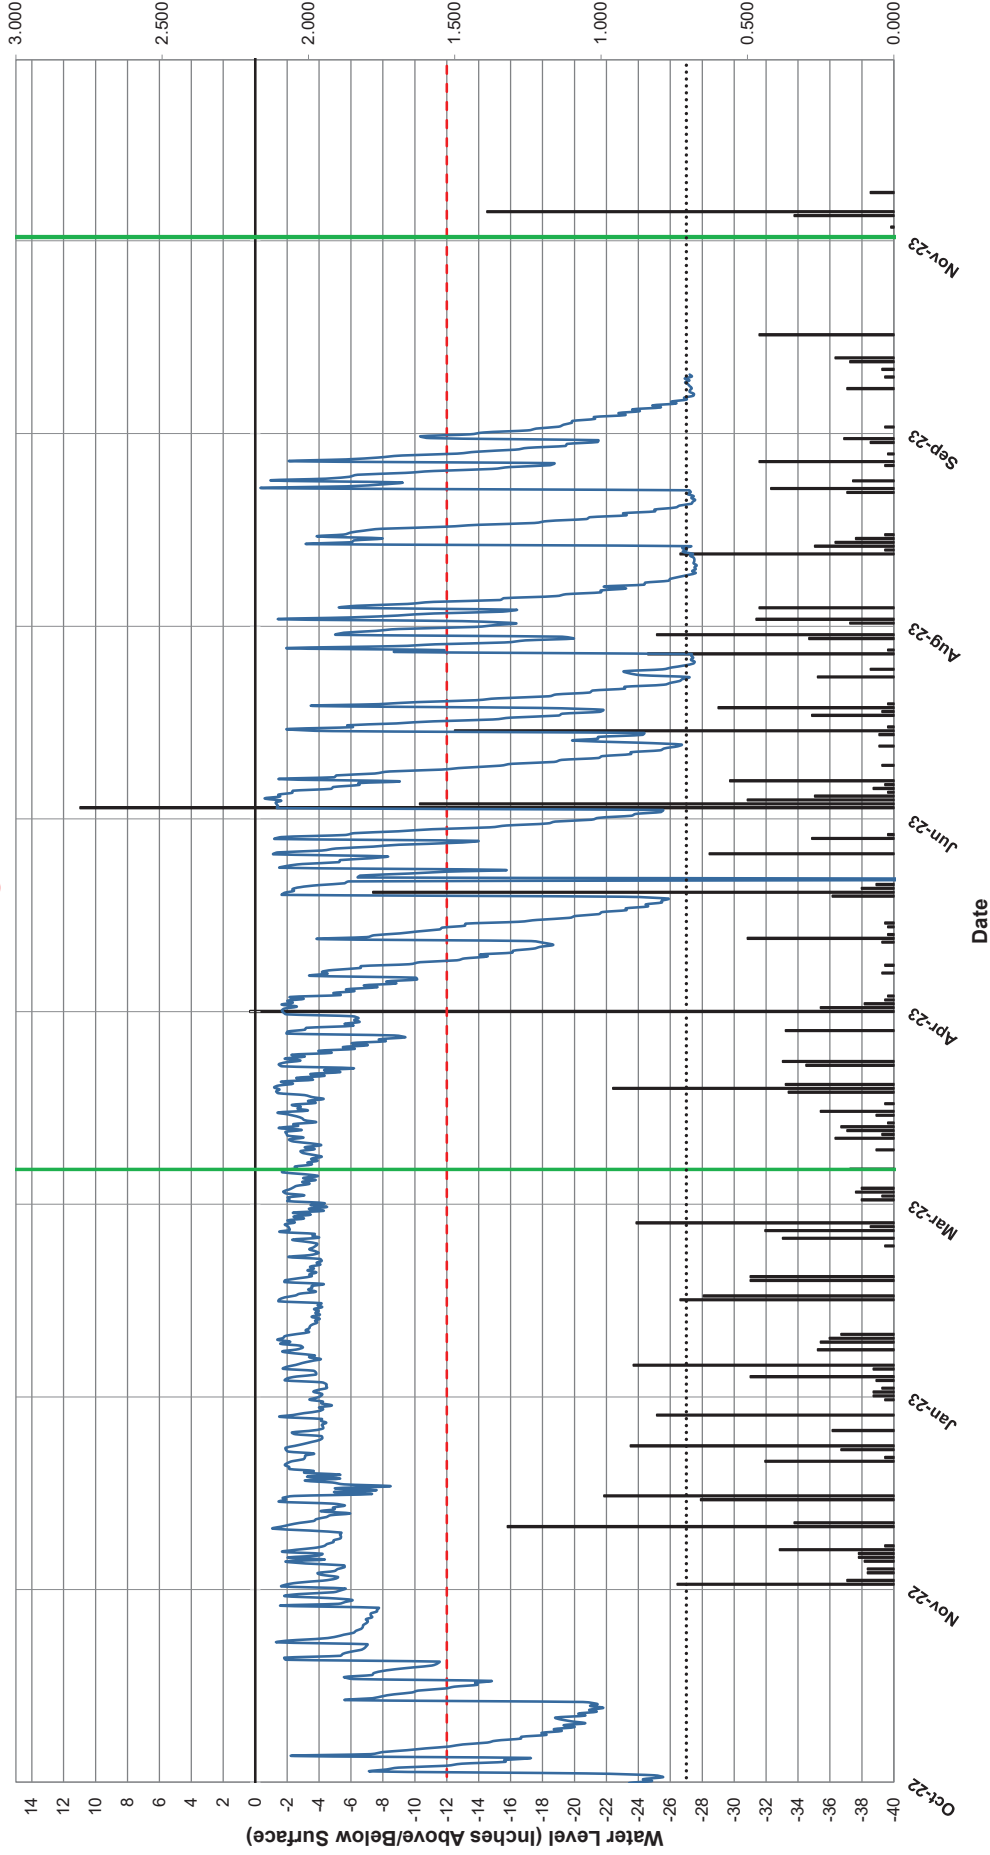
2023 Mockingbird GW1

One groundwater well (GW1) was installed in April 2020. The goal of the groundwater well is to track the hydrology in the jurisdictional wetlands on site post-construction. There is no hydroperiod success criteria for this groundwater well. In MY3, GW1 recorded a consecutive hydroperiod of 22 percent of the growing season. Wetland hydrology data is included in **Appendix E**. The groundwater well location can be found on **Figure 2**.

33 Consecutive Days of Hydrology
03/18/2023 - 06/01/2023

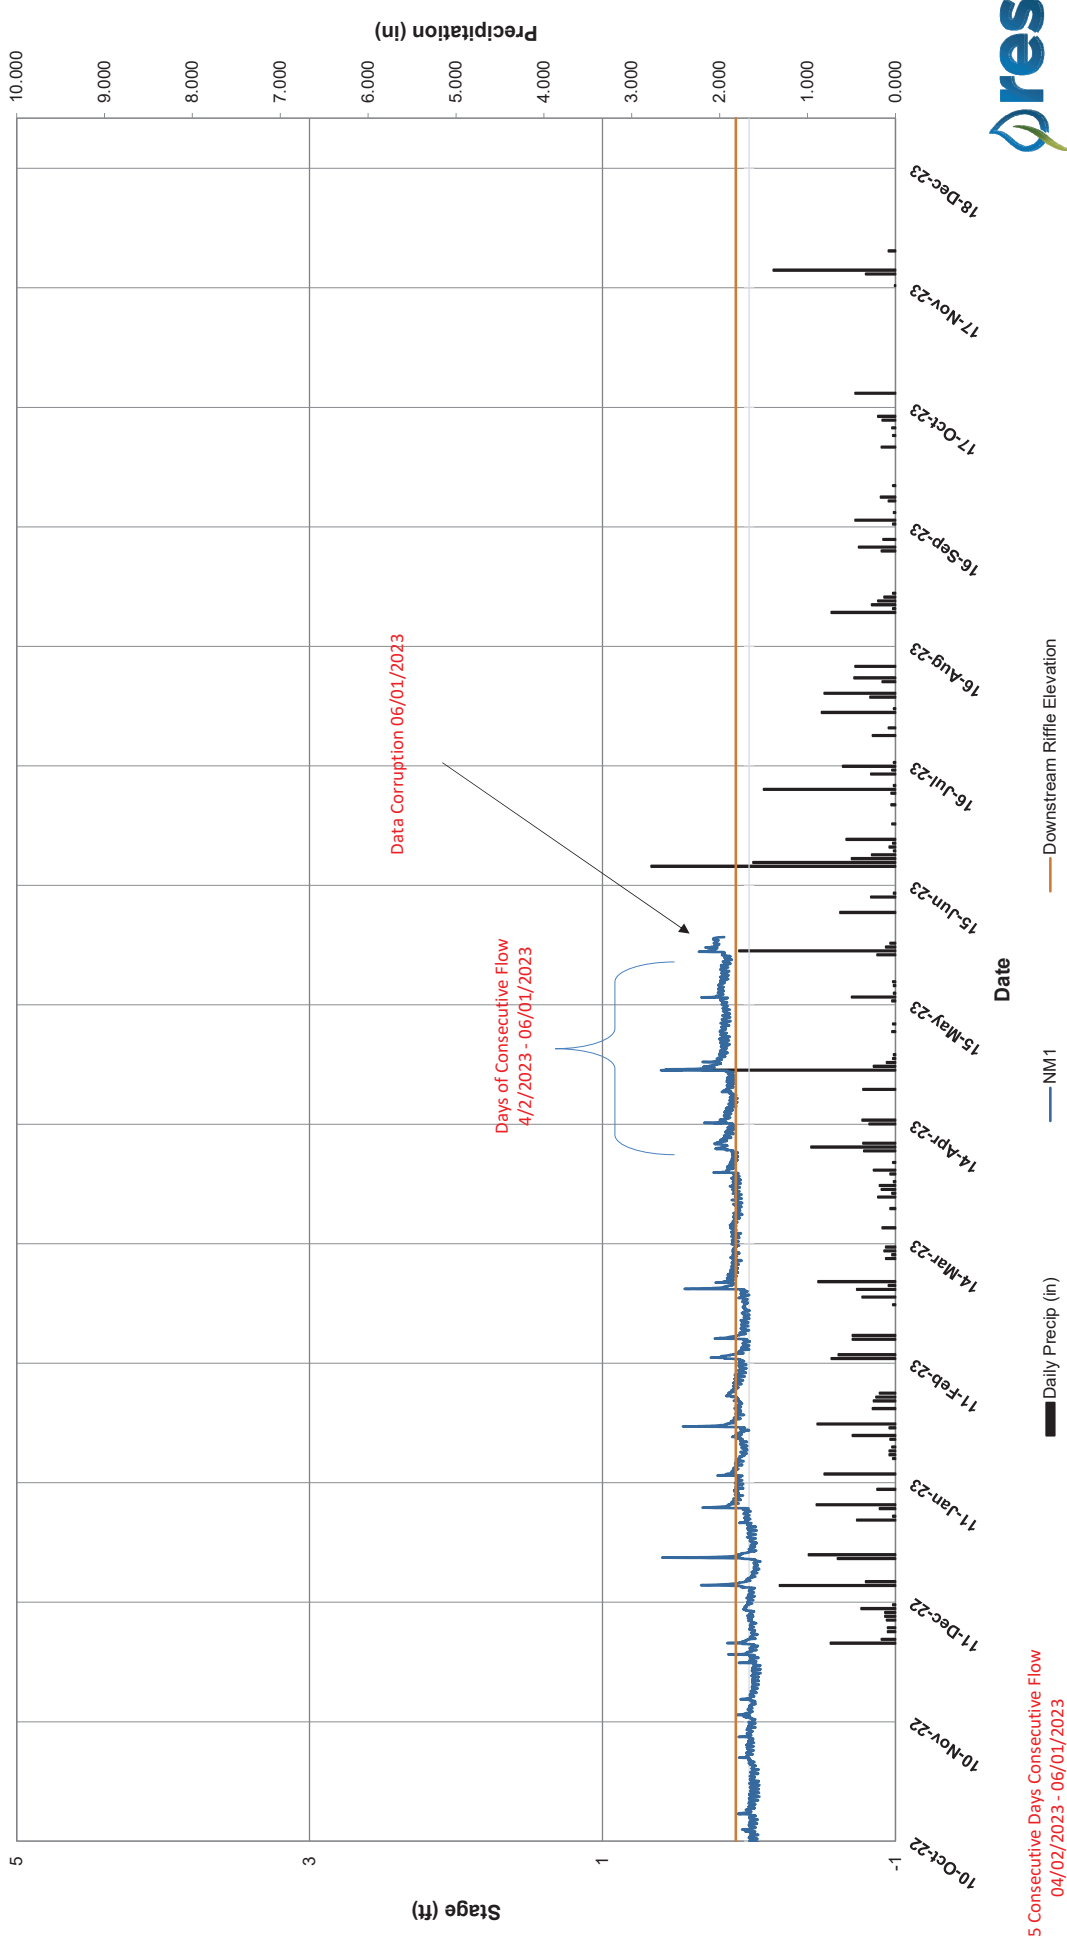
2023 Mockingbird NM1 Flow Gauge Graph

55 Consecutive Days Consecutive Flow
04/02/2023 - 06/01/2023

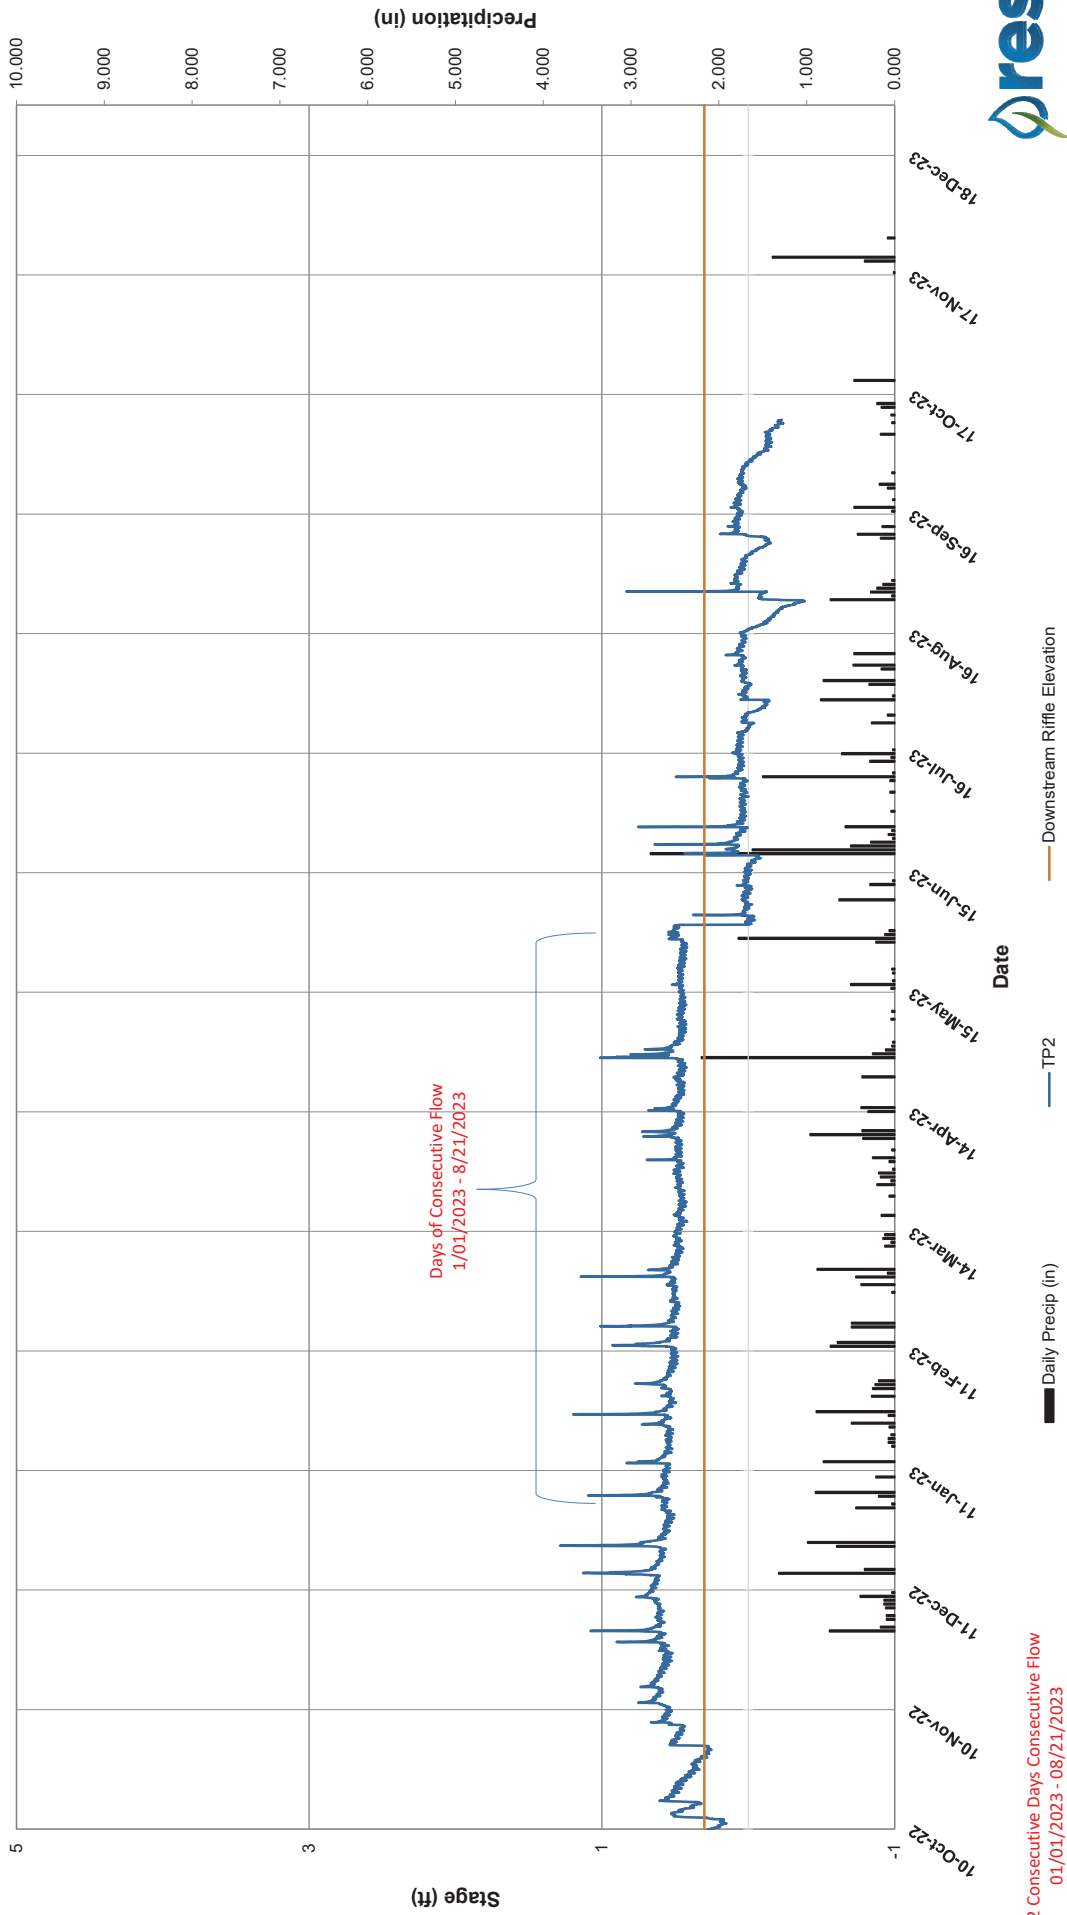
2023 Mockingbird TP2 Flow Gauge Graph

232 Consecutive Days Consecutive Flow
01/01/2023 - 08/21/2023

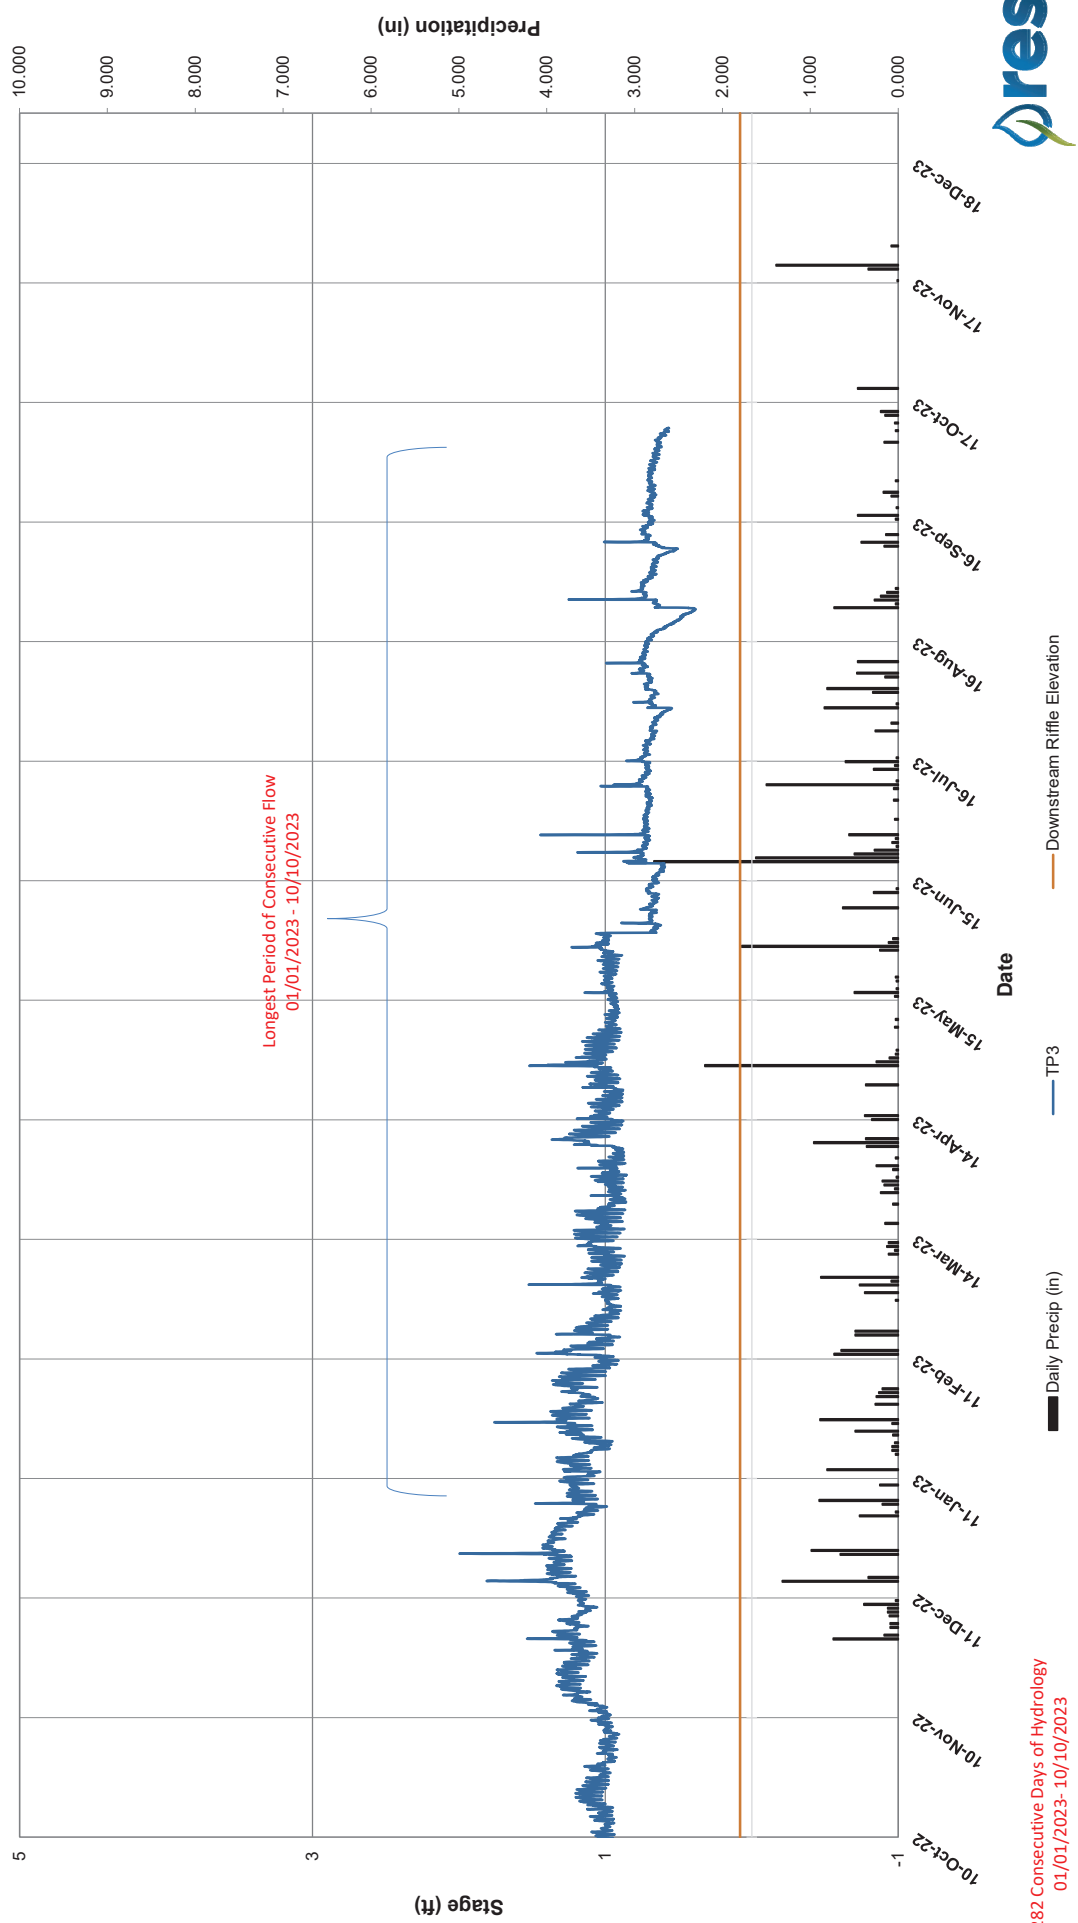
2023 Mockingbird TP3 Flow Gauge Graph

282 Consecutive Days of Hydrology
01/01/2023- 10/10/2023
