**Modlin Property Wetland Mitigation Project
Martin County, NC**

**2010 Annual Monitoring Report
Year 4**

**NCEEP Project Number D050241
Roanoke River Basin**

Date: October, 2010

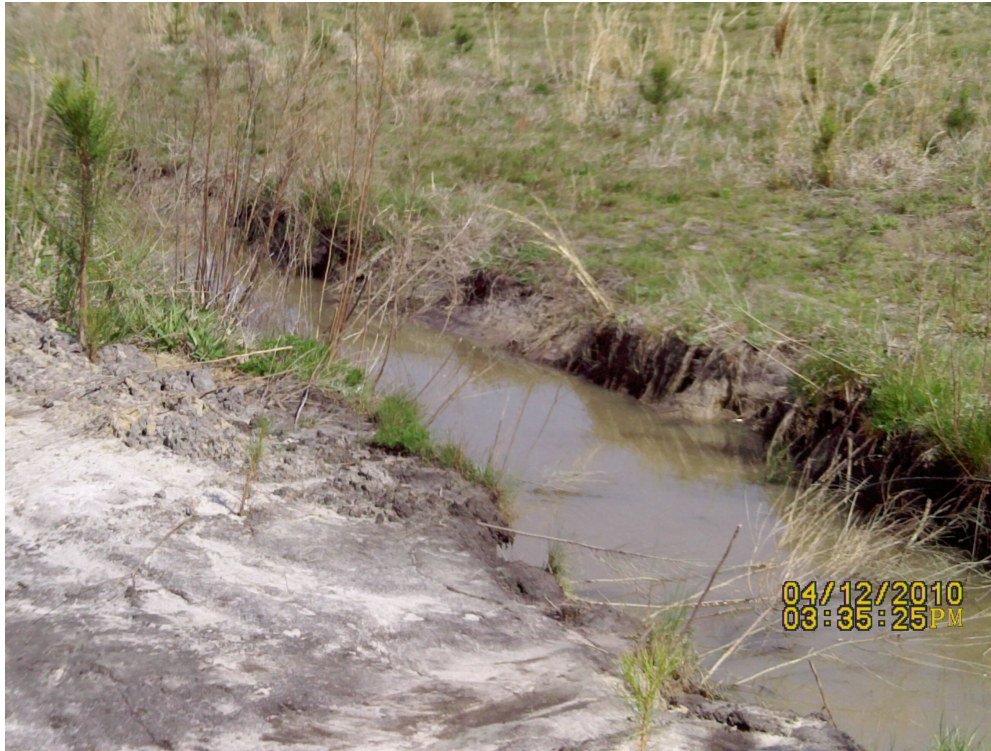
The hydrology pattern around gauge 1 continued to be unsuccessful and in fact, largely unchanged since monitoring began in 2007. Since gauge 4 is actually closer to the perimeter ditch than gauge 1, and gauge 4 will show successful hydrology given normal rainfall patterns, the problem at gauge 1 appeared to be something other than connectivity to the perimeter ditch. Despite that, and in order to make all efforts toward successful hydrology, the perimeter ditch at gauge 1 was plugged in both directions and the berm was reshaped to allow overflow from the ditch onto the project (as protection to the adjoining land).

Ditch near Gauge 1 after plugging

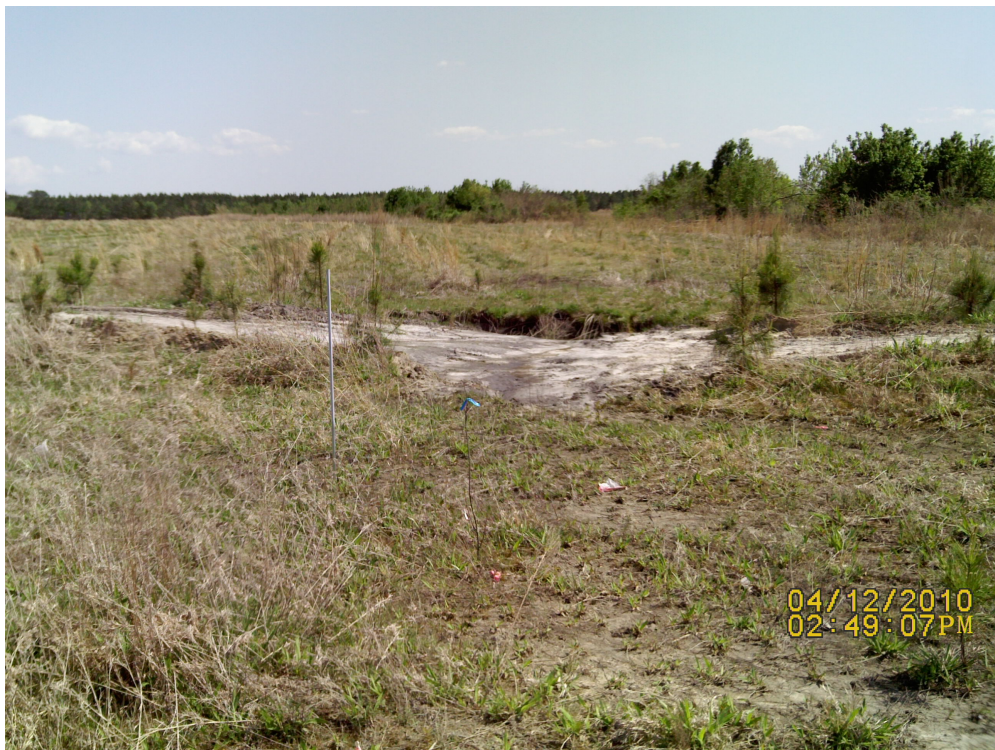
Reprofiling of berm near Gauge 1 to allow water onto site

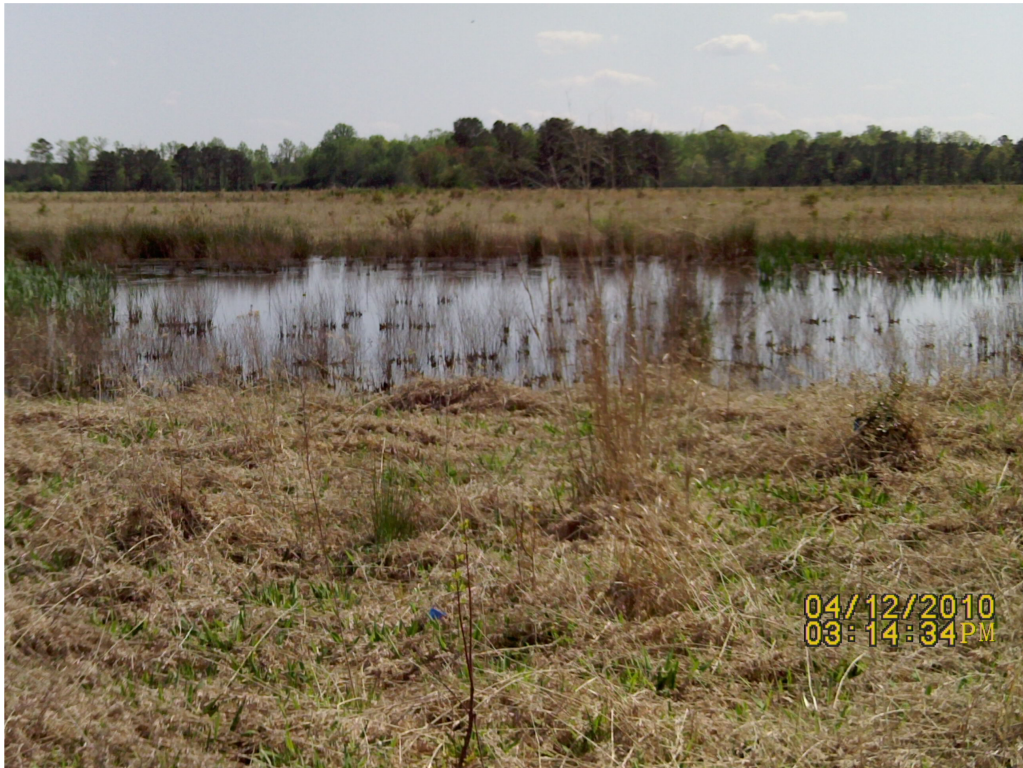
Low areas are completely filled in April of 2010

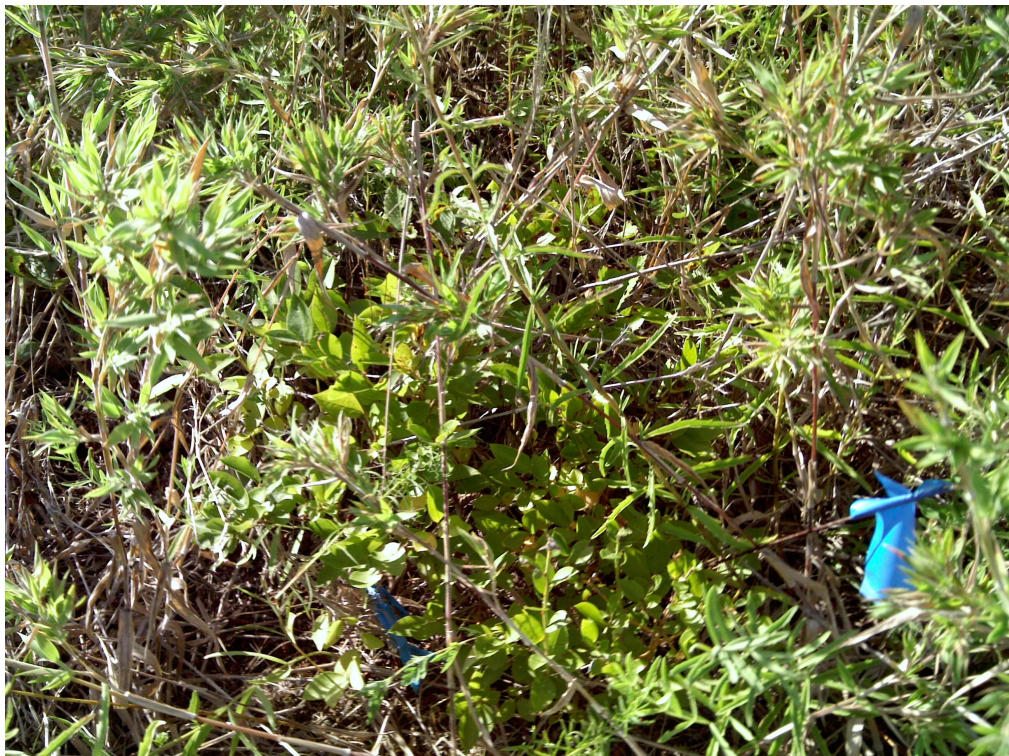
Rainfall data collected on site show total precipitation for January through September 2010 to be well below normal with an 11.52" deficit. It appears that lack of rain had little effect on vegetation mortality, but intense herbaceous competition continues to take a toll on vegetation development and growth. The photos in Appendix C illustrate the dense, heavy layer of vegetation that the trees and shrubs must compete with for scarce moisture during the peak of the growing season.

Feature/Issue	Plot	Probable Cause	Photo #
Herbaceous competition causing slow tree and shrub growth	All, but a minor problem at this point. Most stems are well established.	Dense herbaceous cover	Visible in all general photos

Extremely dense herbaceous vegetation in Sept. Blueberry bush in heavy competition

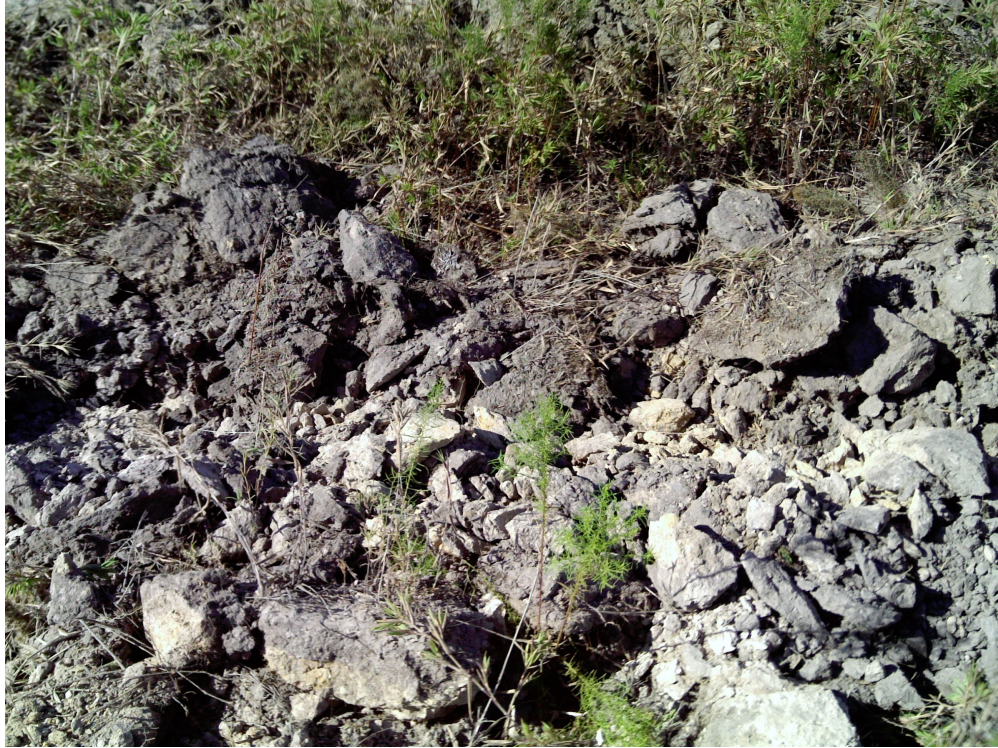
A view after subsoiling in September of 2010

Also, after experimenting with various configurations of additional gauges (1A and 1B**) near gauge 1, it was determined that soil compaction may be at least a contributing factor to the problem since plugging the perimeter ditch had little affect on groundwater levels within the project site. To alleviate the potential problem of compacted soil, five acres along the perimeter ditch from west of gauge 1 all the way to gauge 1A were subsoiled to a depth of approximately 24 to 30 inches in September of 2010. The photos in Appendix C show good fracturing of the clay layers since the ground was extremely dry when subsoiling was done. Gauges 1, 1A and 1B were reset after subsoiling and monitoring will continue. The area will receive supplemental planting with appropriately sized stock in the fall of 2010.

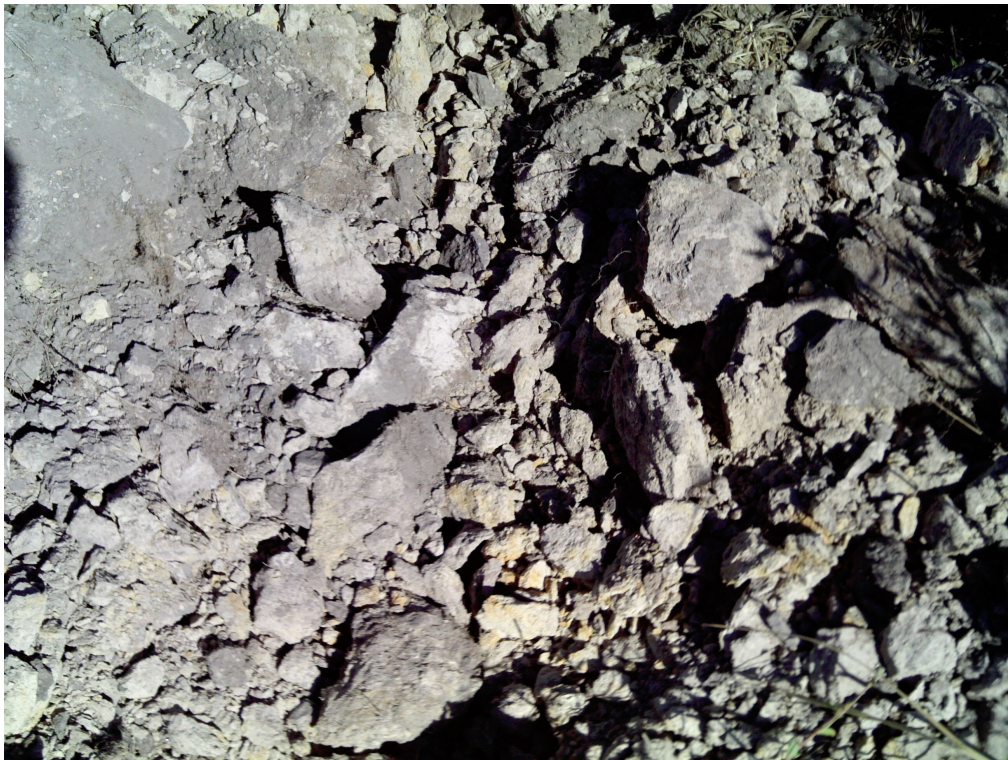
Another view of subsoiled area showing good clay fracturing

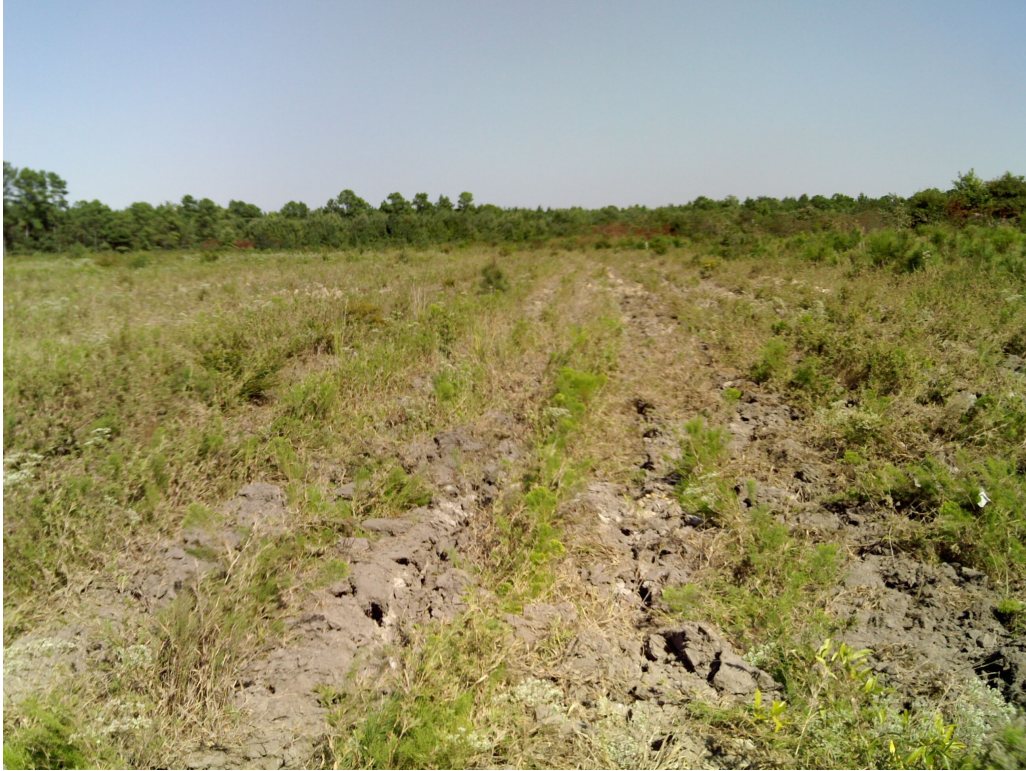
View of subsoiled area near Gauge/Plot 1

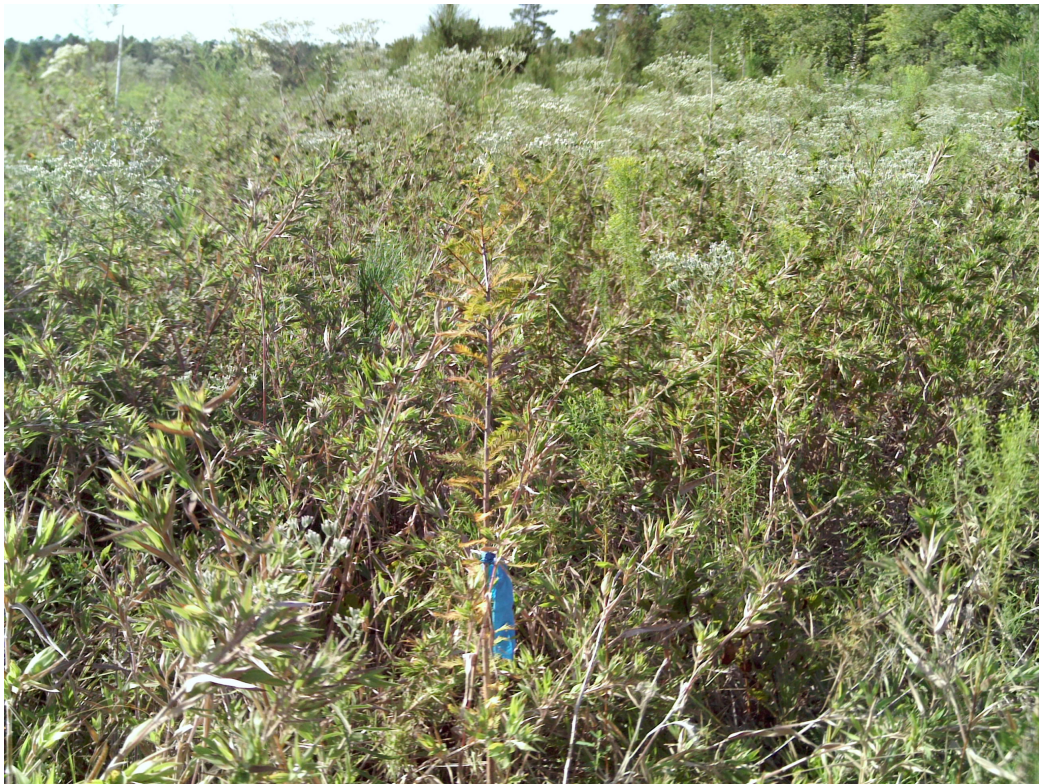
A healthy Cypress stem in extremely dense herbaceous layer

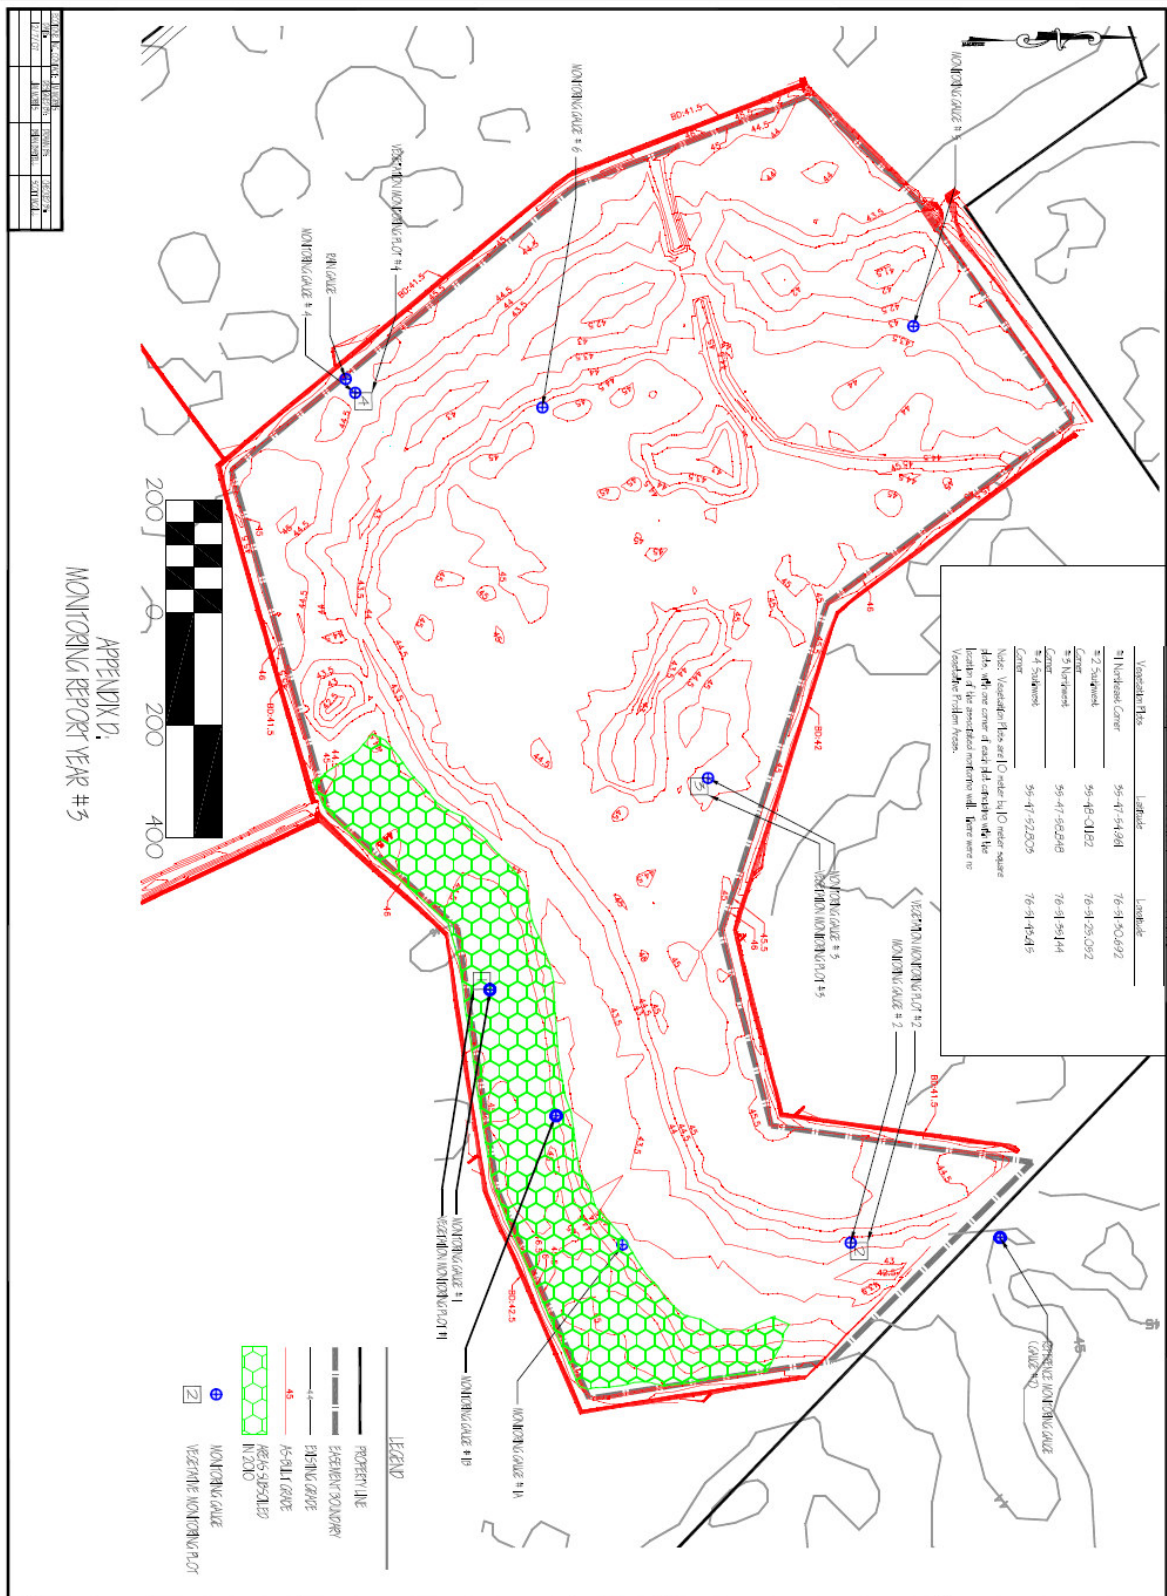
Monitoring Plan View (Integrated)

Figure 4 in Appendix D illustrates an area of the site where hydrology is a potential problem, but there are no apparent micro scale problems with vegetation.

Figure 4 in Appendix D provides an overview of the site. The area shaded in green on the plan view indicates where subsoiling took place and where replanting will be done in the fall of 2010. The remainder of the site appears to be functioning properly in the event of normal rainfall.
