Year 2 Monitoring Report

MONKEY WALL PROJECT

NCDMS Project #100069 (Contract #7536)
USACE Action ID: 2018-01162
DWR Project #20181029

Mitchell County, North Carolina
French Broad River Basin
HUC 06010108

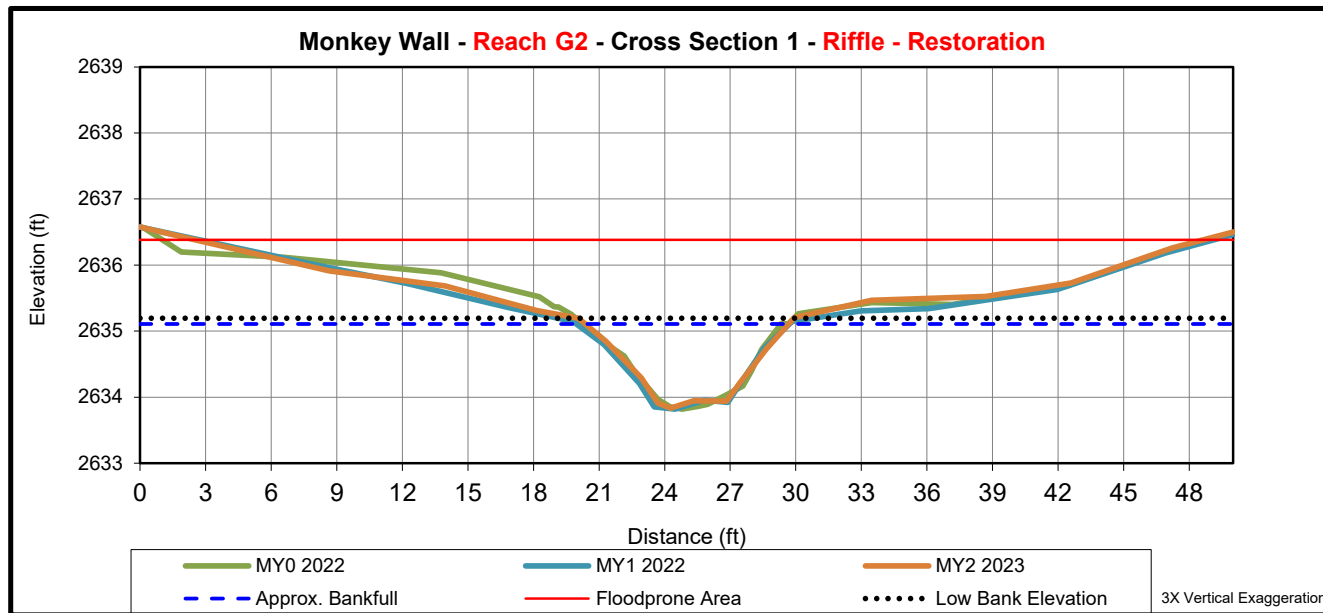
Cross Section 1 (Riffle)						
	MY0	MY1	MY2	MY3	MY5	MY7	MY+
Bankfull Elevation (ft) - Based on AB-XSA¹	2635.1	2635.1	2635.1				
Bankfull Width (ft) ¹	9.1	9.5	9.3				
Floodprone Width (ft) ¹	49.1	44.8	46.2				
Bankfull Max Depth (ft) ²	1.3	1.3	1.4				
Low Bank Elevation (ft)	2635.1	2635.1	2635.2				
Bankfull Cross Sectional Area (ft ²) ²	7.1	7.9	7.9				
Bankfull Entrenchment Ratio ¹	5.6	4.7	5.0				
Bankfull Bank Height Ratio ¹	1.0	1.1	1.1

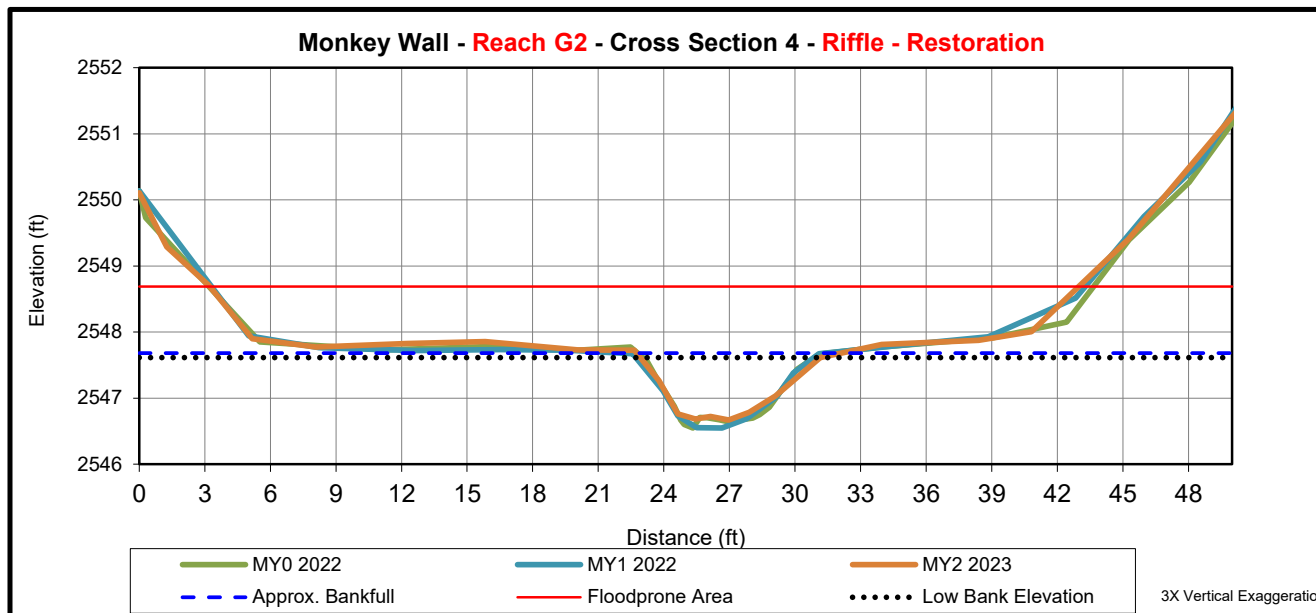
Cross Section 4 (Riffle)						
	MY0	MY1	MY2	MY3	MY5	MY7	MY+
Bankfull Elevation (ft) - Based on AB-XSA¹	2547.7	2547.6	2547.7				
Bankfull Width (ft) ¹	8.3	8.3	8.4				
Floodprone Width (ft) ¹	40.9	40.1	39.8				
Bankfull Max Depth (ft) ²	1.1	1.1	0.9				
Low Bank Elevation (ft)	2547.7	2547.7	2547.6				
Bankfull Cross Sectional Area (ft ²) ²	5.6	5.9	5.0				
Bankfull Entrenchment Ratio ¹	6.1	4.9	4.7				
Bankfull Bank Height Ratio ¹	1.0	1.0	0.9

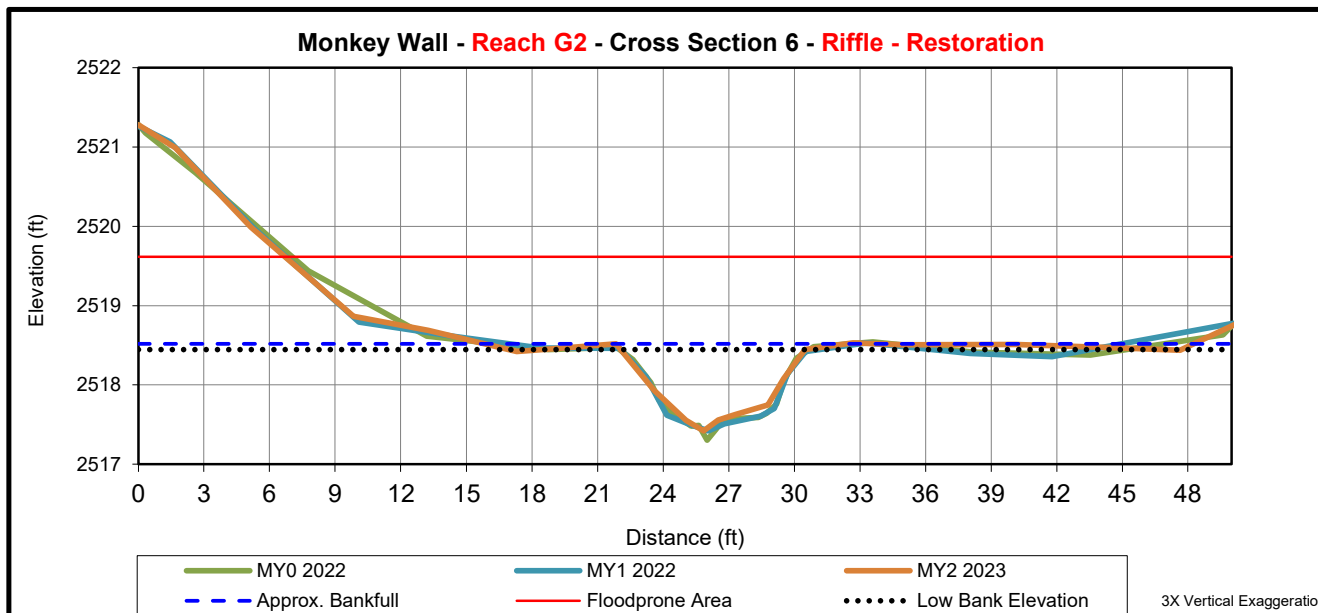
Cross Section 6 (Riffle)						
	MY0	MY1	MY2	MY3	MY5	MY7	MY+
Bankfull Elevation (ft) - Based on AB-XSA¹	2518.5	2518.5	2518.5				
Bankfull Width (ft) ¹	9.0	8.5	8.6				
Floodprone Width (ft) ¹	>43.2	>42.8	>43.4				
Bankfull Max Depth (ft) ²	1.2	1.0	1.0				
Low Bank Elevation (ft)	2518.5	2518.4	2518.4				
Bankfull Cross Sectional Area (ft ²) ²	5.8	5.5	5.2				
Bankfull Entrenchment Ratio ¹	>5.6	>5	>5				
Bankfull Bank Height Ratio ¹	1.0	1.0	0.9

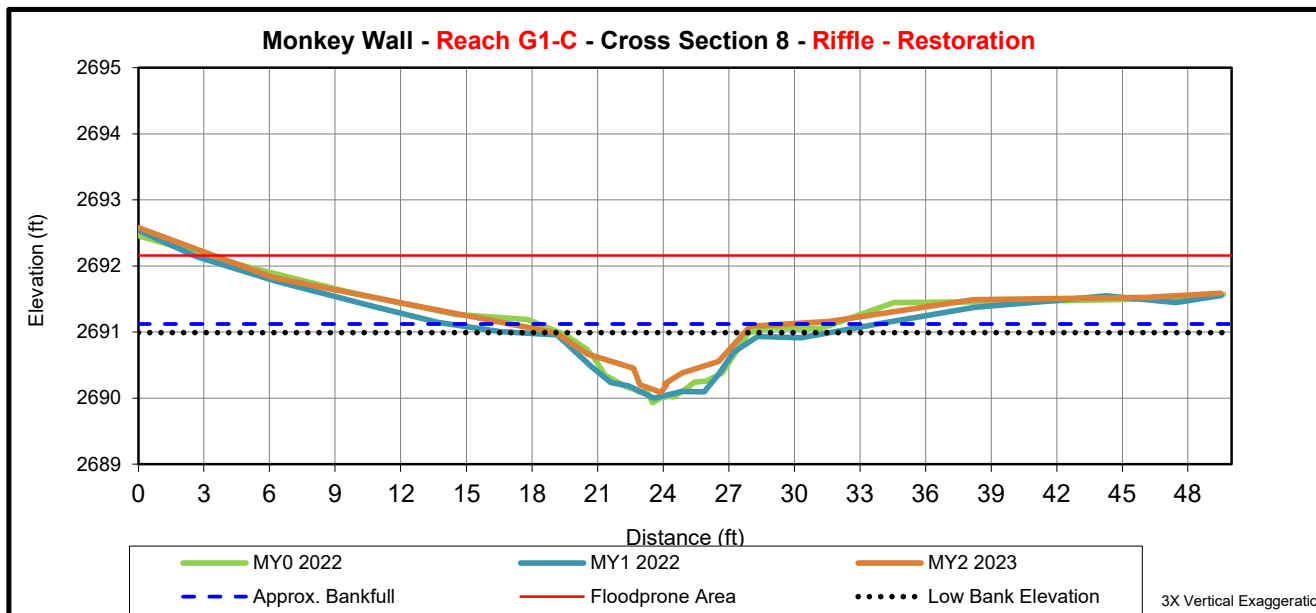
Cross Section 8 (Riffle)						
	MY0	MY1	MY2	MY3	MY5	MY7	MY+
Bankfull Elevation (ft) - Based on AB-XSA¹	2691.0	2690.9	2691.1				
Bankfull Width (ft) ¹	8.4	8.9	8.9				
Floodprone Width (ft) ¹	>44.8	>43.7	>46				
Bankfull Max Depth (ft) ²	1.0	0.9	0.9				
Low Bank Elevation (ft)	2691.0	2690.9	2691.0				
Bankfull Cross Sectional Area (ft ²) ²	5.1	5.3	4.0				
Bankfull Entrenchment Ratio ¹	>5.9	>4.9	>5.2				
Bankfull Bank Height Ratio ¹	1.0	1.0	0.9

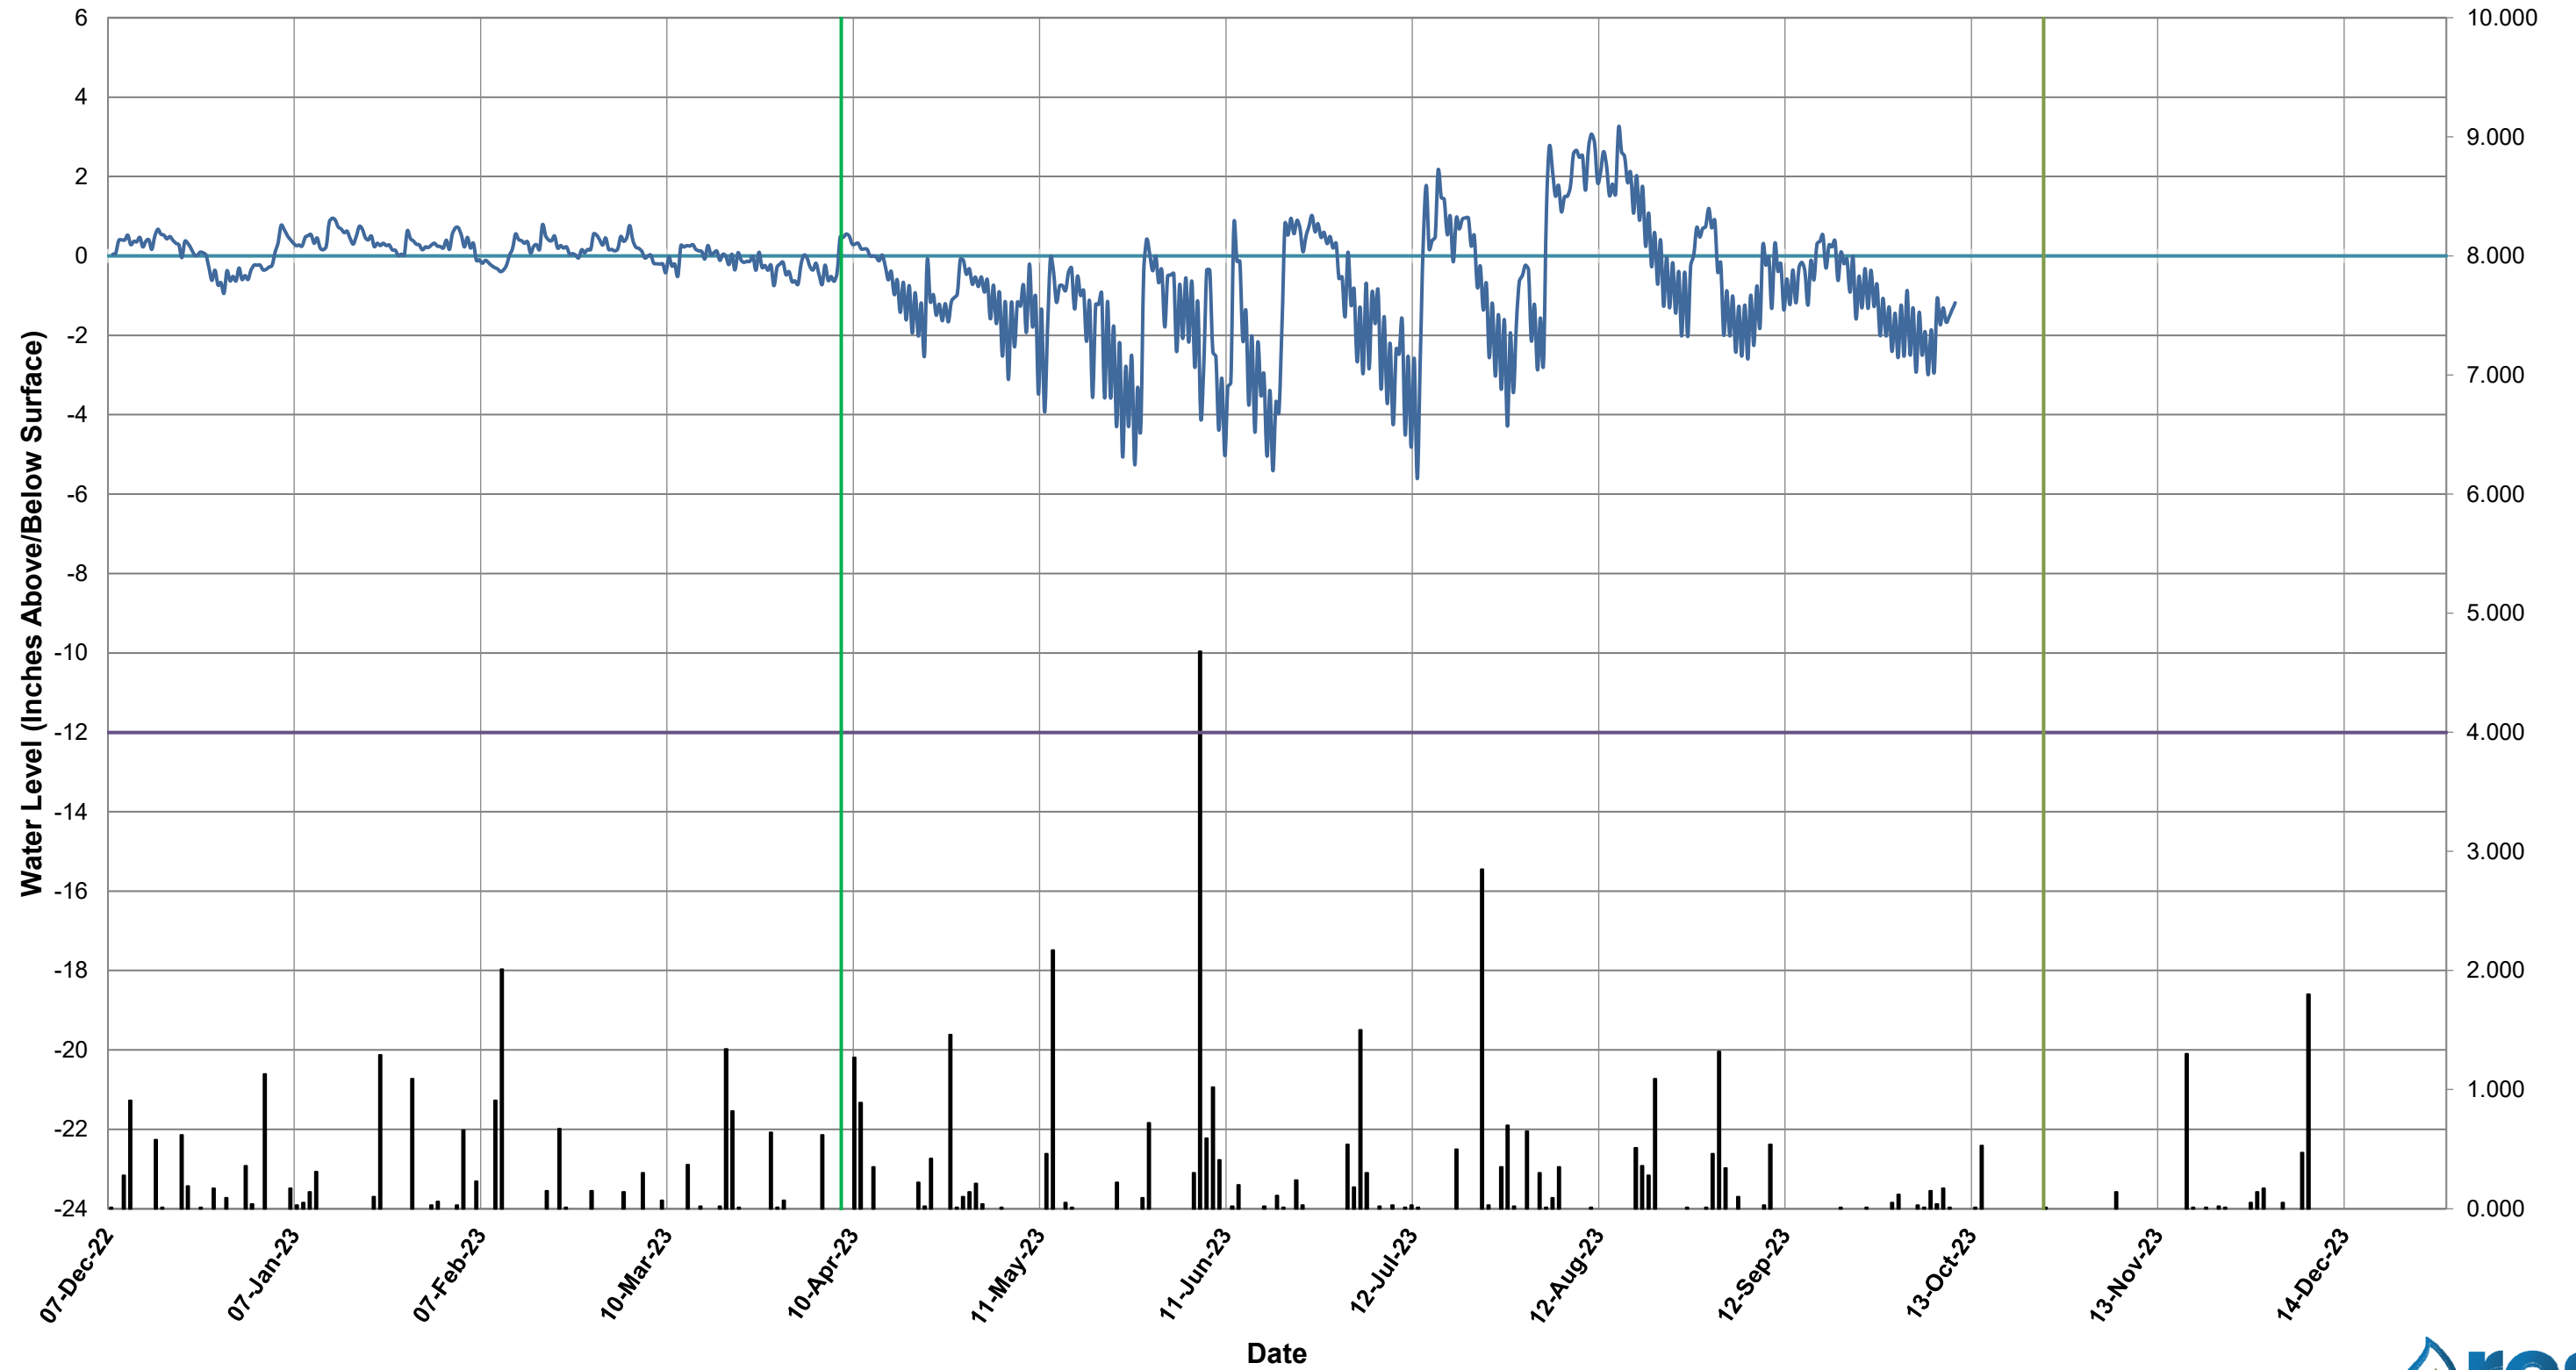
MY2 Monkey Wall GW1

96 Consecutive Days of Hydrology
07/11/23-10/10/23

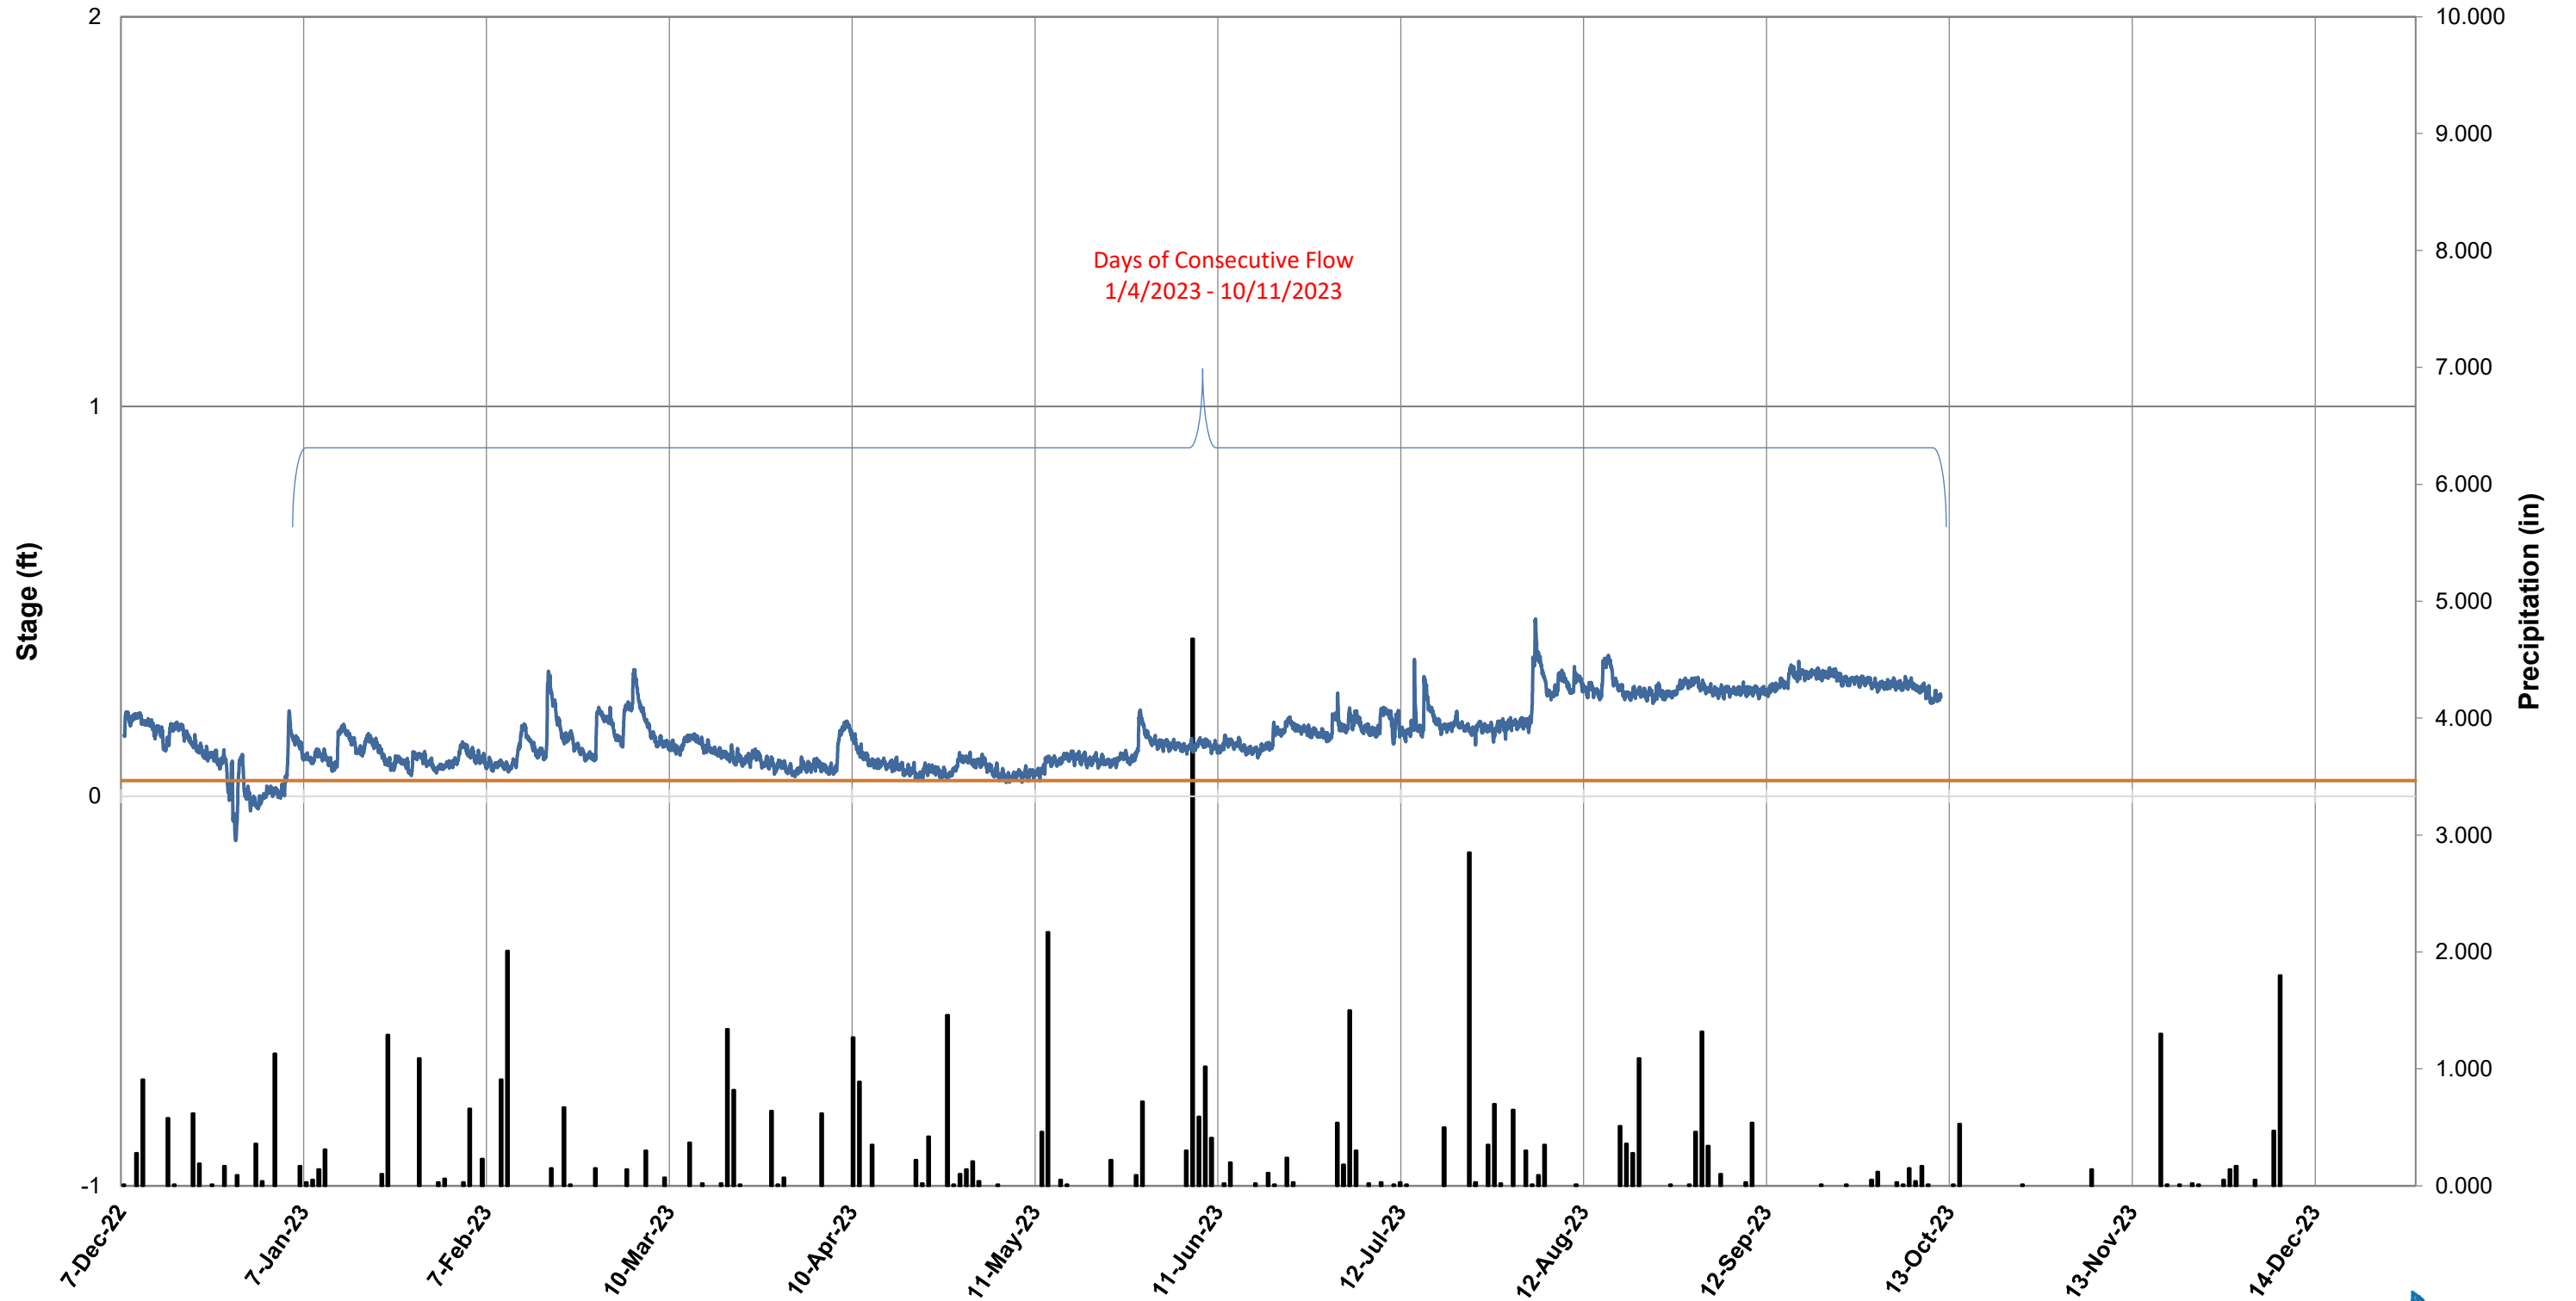
2023 Monkey Wall G1 Flow Gauge Graph

278 Consecutive Days Consecutive Flow
01/04/2023 - 10/11/2023

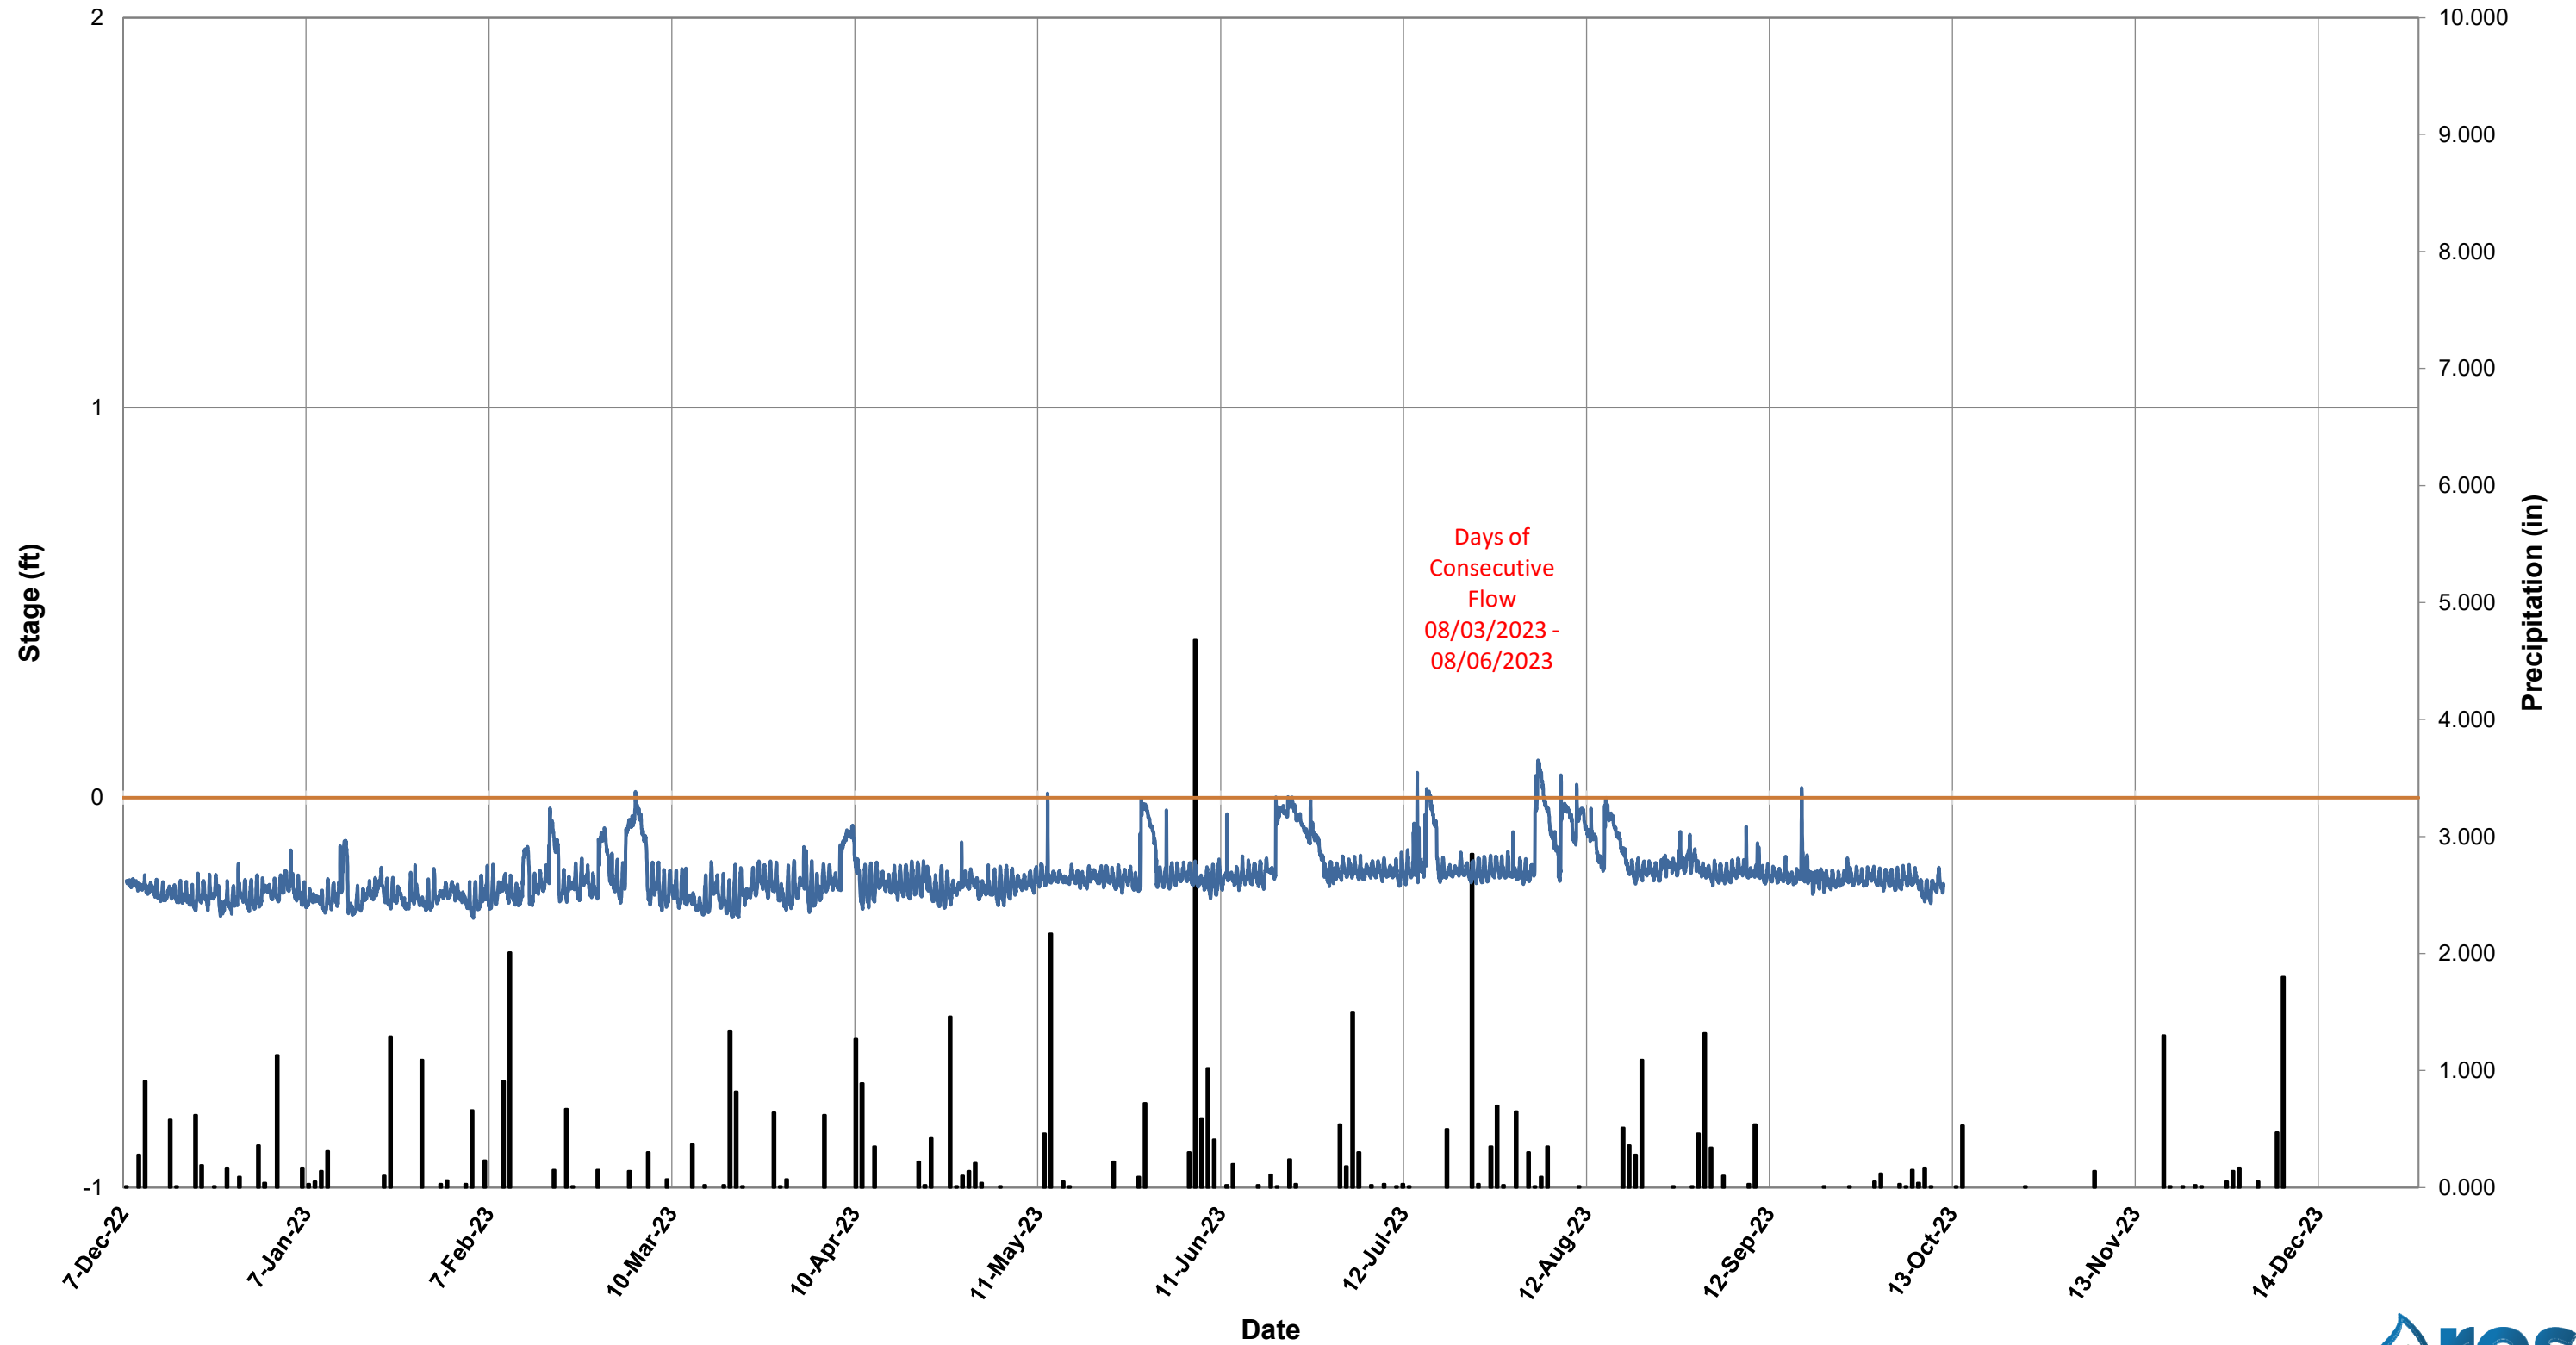
2023 Monkey Wall G2 Flow Gauge Graph

03 Consecutive Days of Hydrology
08/03/2023-08/06/2023
