As-Built Baseline Monitoring Report

MONKEY WALL PROJECT

NCDMS Project #100069 (Contract #7536)
USACE Action ID: 2018-01162
DWR Project #20181029

Mitchell County, North Carolina
French Broad River Basin
HUC 06010108

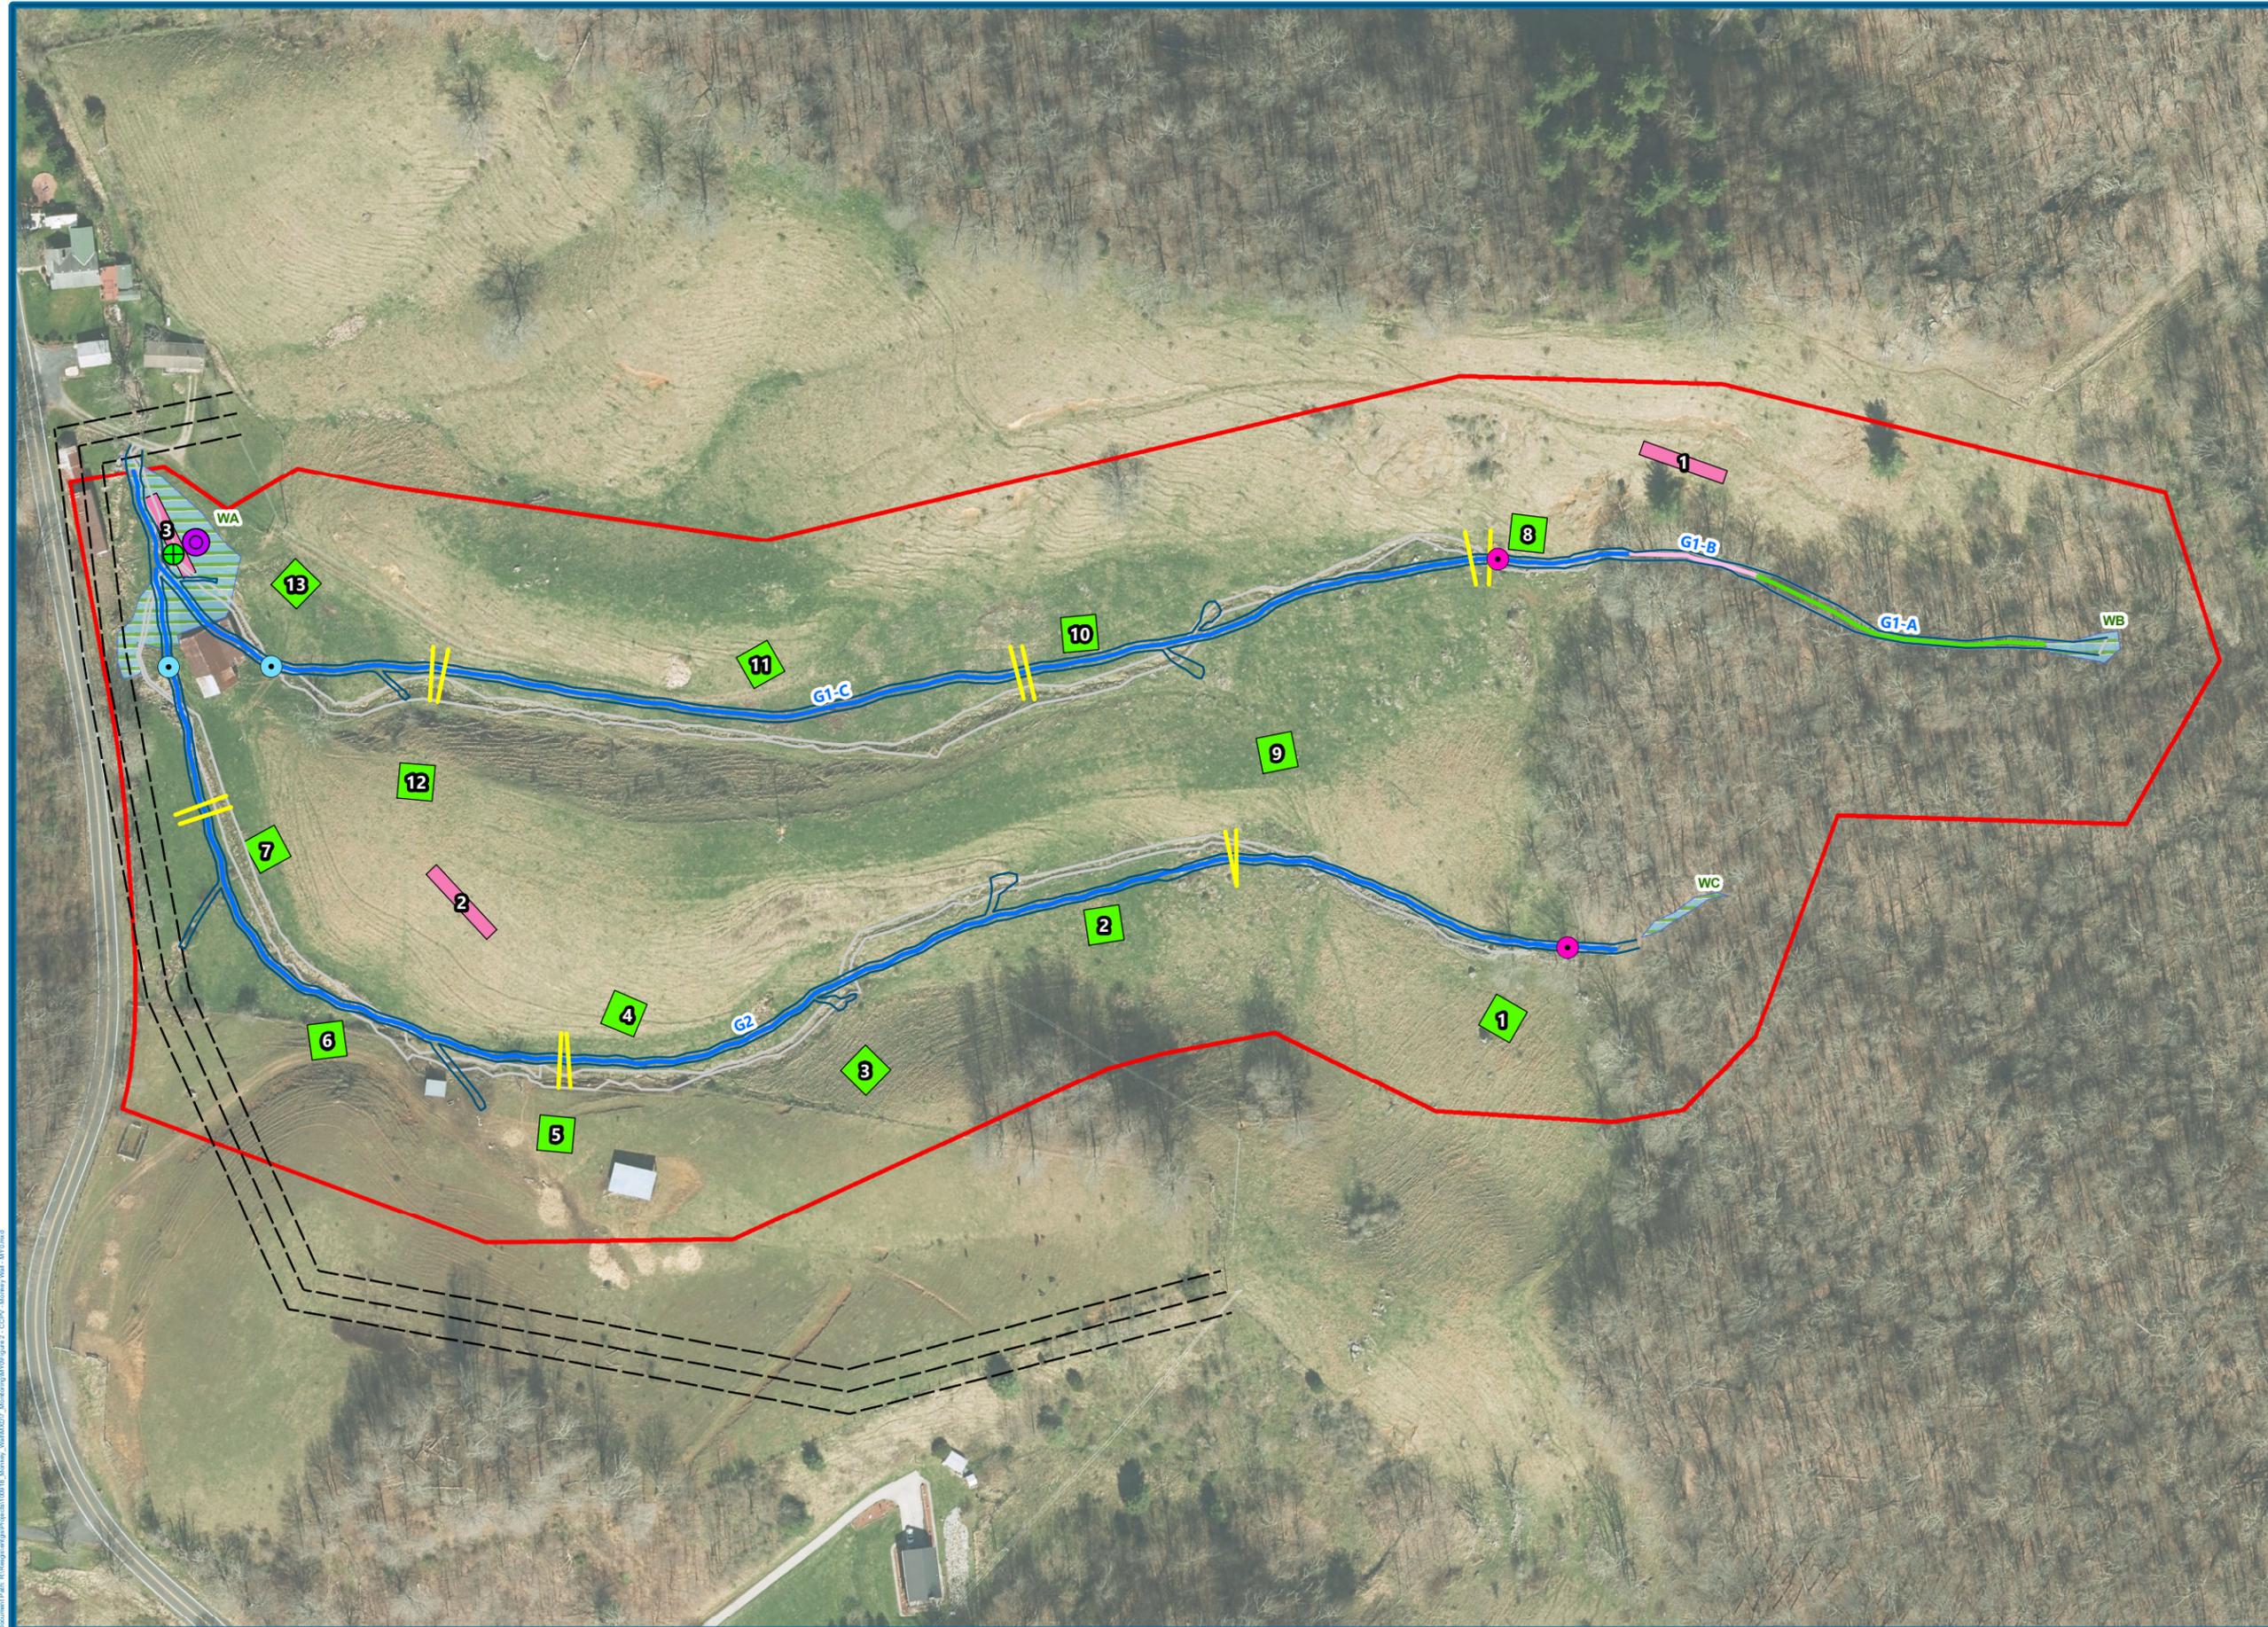
Figure 2 - Current Conditions
Plan View

Visual assessment of the stream channel was performed to document signs of instability, such as eroding banks, structural instability, or excessive sedimentation. The channel is transporting sediment as designed and will continue to be monitored for aggradation and degradation.

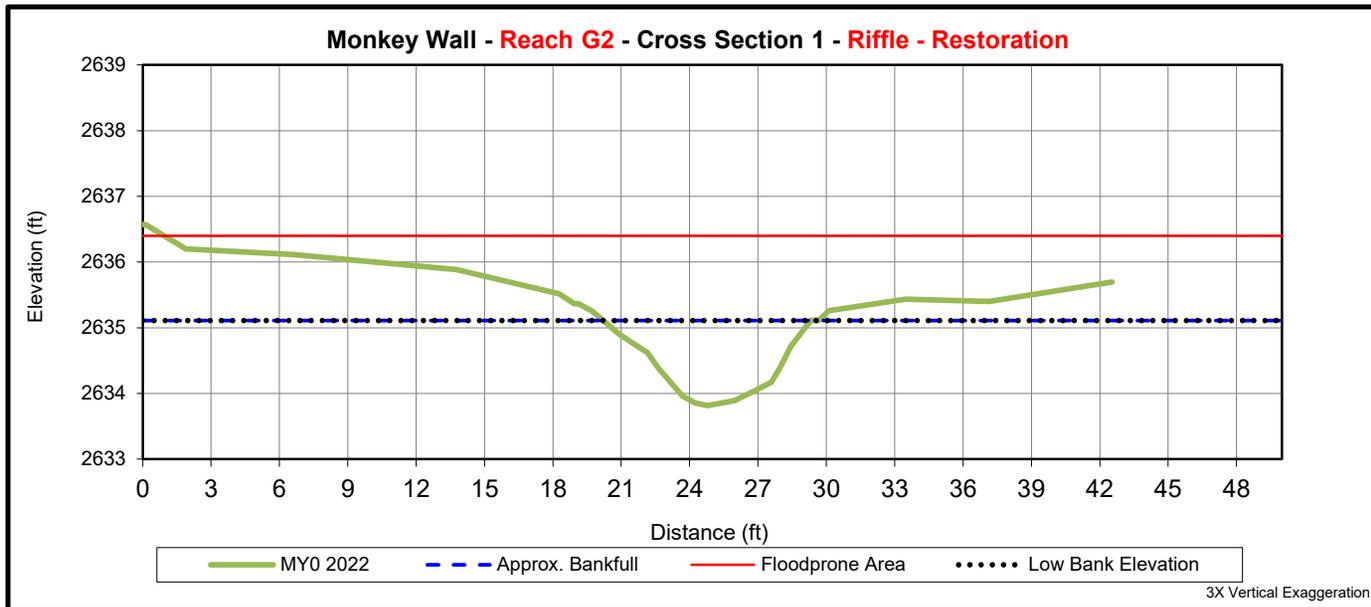
Cross Section 1 (Riffle)						
	MY0	MY1	MY2	MY3	MY5	MY7	MY+
Bankfull Elevation (ft) - Based on AB-XSA¹	2635.1						
Bankfull Width (ft) ¹	9.1						
Floodprone Width (ft) ¹	49.1						
Bankfull Max Depth (ft) ²	1.3						
Low Bank Elevation (ft)	2635.1						
Bankfull Cross Sectional Area (ft ²) ²	7.1						
Bankfull Entrenchment Ratio ¹	5.6						
Bankfull Bank Height Ratio ¹	1.0

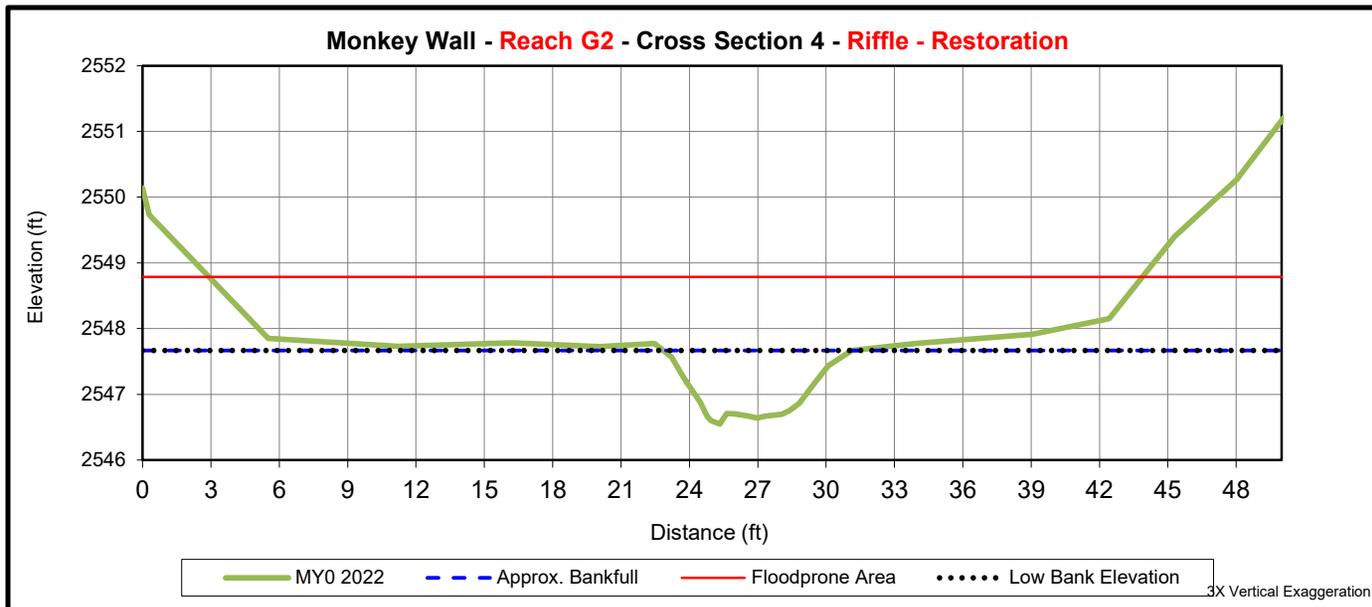
Cross Section 4 (Riffle)						
	MY0	MY1	MY2	MY3	MY5	MY7	MY+
Bankfull Elevation (ft) - Based on AB-XSA¹	2547.7						
Bankfull Width (ft) ¹	8.3						
Floodprone Width (ft) ¹	40.9						
Bankfull Max Depth (ft) ²	1.1						
Low Bank Elevation (ft)	2547.7						
Bankfull Cross Sectional Area (ft ²) ²	5.6						
Bankfull Entrenchment Ratio ¹	6.1						
Bankfull Bank Height Ratio ¹	1.0
