Year 1 Monitoring Report

MONKEY WALL PROJECT

NCDMS Project #100069 (Contract #7536)
USACE Action ID: 2018-01162
DWR Project #20181029

Mitchell County, North Carolina
French Broad River Basin
HUC 06010108

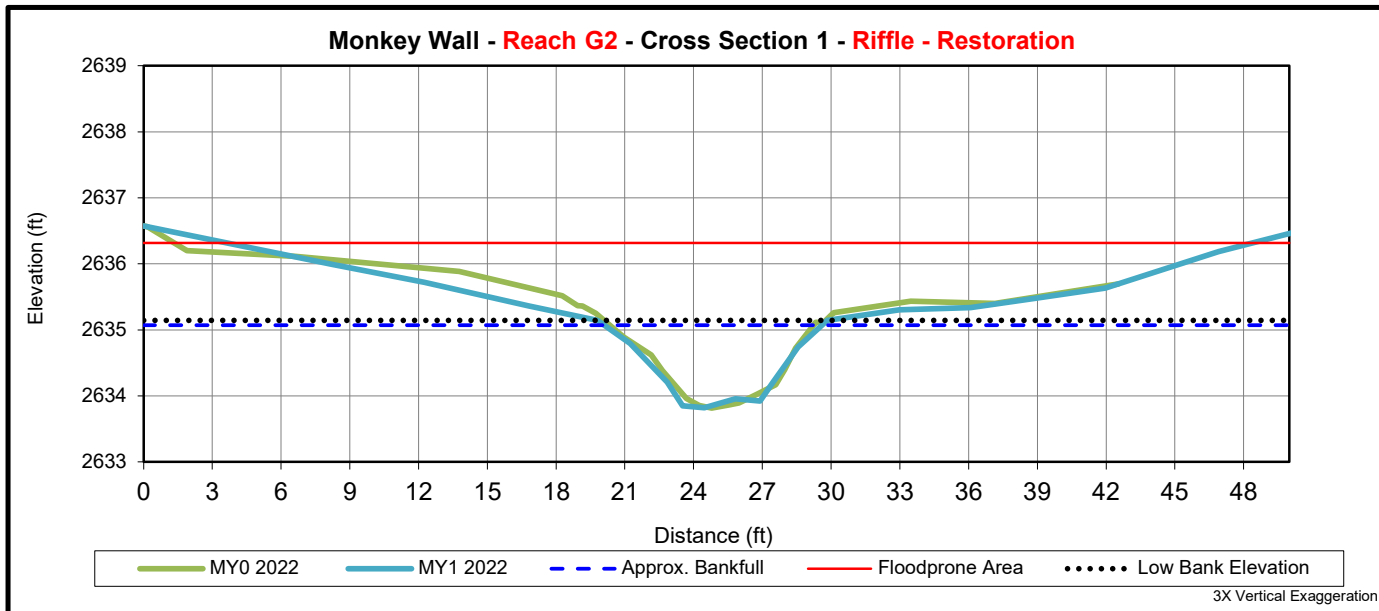
Cross Section 1 (Riffle)						
	MY0	MY1	MY2	MY3	MY5	MY7	MY+
Bankfull Elevation (ft) - Based on AB-XSA¹	2635.1	2635.1					
Bankfull Width (ft) ¹	9.1	9.5					
Floodprone Width (ft) ¹	49.1	44.8					
Bankfull Max Depth (ft) ²	1.3	1.3					
Low Bank Elevation (ft)	2635.1	2635.1					
Bankfull Cross Sectional Area (ft ²) ²	7.1	7.9					
Bankfull Entrenchment Ratio ¹	5.6	4.7					
Bankfull Bank Height Ratio ¹	1.0	1.1

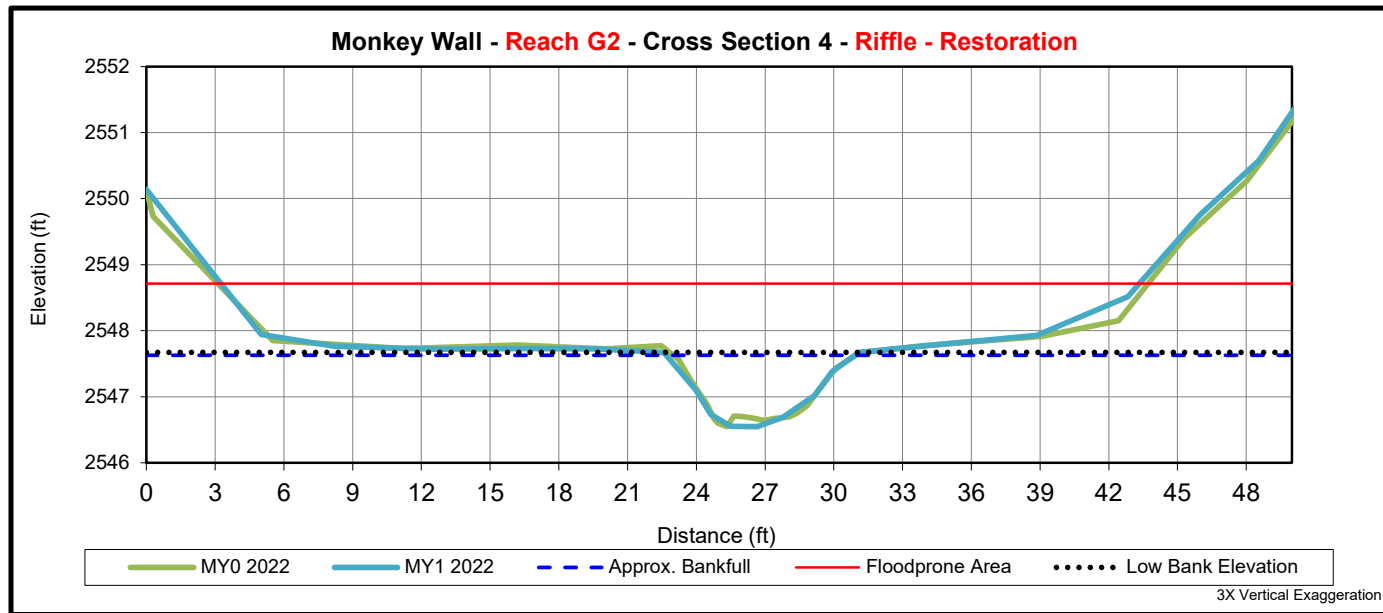
Cross Section 4 (Riffle)						
	MY0	MY1	MY2	MY3	MY5	MY7	MY+
Bankfull Elevation (ft) - Based on AB-XSA¹	2547.7	2547.6					
Bankfull Width (ft) ¹	8.3	8.3					
Floodprone Width (ft) ¹	40.9	40.1					
Bankfull Max Depth (ft) ²	1.1	1.1					
Low Bank Elevation (ft)	2547.7	2547.7					
Bankfull Cross Sectional Area (ft ²) ²	5.6	5.9					
Bankfull Entrenchment Ratio ¹	6.1	4.9					
Bankfull Bank Height Ratio ¹	1.0	1.0

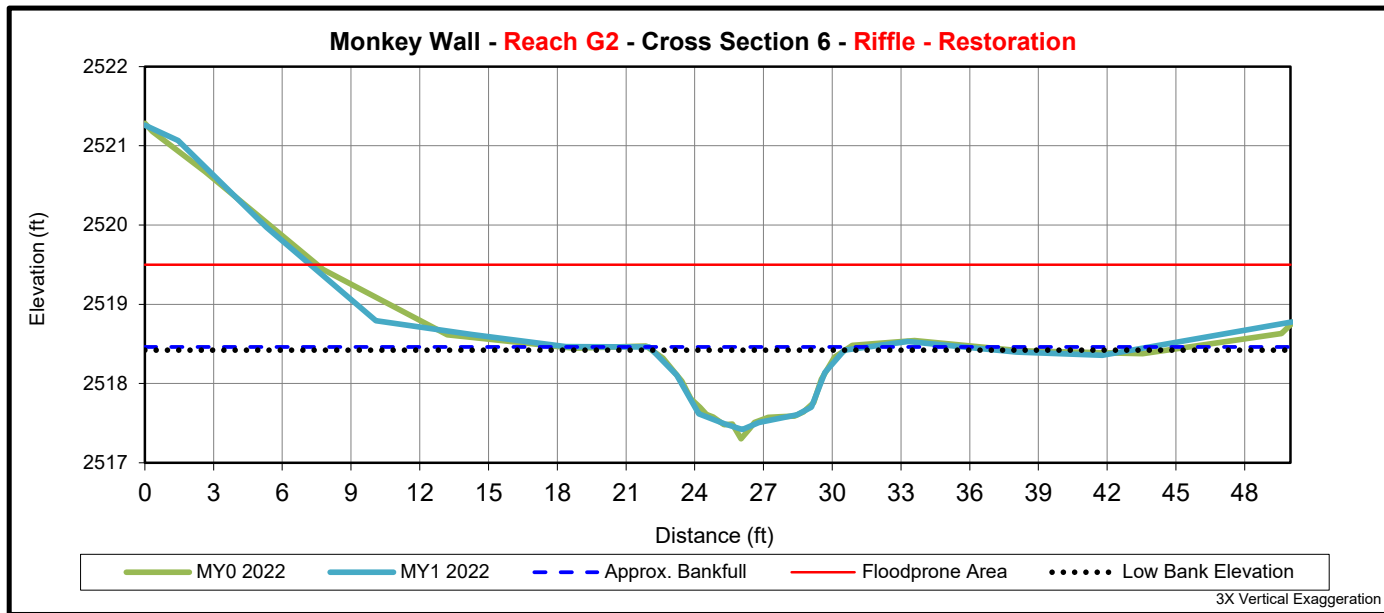
Cross Section 6 (Riffle)						
	MY0	MY1	MY2	MY3	MY5	MY7	MY+
Bankfull Elevation (ft) - Based on AB-XSA¹	2518.5	2518.5					
Bankfull Width (ft) ¹	9.0	8.5					
Floodprone Width (ft) ¹	>43.2	>42.8					
Bankfull Max Depth (ft) ²	1.2	1.0					
Low Bank Elevation (ft)	2518.5	2518.4					
Bankfull Cross Sectional Area (ft ²) ²	5.8	5.5					
Bankfull Entrenchment Ratio ¹	>5.6	>5					
Bankfull Bank Height Ratio ¹	1.0	1.0

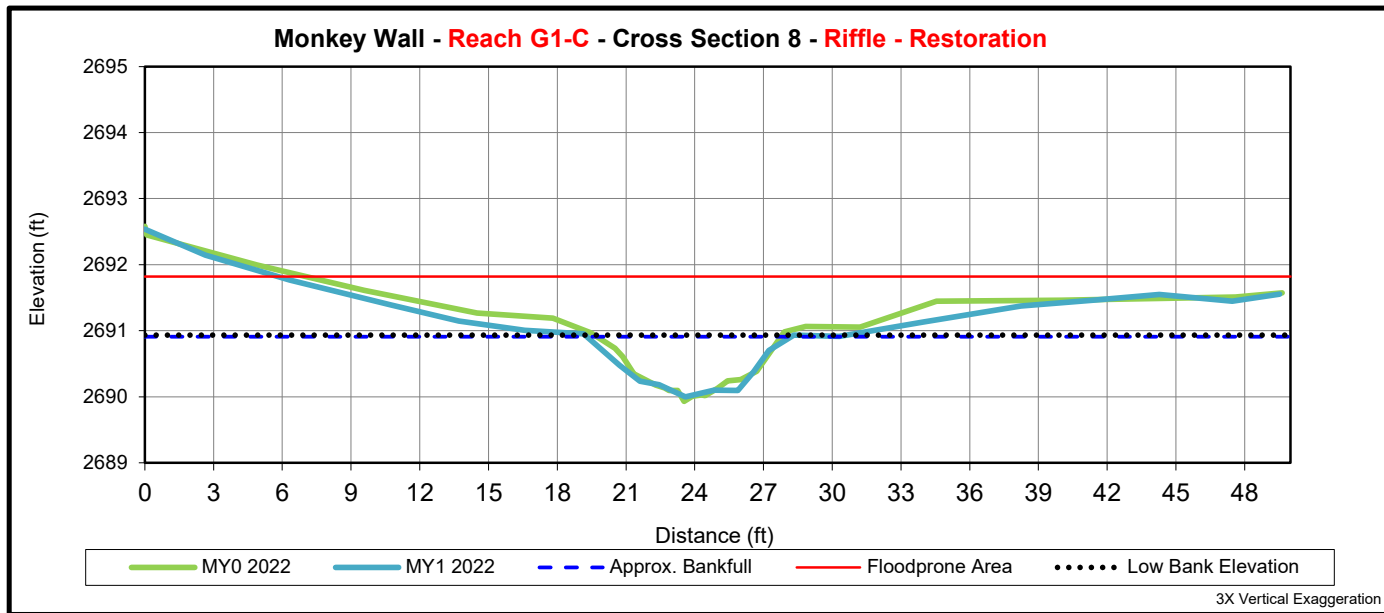
Cross Section 8 (Rifle)						
	MY0	MY1	MY2	MY3	MY5	MY7	MY+
Bankfull Elevation (ft) - Based on AB-XSA¹	2691.0	2690.9					
Bankfull Width (ft) ¹	8.4	8.9					
Floodprone Width (ft) ¹	>44.8	>43.7					
Bankfull Max Depth (ft) ²	1.0	0.9					
Low Bank Elevation (ft)	2691.0	2690.9					
Bankfull Cross Sectional Area (ft ²) ²	5.1	5.3					
Bankfull Entrenchment Ratio ¹	>5.9	>4.9					
Bankfull Bank Height Ratio ¹	1.0	1.0
