MONITORING YEAR 2
REPORT
Final

MOORES FORK STREAM MITIGATION PROJECT

Surry County, NC

DMS Project Number 94709

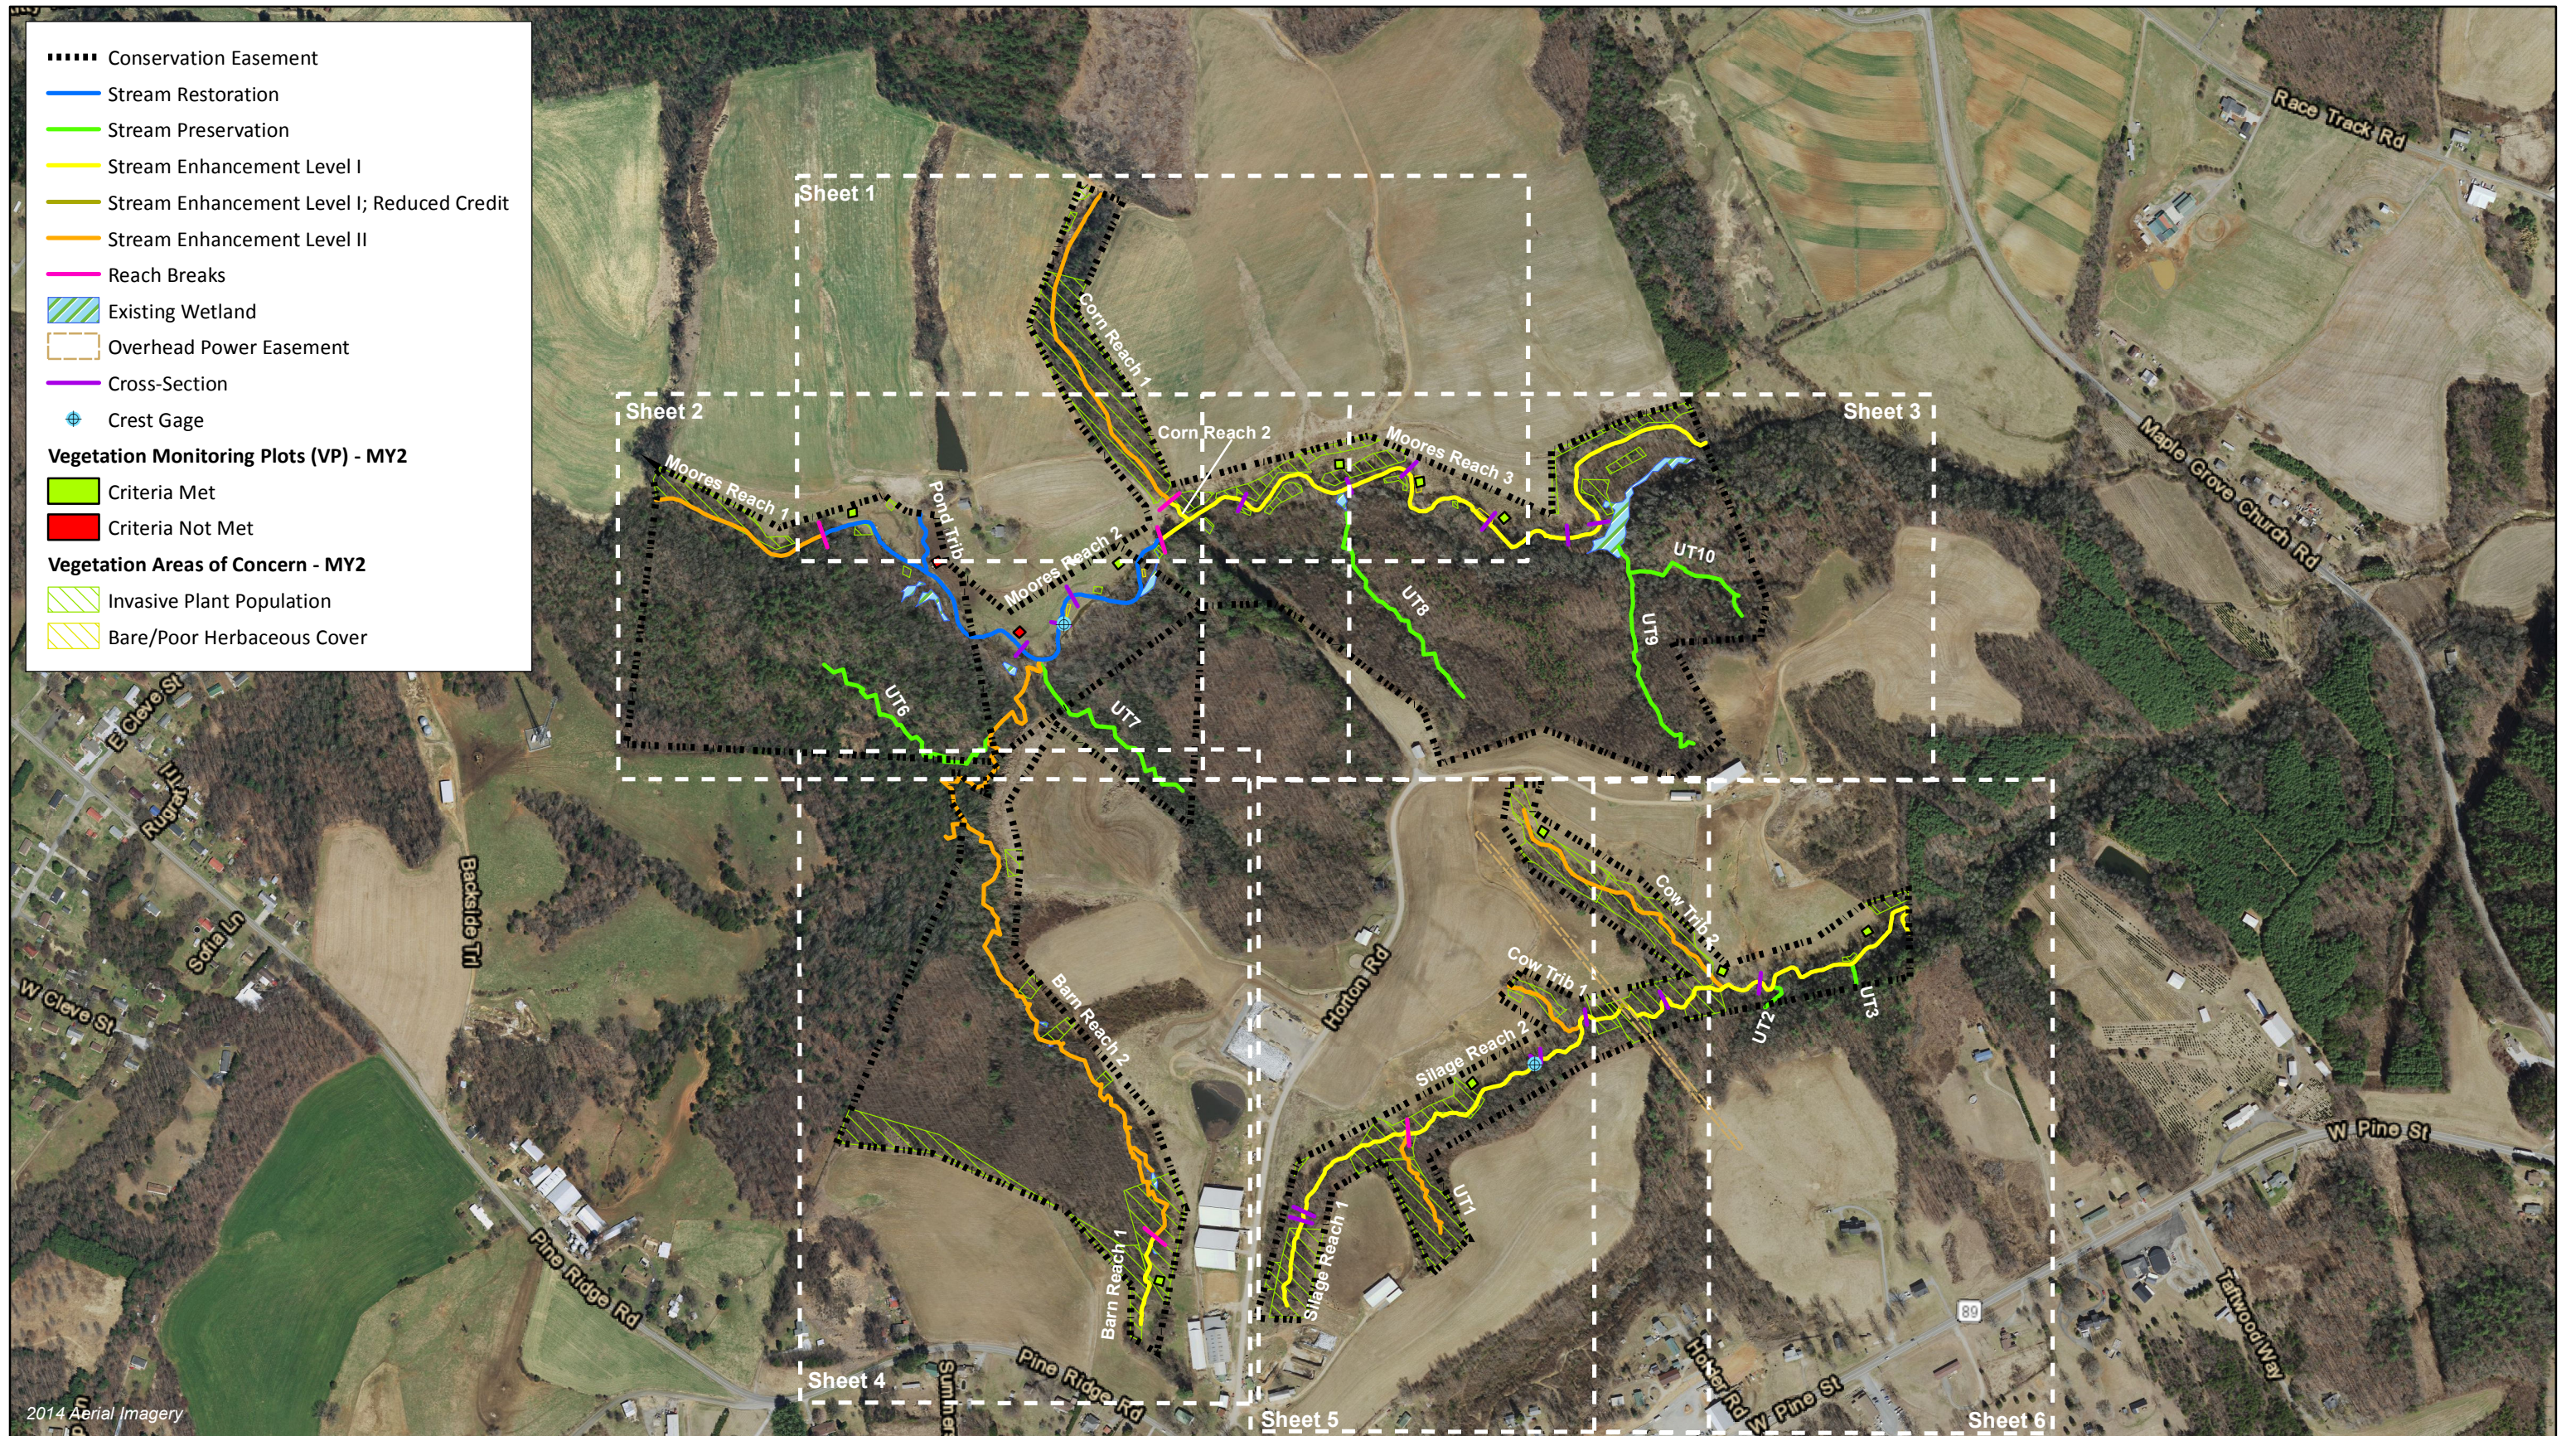
Figure 3.0 Integrated Current Condition Plan View (Key)
 Moores Fork Stream Mitigation Project
 DMS Project No. 94709
 Monitoring Year 2 - 2017

Generally, the site has a strong herbaceous cover consisting of various species of clover, rye grass, fescue, and sedge. Small isolated bare/poorly vegetated areas were observed along the right bank of Moores Fork Reach 2 near stations 30+50 and 34+50 and the left bank of Moores Fork Reach 3 near stations 48+00 and 52+00. These vegetation areas of concern are shown in Figure 3 in Appendix B.
