MONITORING YEAR 4

ANNUAL REPORT

MOORES FORK STREAM MITIGATION PROJECT

DMS Project Number 94709

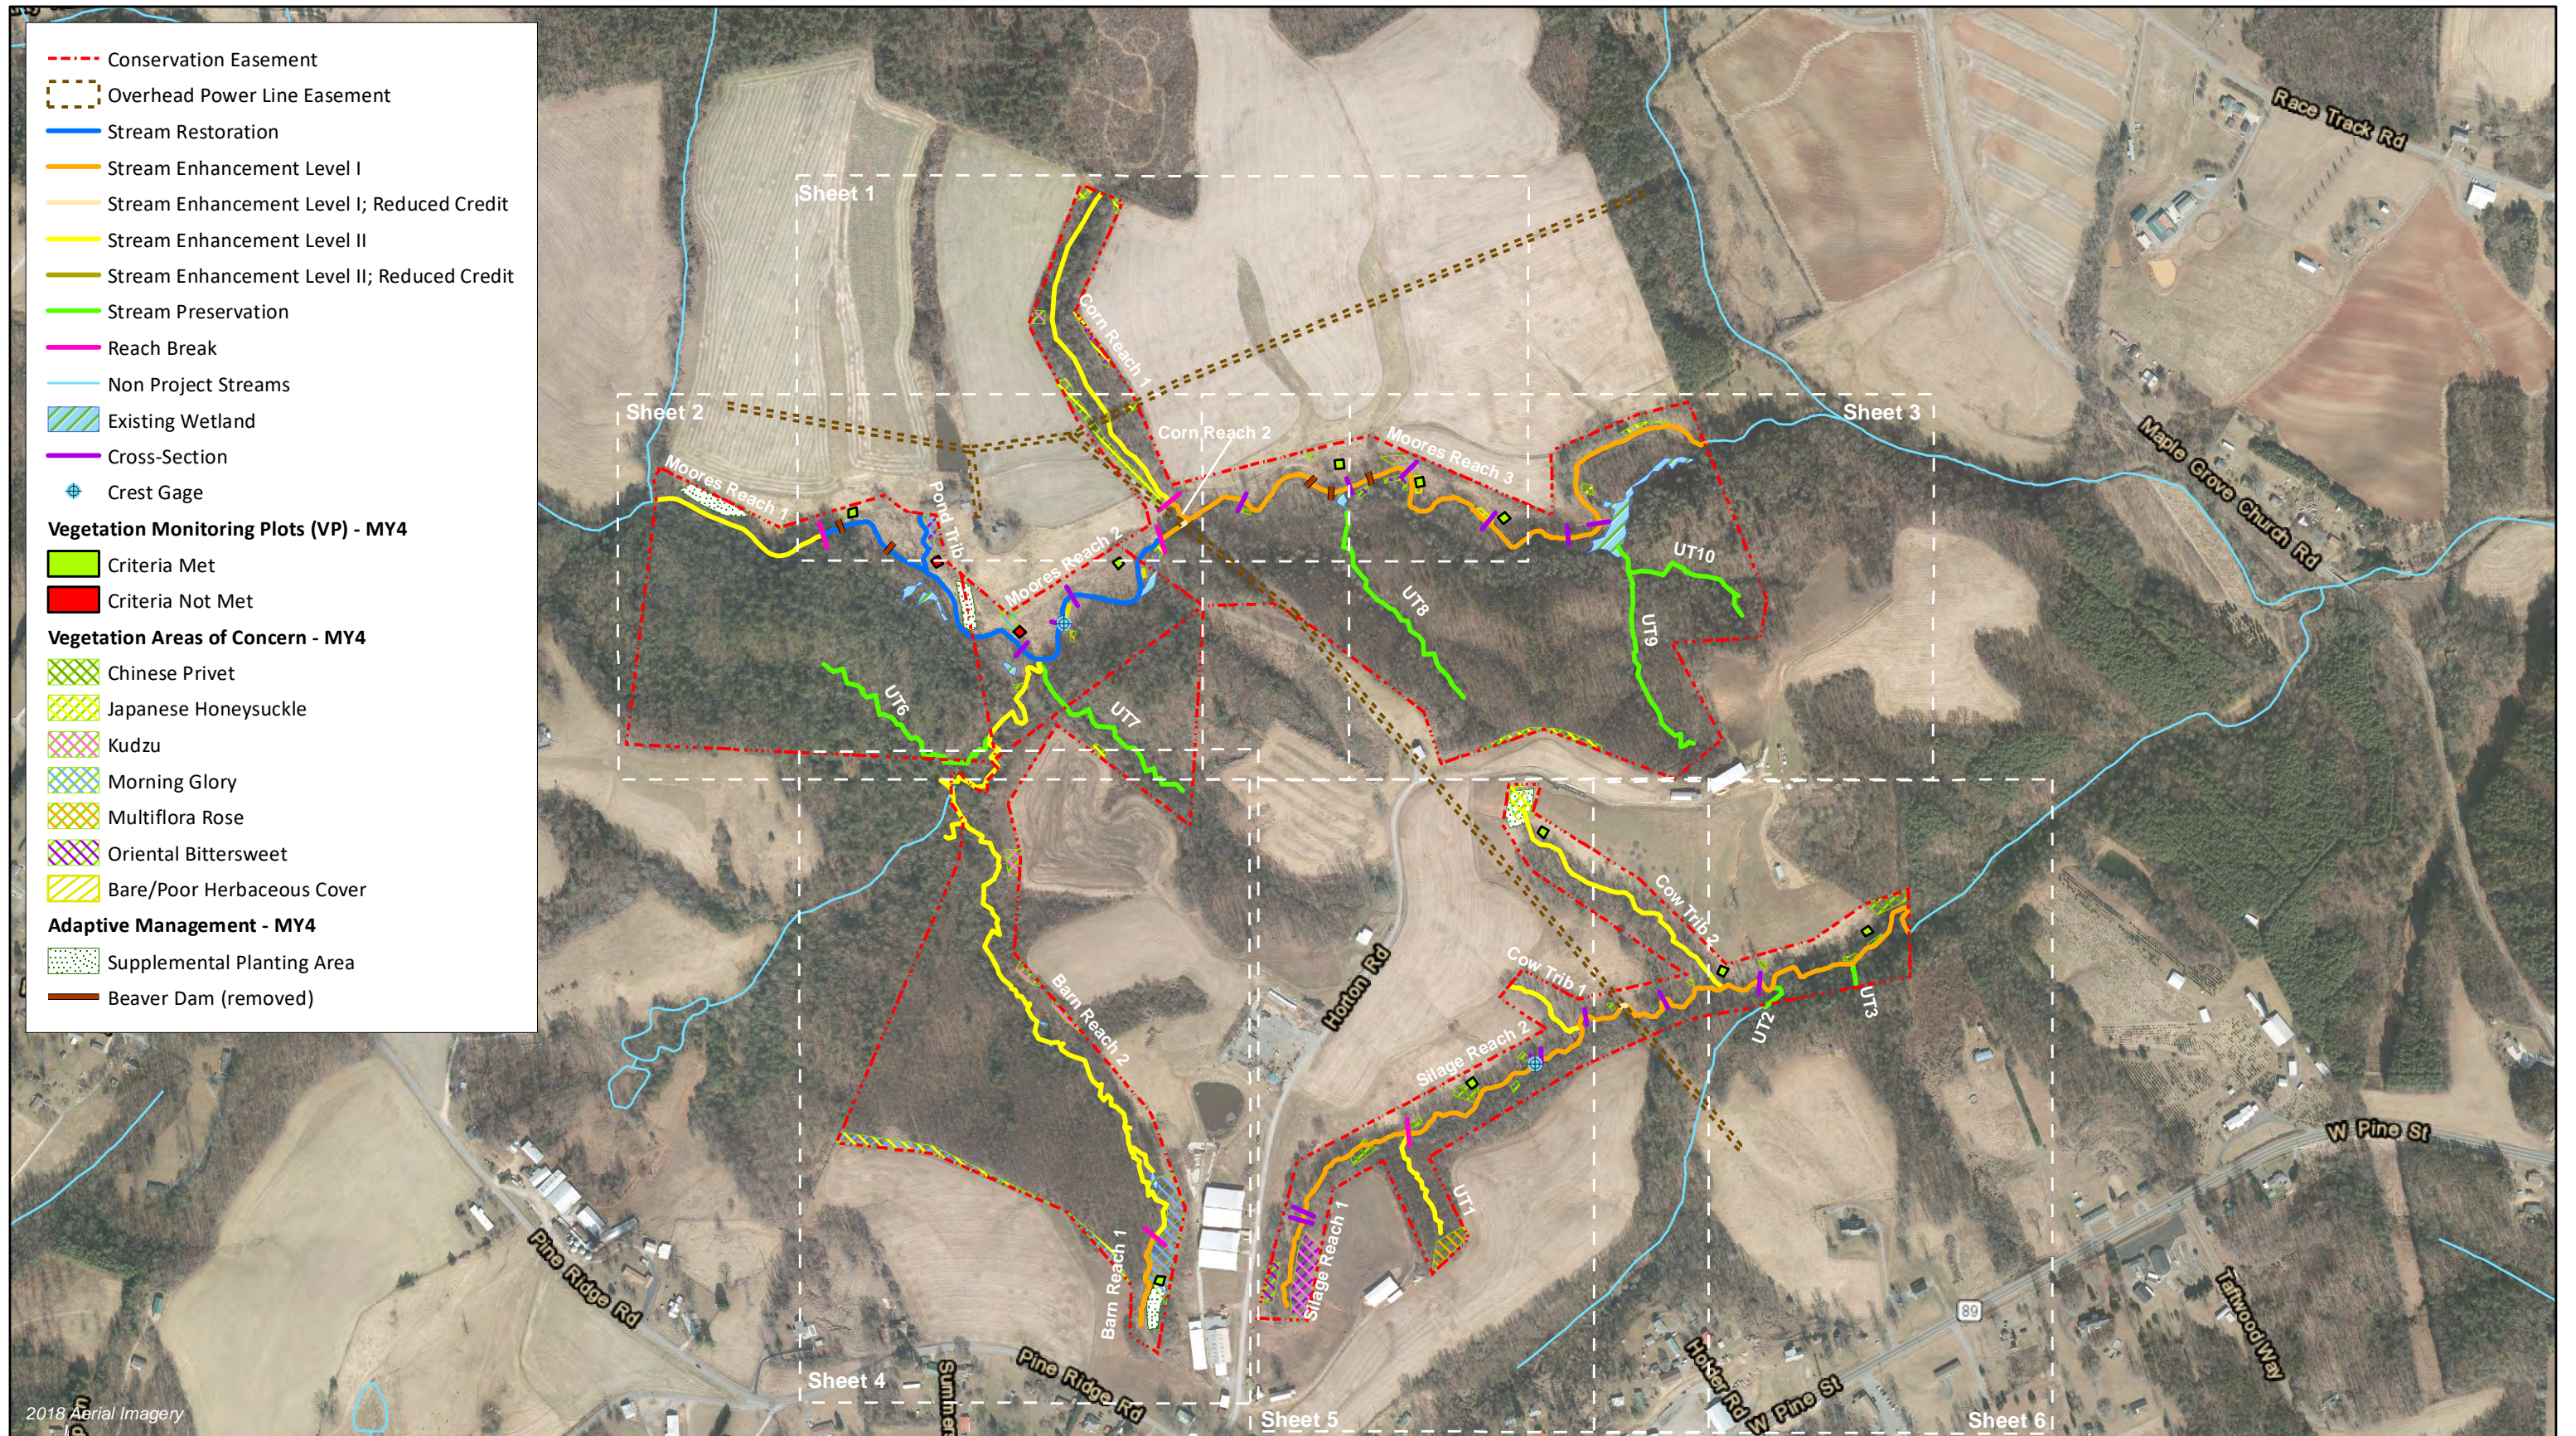
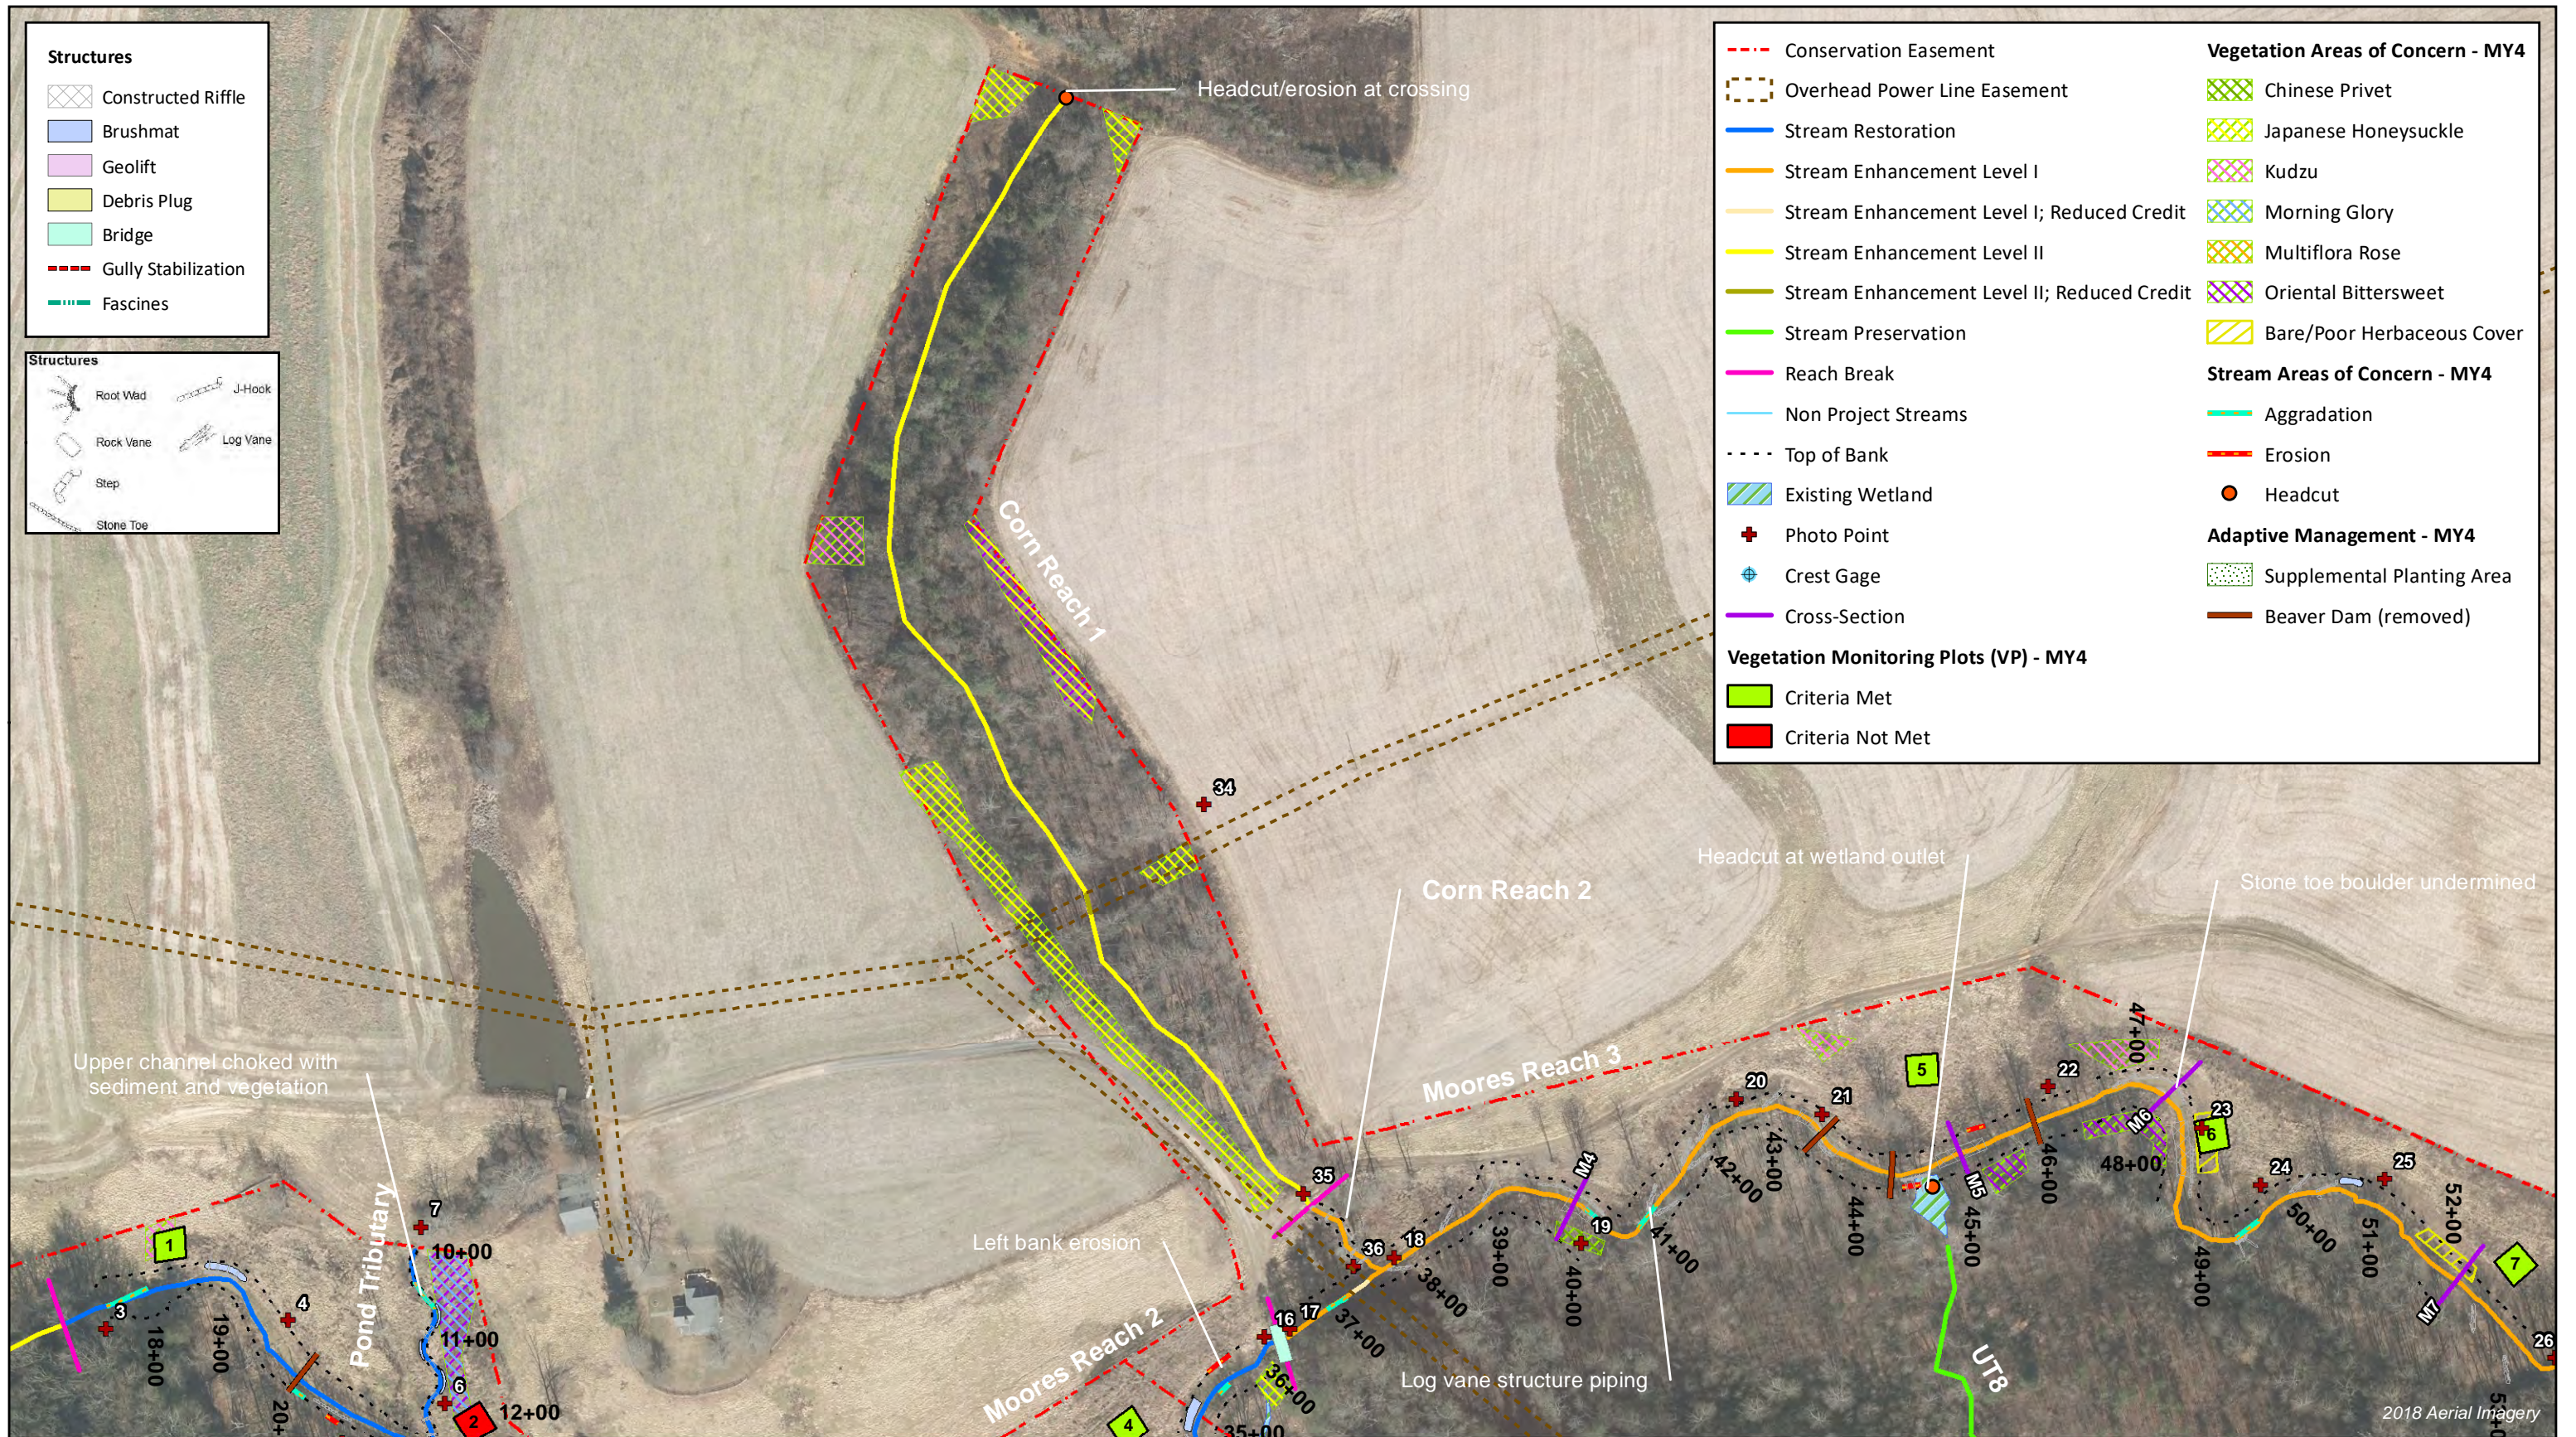
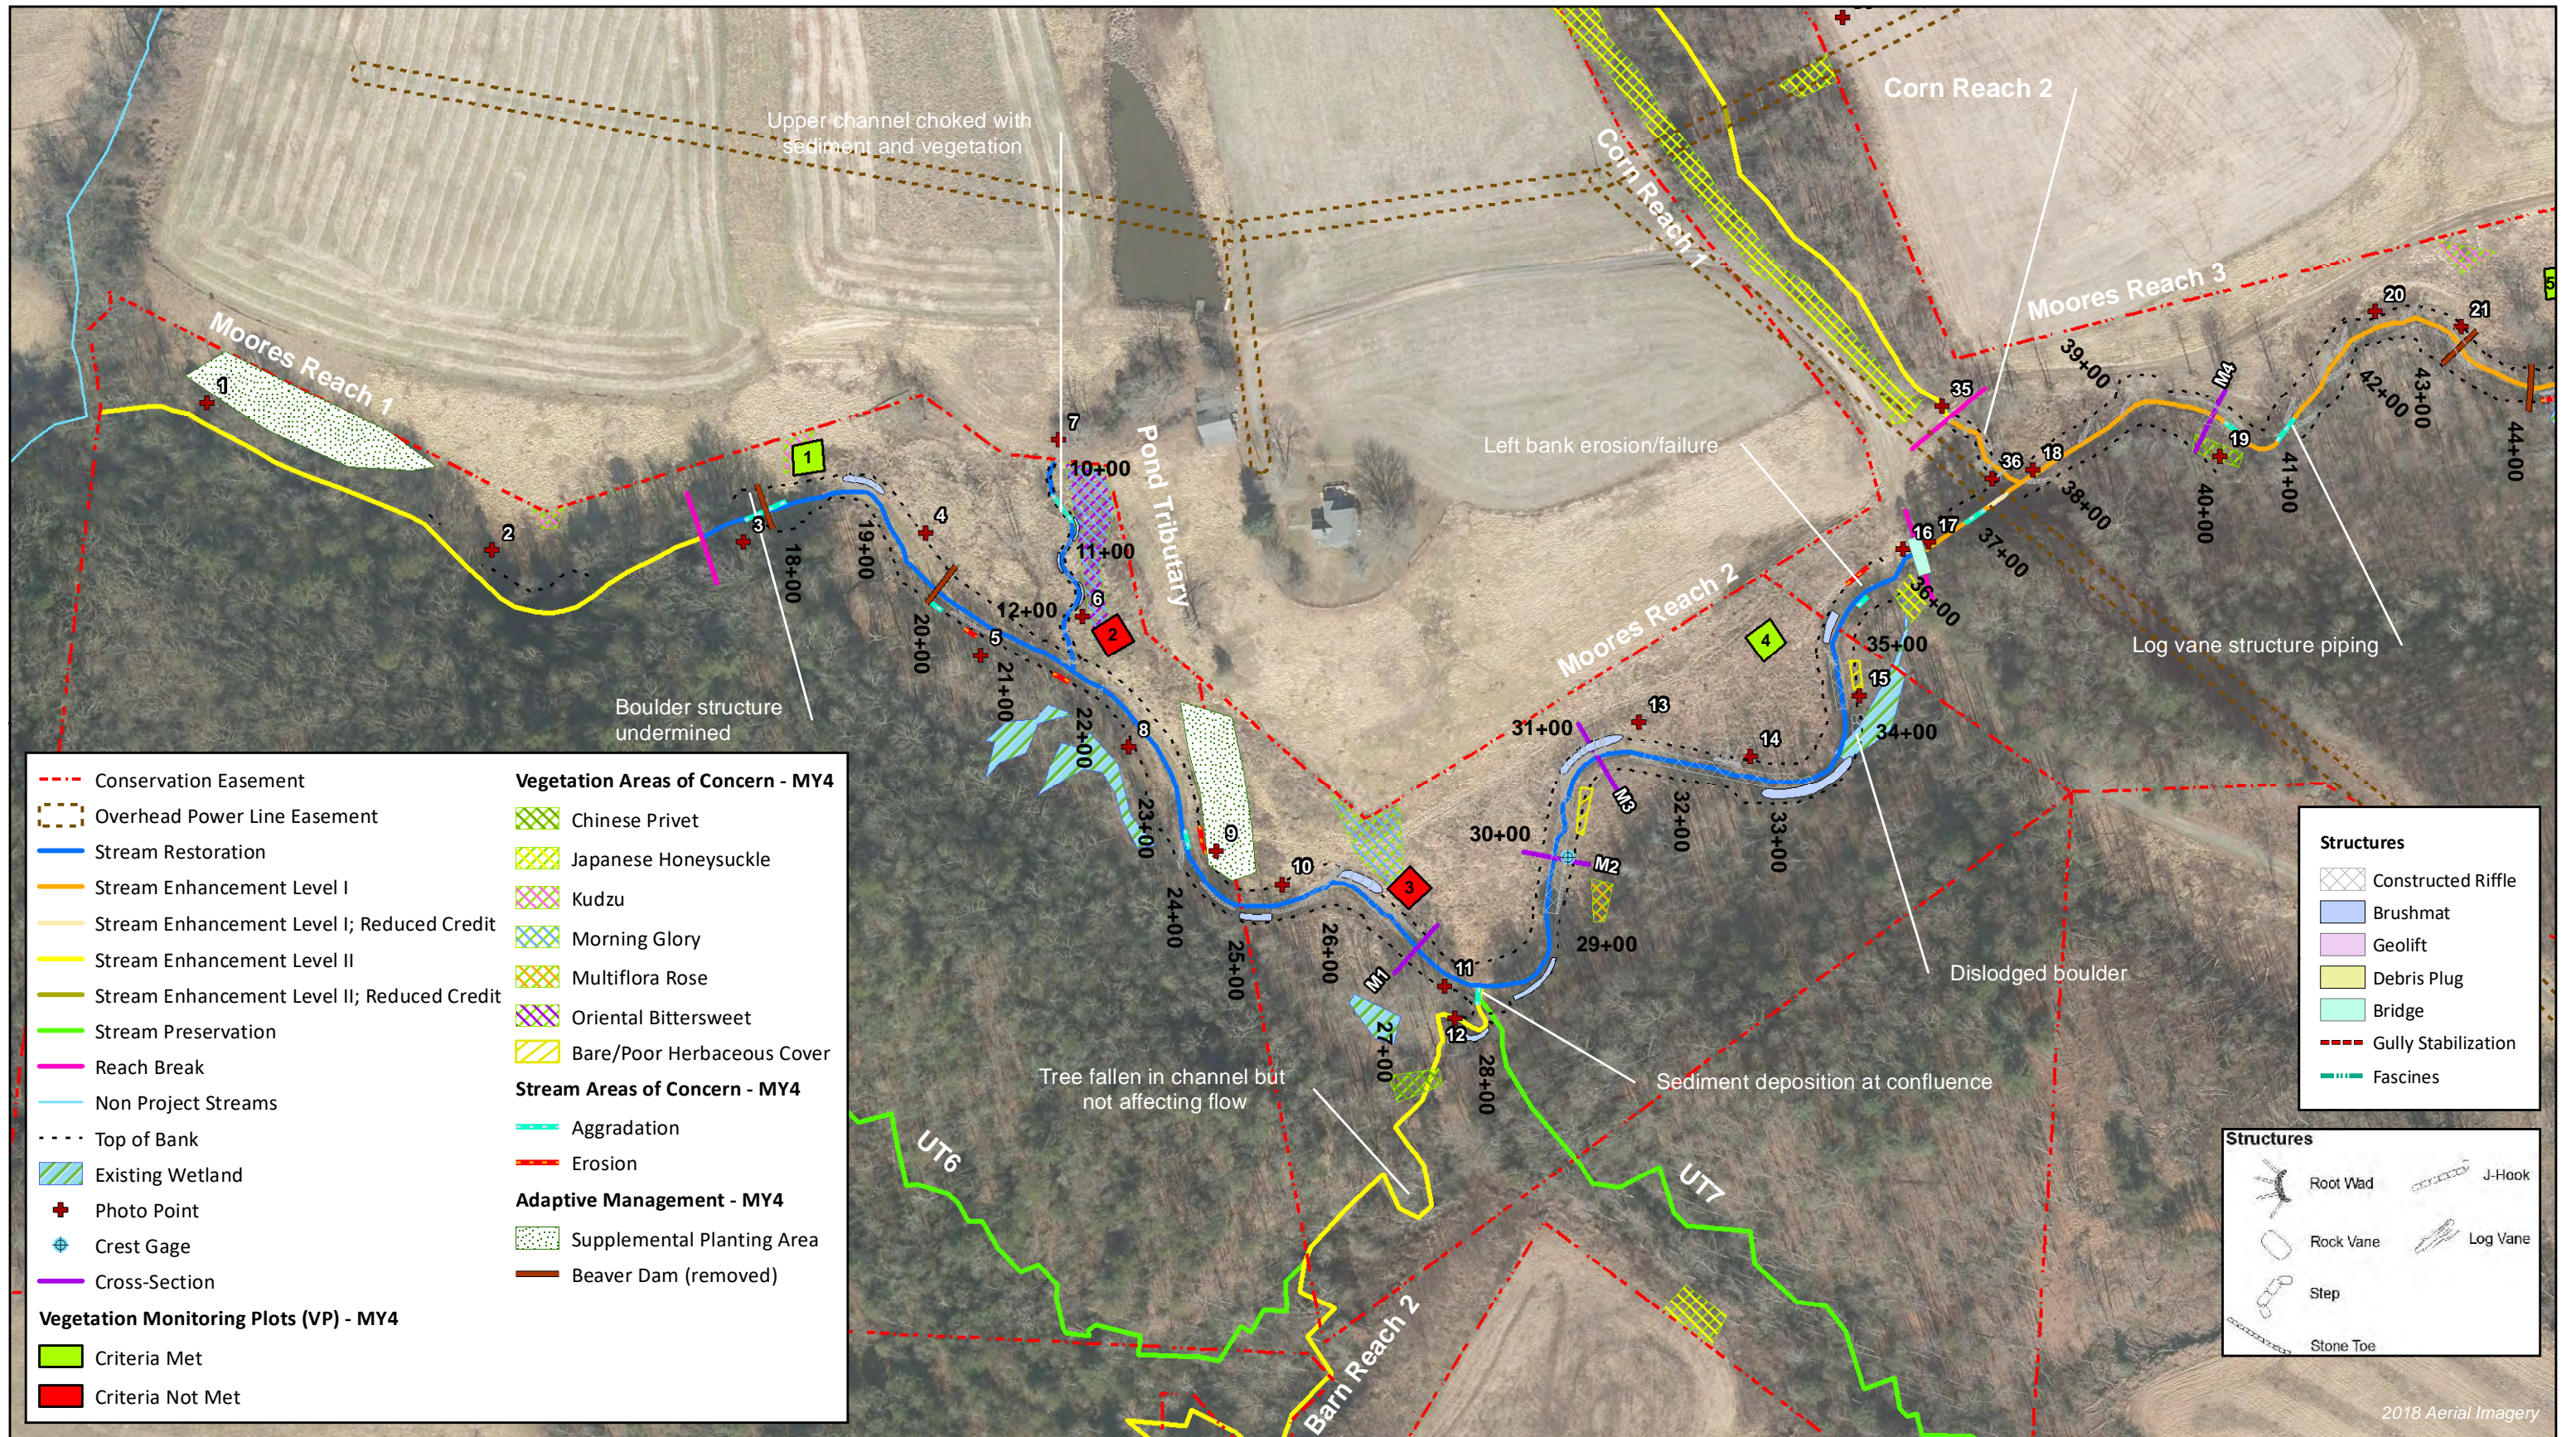
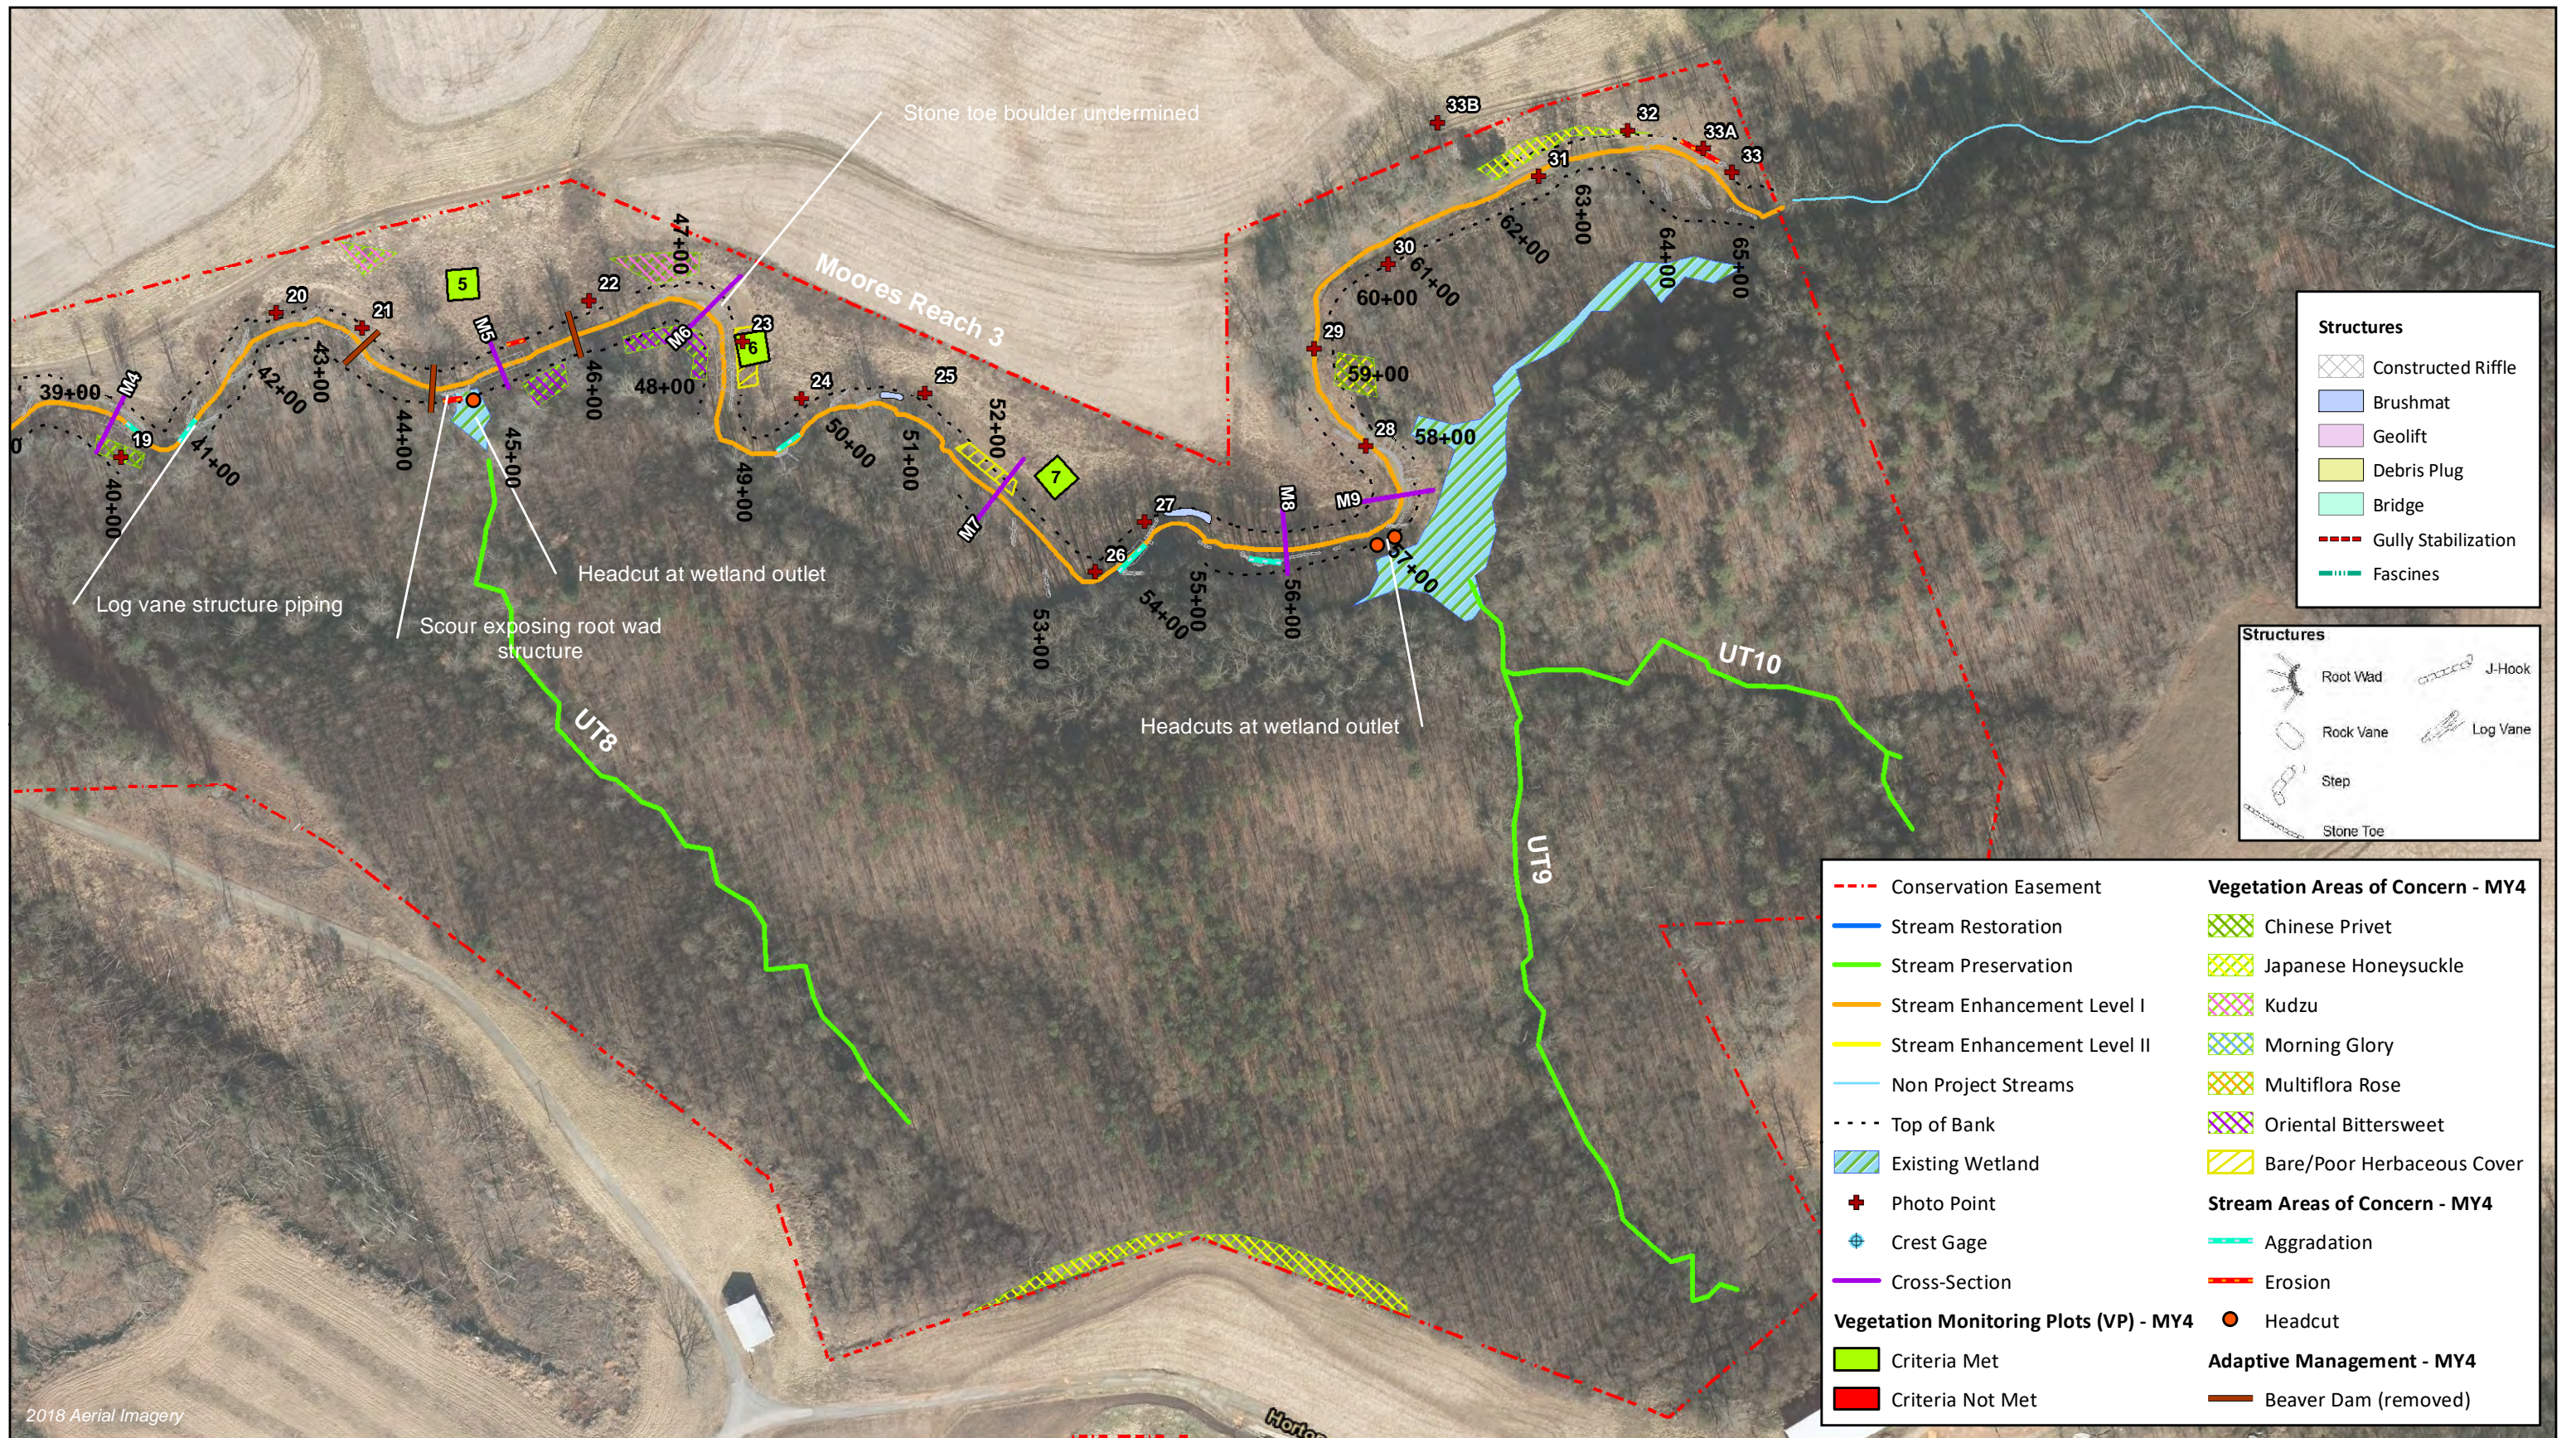
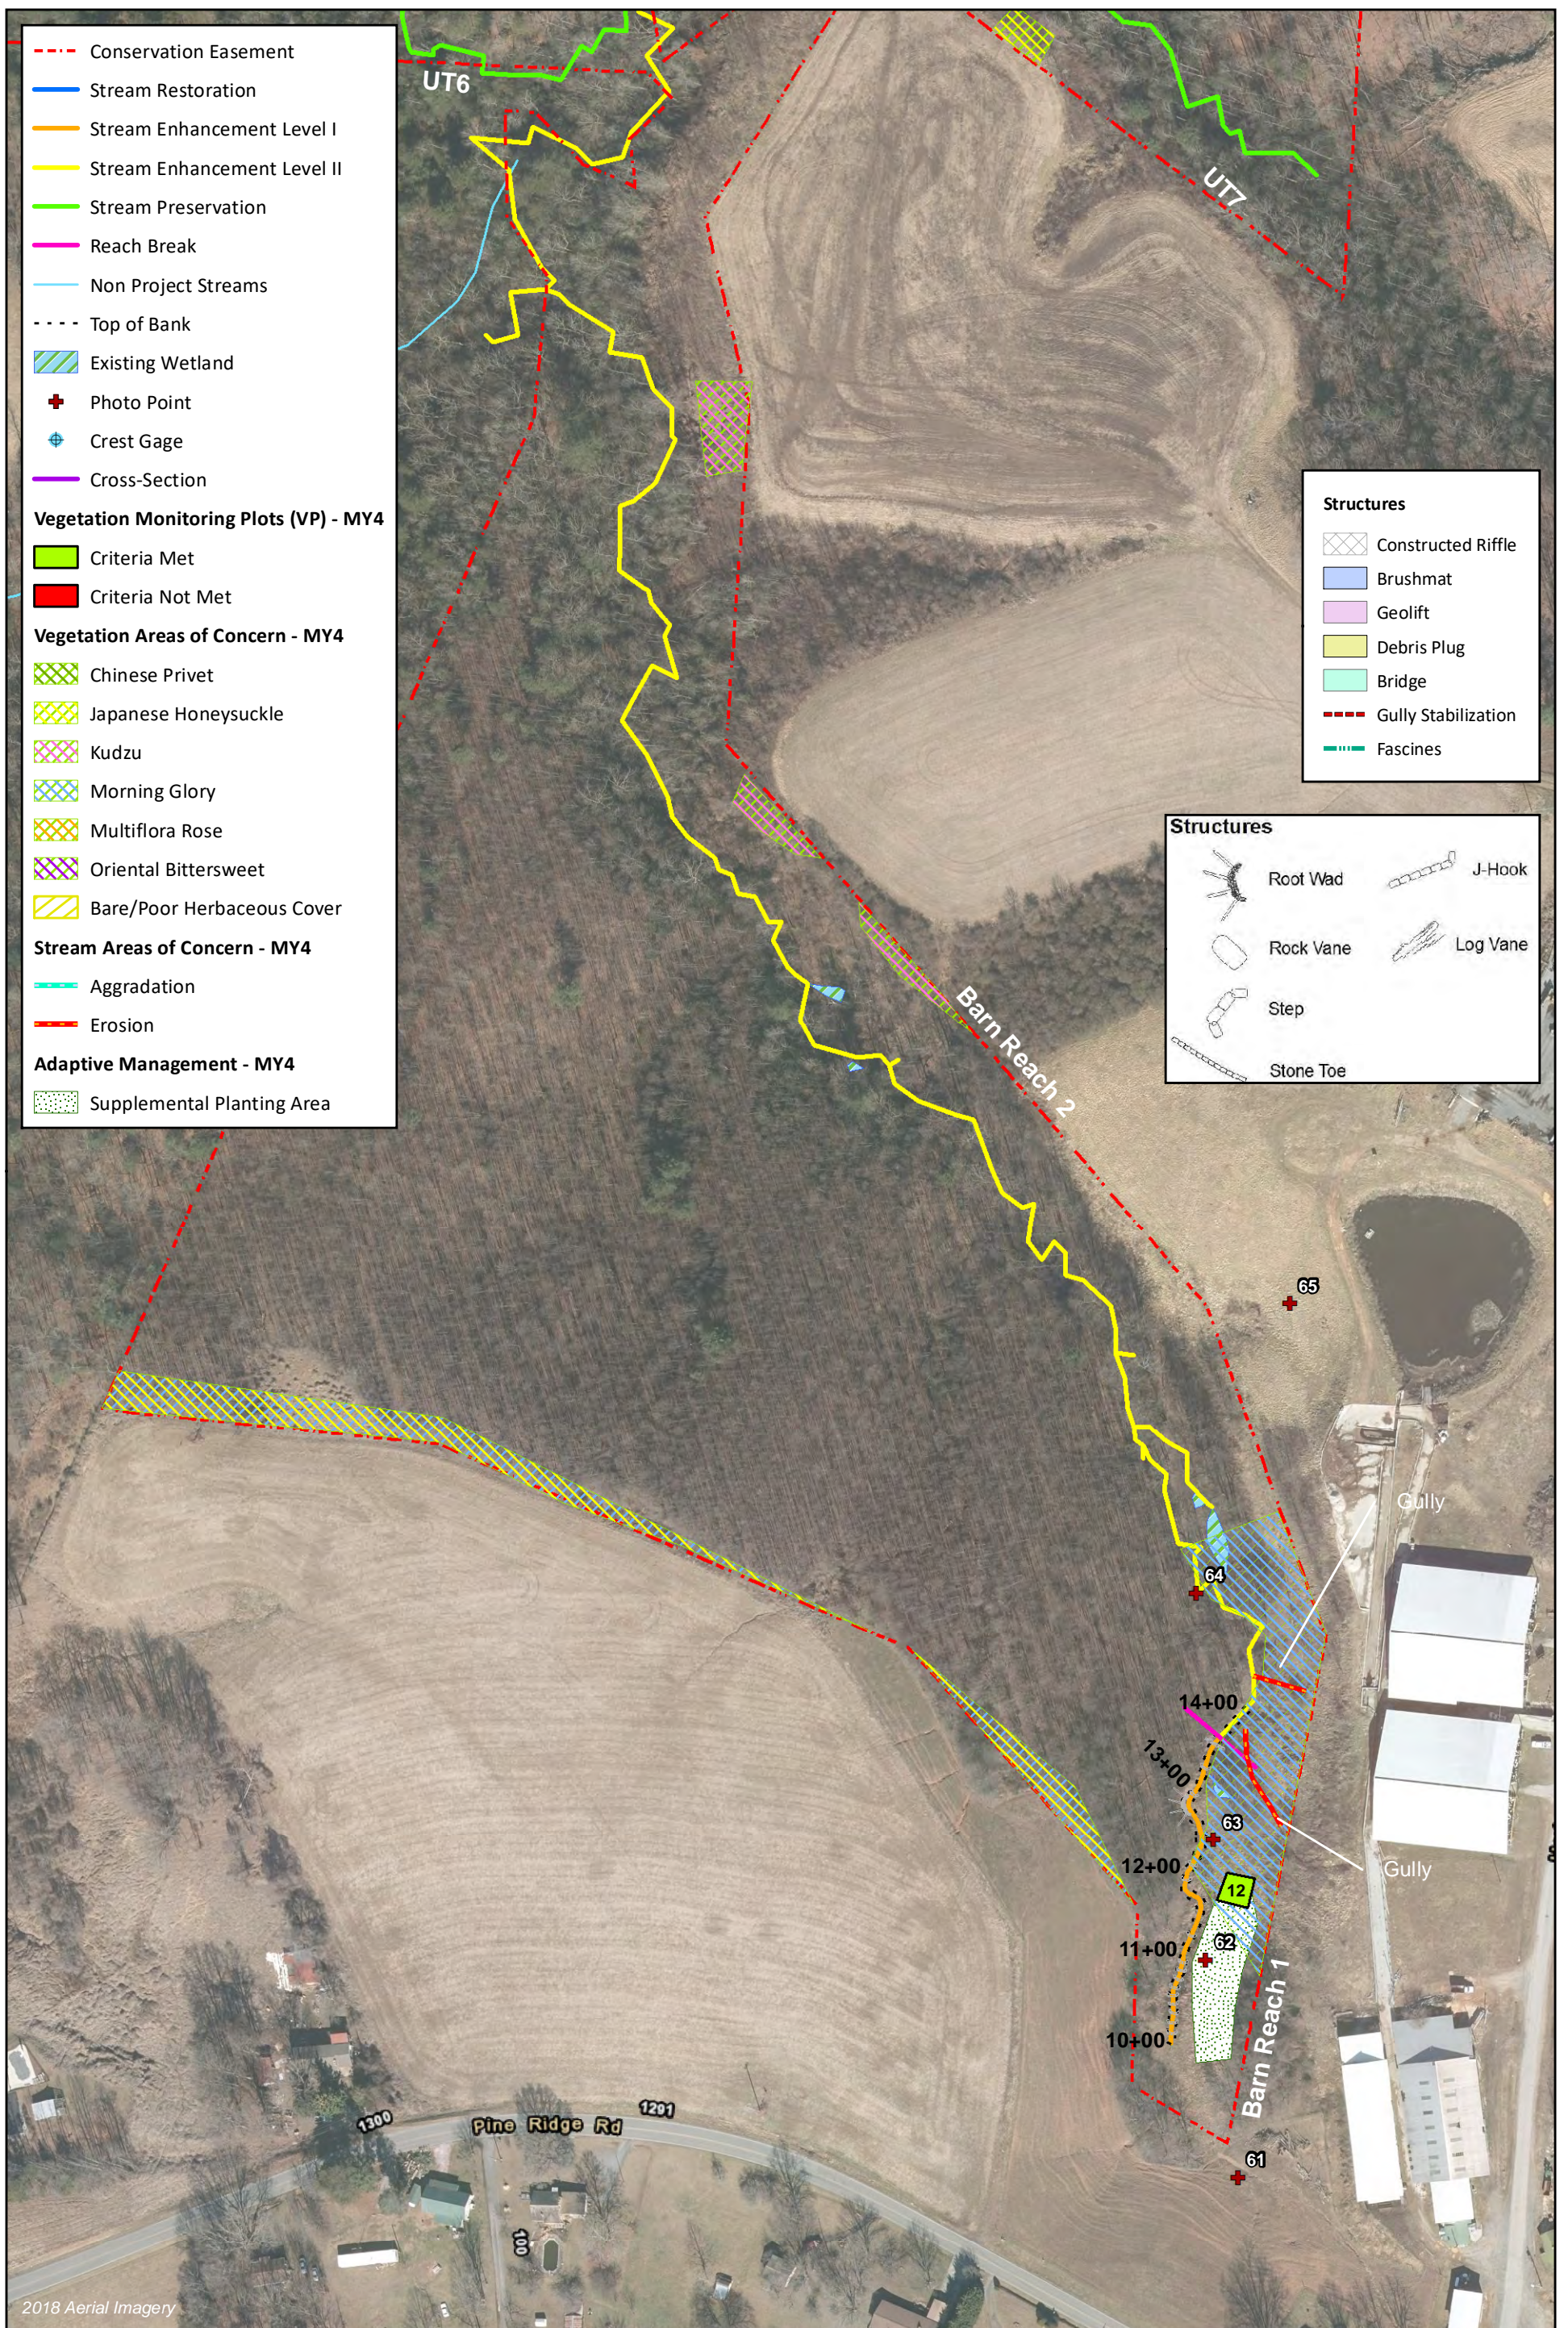
Some vegetation problem areas of invasive plant populations were identified MY4 throughout the Site. Species included: kudzu (*Pueraria montana*), Chinese privet (*Ligustrum sinense*), Japanese honeysuckle (*Lonicera japonica*), Multiflora rose (*Rosa multiflora*), Winter Creeper (*Euonymus fortunei*), oriental bittersweet (*Celastrus orbiculatus*), and Japanese stilt grass (*Microstegium vimineum*). The invasive treatments that occurred in 2018 and continued in February, July, and September 2019 have significantly reduced these vegetation areas of concern. Invasive treatments at the Site will continue through closeout. Many planted stems continue to be damaged from vine strangulation along Barn Tributary Reach 1. Areas of invasive species that persist throughout the conservation easement are indicated on Figures 3.0-3.6 in Appendix B.

The site has a strong herbaceous cover consisting of various species of clover, rye grass, fescue, and sedge. Supplemental planting consisting of 400 bare roots was completed in March 2019 in areas with low stem density based on the MY3 plant warranty inspection report. Isolated bare/poorly vegetated areas that were observed in MY3 have herbaceous cover that is becoming established in MY4. These vegetation areas of concern and management activities are shown in Figures 3.0-3.6 in Appendix B.

Stream areas of concern include localized instances of bank instability and sediment deposition. Along Moores Fork, new or expanded areas of bank erosion was noted in MY4 (STA 21+60, 23+80, 35+40, 45+10, 64+10). The most significant erosion along Moores Fork is located just upstream of the bridge (STA 35+40) where a point bar is re-directing flow into the left bank. Additionally, at the end of Moores Fork Reach 3 (STA 64+10) bank erosion has continued to scour the left bank behind a log vane structure. At both wetland outlets to Moores Fork below UT8 and UT10, the headcuts have worsened and migrated further into the wetlands. These headcuts are likely to worsen without maintenance. Along Silage Tributary, several new or expanded areas of bank instability were noted in MY4 (STA 23+00, 24+50, 25+60, 28+70, 31+10). Areas with rill formations (gully) were noted, especially on the left bank of Silage Reach 1 near STA 14+30. Several structures along Silage Tributary Reach 1 and 2 have been undermined including log structures at STA 15+80, 18+20, 26+90, 31+90, 33+10 and a boulder step footer at STA 35+20. The Pond Tributary continues to experience sedimentation that is accumulating within the upstream section of the tributary, resulting in channel braiding. At the project start of Corn Tributary, a significant headcut and erosion around the culvert was observed. These areas will continue to be monitored in future years for signs of accelerated instability.

DMS has contracted with a design firm to develop a repair plan for approximately nine areas of instability throughout the Site. The assessment and design will occur fall/winter 2019 followed by construction in fall 2020. DMS has also contracted with APHIS to control beaver and dams at the Site in 2019. APHIS removed multiple beaver and five dams in July 2019 and will continue to monitor the Site for beaver activity through closeout. Stream areas of concern and management activities are shown in Figures 3.0-3.6 in Appendix B.

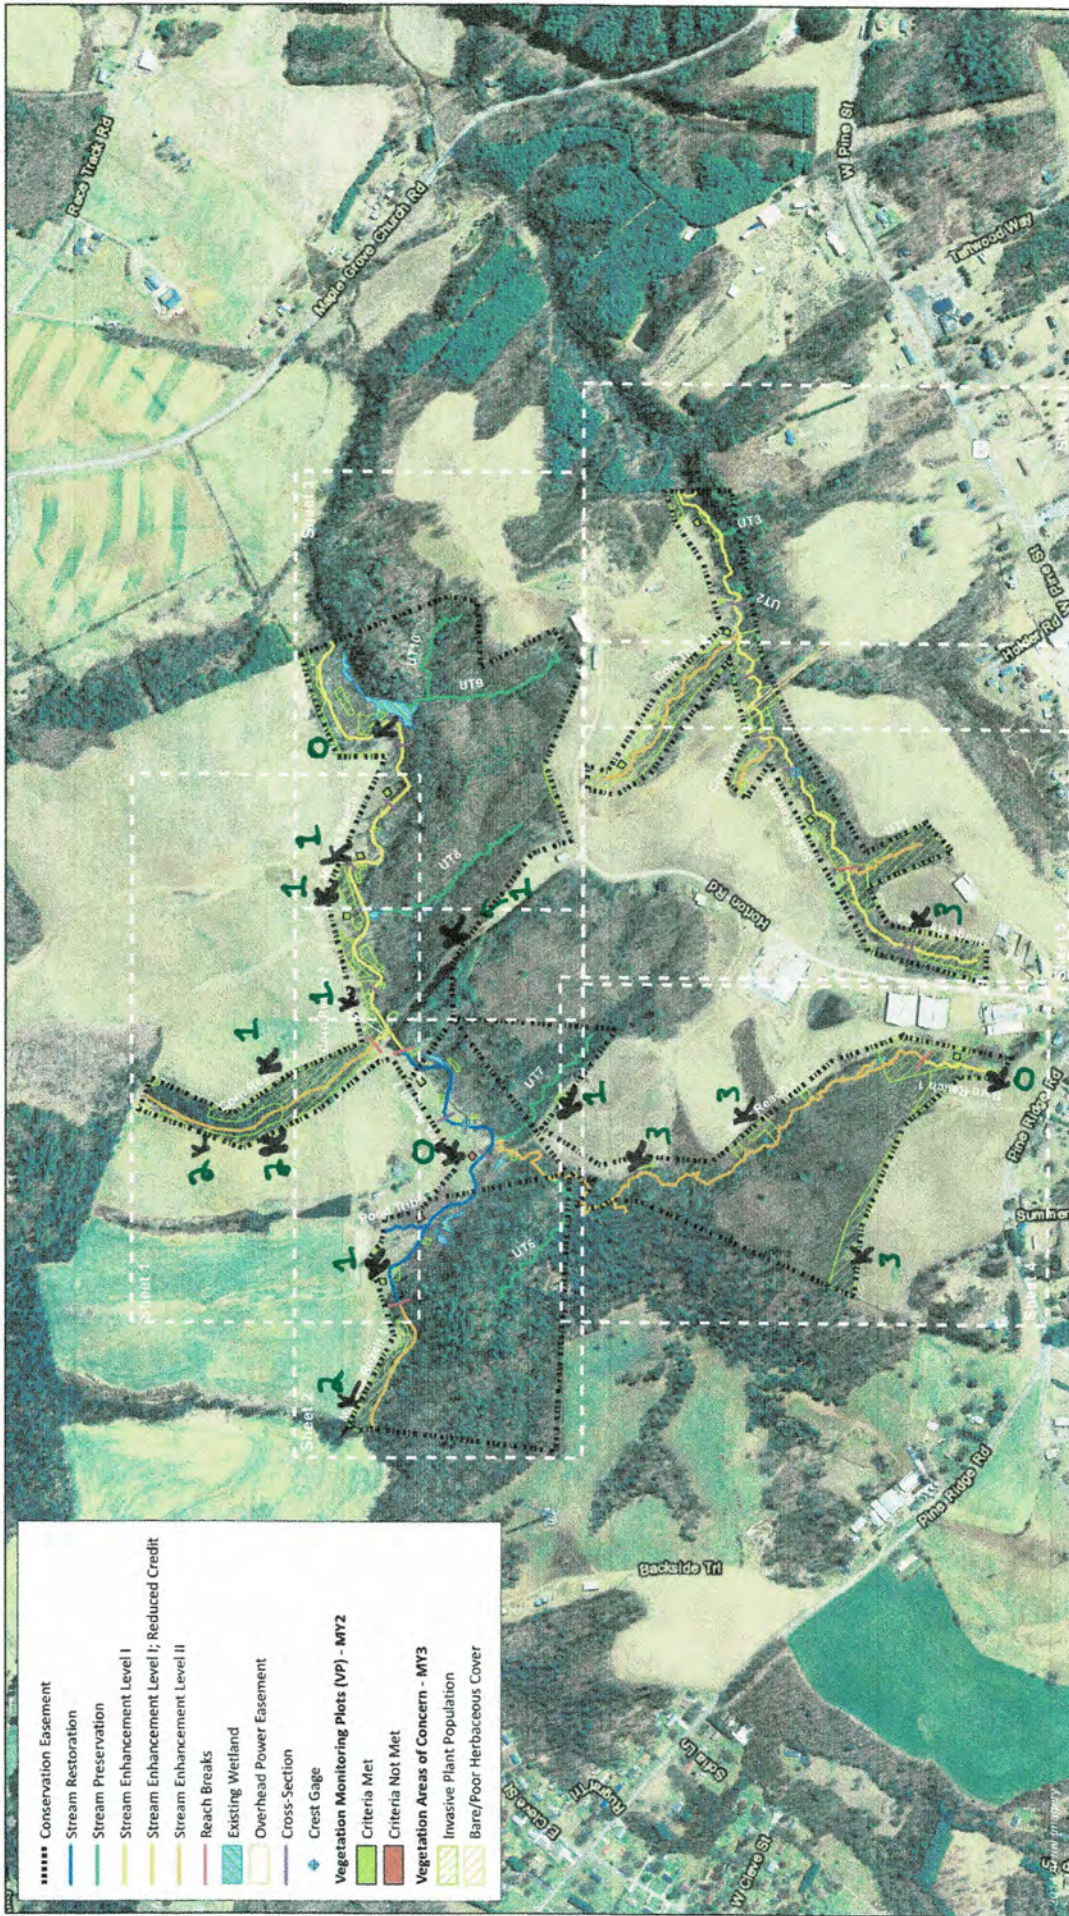
2018 Kudzu Locations - July 2019 Status

0-1 - Little/No Kudzu Found
 2 - Moderate Infestation
 3 - Heavy Infestation
