MONITORING YEAR 5

MOORES FORK STREAM MITIGATION PROJECT

Surry County, NC

DMS Project Number 94709

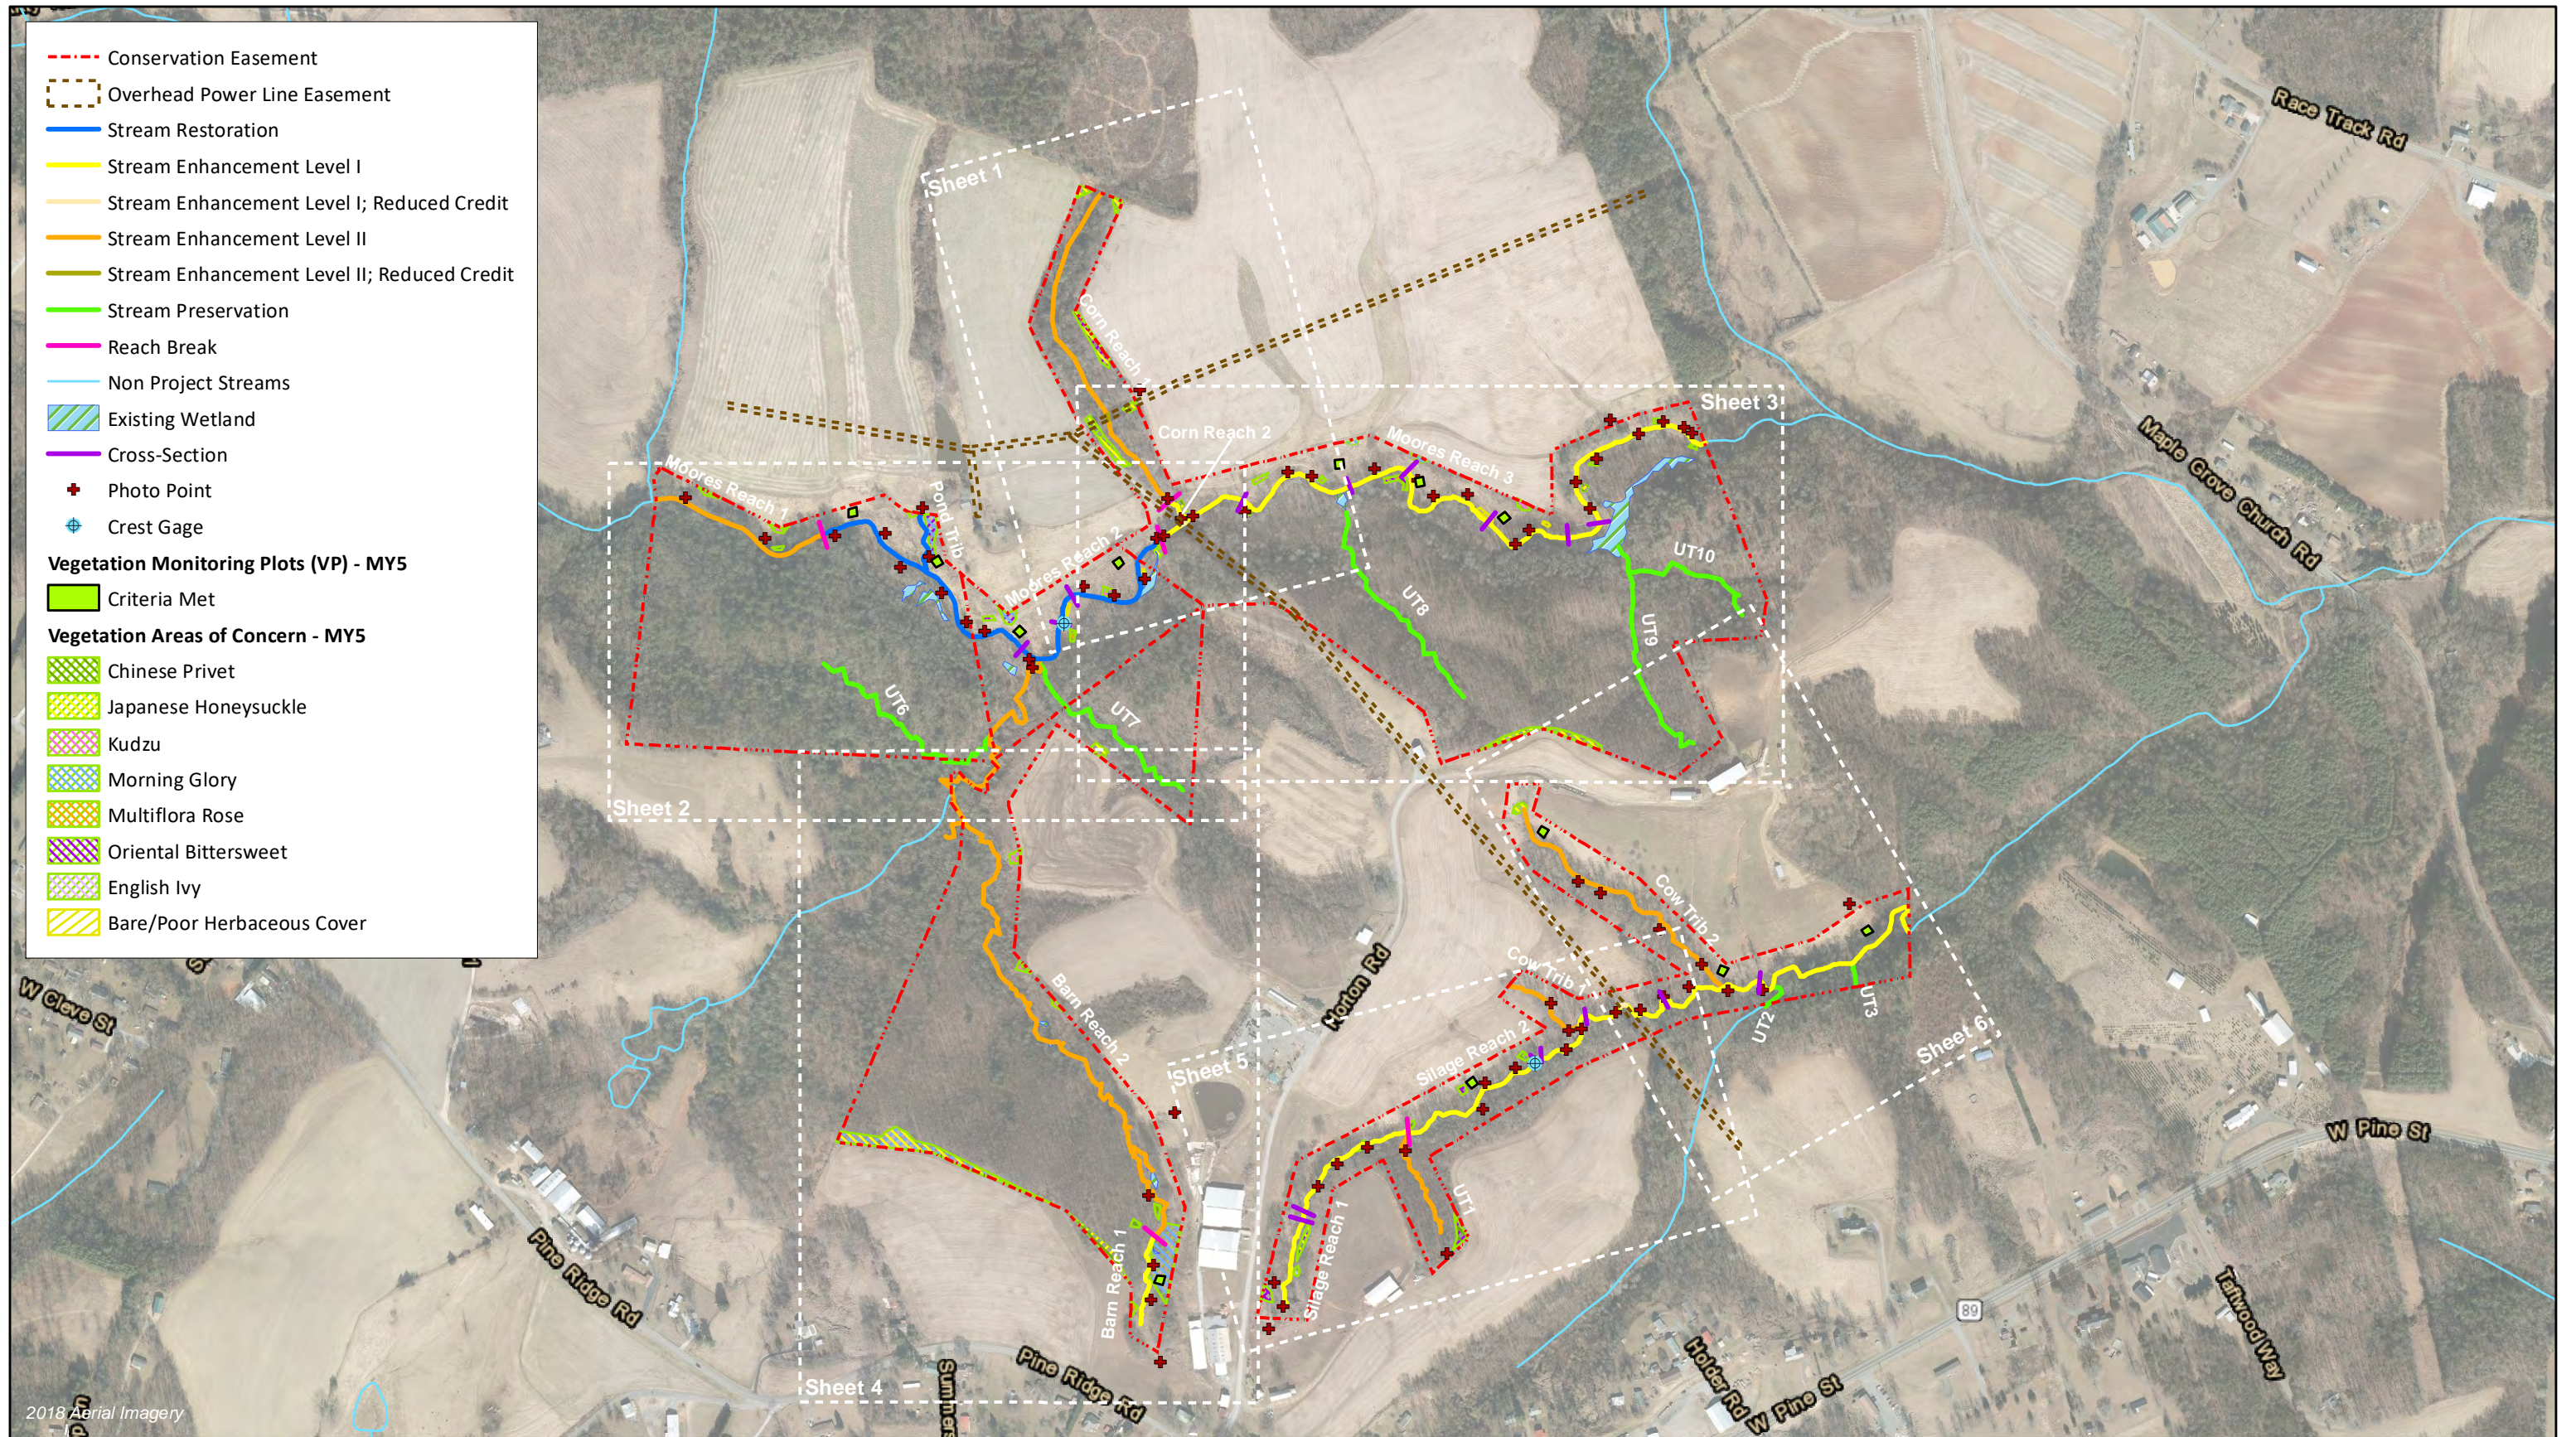
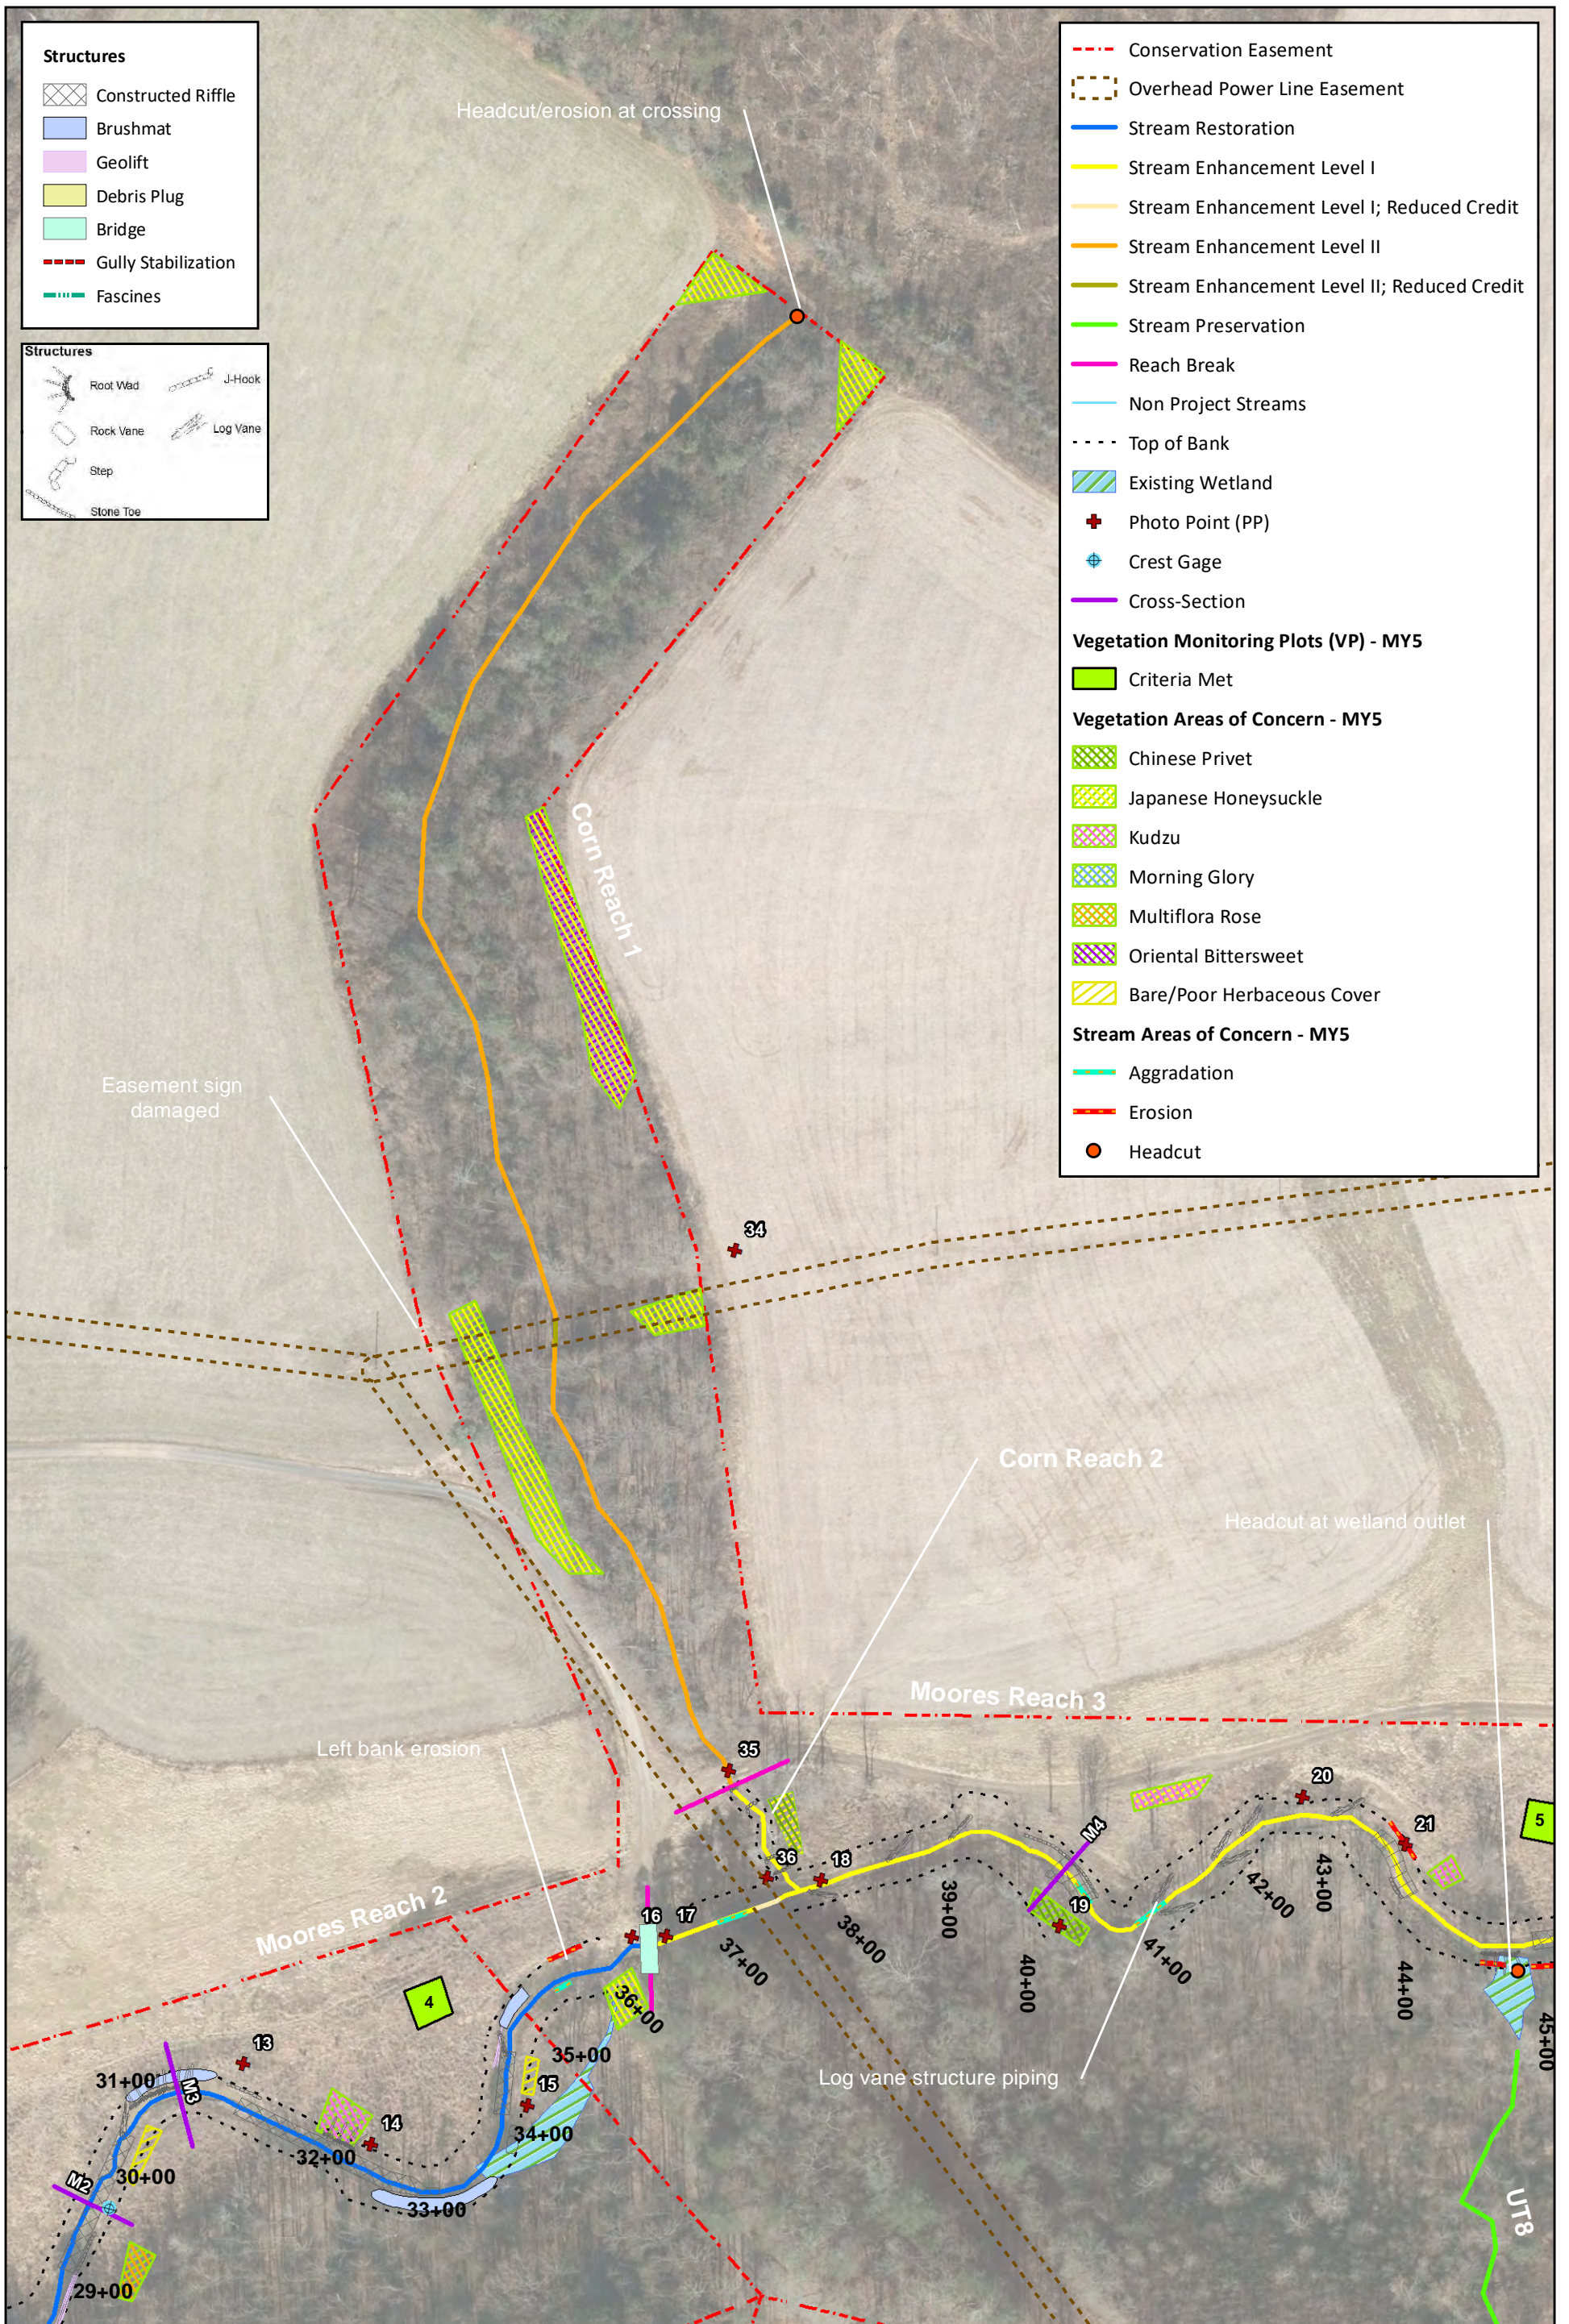
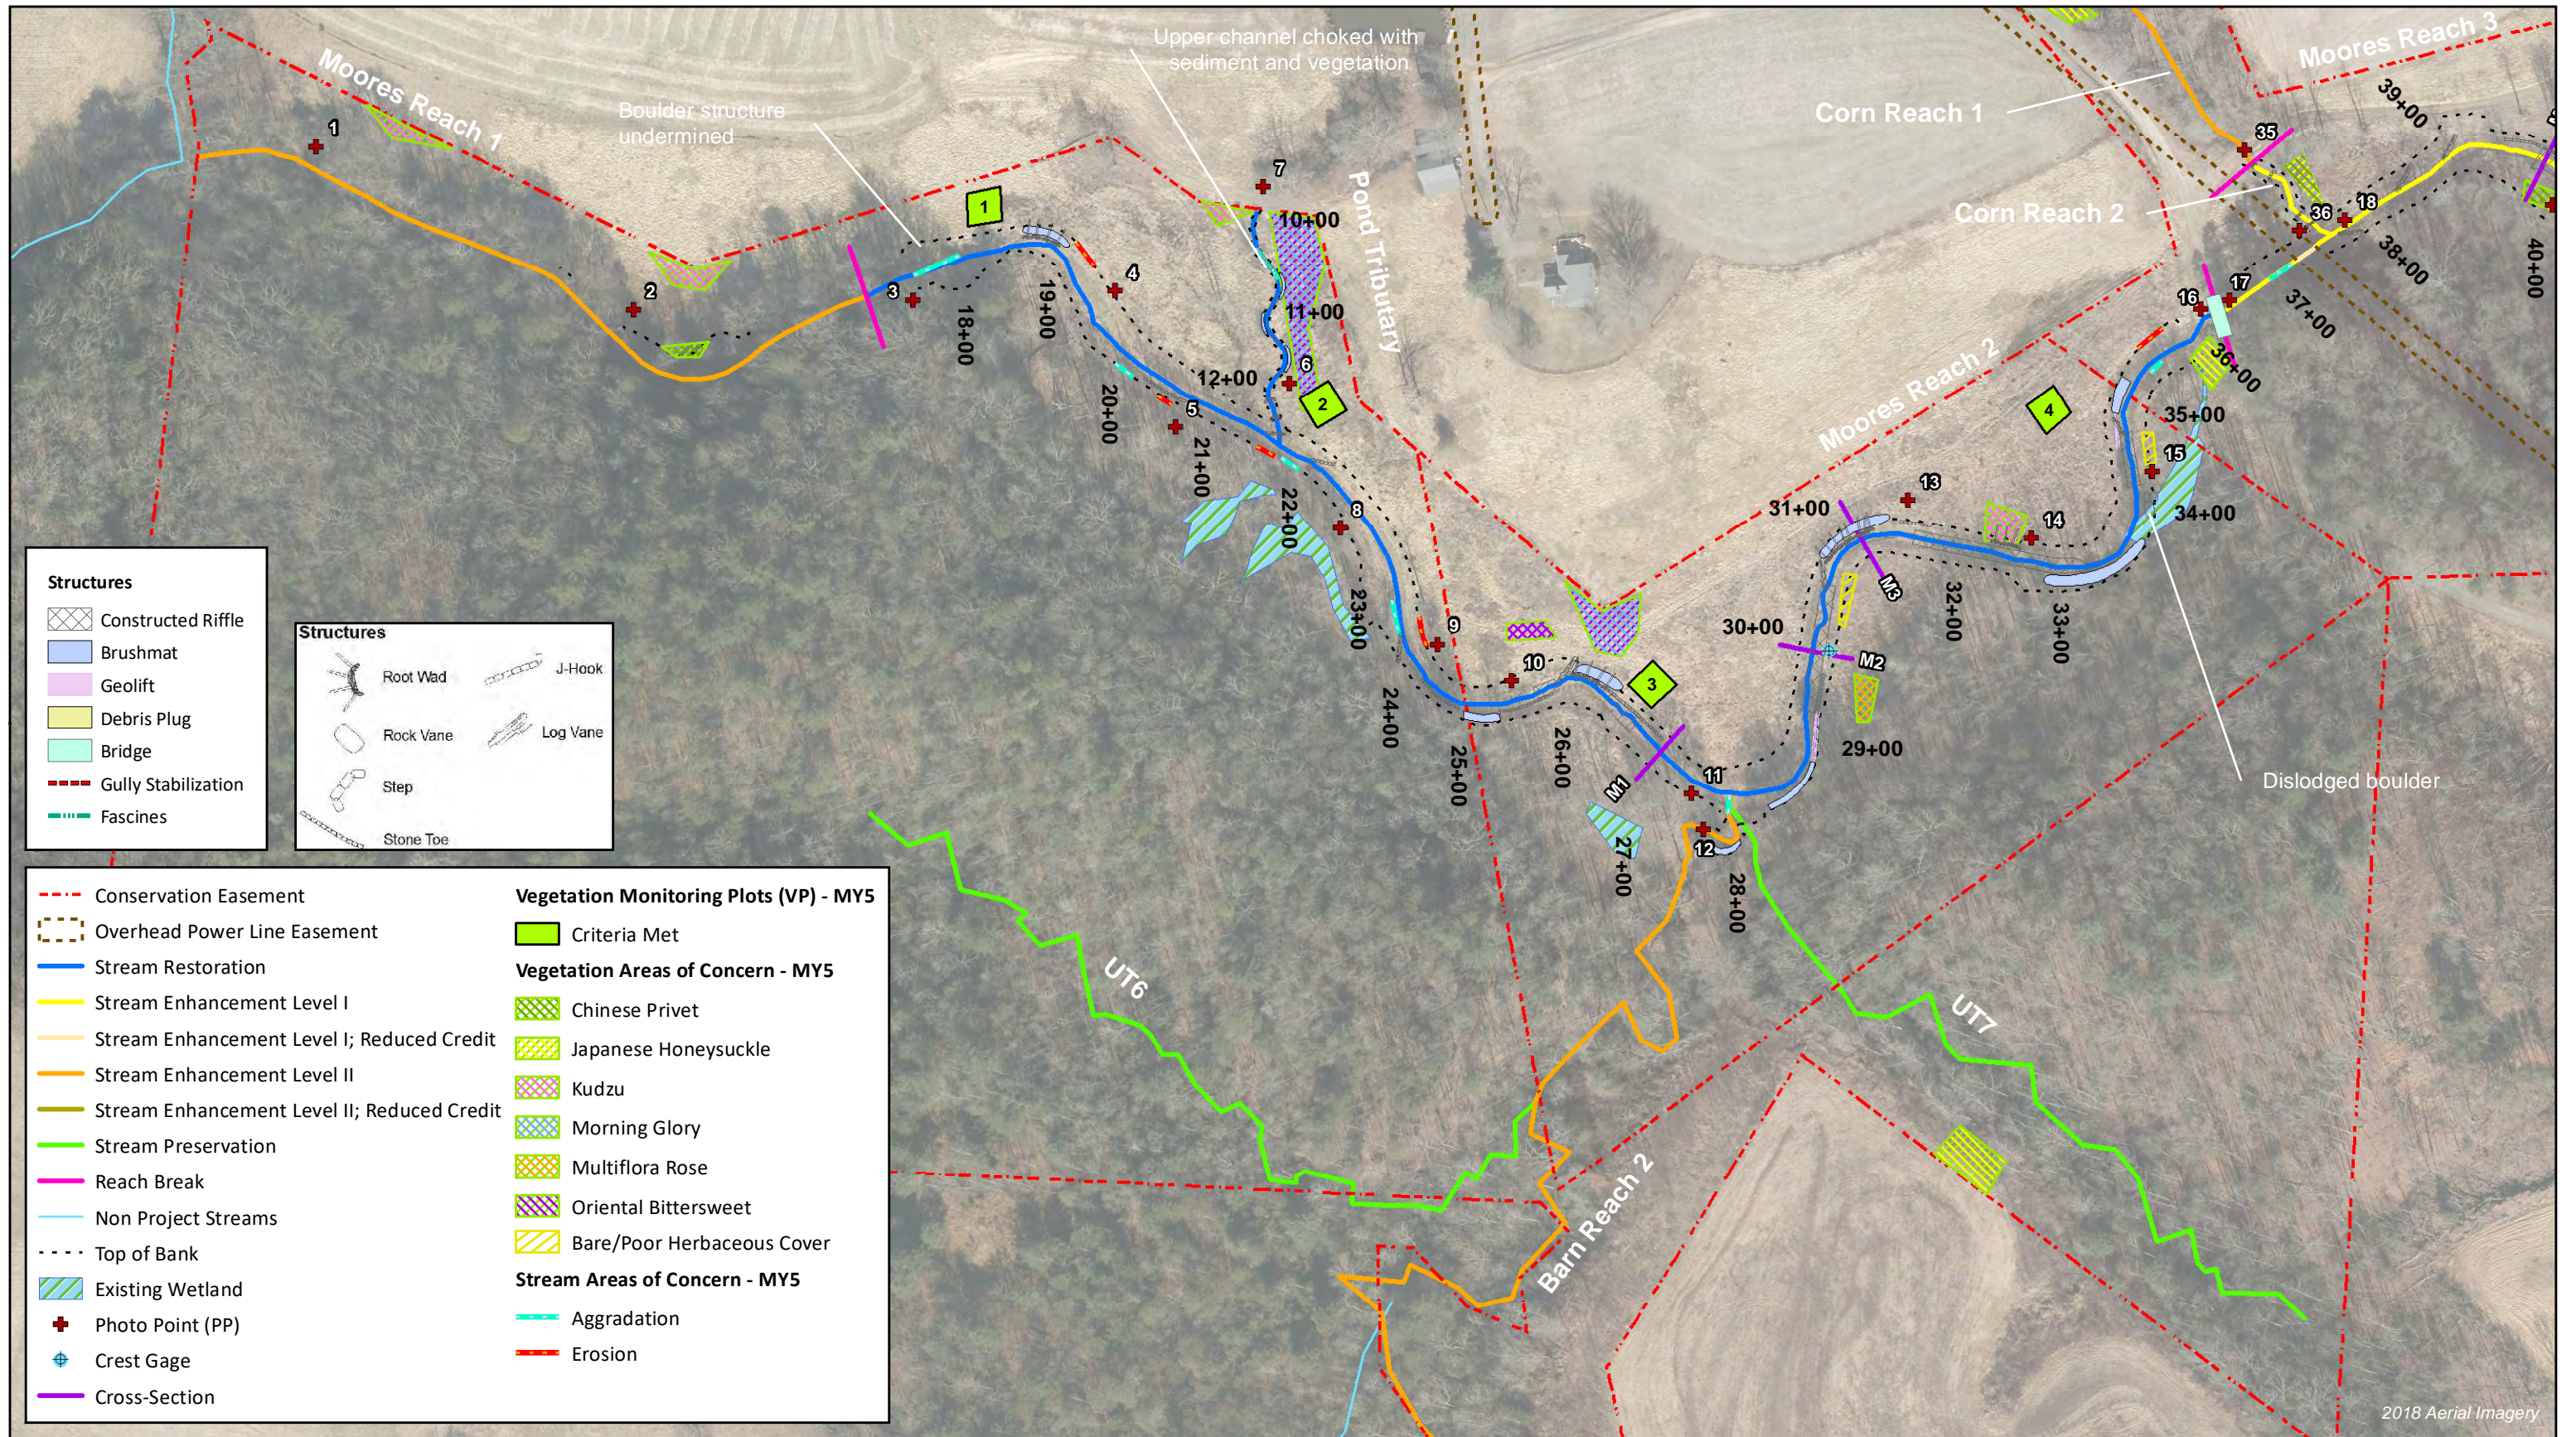
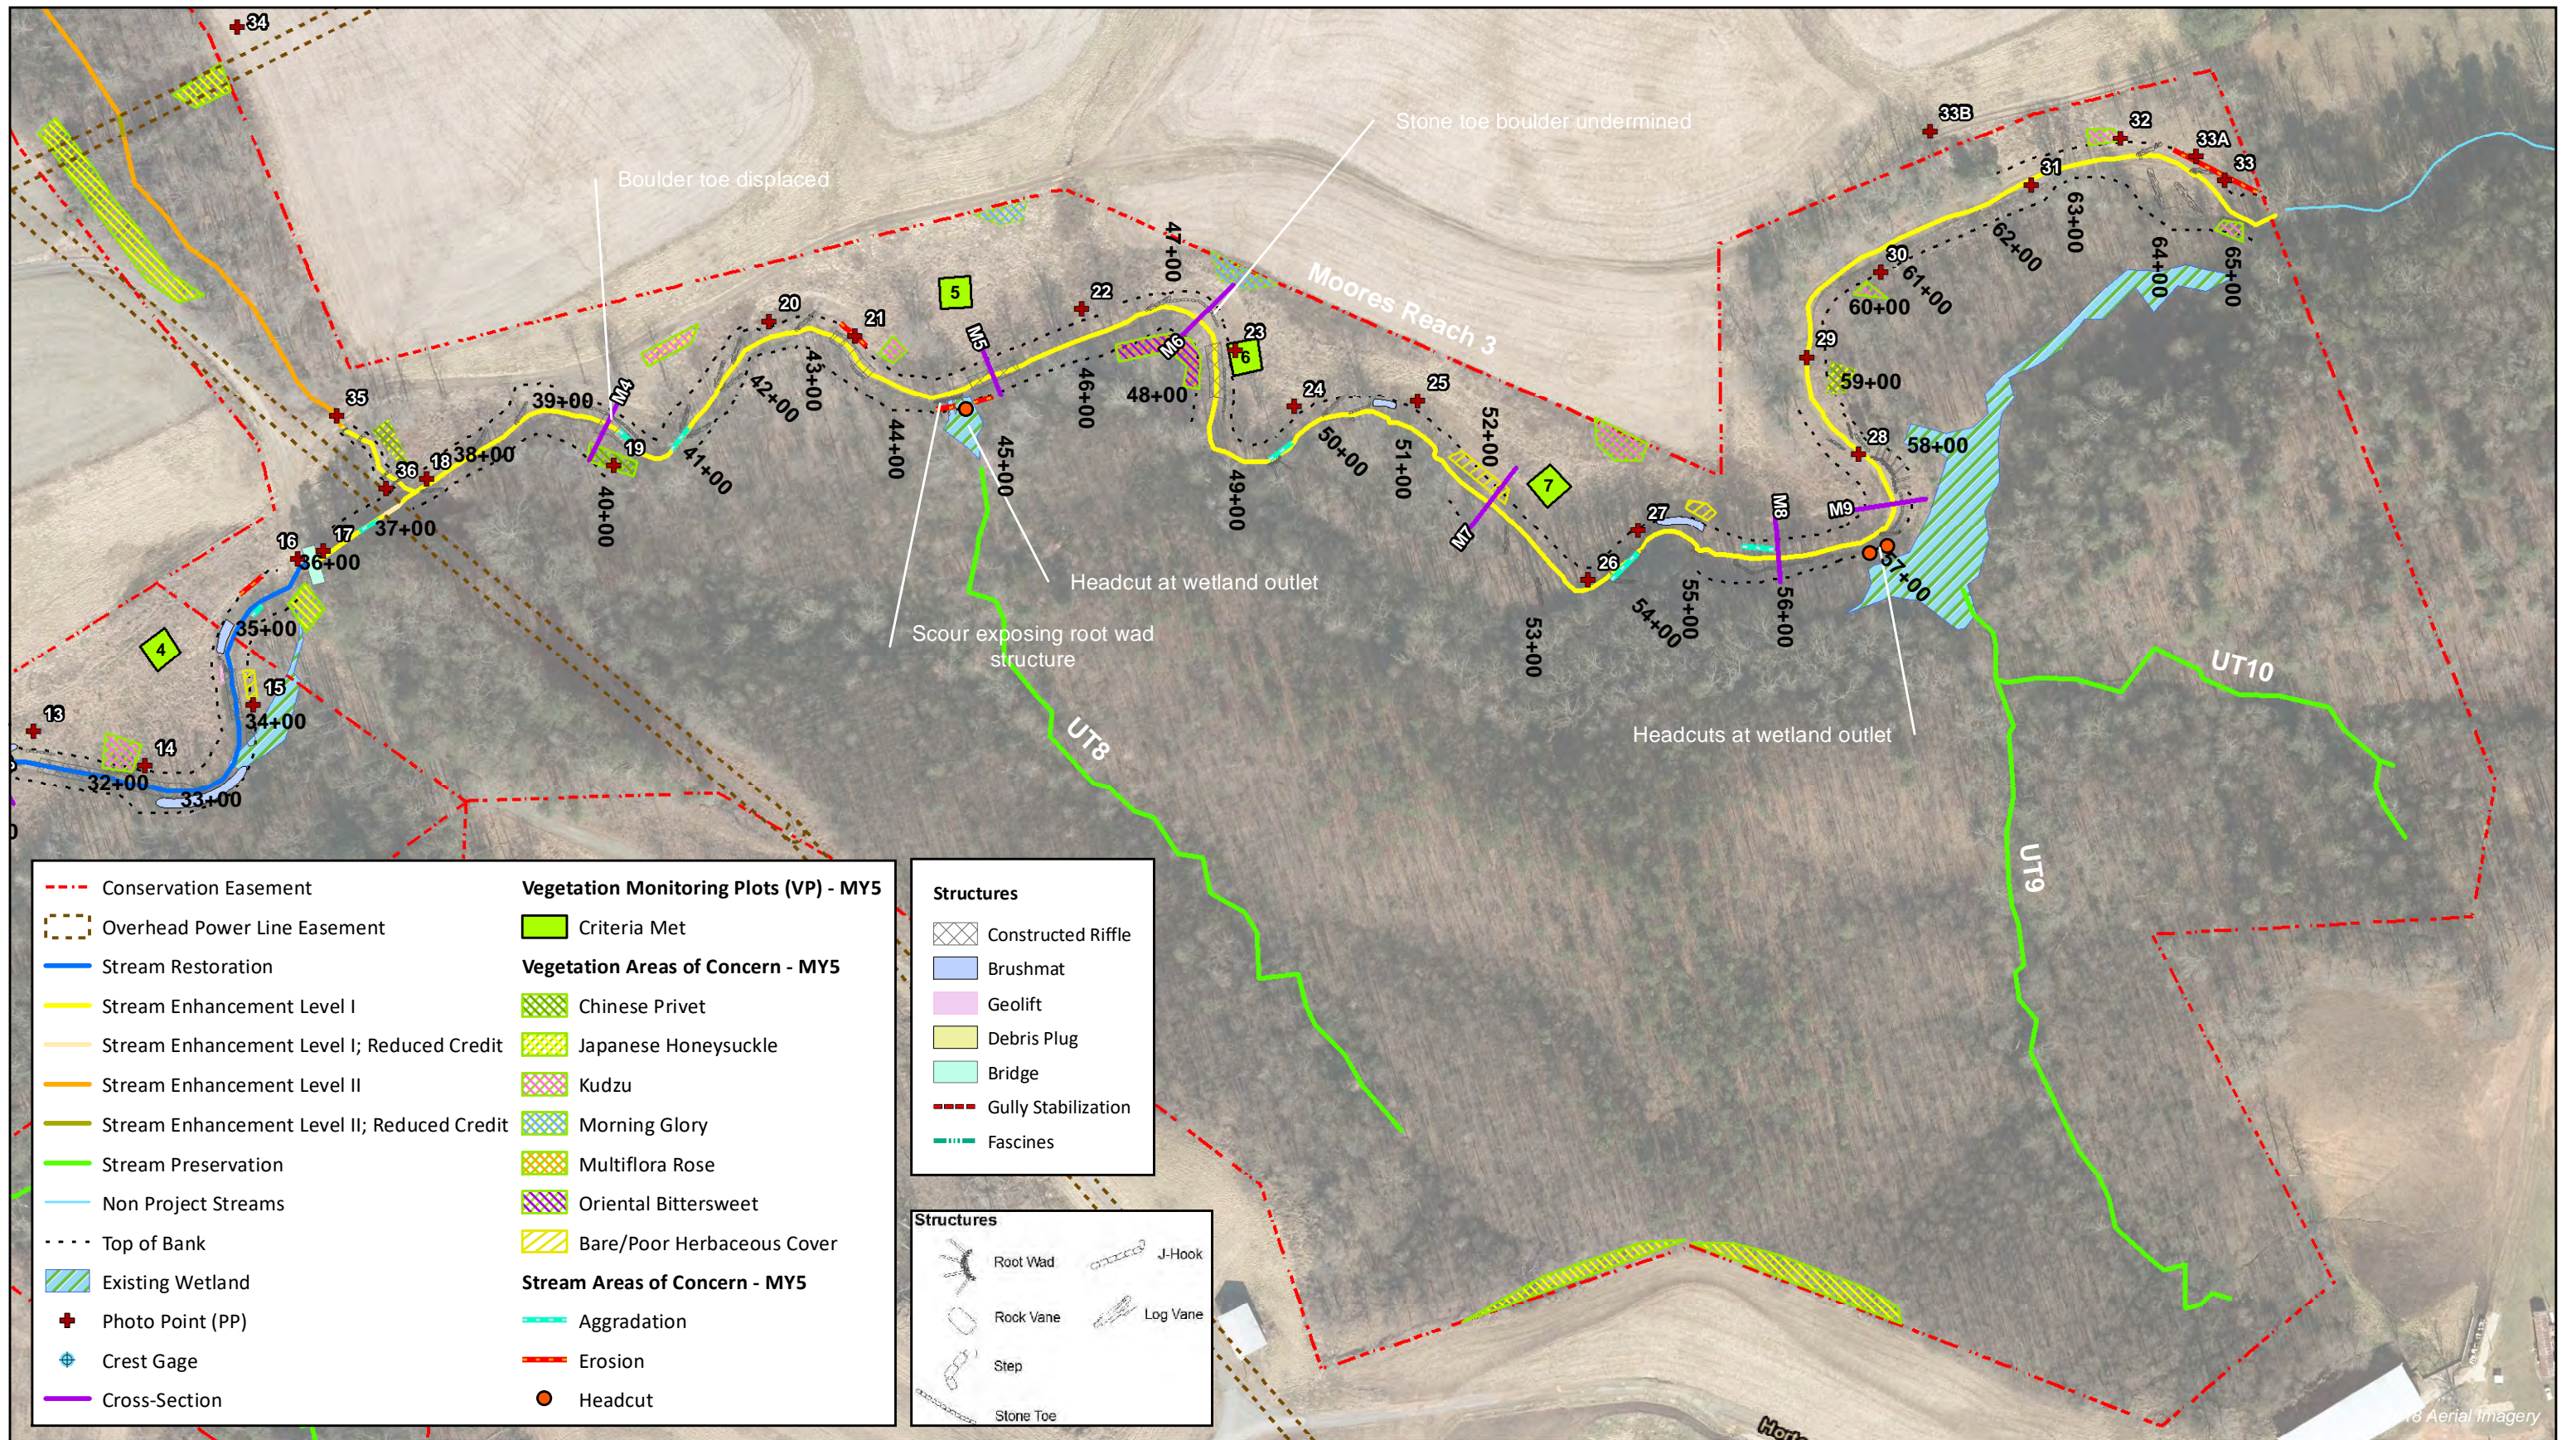
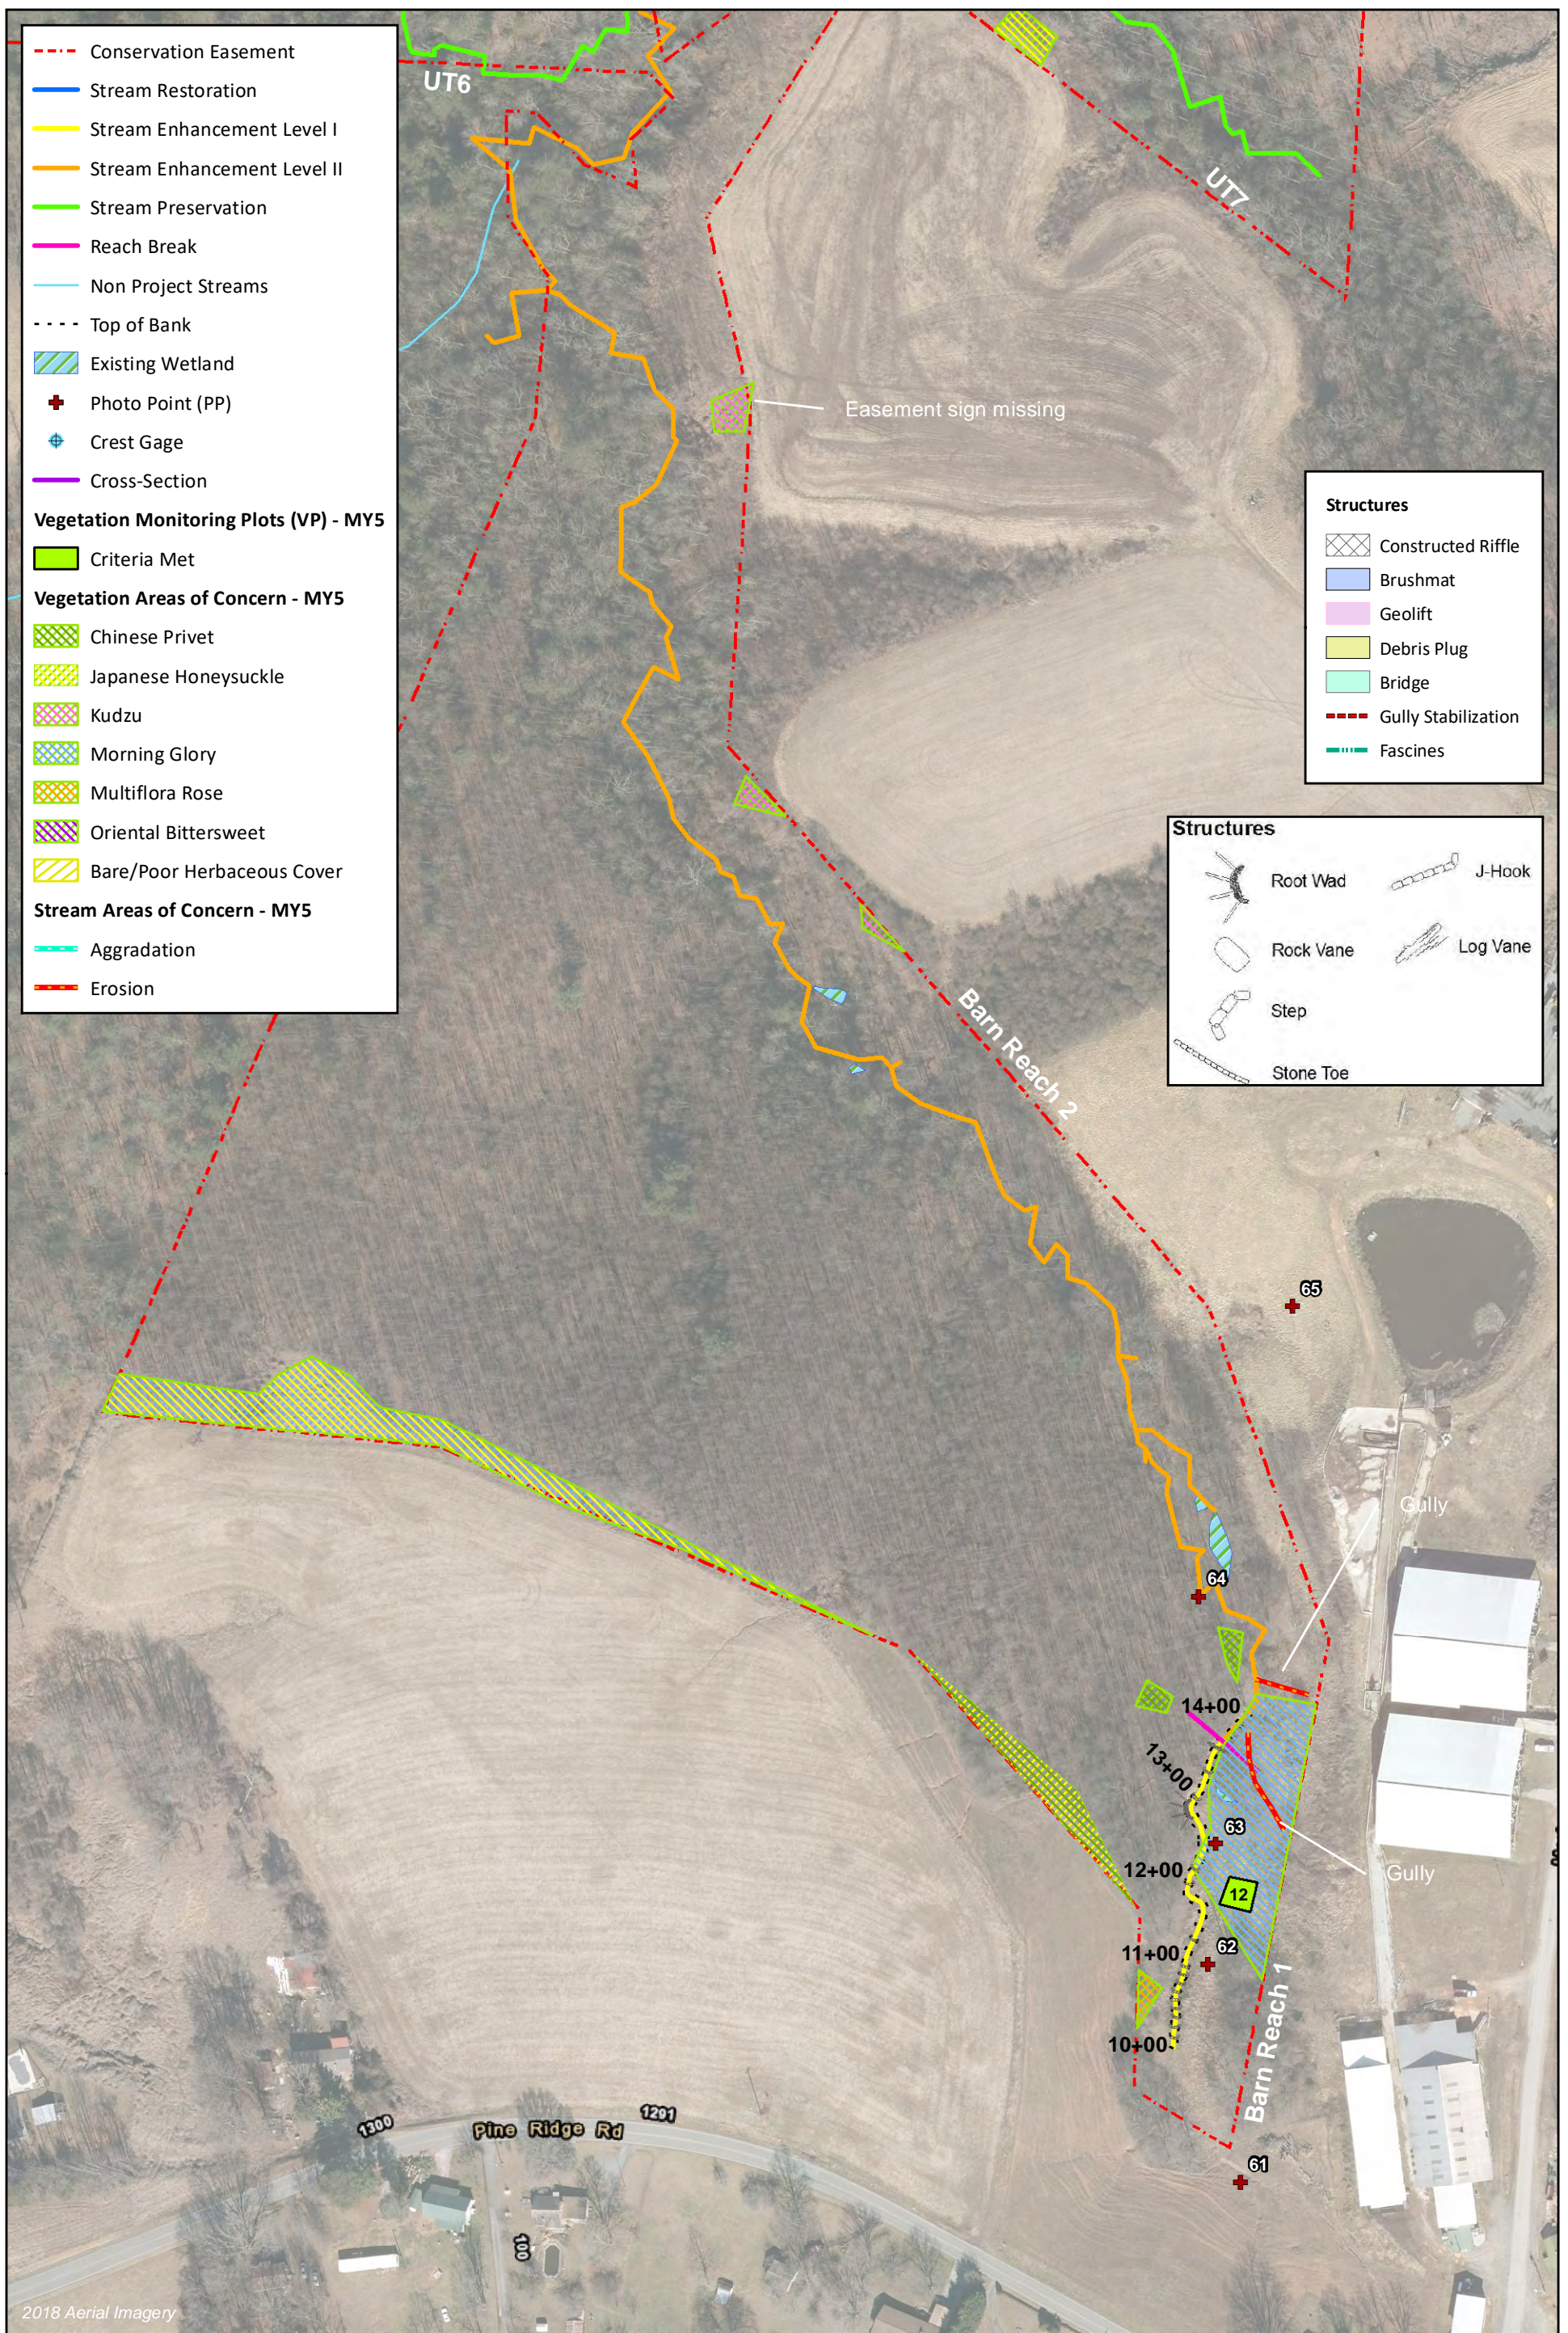
Figure 3.0 Current Condition Plan View (Key)
 Moores Fork Stream Mitigation Project
 DMS Project No. 94709
 Monitoring Year 5 - 2020

In areas that received supplemental planting in 2019, stems were found to be healthy and stem density appears higher. Isolated bare/poorly vegetated areas observed in MY5 continue to be improving with herbaceous cover becoming established. These vegetation areas of concern are shown in Figures 3.0-3.6 in Appendix B.

Stream areas of concern include localized instances of bank instability and sediment deposition. Along Moores Fork, new or expanded areas of bank instability were noted in MY5 (STA 19+10, 43+10, 44+90, and 64+10). At both wetland outlets to Moores Fork below UT8 and UT10, the headcuts have continued to worsen and are migrating further up into the wetlands. Along Moores Fork, a few additional boulder toe structures have shifted resulting in bank scour behind them. However, these stream areas of concern seem to be isolated and not prevalent along Moores Fork.

Along Silage Tributary, several new or expanded areas of bank instability were noted in MY5 (STA 13+40, 21+80, 25+70, 30+30, 32+50, and 37+60) where woody vegetation has failed to become established along the banks. Several structures that were used for grade control along Silage Tributary have been

DMS has contracted with a design firm to develop a repair plan for approximately nine areas of instability throughout the Site. The assessment and design occurred fall/winter 2019 followed by construction that will occur in January 2021. Stream repairs will be captured in the MY7 (2022) geomorphic stream assessment. DMS has also contracted with APHIS to control beaver and dams at the Site in 2019. APHIS removed multiple beaver and dams in 2019 and will continue to monitor the Site for beaver activity through closeout. Stream areas of concern and management activities are shown in Figures 3.0-3.6 in Appendix B.

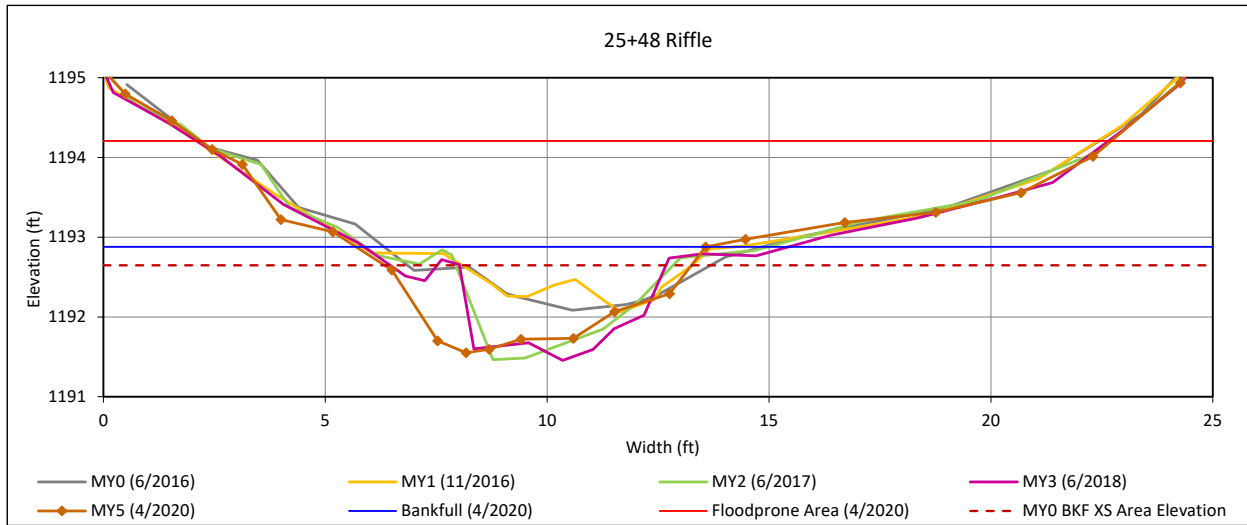
Cross-Section ST3 - Silage Trib

Along Silage Tributary, the surveyed cross-sections, are representative of vertical and lateral instability observed throughout Silage Tributary Reach 1 and 2. Downcutting present at cross-sections ST2, ST3, and ST6, and bank scour present at cross-sections ST1 and ST5, accounts for the increased channel dimensions as compared to MY0. In general, MY5 riffle pebble counts indicate similar or coarser sediment size distribution as compared to MY0. See section 1.2.4 for further discussion about stream areas of concern along Silage Tributary. Please refer to Appendix D for cross-section plots and morphological summary tables.

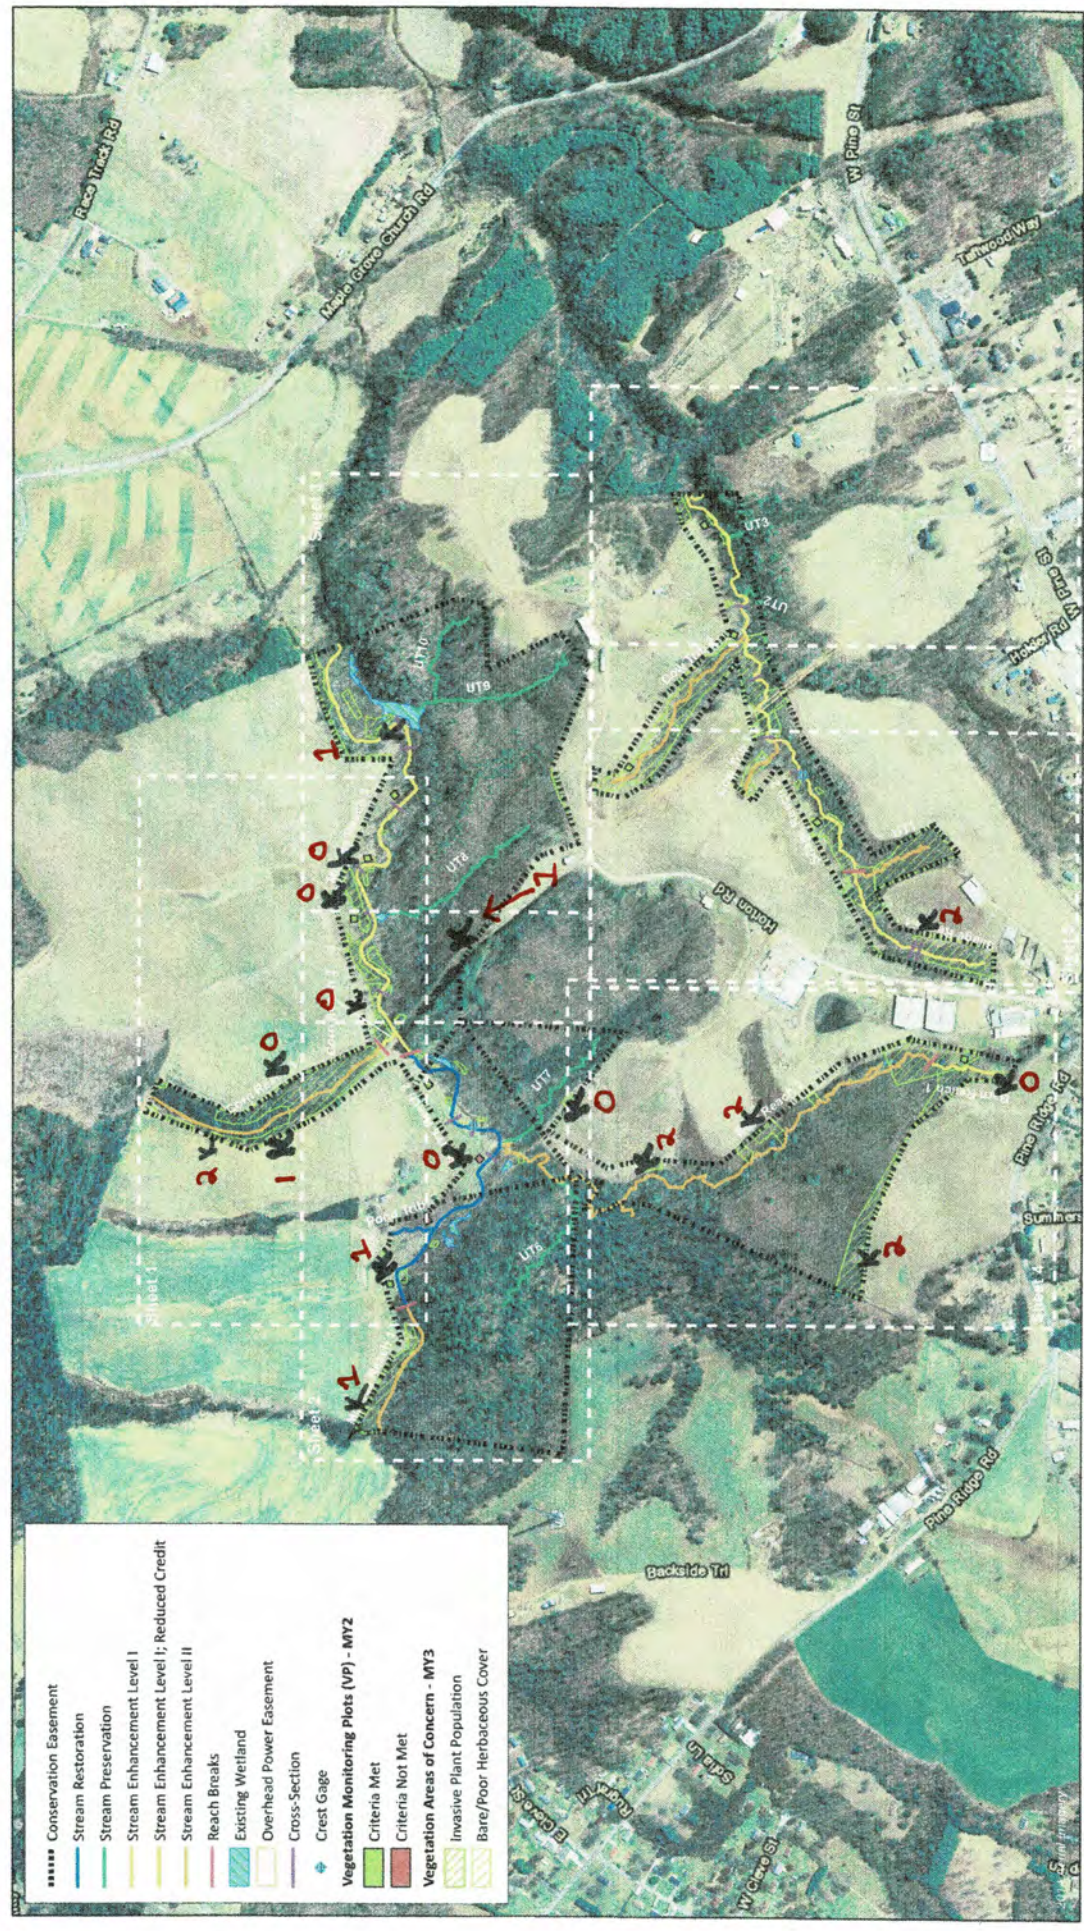
2018 Kudzu Locations - July 2020 Status

Areas of invasive plant populations were identified in MY5 throughout the Site. Species included: kudzu (*Pueraria montana*), Chinese privet (*Ligustrum sinense*), Japanese honeysuckle (*Lonicera japonica*), Multiflora rose (*Rosa multiflora*), oriental bittersweet (*Celastrus orbiculatus*), morning glory (*Convolvulus sp.*), and English ivy (*Hedera helix*). The invasive treatments that occurred in 2019 and continued in 2020 have caused over a 40% reduction compared to MY4. Currently, less than 2% of the easement acreage is mapped with some invasive species areas of concern. In 2020, invasive treatments occurred in May, June, and July and will continue through closeout. Along the left floodplain of Moores Fork, there continue to be some persistent areas of kudzu and additional pockets discovered in MY5 along the stream banks.
