# MONITORING YEAR 6 ANNUAL REPORT

## MOORES FORK STREAM MITIGATION PROJECT

Surry County, NC

DMS Project Number 94709

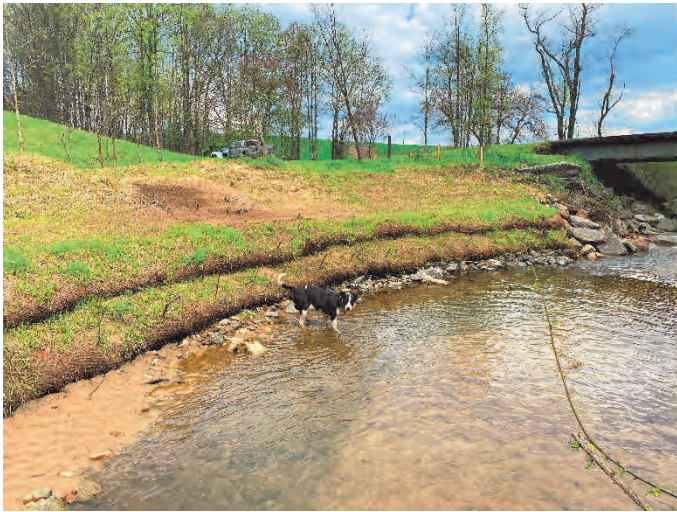
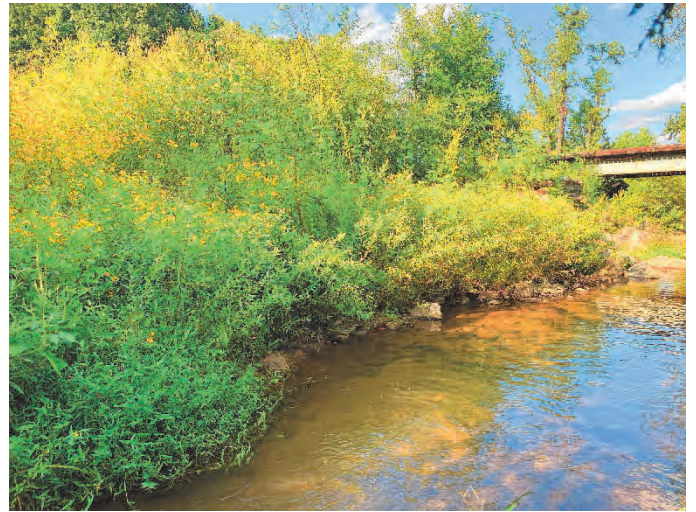
Moore's Fork Reach 2 STA 35+40 left bank repair – 4/19/2021

Moore's Fork Reach 2 STA 35+40 left bank repair – 9/7/2021

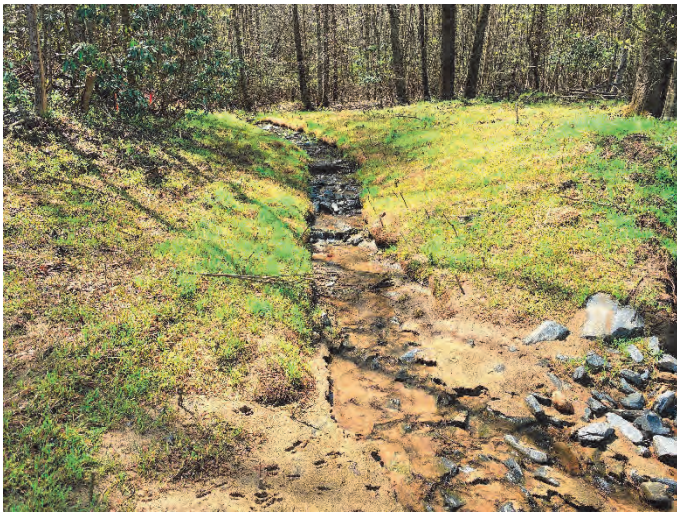
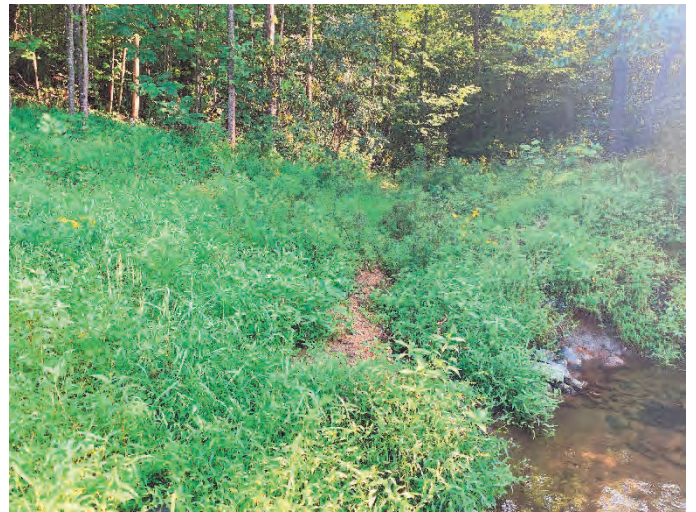
UT8/Wetland outlet repair at confluence with Moore's Fork – 4/19/2021

UT8/Wetland outlet repair at confluence with Moore's Fork – 9/7/2021

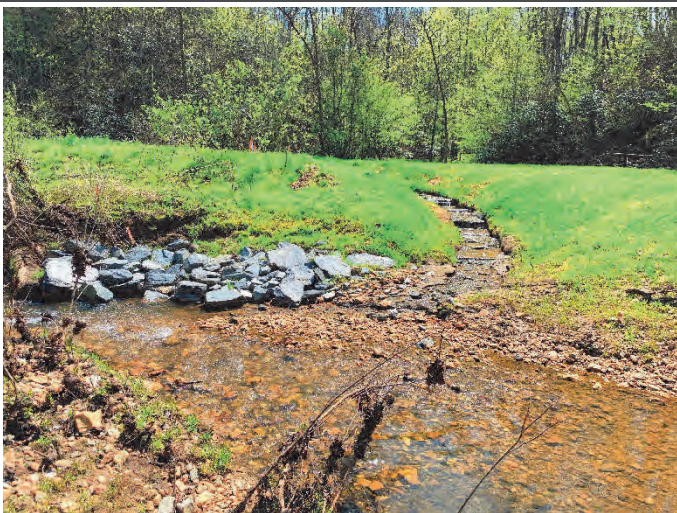
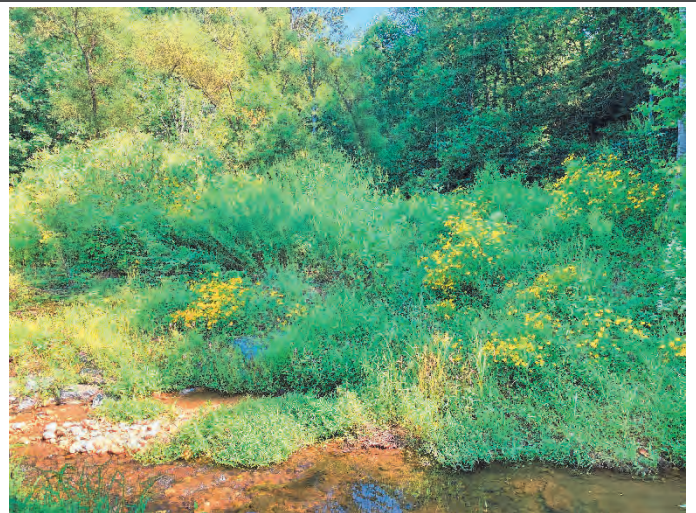
UT10/Wetland outlet repair at confluence with Moore's Fork – 4/19/2021

UT10/Wetland outlet repair at confluence with Moore's Fork – 9/7/2021

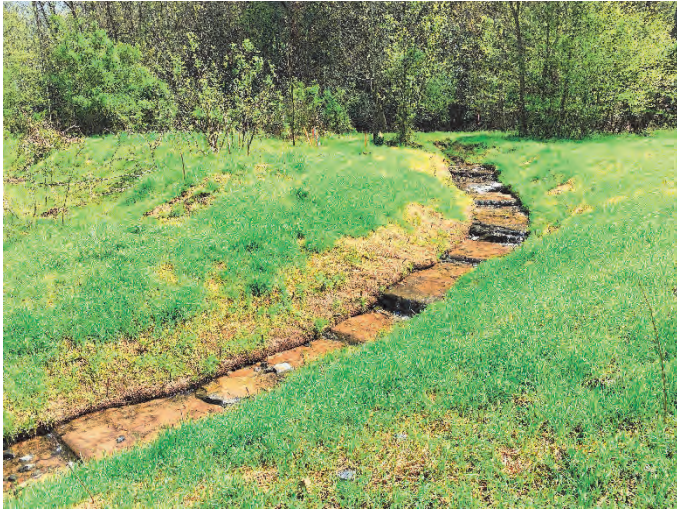
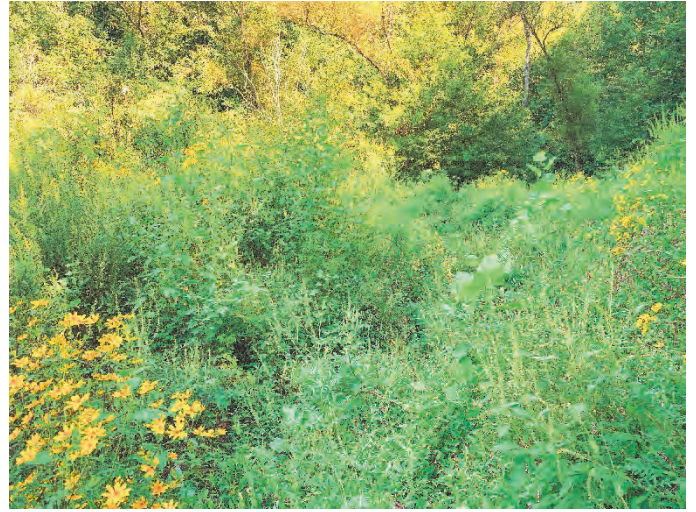
UT10/Wetland outlet repair – 4/19/2021

UT10/Wetland outlet repair – 9/7/2021

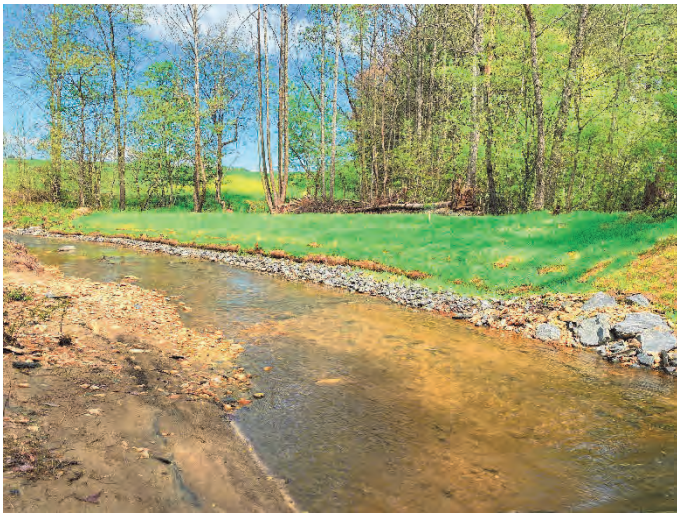
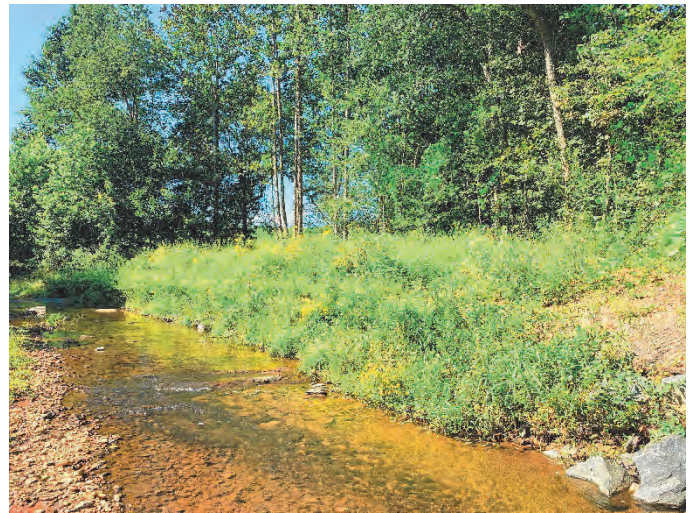
Moore's Fork Reach 3 STA 64+10 left bank repair – 4/19/2021

Moore's Fork Reach 3 STA 64+10 left bank repair – 9/7/2021

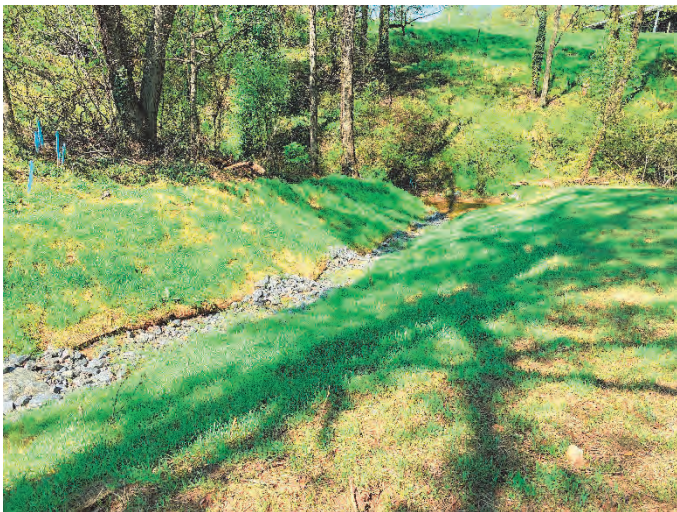
Silage Reach 1 STA 10+40 gully stabilization – 4/19/2021

Silage Reach 1 STA 10+40 gully stabilization – 9/8/2021

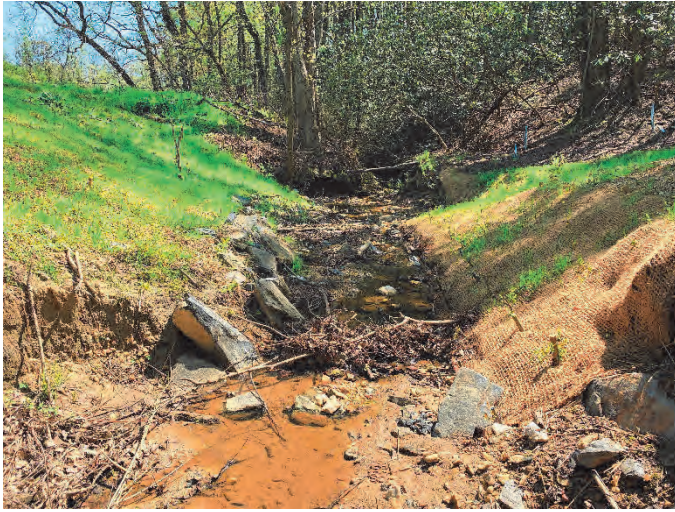
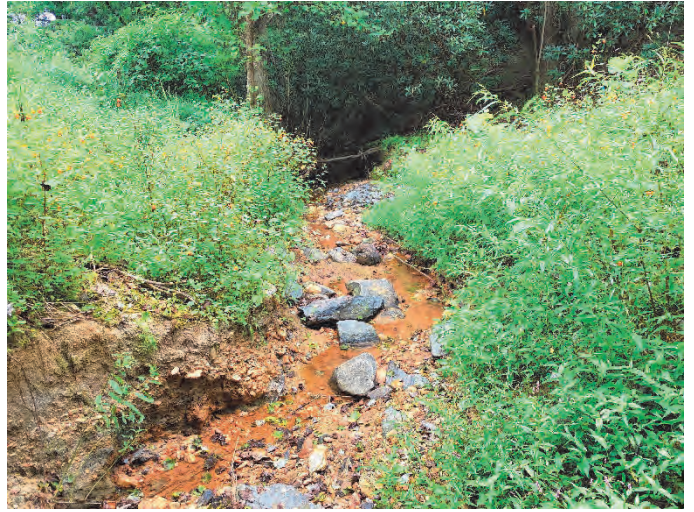
Silage Reach 1 STA 19+00 right bank repair – 4/20/2021

Silage Reach 1 STA 19+00 right bank repair – 9/8/2021

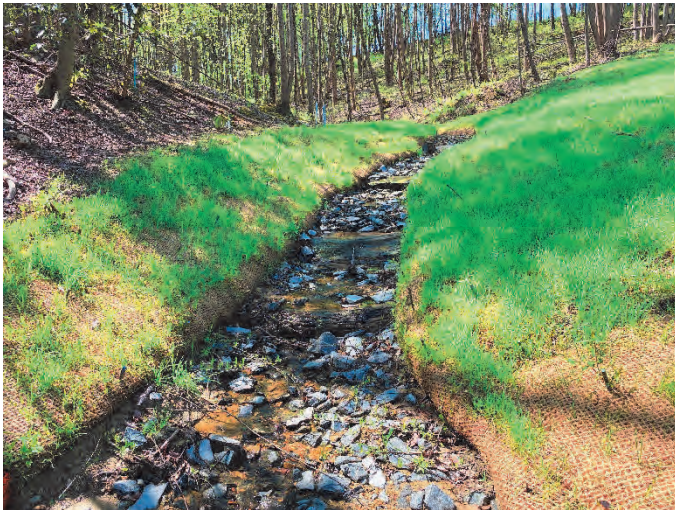
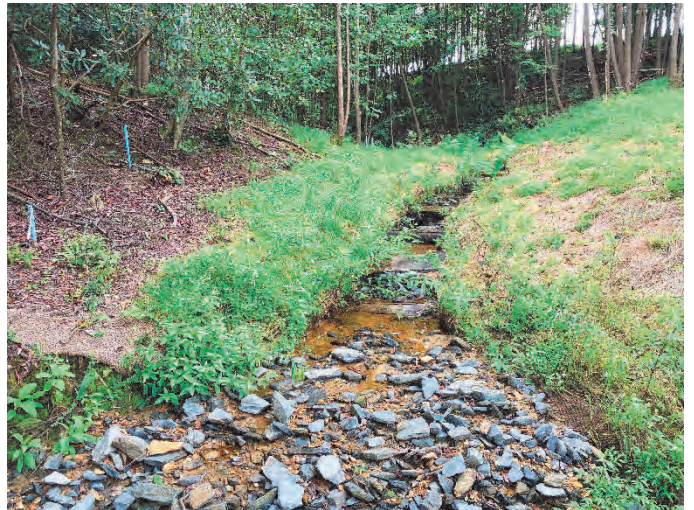
UT1 downstream repair near confluence with Silage Reach 1 – 4/20/2021

UT1 downstream repair near confluence with Silage Reach 1 – 9/8/2021

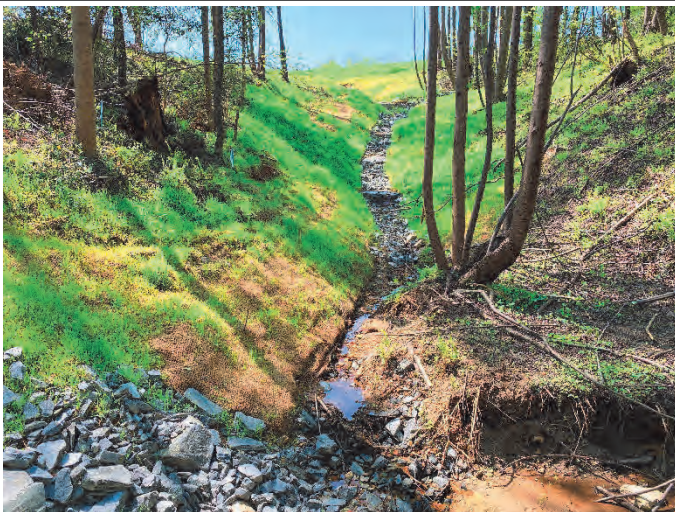
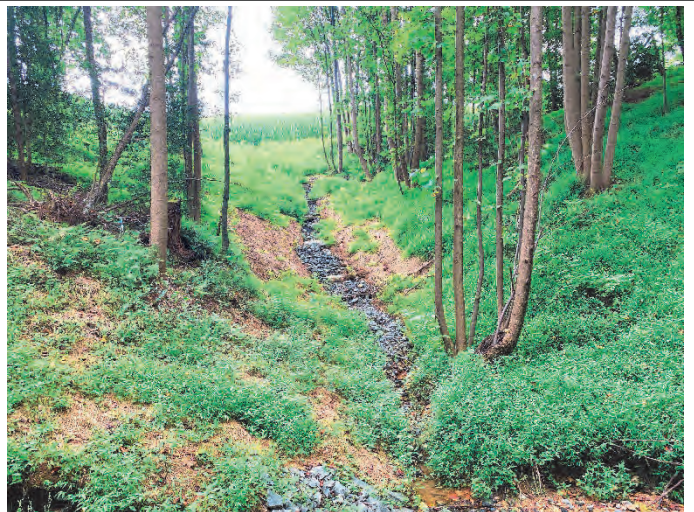
Upper UT1 repair area gully stabilization – 4/20/2021

Upper UT1 repair area gully stabilization – 9/8/2021

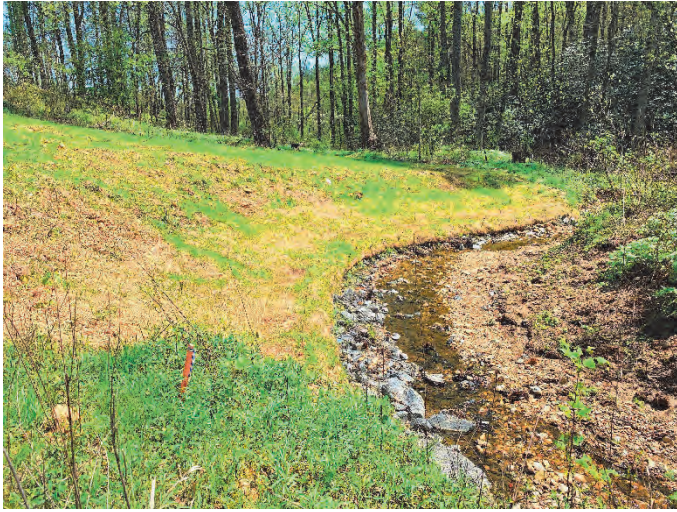
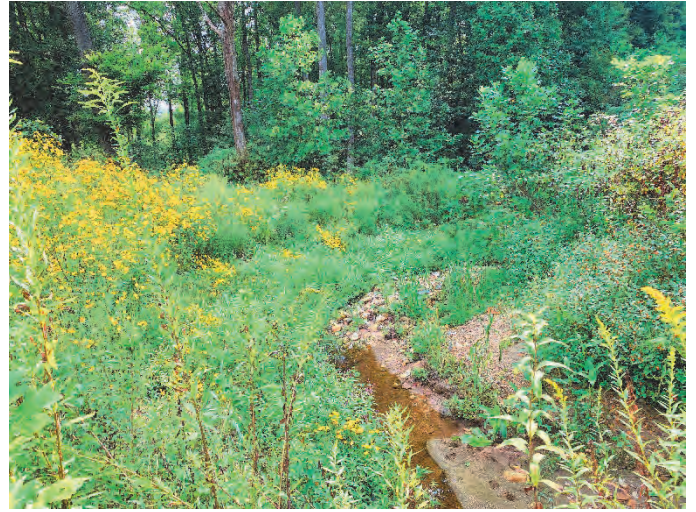
Silage Reach 1 STA 30+30 left bank repair – 4/20/2021

Silage Reach 1 STA 30+30 left bank repair – 9/8/2021

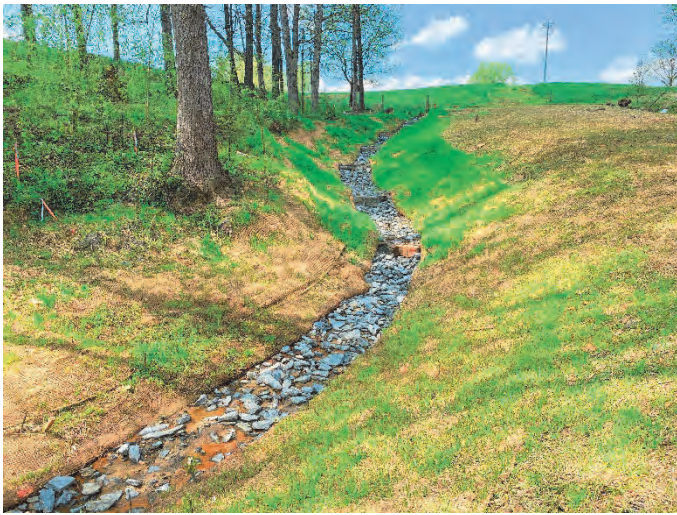
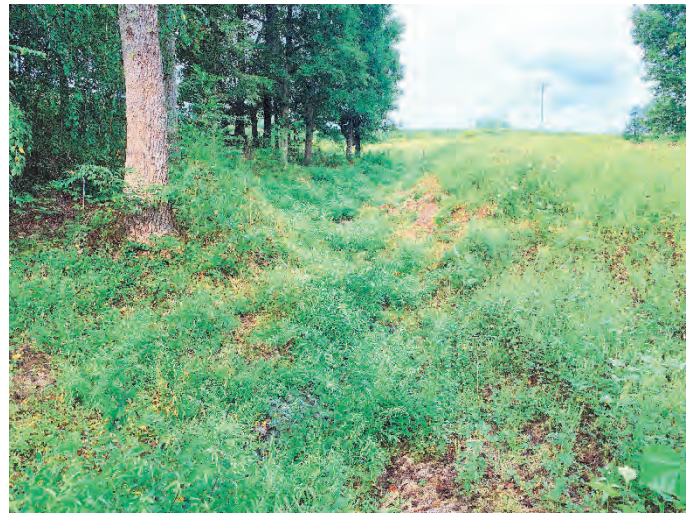
Upper Cow Trib 2 repair area gully stabilization – 4/20/2021

Upper Cow Trib 2 repair area gully stabilization – 9/8/2021

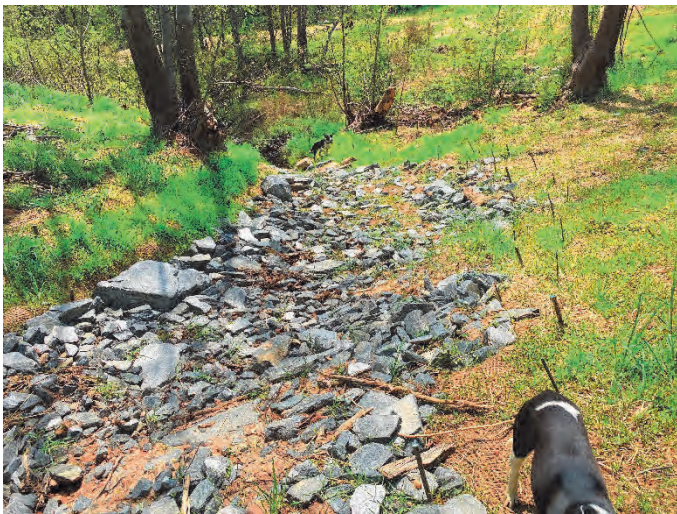
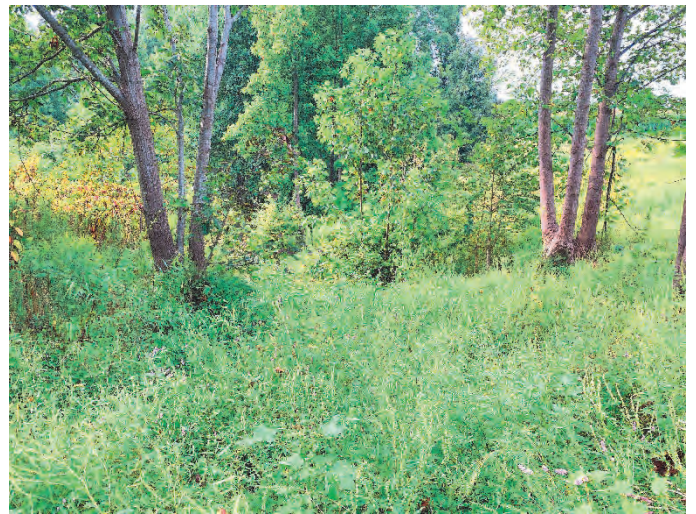
Upper Cow Trib 2 repair area – 4/20/2021

Upper Cow Trib 2 repair area – 9/8/2021
