# MONITORING YEAR 7 ANNUAL/CLOSEOUT REPORT

## MOORES FORK STREAM MITIGATION PROJECT

DMS Project Number 94709

Data Collection Period: April-September 2022

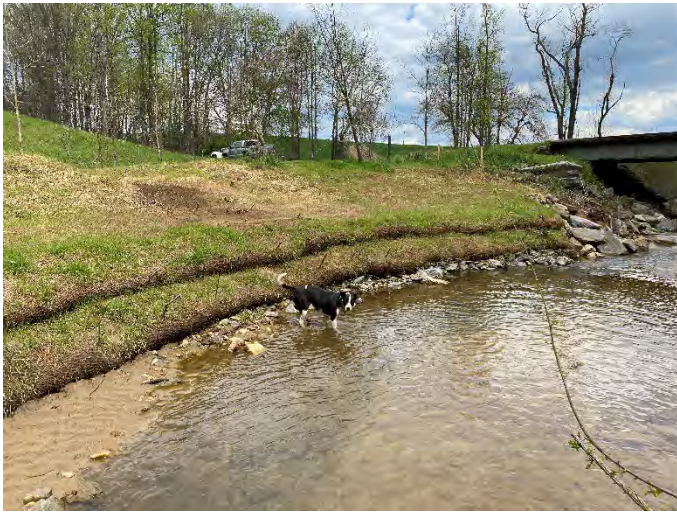
Moore's Fork Reach 2 STA 35+40 left bank repair – 4/19/2021

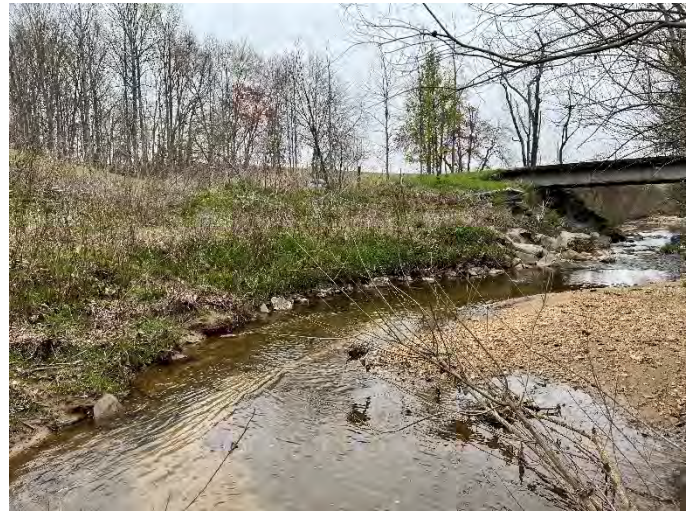
Moore's Fork Reach 2 STA 35+40 left bank repair – 4/05/2022

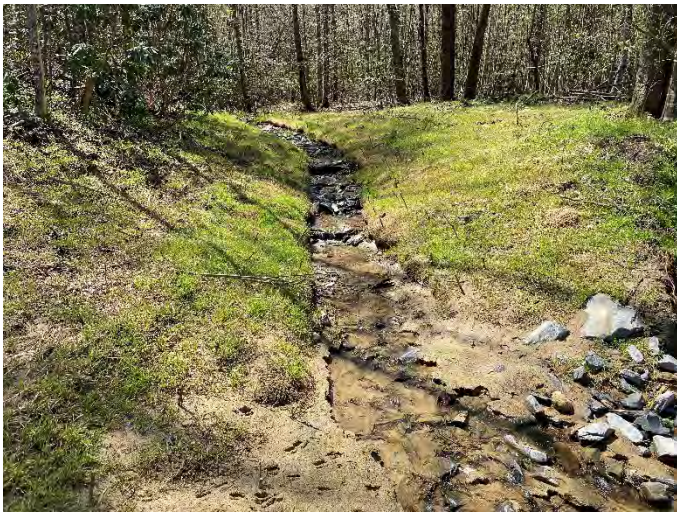
UT8/Wetland outlet repair at confluence with Moore's Fork – 4/19/2021

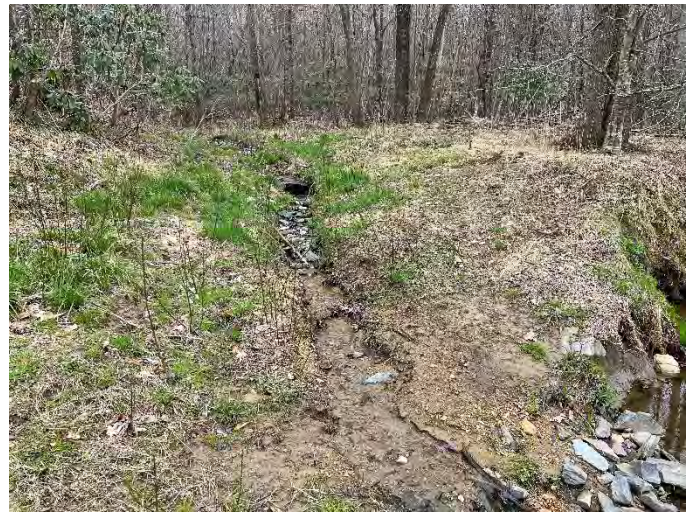
UT8/Wetland outlet repair at confluence with Moore's Fork – 4/05/2022

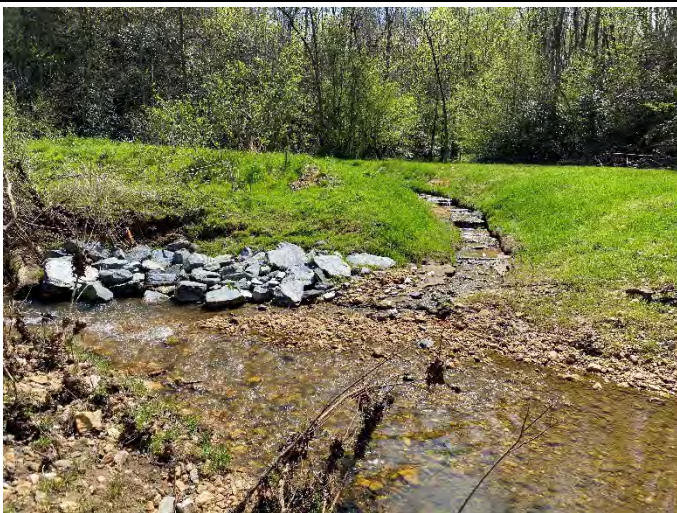
UT10/Wetland outlet repair at confluence with Moore's Fork – 4/19/2021

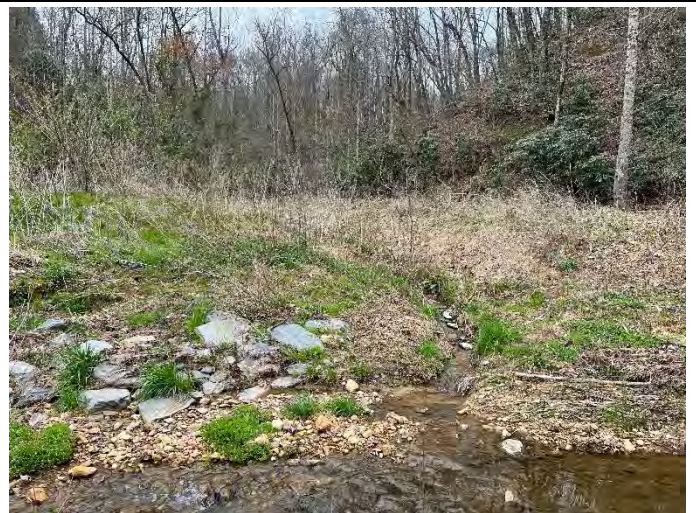
UT10/Wetland outlet repair at confluence with Moore's Fork – 4/05/2022

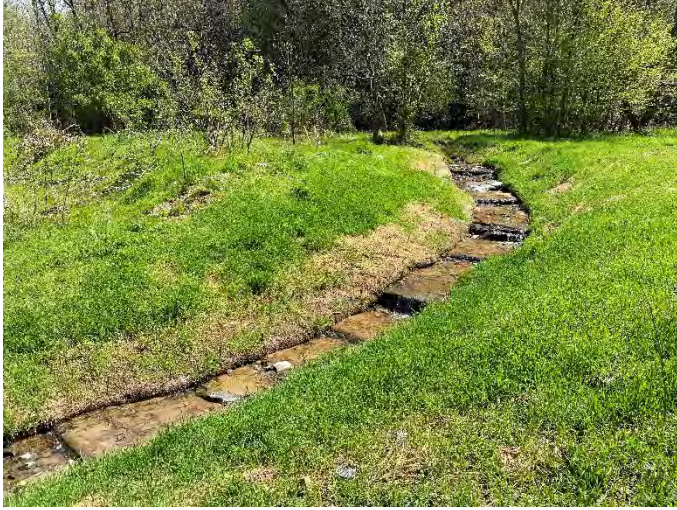
UT10/Wetland outlet repair – 4/19/2021

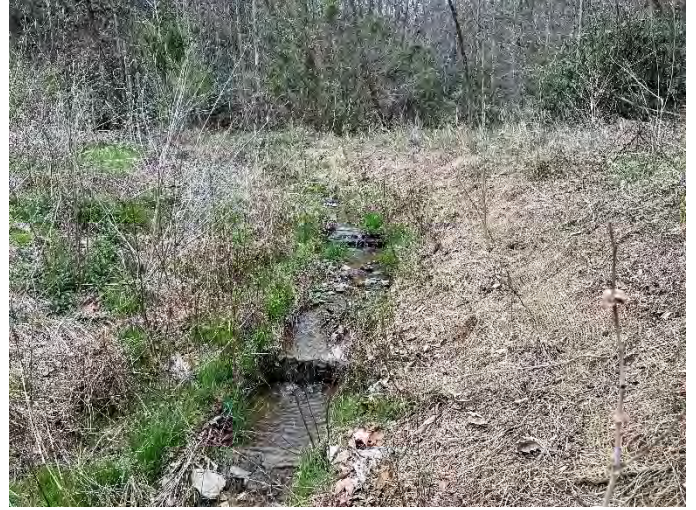
UT10/Wetland outlet repair – 4/05/2022

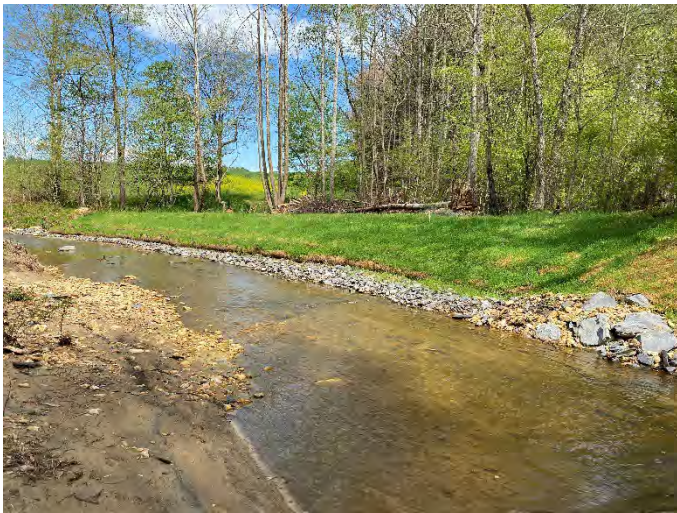
Moores Fork Reach 3 STA 64+10 left bank repair – 4/19/2021

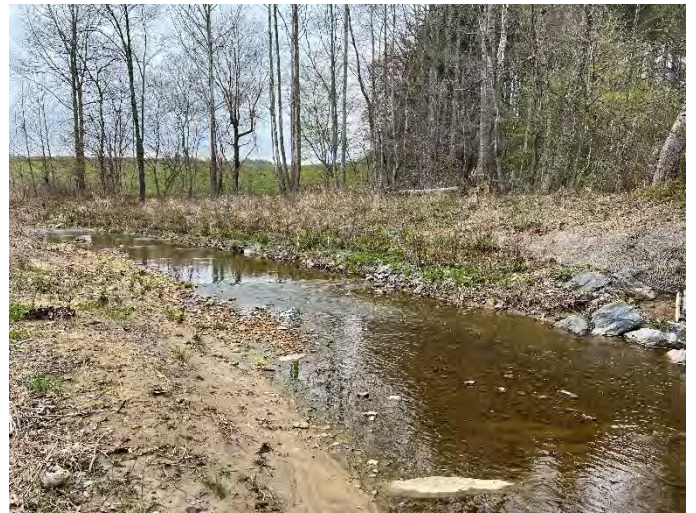
Moores Fork Reach 3 STA 64+10 left bank repair – 4/05/2022

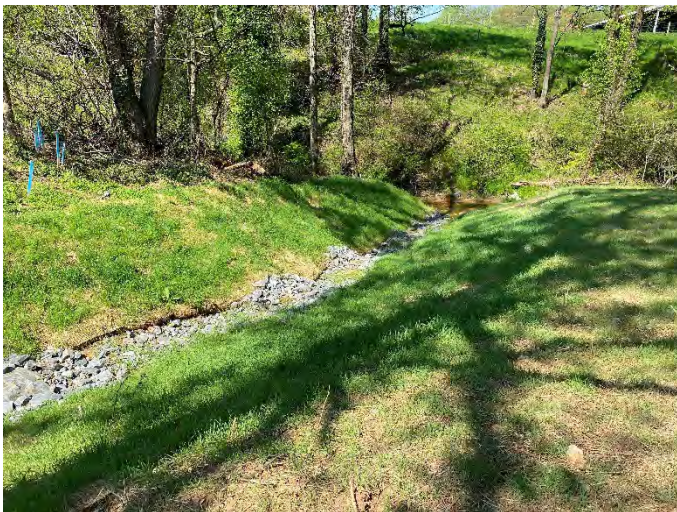
Silage Reach 1 STA 10+40 gully stabilization – 4/19/2021

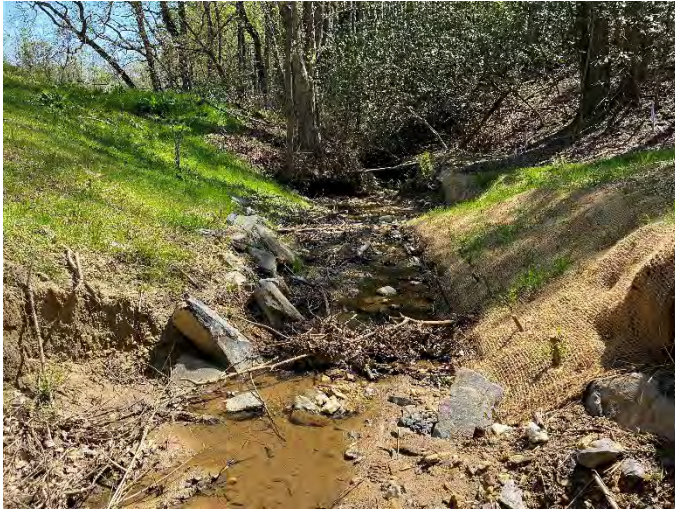
Silage Reach 1 STA 19+00 right bank repair – 4/20/2021

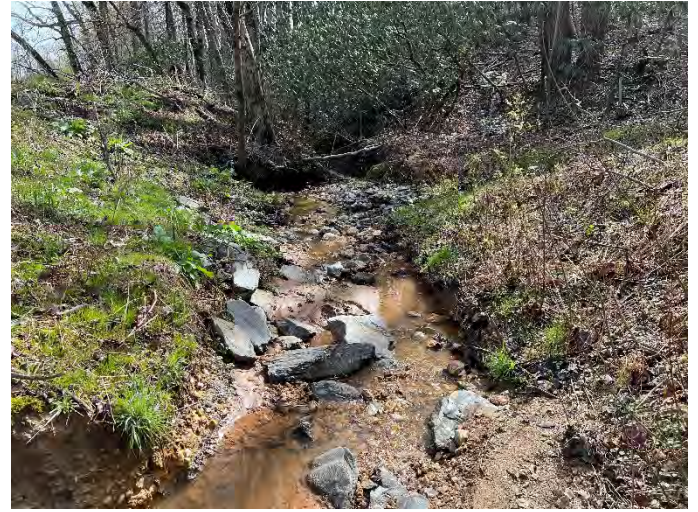
Silage Reach 1 STA 19+00 right bank repair – 4/06/2022

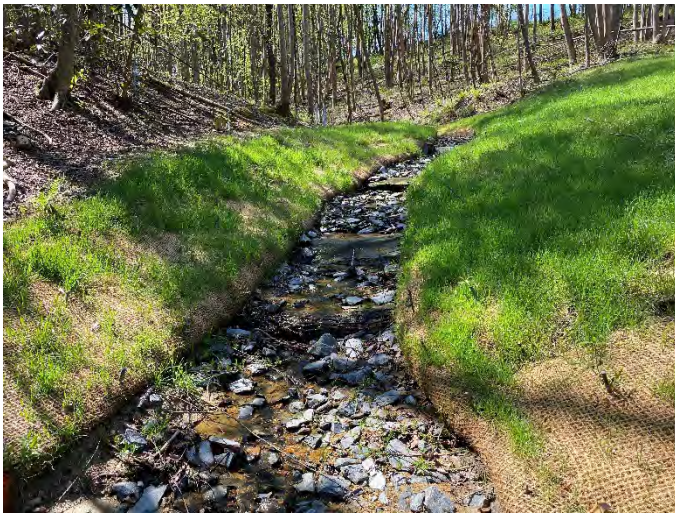
UT1 downstream repair near confluence with Silage Reach 1 – 4/20/2021

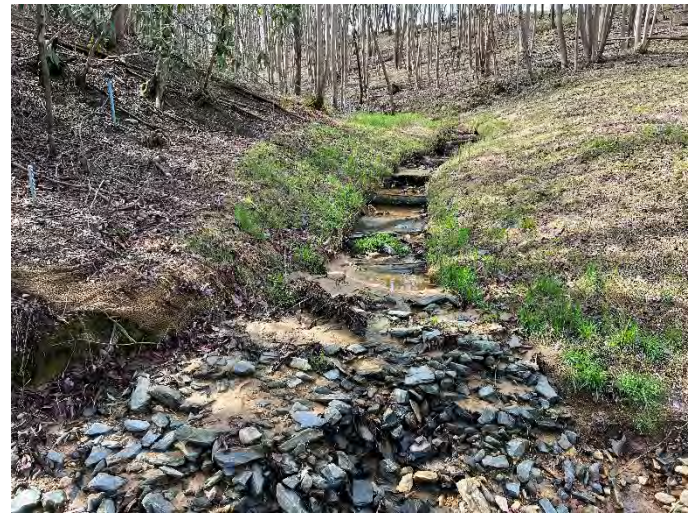
UT1 downstream repair near confluence with Silage Reach 1 – 4/06/2022

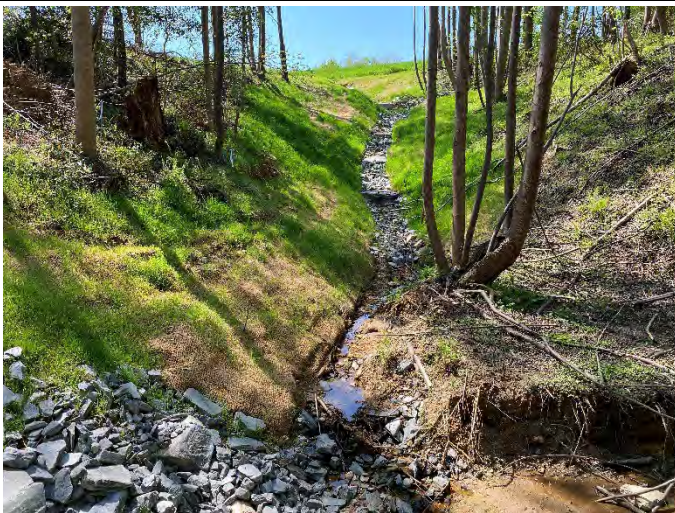
Upper UT1 repair area gully stabilization – 4/20/2021

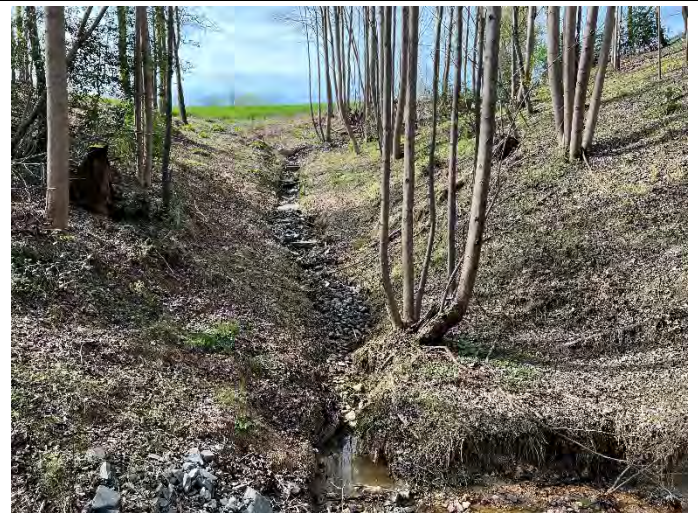
Upper UT1 repair area gully stabilization – 4/06/2022

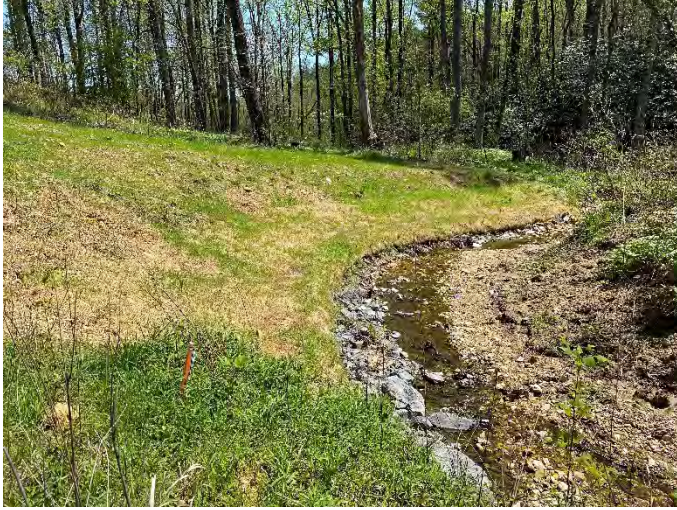
Silage Reach 1 STA 30+30 left bank repair – 4/20/2021

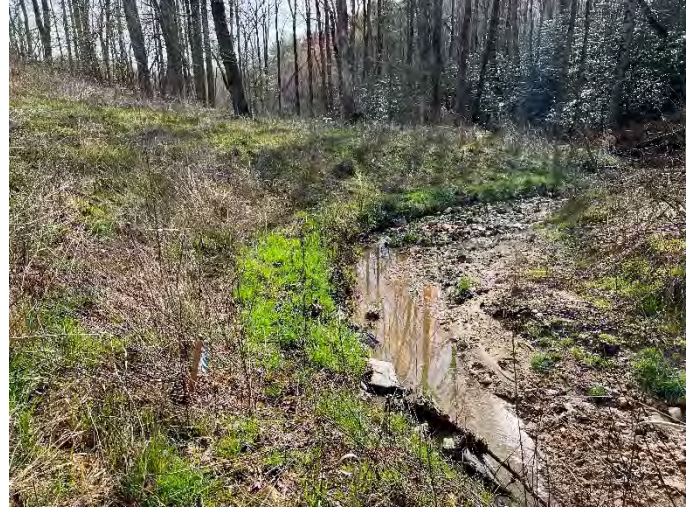
Silage Reach 1 STA 30+30 left bank repair – 4/06/2022

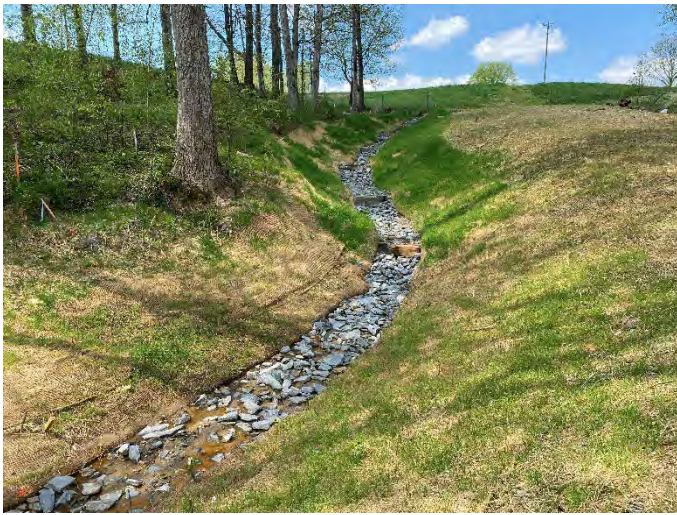
Upper Cow Trib 2 repair area gully stabilization – 4/20/2021

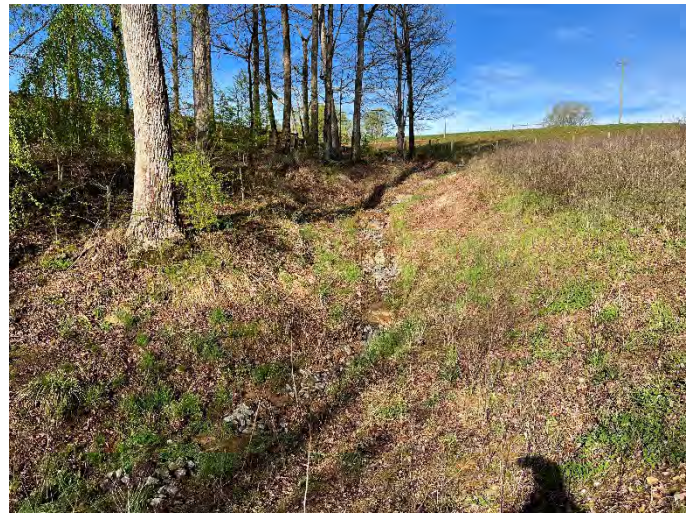
Upper Cow Trib 2 repair area gully stabilization – 4/06/2022

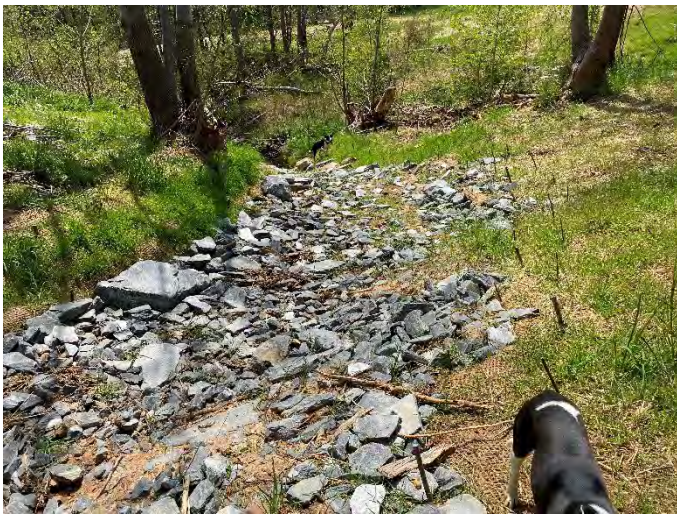
Upper Cow Trib 2 repair area – 4/20/2021

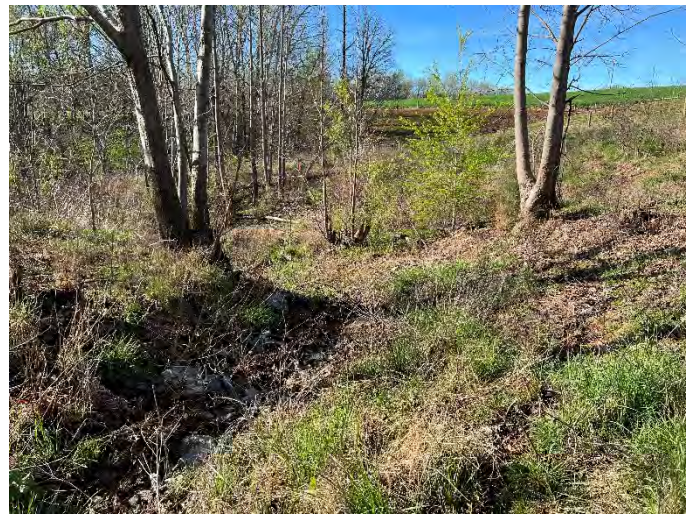
Upper Cow Trib 2 repair area – 4/06/2022

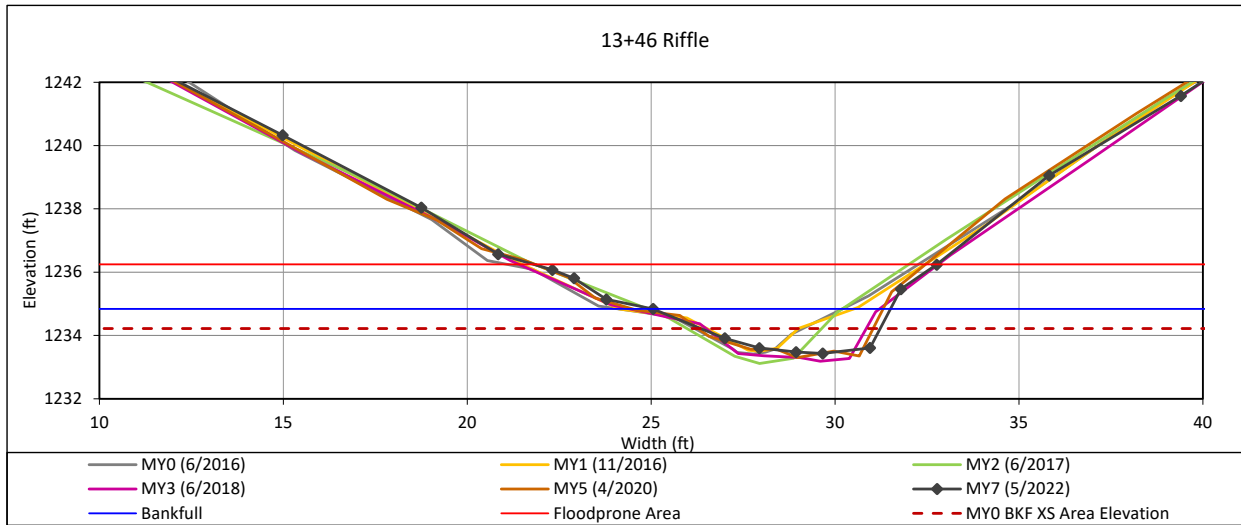
**Cross Section ST1- Silage Trib**

Along Silage Tributary, the surveyed cross-sections are indicative of instances of vertical and lateral instability observed throughout Silage Tributary Reach 1 and 2. Downcutting and/or bank scour is present at riffle cross-sections ST1, ST3, and ST6 which has caused an increase in bank height ratio. See section 1.2.4 for further discussion about stream areas of concern along Silage Tributary. Please refer to Appendix D for cross-section plots and morphological summary tables.
