Morgan Creek Stream Restoration Site

Year 1 Final Monitoring Report
Project ID Number: 16-D06027

Prepared by:
Equinox Environmental Consultation and Design, Inc.

Submitted to:
NCDENR - Ecosystem Enhancement Program

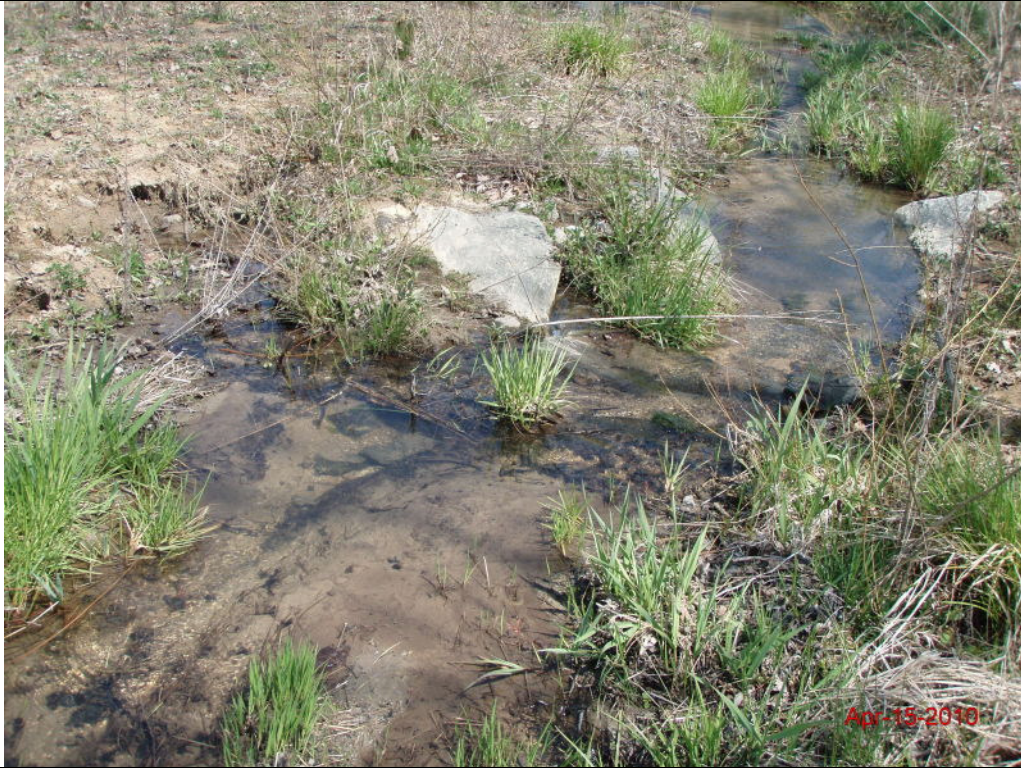
SPA2 UT1 Sta. 2001+50 – Grade Control Degradation

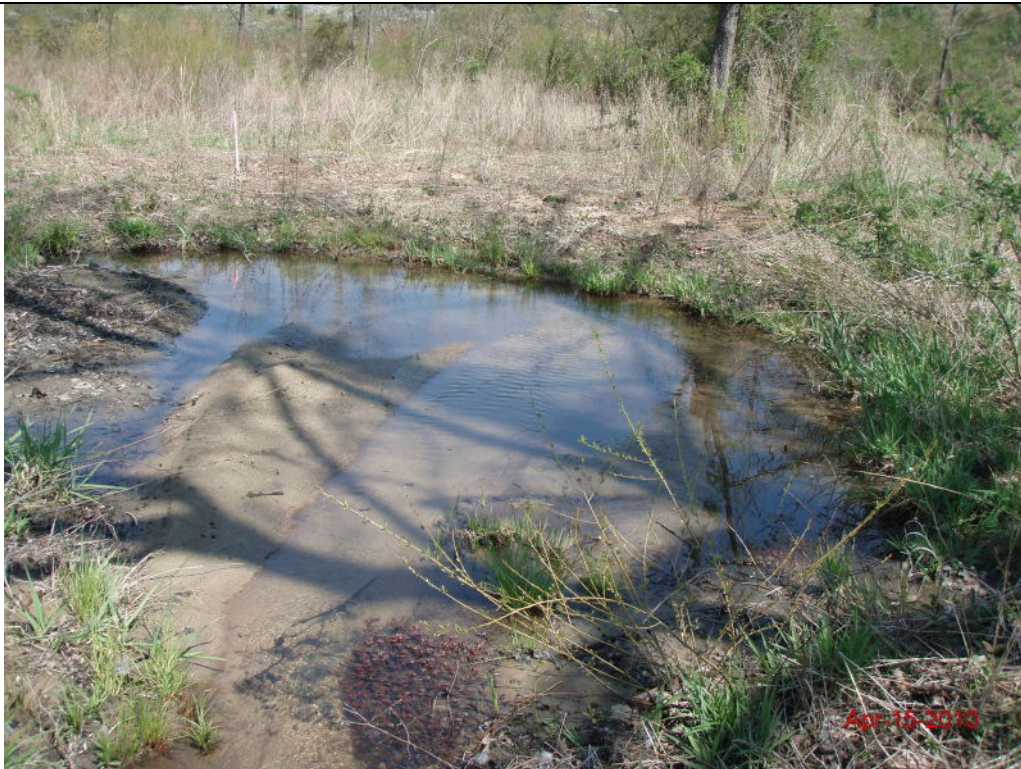
SPA3 UT1 Sta. 2001+75 – Pool Aggradation
