Morgan Creek Stream Restoration Site

Year 5 Final Monitoring Report

Project ID Number: 16-D06027

Equinox Environmental Consultation and Design, Inc.

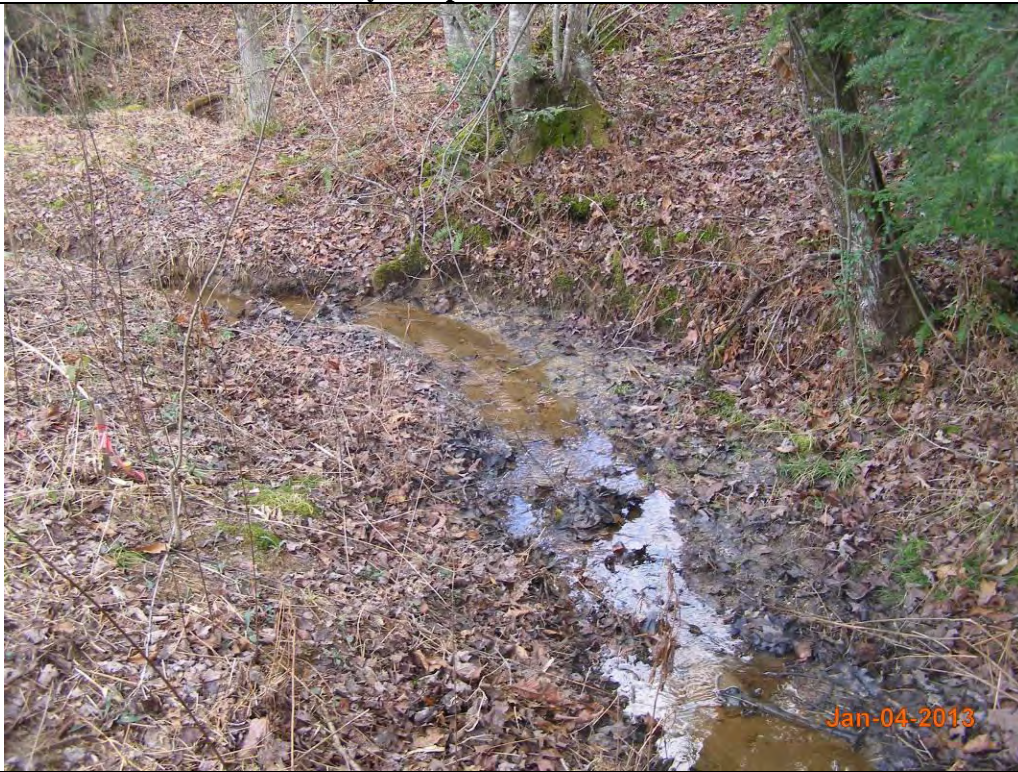
SPA 13 UT3 Sta. 4001+90 – Reduced pool depth due to aggradation
