Morgan Creek Stream Restoration Site

Haywood County, North Carolina

EEP Contract #: D06035-A

MONITORING REPORT 2009 (YEAR 1)

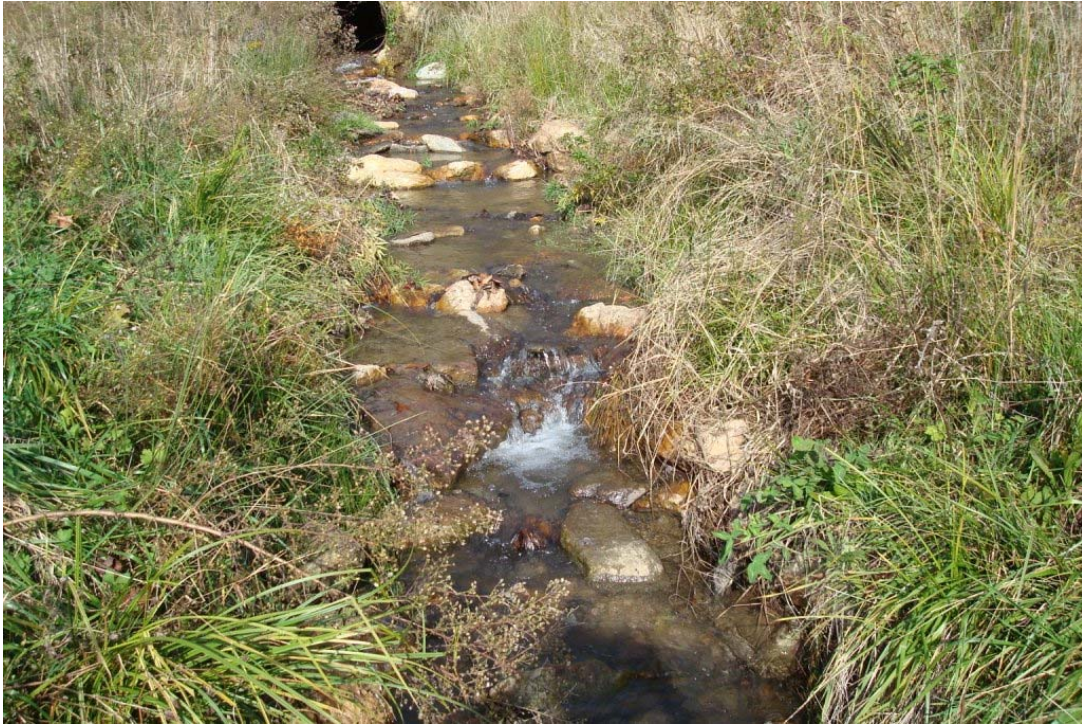
Photo No. 1

Stabilized Nick Point in Riffle on Morgan Cr, Sta 100+50

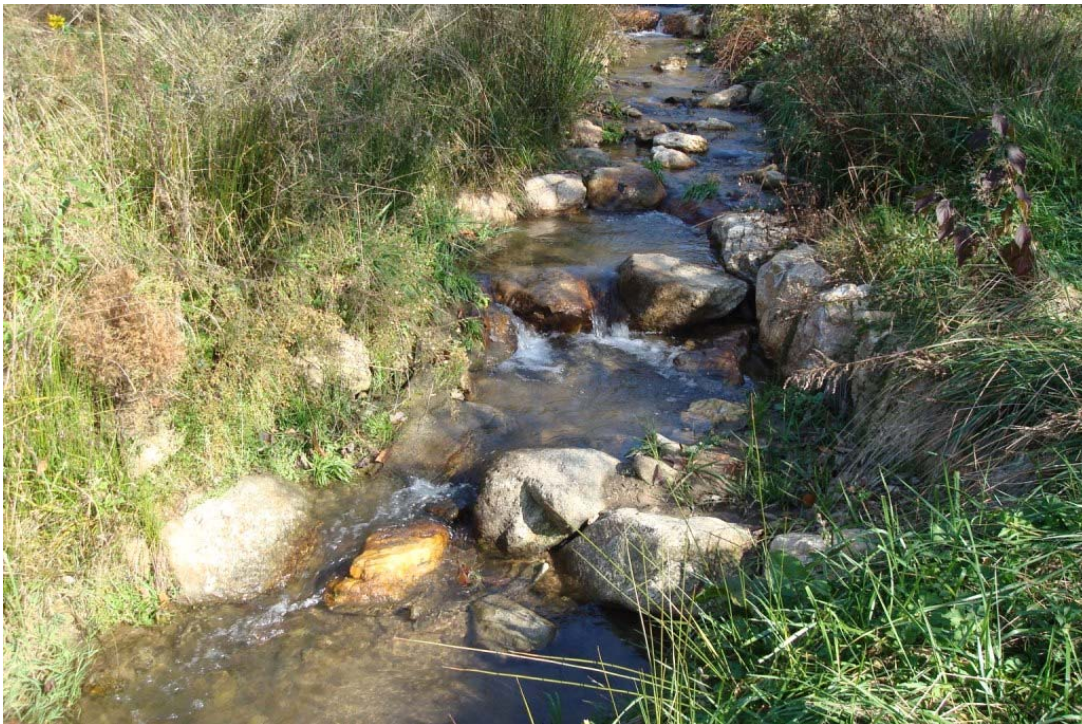
Photo No. 2

Gap in Structure Baffle, Morgan Cr, Sta 102+06 (Appears Stable)

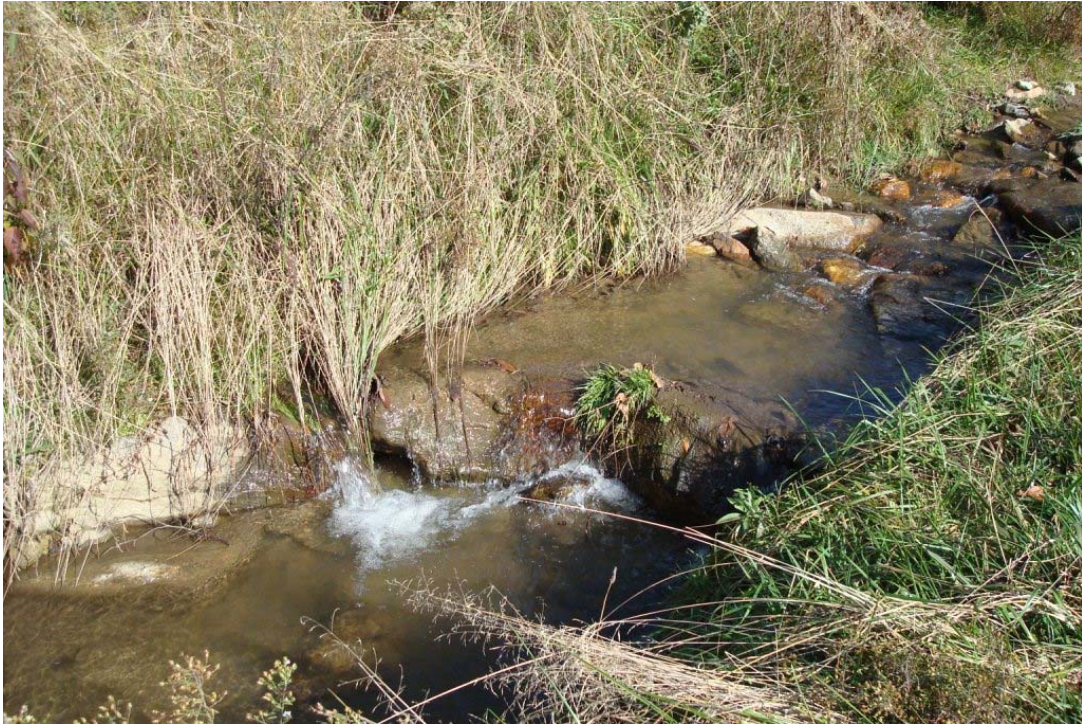
Excessive Drop on Boulder Run Arch, Morgan Cr, Sta 102+47 (Appears to be holding)
Year 1 10/30/09 Photo No. 3

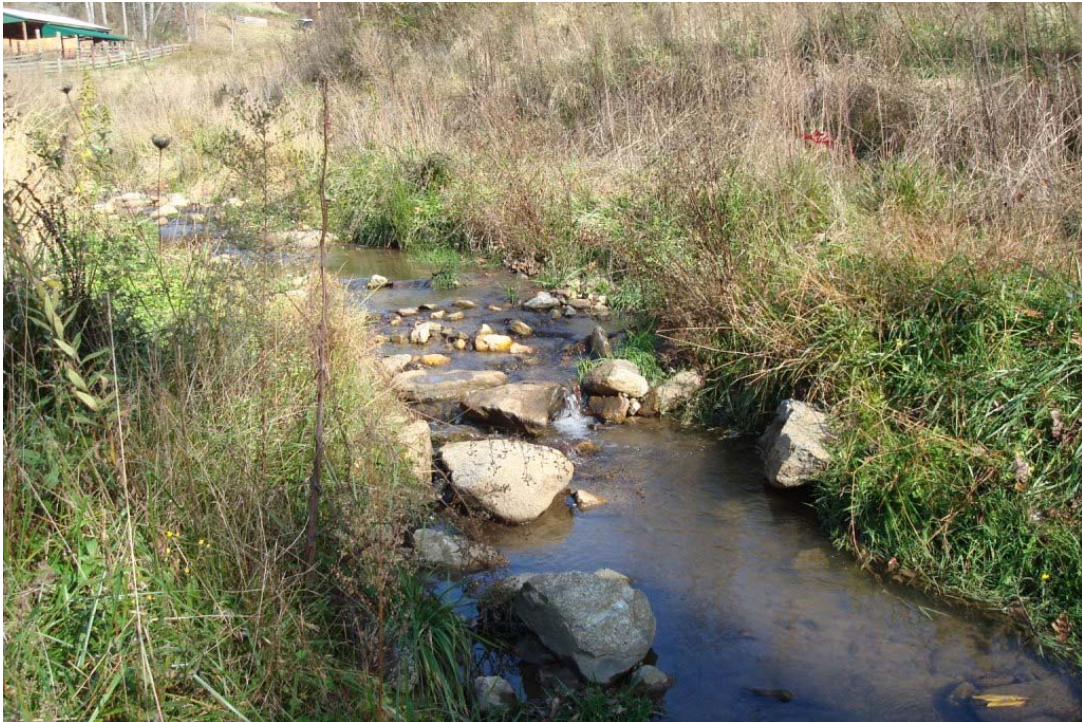
Nick Point in Riffle, Morgan Cr, Sta 107+60 (Larger boulders presently holding nick)
Year 1 10/30/09 Photo No. 4

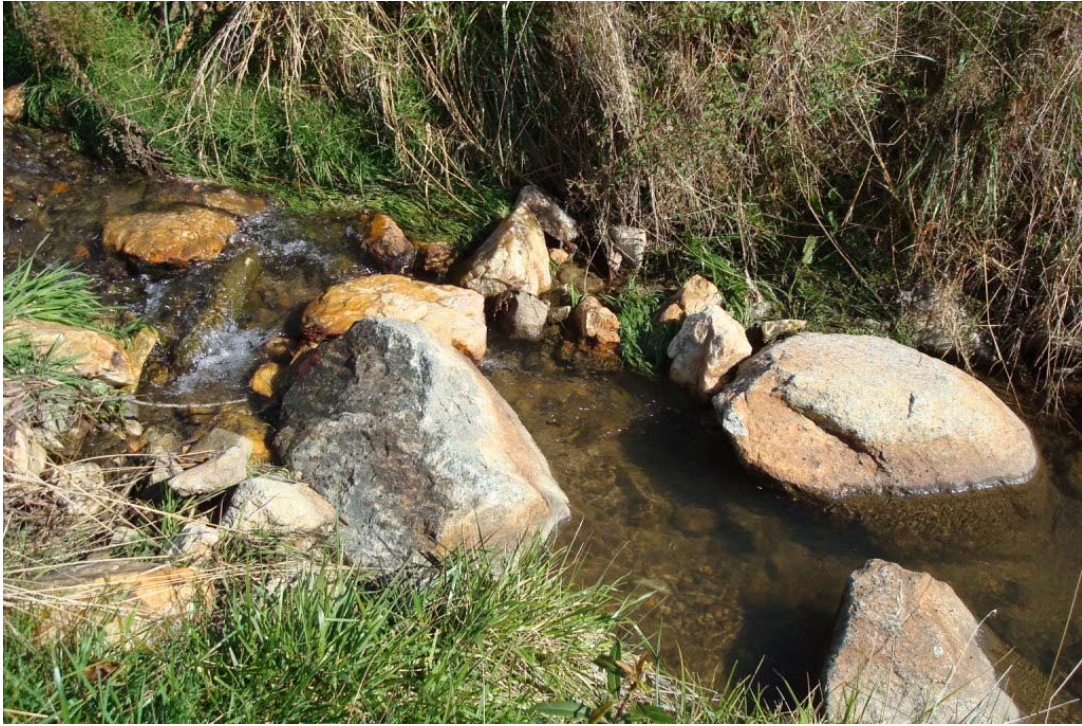
Photo No. 5

Material scoured out of Boulder Run Structure, Morgan Cr, Sta 112+30
(Grade is being held by upper portion of structure)

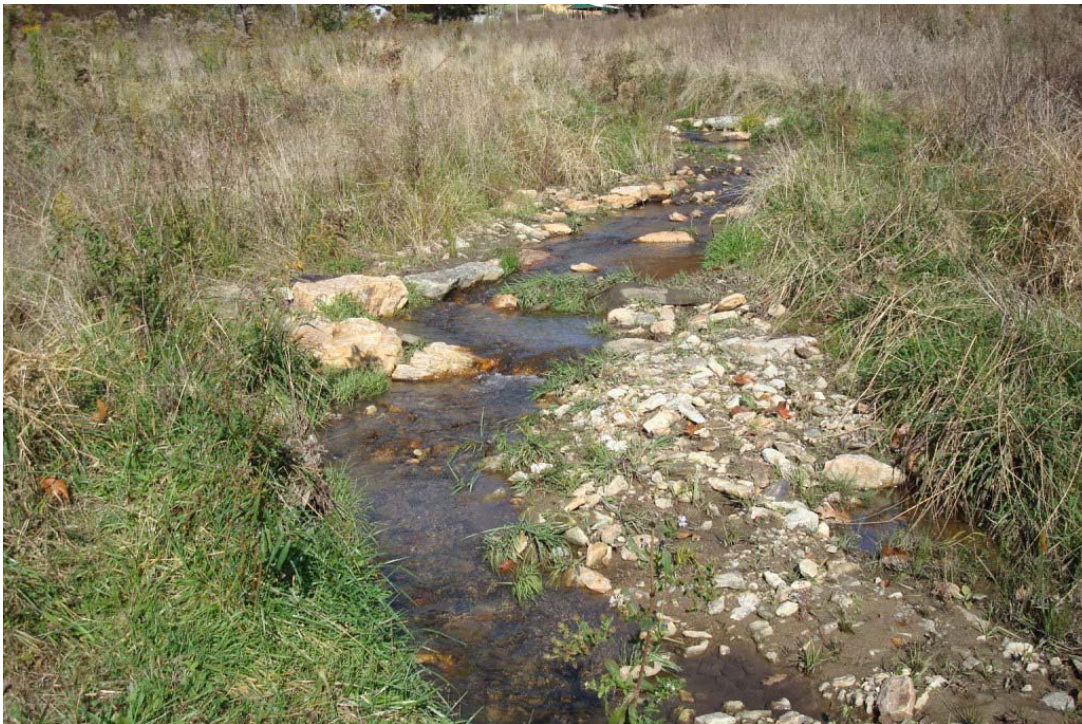
Photo No. 6

Deposition in Pool, Morgan Cr, Sta 113+20

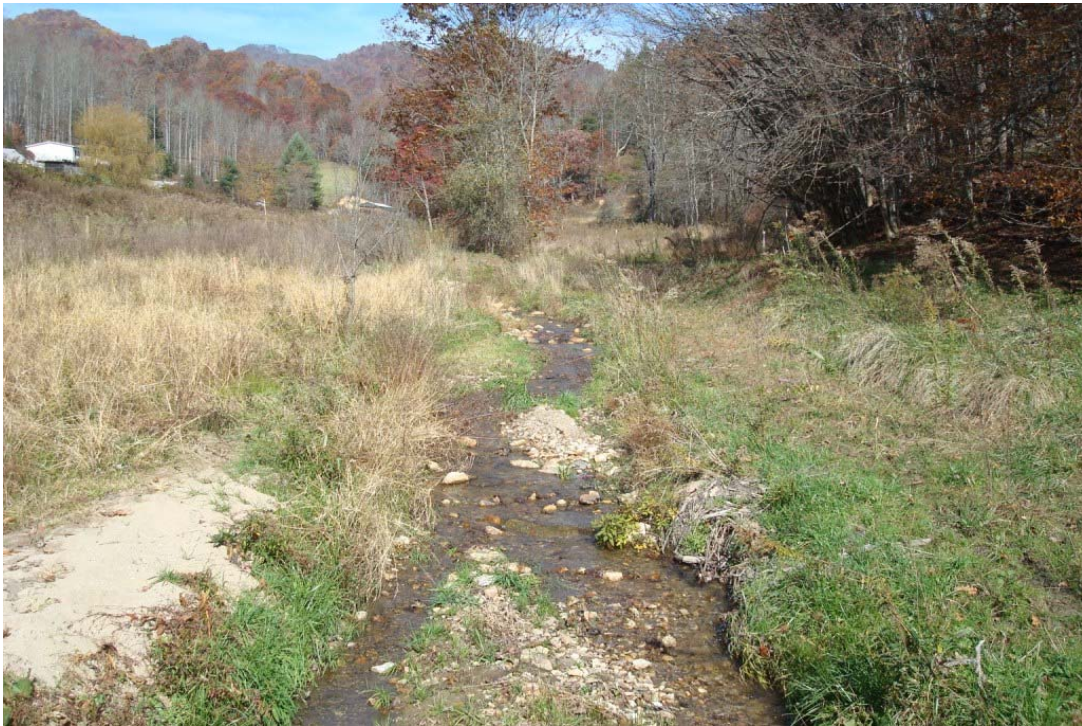
Photo No. 7

Deposition caused by pipe blockage, Morgan Cr, Sta 118+05

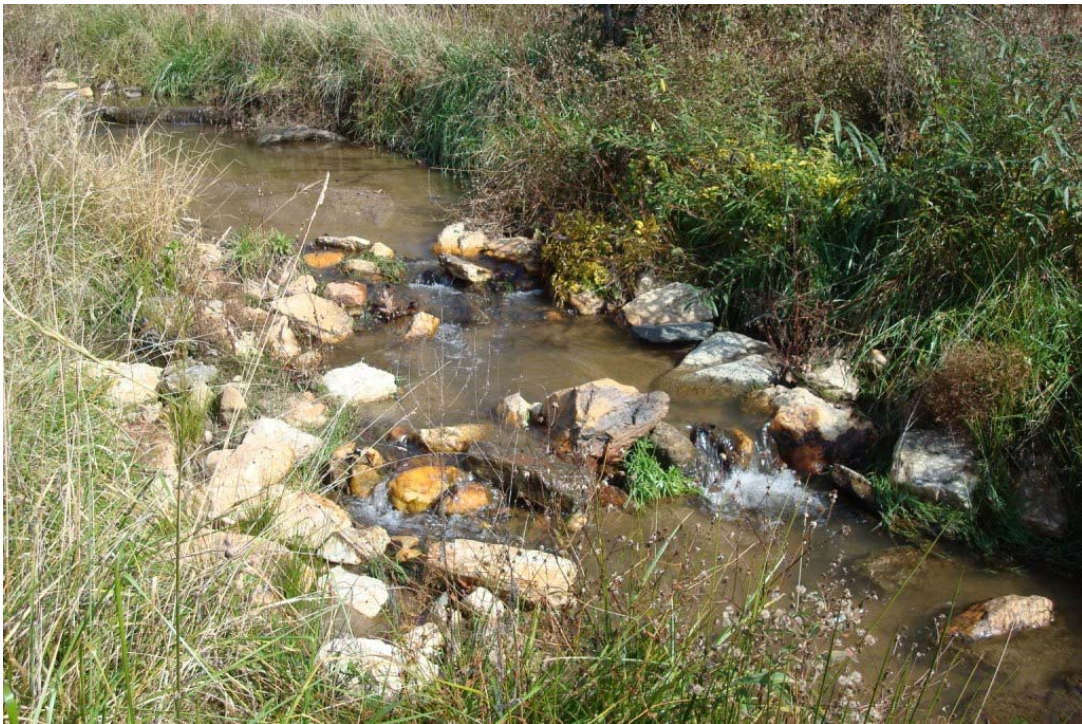
Nick point formations in Riffle, Morgan Cr, Sta 124+20
