# Morgan Creek Stream Restoration Site

Haywood County, North Carolina

December 14, 2010

## MONITORING REPORT 2010 (YEAR 2)

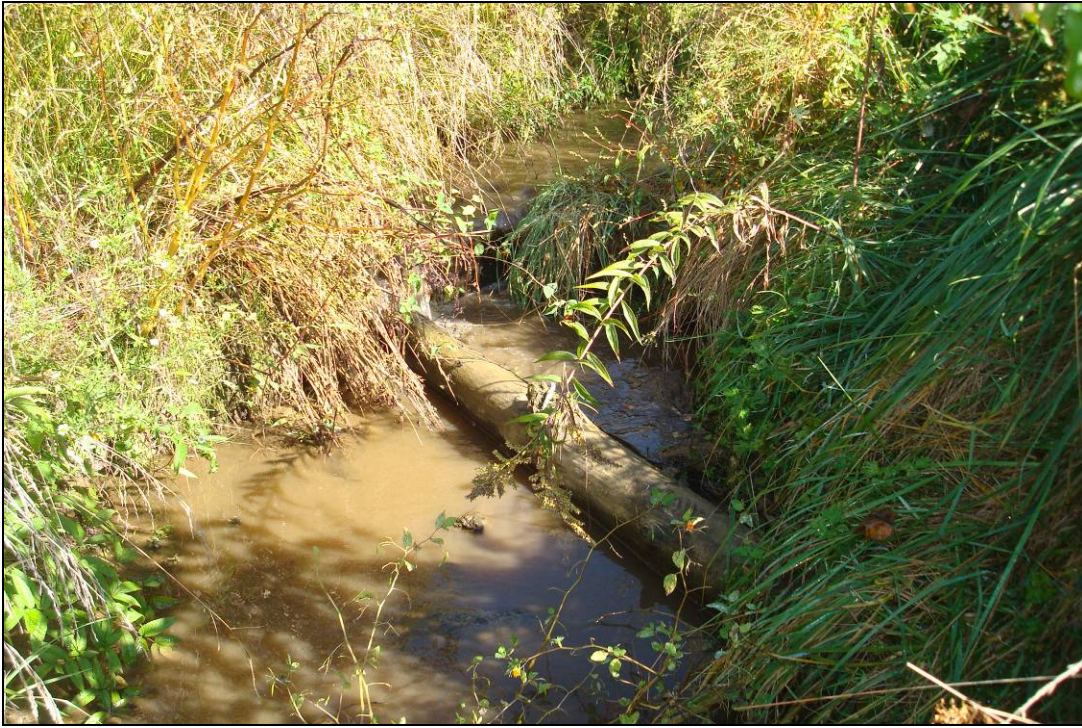
Photo No. 13

Minor piping of log hook, Morgan Cr, Sta 102+90

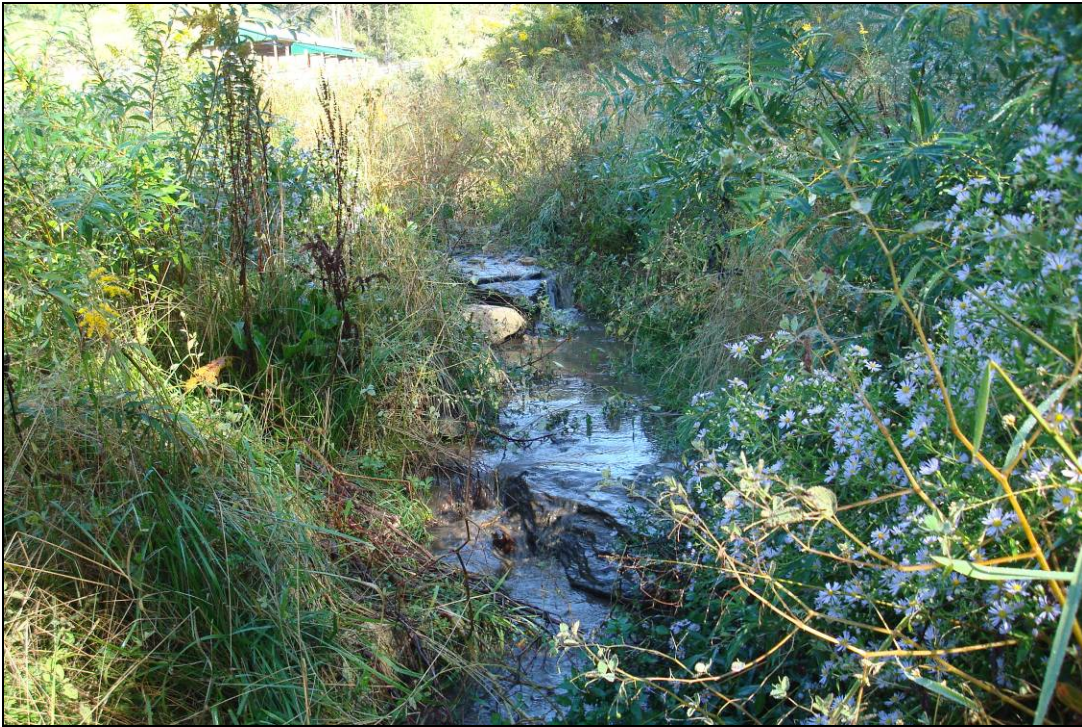
Photo No. 14

Stabilized nick point in riffle, Morgan Cr, Sta 107+60 (No change from Year 1)

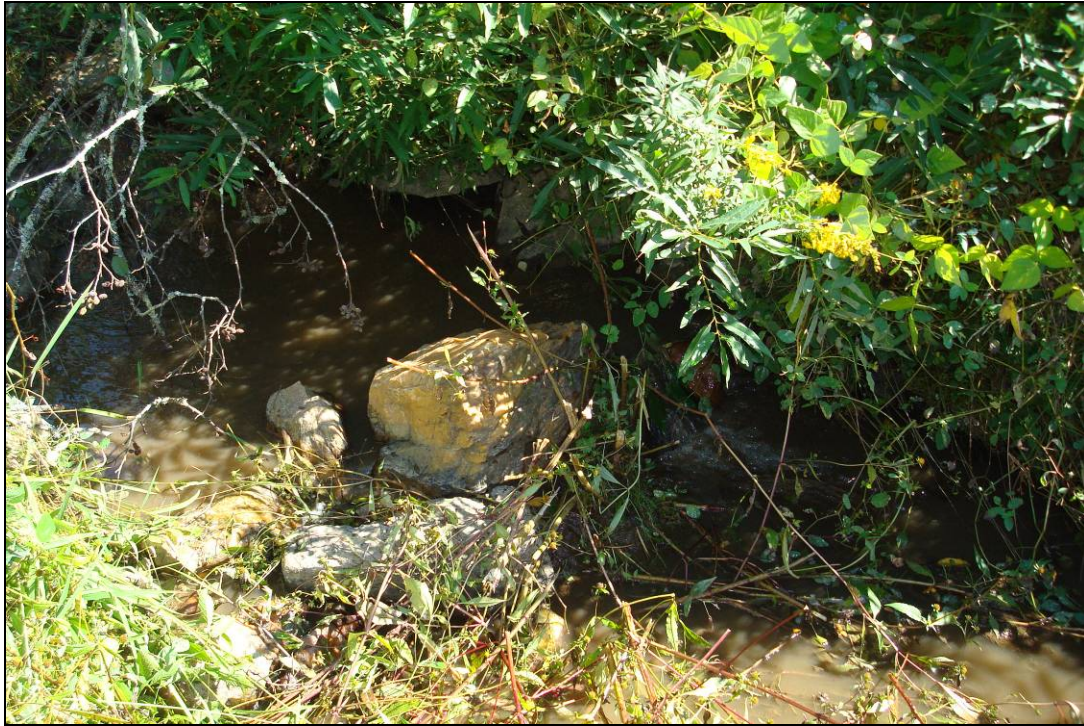
Nick point formations in riffle, Morgan Cr, Sta 124+20 (Appears to be stable)  
Year 2 10/02/10 Photo No. 15

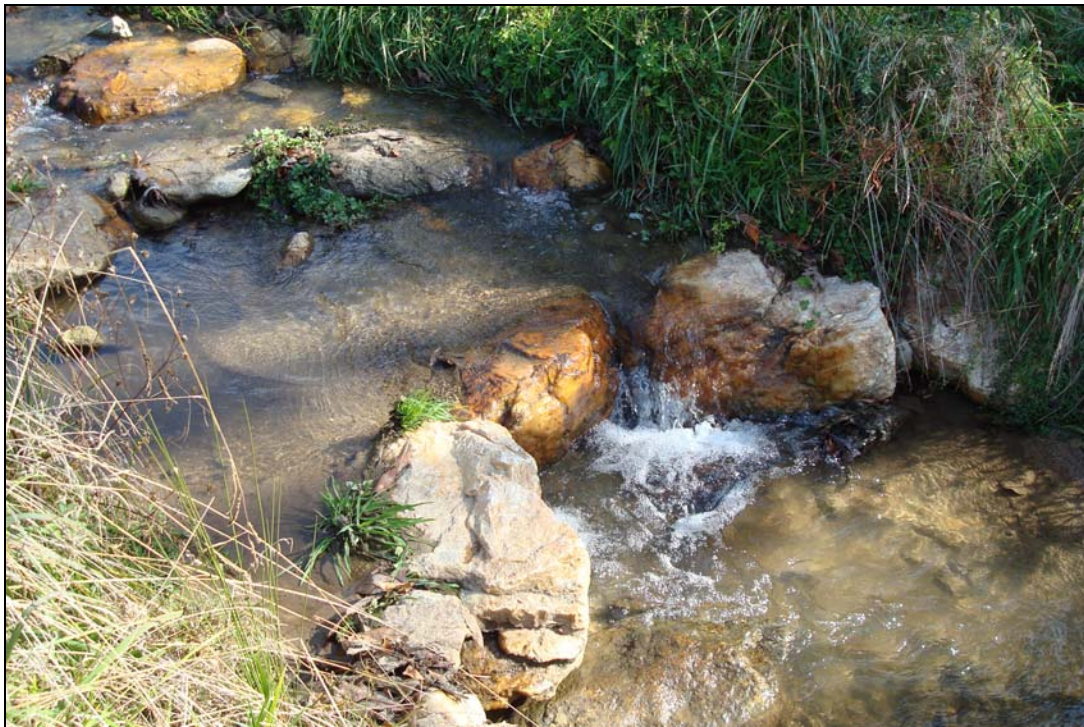
Excessive drop over structure, Morgan Cr, Sta 101+90 (Stable in Year 2)  
Year 1 10/30/09 Photo No. 16

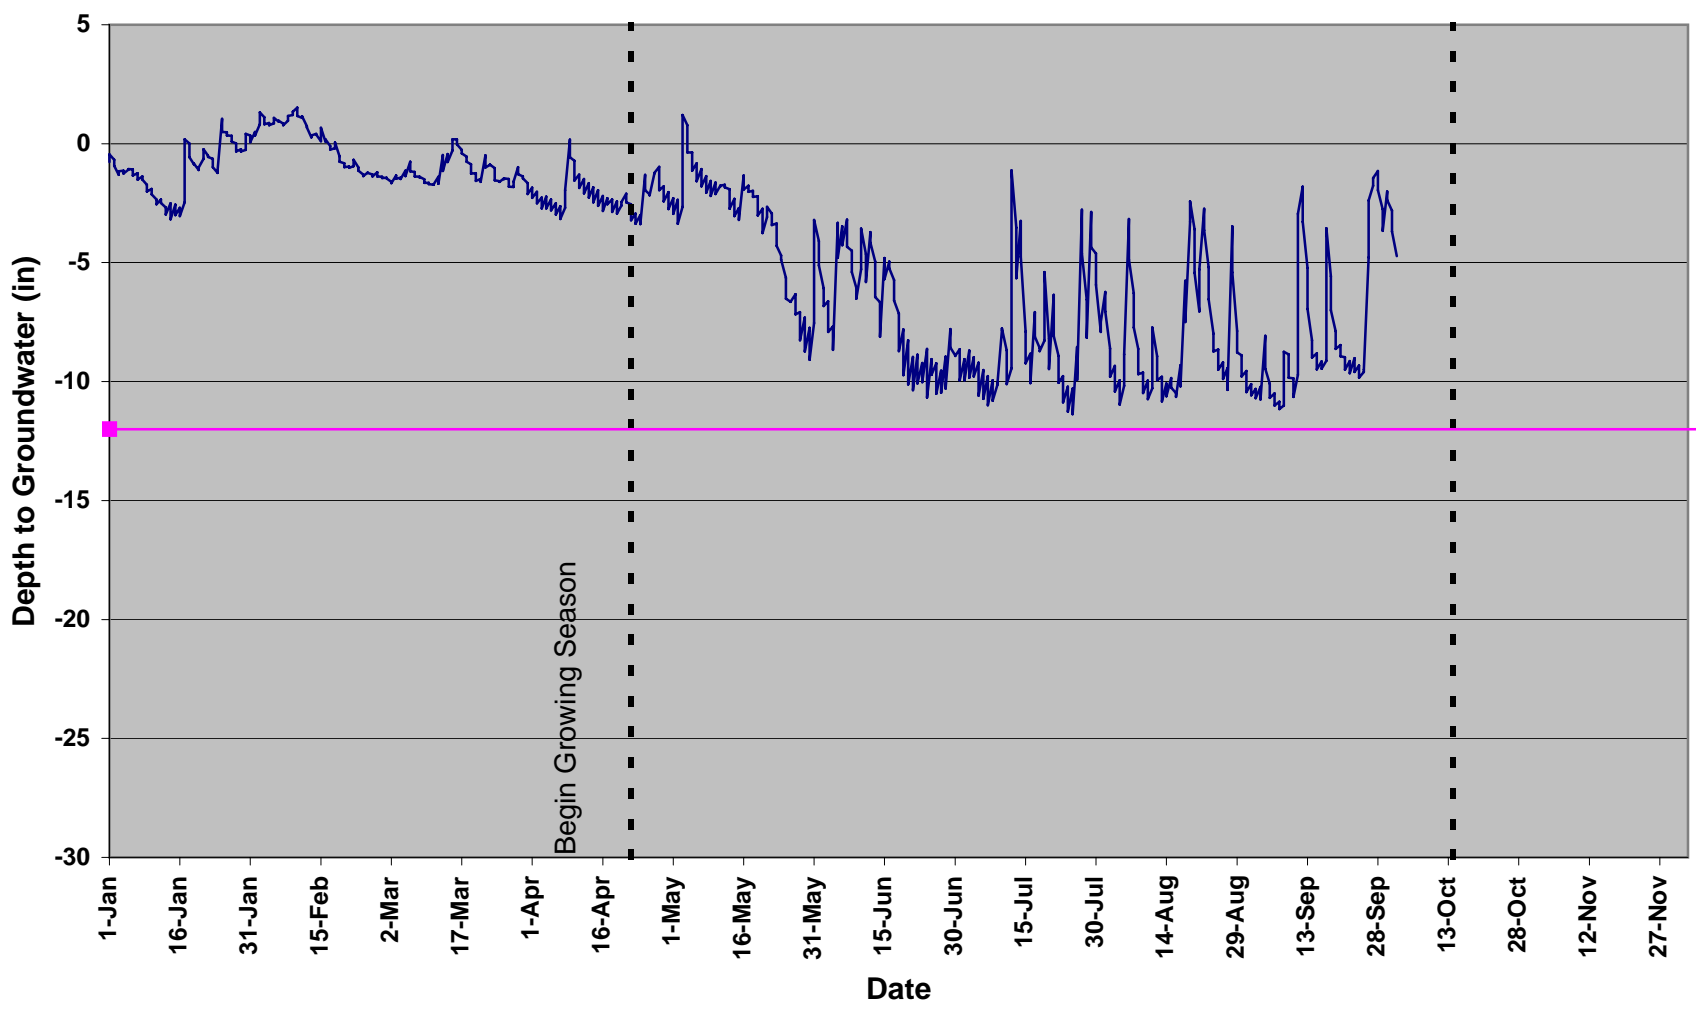
# GW1 2010

One of the three gauges met wetland hydrology criteria during the 2010 growing season (Table III). Gauge GW1 had groundwater present within twelve (12) inches of the surface throughout the entire growing season. Gauge GW2 had groundwater present within 12 inches for a total of 42 days with a peak of 7 consecutive days. Gauge GW3 had groundwater present within 12 inches for a total of 21 days with a peak of 5 consecutive days. Plots of the gauge data can be found in Appendix C

In general, Site wetland areas appear to have suffered insufficient hydrology due to drought conditions during Monitoring Year 2. Restoration Systems will coordinate with EEP in the Spring 2011 to develop an appropriate response.
