Morgan Creek Stream Restoration Site

Haywood County, North Carolina

EEP Contract #: D06035-A

MONITORING REPORT 2012 (YEAR 4)

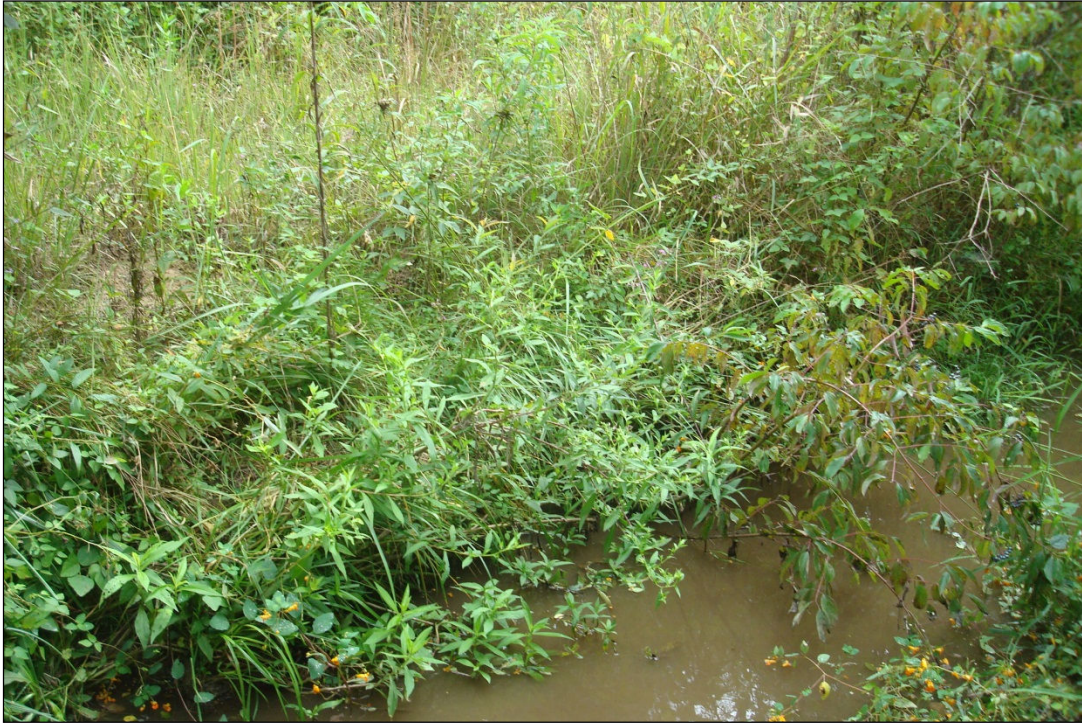
Repaired Minor Bank Failure, Morgan Cr, Sta 125+00

The bank failure that was identified in Year 3 at STA 125+00 was repaired in March of 2012 and appeared stable at the time of the Year 4 monitoring survey.
