# Morgan Creek Stream Restoration Site

Haywood County, North Carolina

February 24, 2014

## MONITORING REPORT 2013 (YEAR 5)

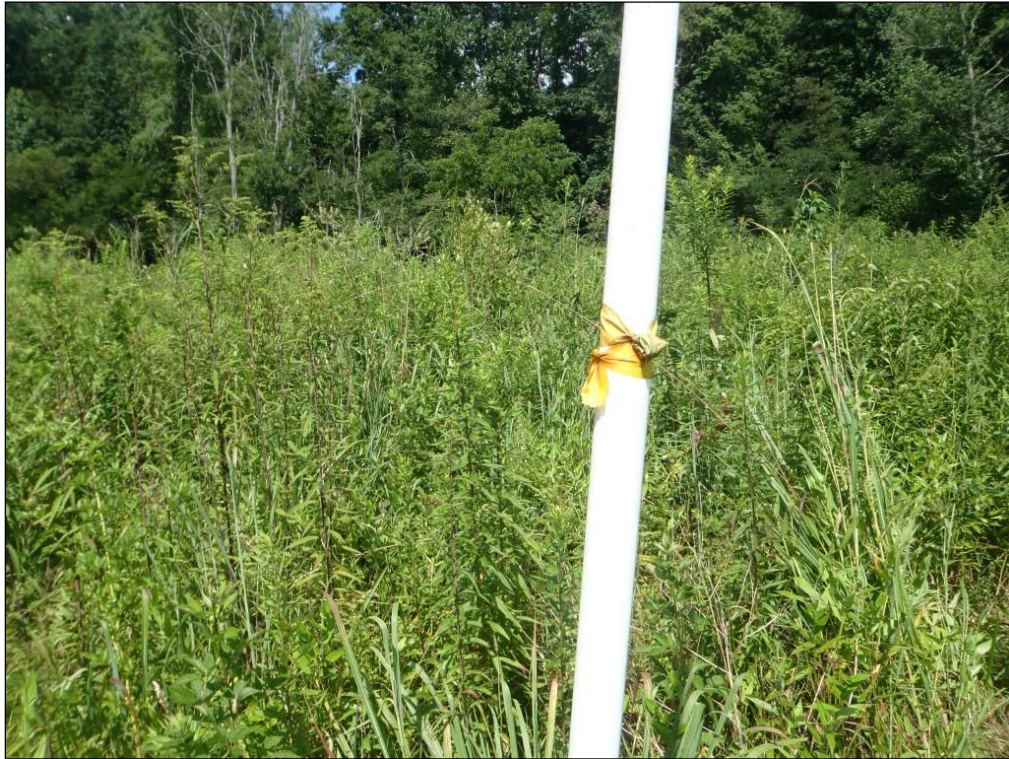
Photo No. 1

Vegetation Plot No. 1

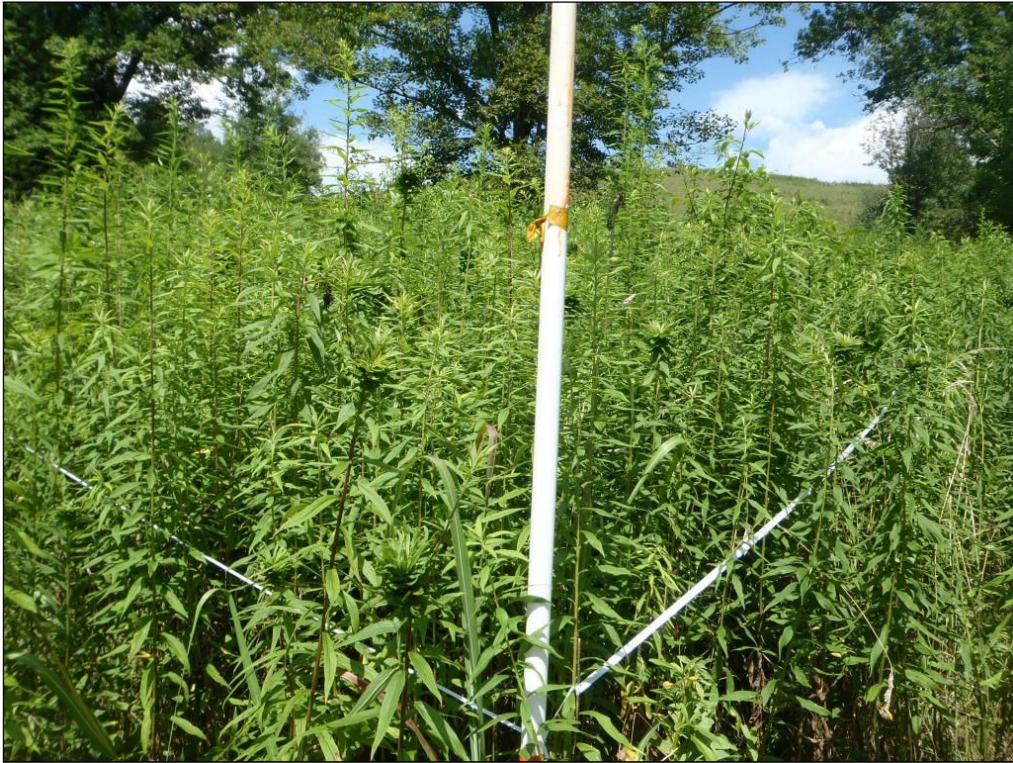
Photo No. 3

Vegetation Plot No. 2

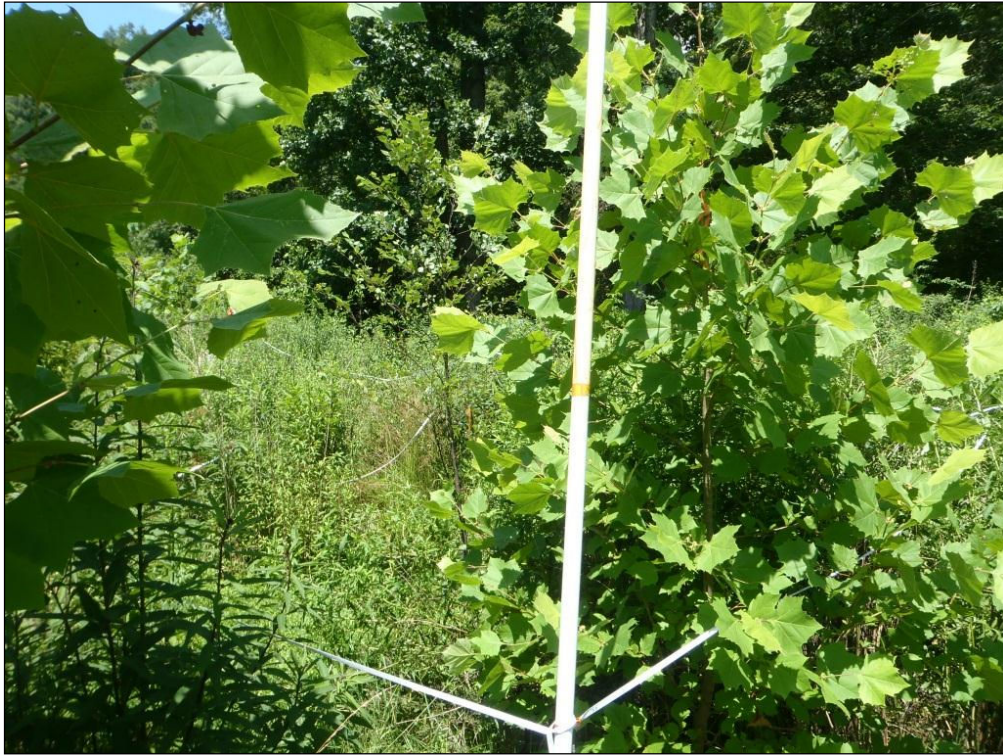
Photo No. 7

Vegetation Plot No. 4

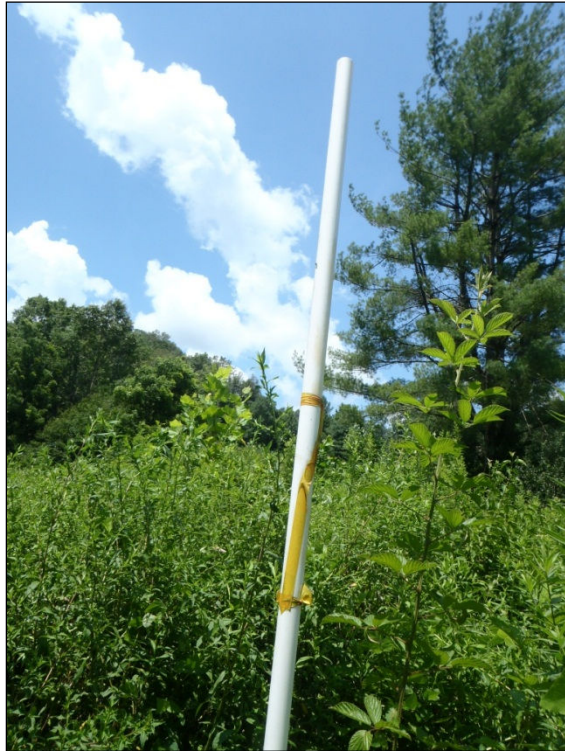
Photo No. 9

Vegetation Plot No. 5

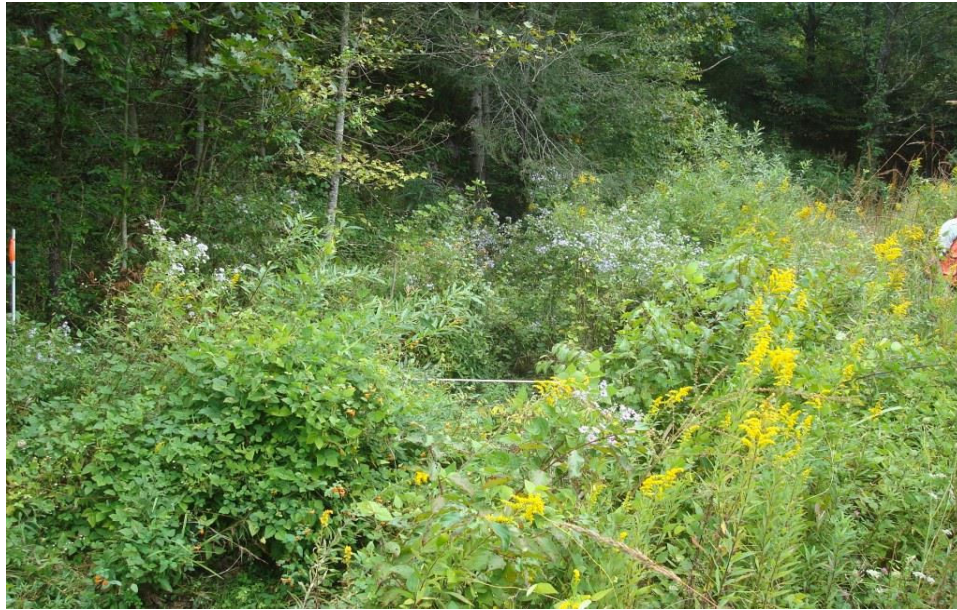
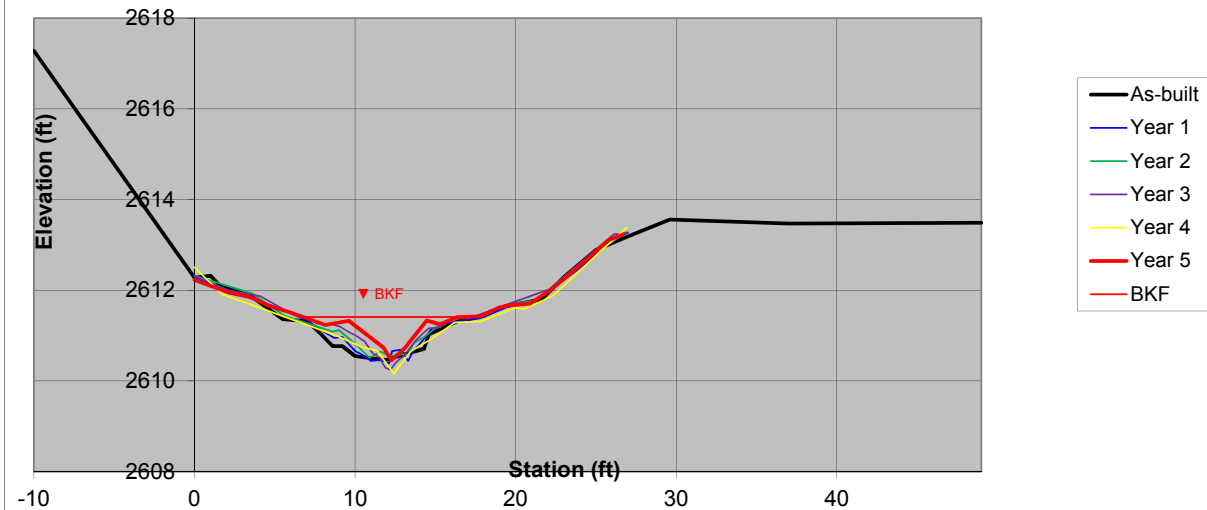
Haywood County, NC  
 Riffle Cross Section RF5  
 Reach 2 - North Branch - Sta 10+83.0

The riffle and pool sections that were taken on North Branch indicate minor change from the Year 4 survey. The riffle section has experienced slight deposition of material along the banks. The pool section appears to be aggrading and returning to the condition prior to Year 4. Overall, the channel is generally consistent with the Year 4 survey.
