South Muddy Creek Stream Restoration Project Year 1 Monitoring Report

NCEEP Project Number – 737

Project Info: Monitoring Year: 1 of 5
 Year of Data Collection: 2012
 Year of Completed Construction: 2011
 NCEEP Project Manager: Paul Wiesner
 Submission Date: November 30th, 2012

Report Prepared and Submitted by Michael Baker Engineering, Inc.

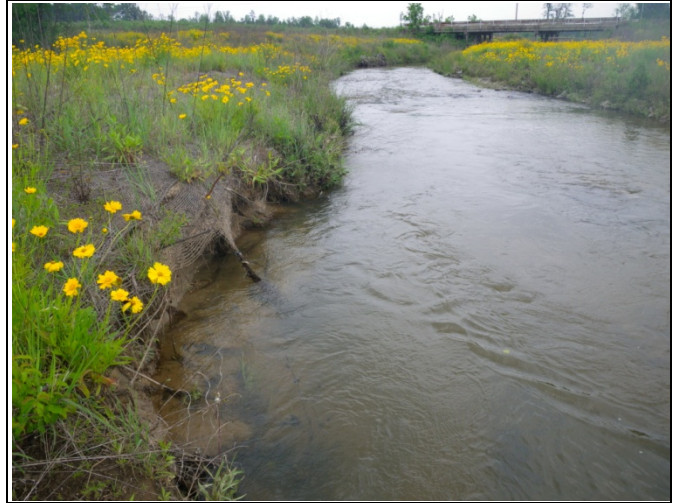
SPA2 and SPA3 consist of scoured portions of the left bank located within the first constructed riffle section upstream of the Sain Road bridge. Bank scour along these two adjacent problem areas appears to be caused by the lack of centering of the thalweg immediately downstream of the upstream meander bend. As a result, some velocity vectors within the riffle have been redirected toward the left bank instead of being centered in the riffle, thereby increasing near bank stress and causing the bank to erode. Bank erosion within SPA2 is moderate but more severe than that of SPA3 due to a deeper near bank third and thus higher near bank stress as the thalweg is located closer the toe of bank; the stream bank of SPA3 is vertical, exposed and devoid of vegetation and matted protection. SPA2 exhibits mild erosion but maintains a low bank angle and some surface protection in the form of existing matting, herbaceous vegetative cover, and scattered riprap material along the toe.

SPA2 – Localized scour along left bank from eddying within the riffle (looking downstream)

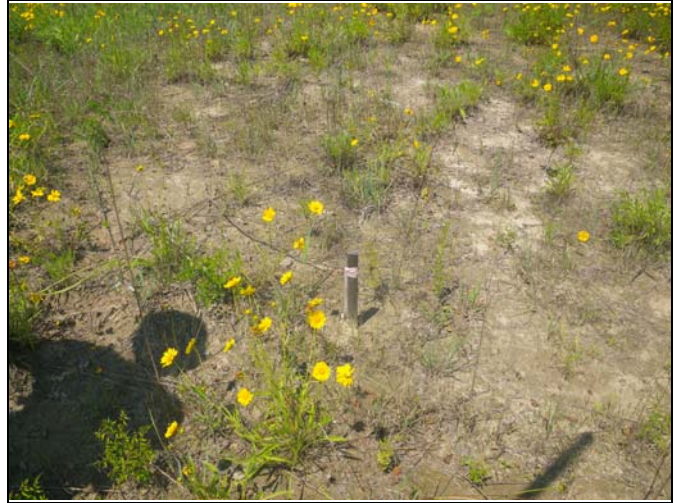
VPA1 – Multiflora Rose

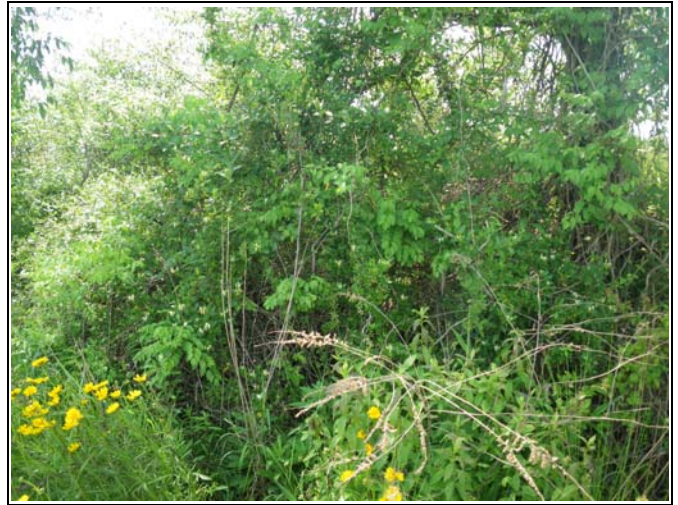
VPA3, VPA4, and VPA5 comprise the next largest VPAs and are characterized as existing tree stands containing persisting invasive vegetation. Privet and multiflora rose was observed in all three VPAs while Japanese honeysuckle (*Lonicera japonica*) was only documented in VPA4. Existing tree stands precluded from removal during construction (that originally contained invasive species) can often be a source of invasive vegetation even after treatment since the soil matrix is undisturbed leaving roots and seeds intact. These areas were previously treated but were exhibiting new growth and are still persisting.

VPA3 – Multiflora Rose and Chinese Privet

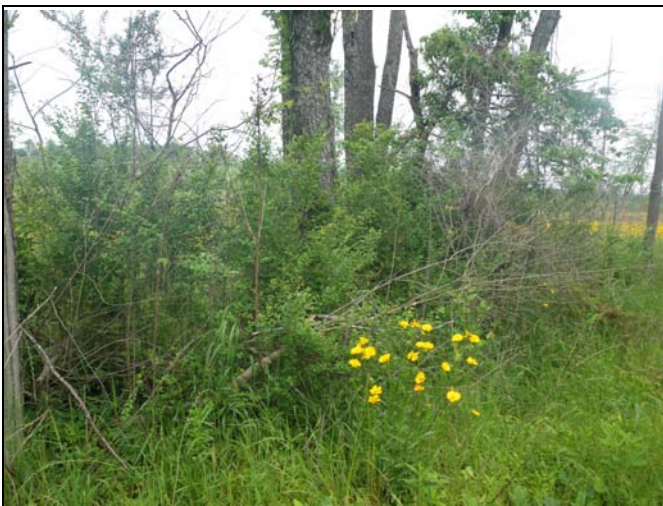
VPA4 – Multiflora Rose, Chinese Privet, Honeysuckle

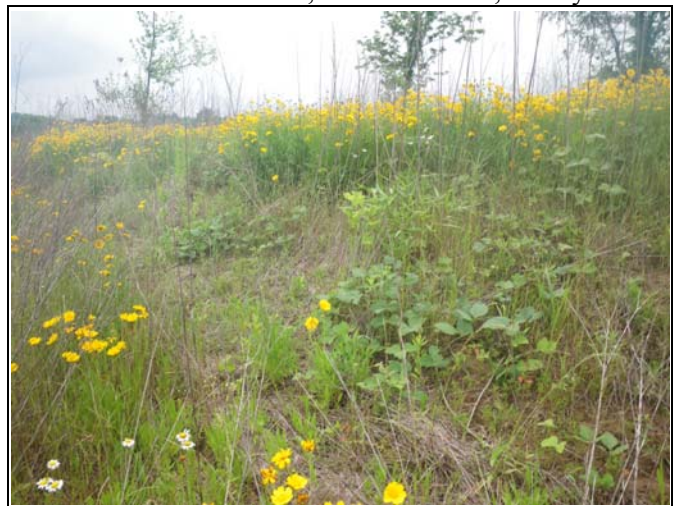
VPA5 - Multiflora Rose and Chinese Privet

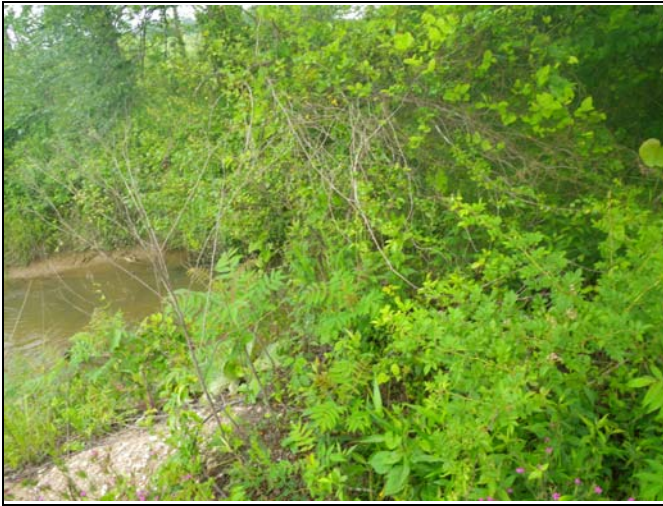
VPA6 – Kudzu persisting after treatment

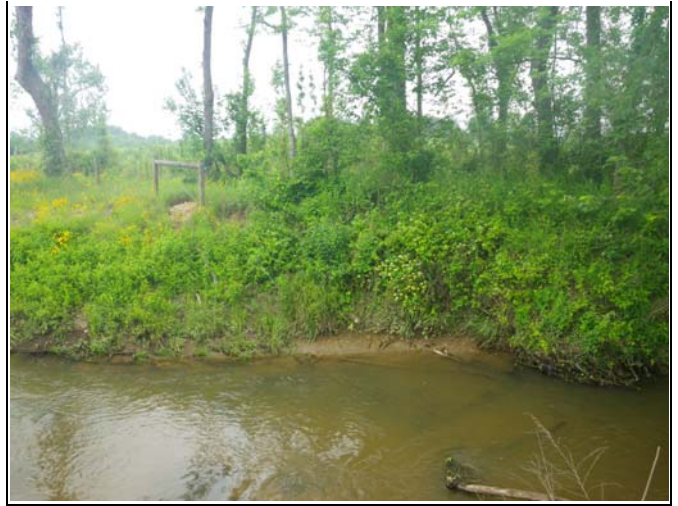
VPA7 - Multiflora Rose and Chinese Privet

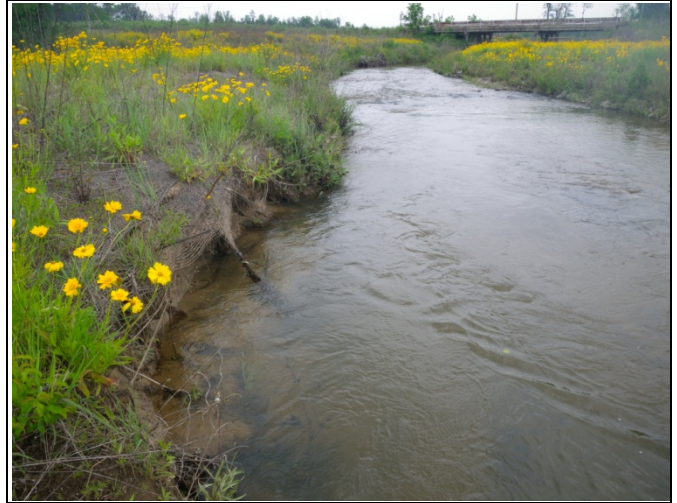
SPA2 – Localized scour along left bank from eddying within the riffle (looking downstream)

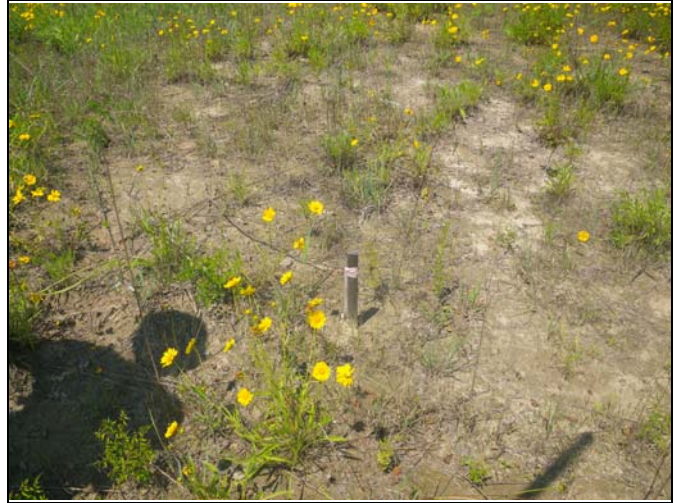
VPA1 – Multiflora Rose

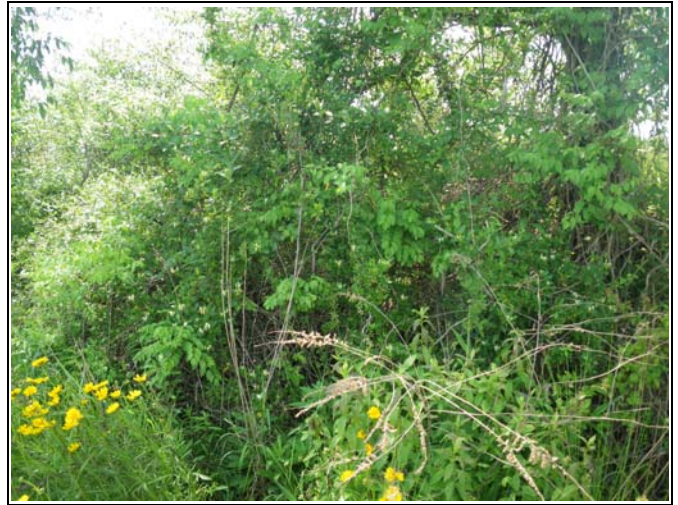
VPA3 – Multiflora Rose and Chinese Privet

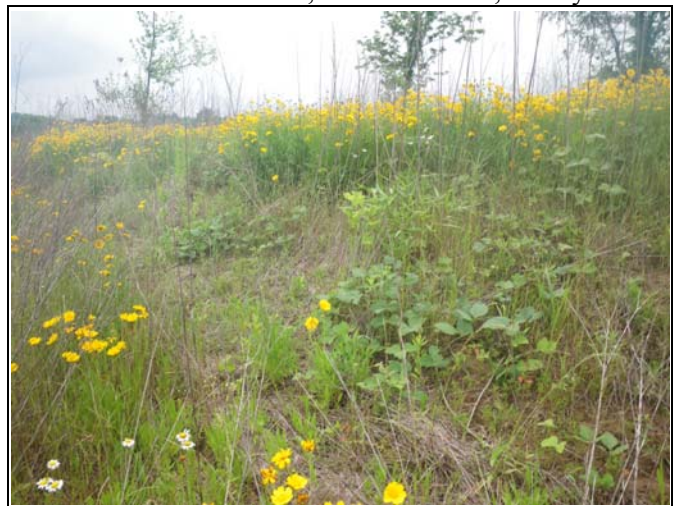
VPA5 - Multiflora Rose and Chinese Privet

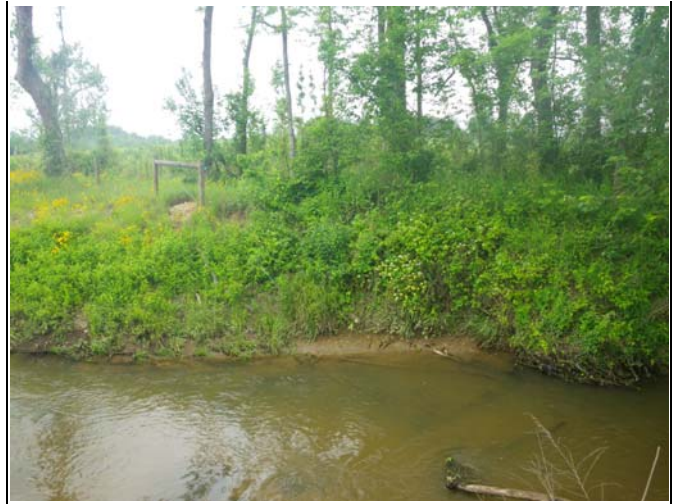
VPA7 - Multiflora Rose and Chinese Privet
