South Muddy Creek Stream Restoration Project Year 2 Monitoring Report

NCEEP Project Number – 737

Site Assessment Report – Monitoring Year 2

South Muddy Creek (Randolph/Duncan Properties) Stream Restoration
Project
McDowell County, North Carolina
May 2013

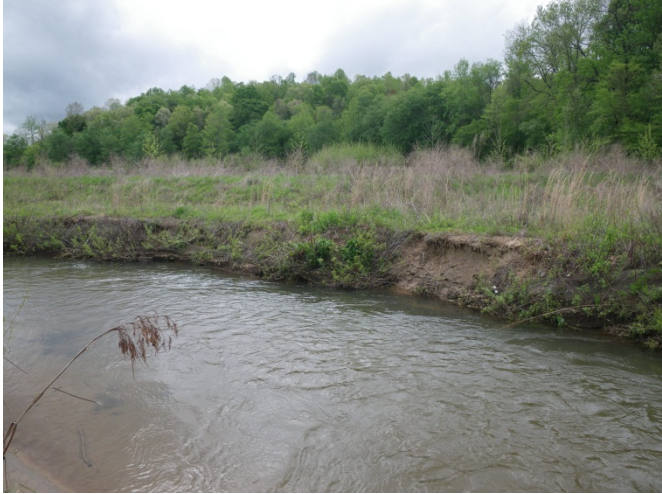
SPA1-1 – Right bank/brush mattress separating from poor compaction and scour along toe of bank (looking downstream from left bank to right bank)

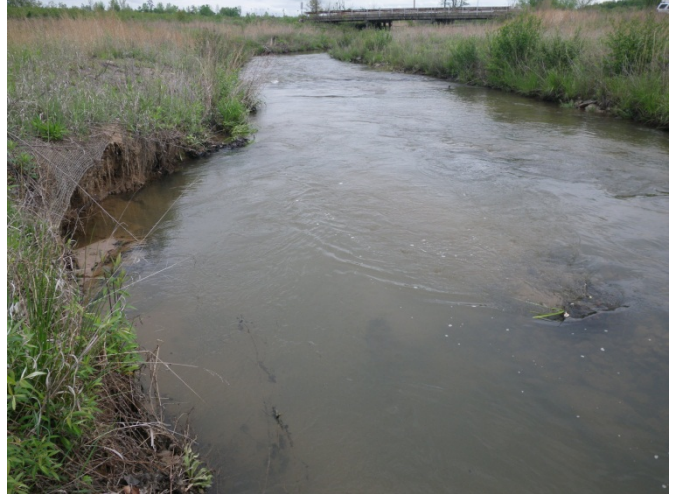
| Feature Issue | Station No. | Suspected Cause | Photo Number* |
|---|---|--|---|
| | 27+90 to 28+10 | Localized scour along left bank resulting in raw, vertical bank, devoid of vegetation and matted protection. Cause appears to be localized eddying within the riffle. | SPA1-2 |

SPA1-2 – Localized scour along left bank from eddying within the riffle (looking downstream)

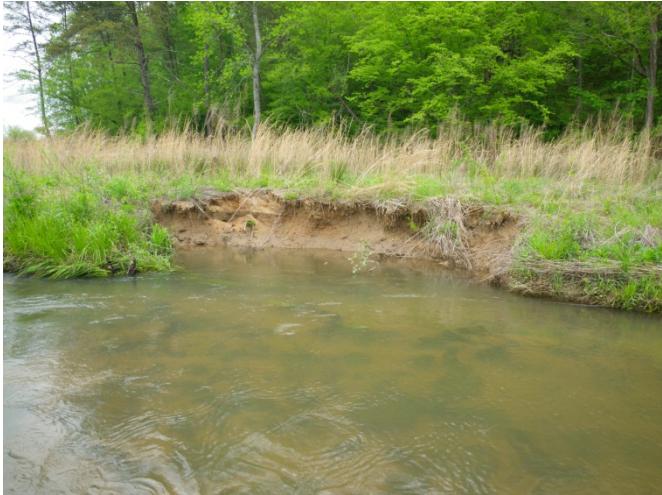
SPA2-1 is an area of localized scour and bank erosion along both banks located within the upstream project reach limits between station 12+30 and 12+60. Bank instability was caused by high near bank stress from the diversion of flow around a recently removed beaver dam.

| Feature Issue | Station No. | Suspected Cause | Photo Number* |
|---|---|--|---|
| | 12+30 to 12+60 | Localized scour and bank erosion along right bank and a small portion of the left bank across the channel. Caused by high near bank stress from the diversion of flow around a recently removed beaverdam. | SPA2-1 |

SPA2-1 – Localized scour along right bank from flow diversion around a recently removed beaverdam

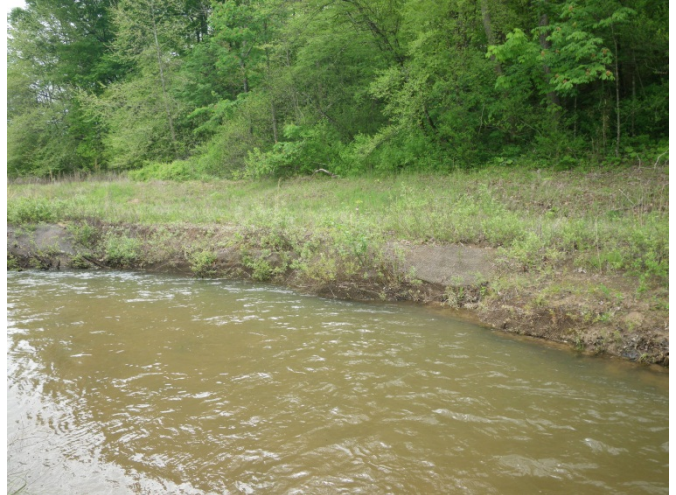
SPA2-2 – Right bank/brush mattress separating from poor compaction and scour along toe of bank (looking downstream from left bank to right bank)

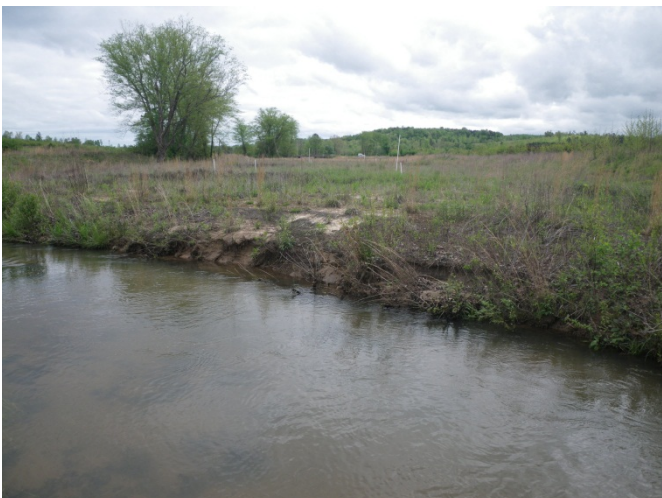
SPA2-3 consists of an area of localized scour along the right bank located downstream of an outer meander bend between station 12+30 and 12+60. Bank scour could potentially be a result of the lack of centering of the thalweg immediately downstream of the upstream meander bend (and was noted accordingly in Table 5a). As a result, some velocity vectors within the riffle have been redirected toward the right bank instead of being centered in the riffle, thereby increasing near bank stress and causing the bank to erode. The bank is vertical, exposed, devoid of vegetation and matted protection, and is mild to moderately eroded.

| Feature Issue | Station No. | Suspected Cause | Photo Number* |
|---|---|--|---|
| | 17+95 to 18+50 | Localized scour along the right bank of a riffle resulting in raw, vertical bank, devoid of vegetation and matted protection. Appears to be caused by high near bank stress as the thalweg appears to have migrated toward the near bank third of the channel within the riffle (lack of centering of thalweg downstream of meander bend). Vegetation and rootmass along that portion of bank is sparse. | SPA2-3 |

SPA2-3 – Localized scour along right bank within a riffle from the lack of thalweg centering downstream of a meander bend (looking downstream from left to right bank)

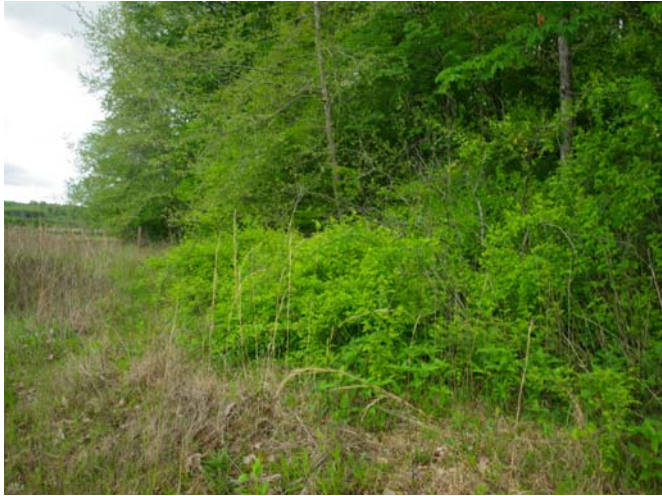
VPA1-1 – Multiflora Rose

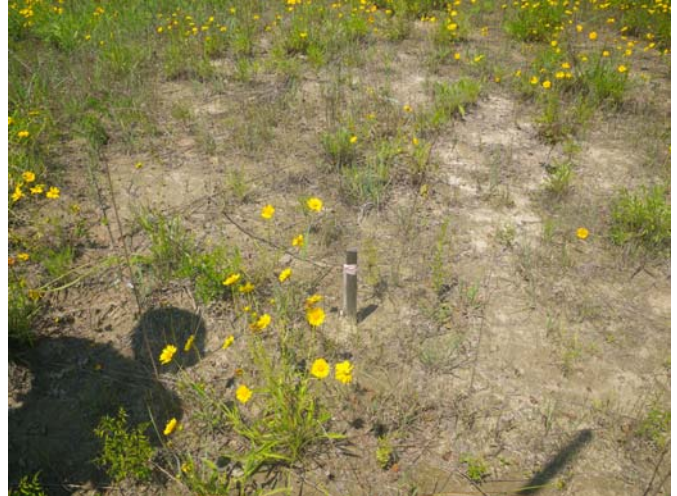
VPA1-2 – Trumpet vine persisting after treatment
(photo from MY1)

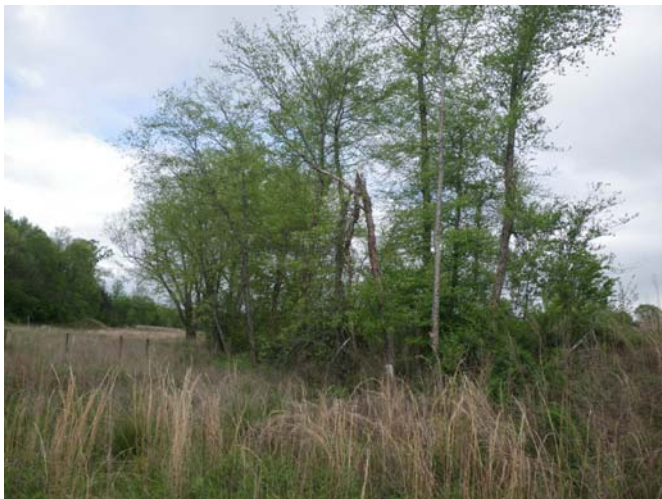
VPA1-3 – Multiflora Rose and Chinese Privet

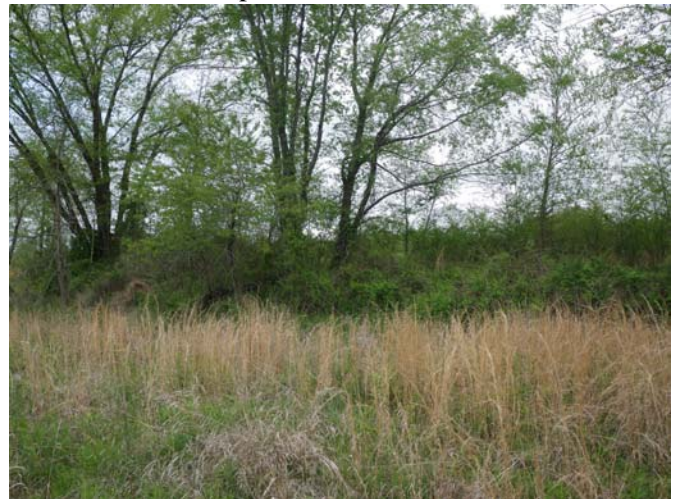
VPA1-4 – Multiflora Rose, Chinese Privet, Japanese
Honeysuckle

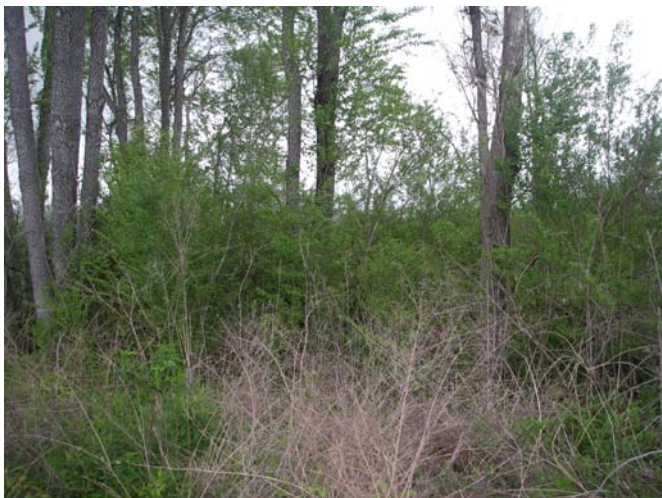
VPA1-5 - Multiflora Rose and Chinese Privet

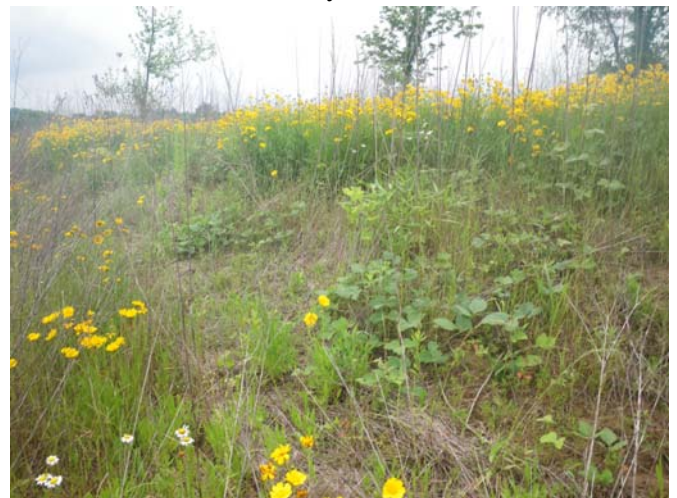
VPA1-6 – Kudzu persisting after treatment (photo from
MY1)

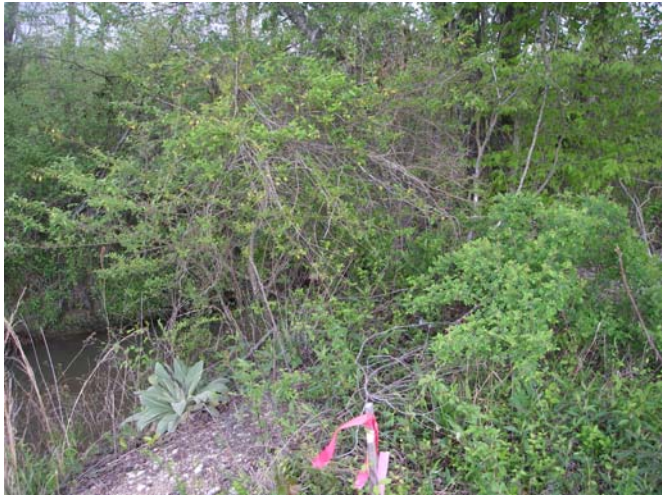
VPA1-7 - Multiflora Rose and Chinese Privet

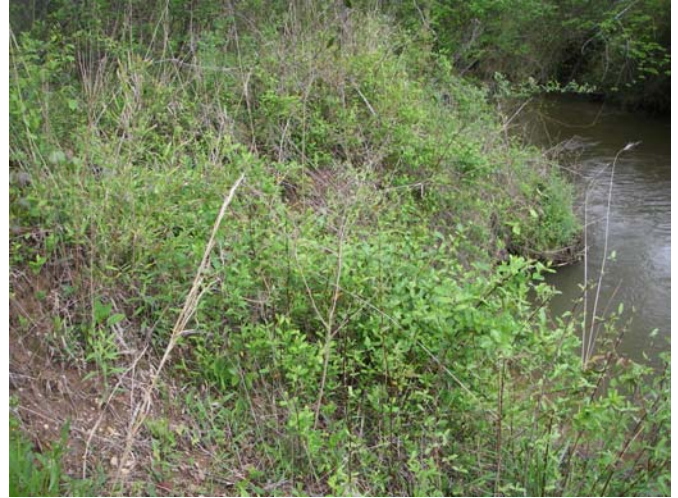
VPA1-8 – Japanese Honeysuckle

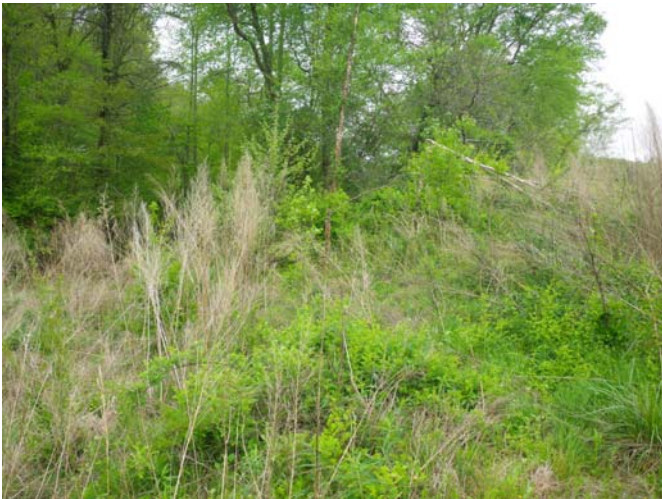
VPA2-1 - Multiflora Rose and Japanese Honeysuckle

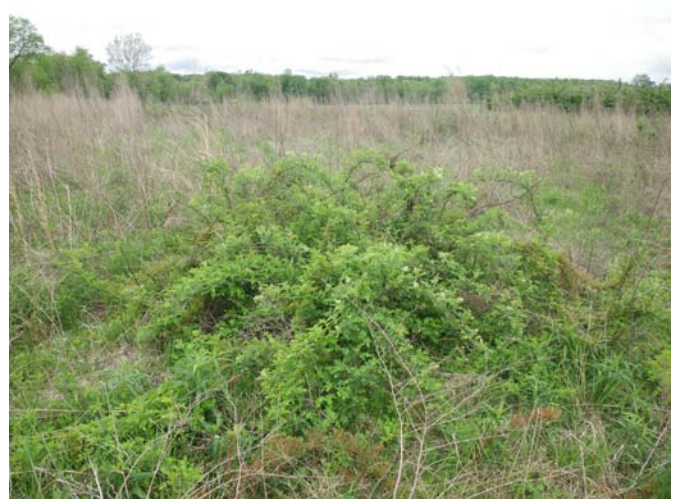
VPA2-2 – Multiflora Rose

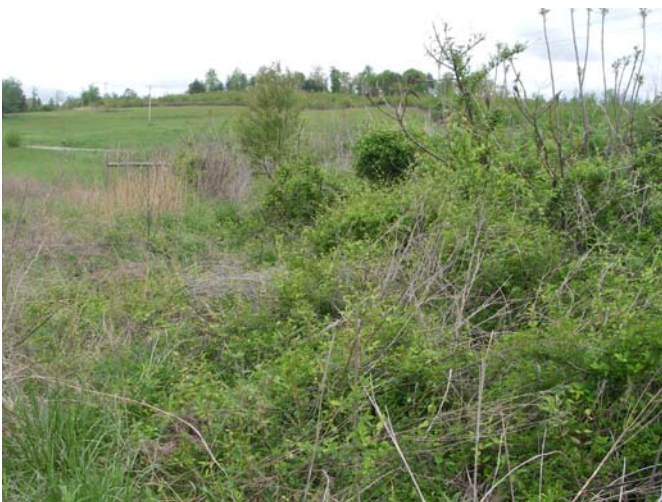
VPA2-3 - Multiflora Rose and Japanese Honeysuckle

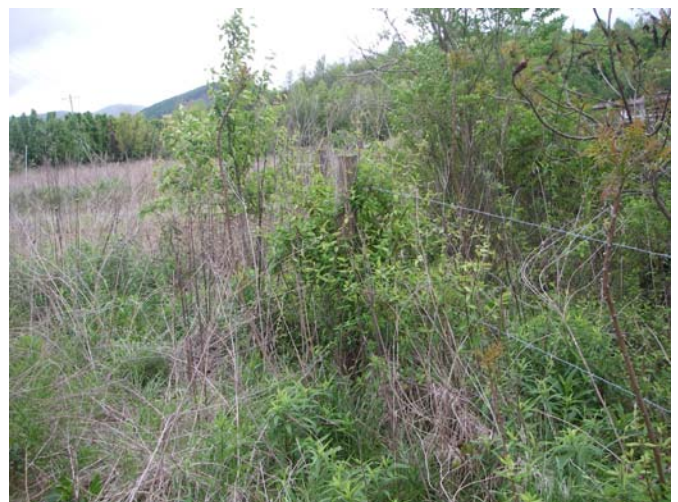
VPA2-4 – Japanese Honeysuckle

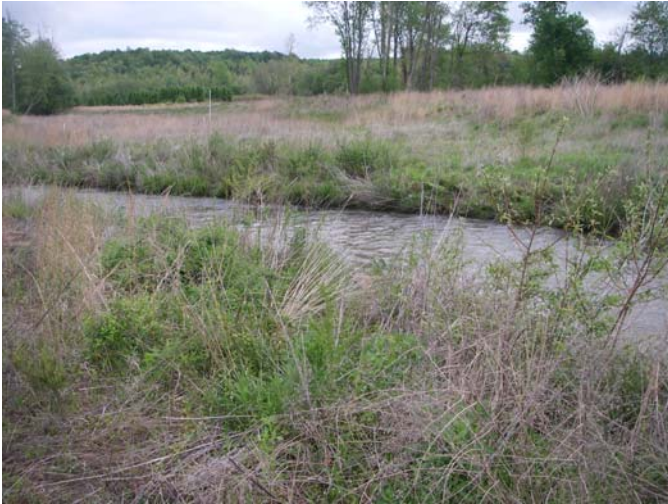
VPA2-5 - Multiflora Rose and Japanese Honeysuckle

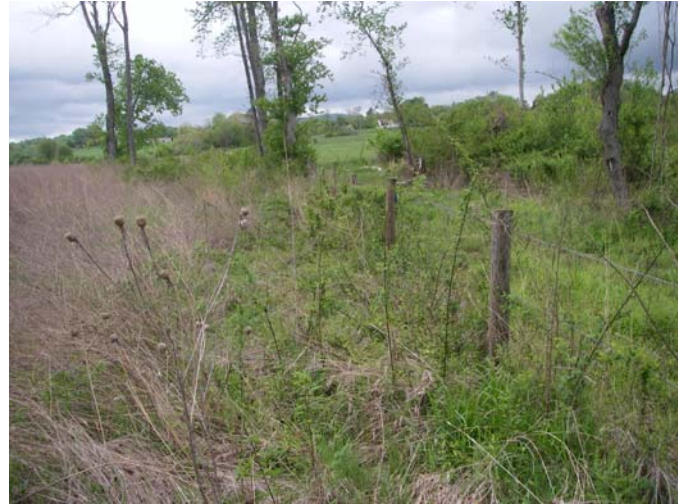
VPA2-6 – Multiflora Rose, Chinese Privet, Japanese Honeysuckle

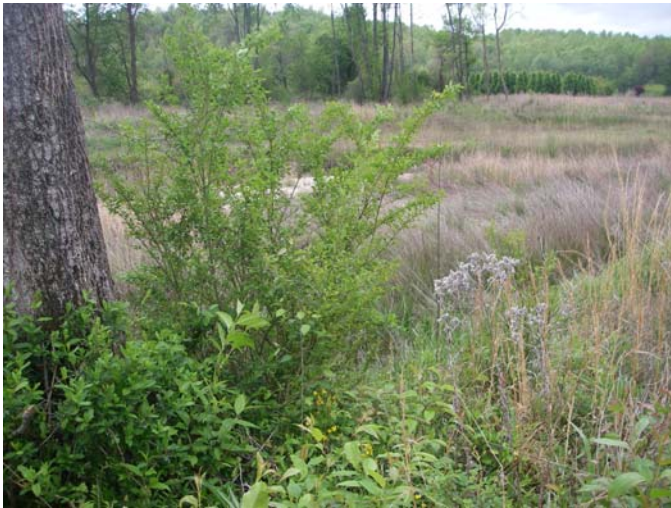
VPA2-7 - Multiflora Rose, Chinese Privet, Japanese Honeysuckle
