# South Muddy Creek Stream Restoration Project Year 3 Monitoring Report

**McDowell County, North Carolina**

**NCEEP Project Number – 737**

Project Info:           Monitoring Year: 3 of 5  
                              Year of Data Collection: 2014  
                              Year of Completed Construction: 2011  
                              NCEEP Project Manager: Mathew Reid  
                              Submission Date: November 28, 2014

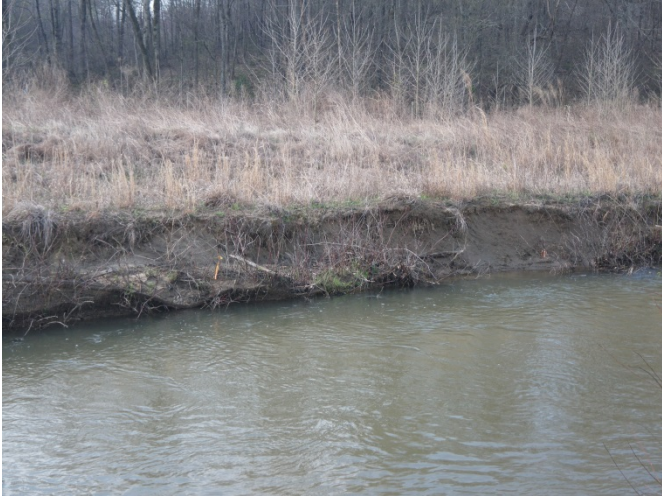
SPA1-1 – Right bank/brush mattress separating from poor compaction and scour along toe of bank (looking upstream from left bank to right bank)

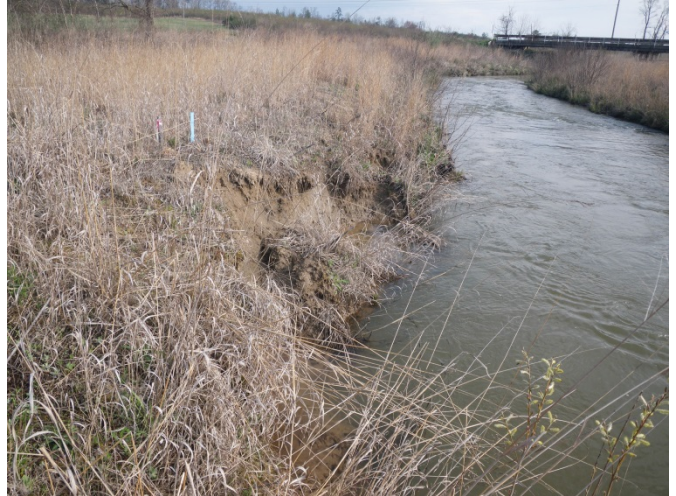
SPA1-2 – Localized scour along left bank from eddying within the riffle (looking downstream)

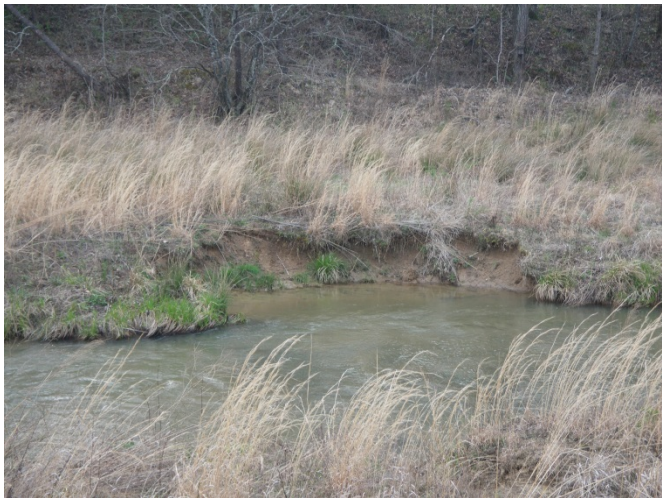
SPA2-1 was identified in the Year 2 visual assessment, and it is an area of localized scour and bank erosion along both banks located within the upstream project reach limits between station 12+30 and 12+60. Bank instability was caused by high near bank stress from the diversion of flow around a recently removed beaver dam. Erosion along the right bank is larger in magnitude and severity than the left bank since that portion of the right bank

SPA2-1 – Localized scour along right bank from flow diversion around a recently removed beaverdam

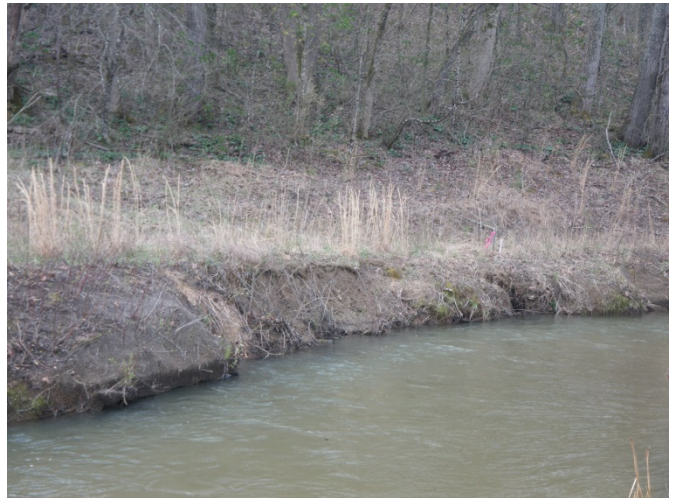
Feature Issue	Station No.	Suspected Cause	Photo Number*
Bank Scour	21+20 to 22+00	Right bank (including brush mattress and matting) separating and beginning to slump at beginning of outer meander bend from a combination of poor compaction and scour along the toe of bank. Bank scour appears to have migrated further downstream along the outer meander bend, eroding an additional 70 linear feet within the past year of monitoring.	SPA1-1
	27+90 to 28+10	Localized scour along left bank resulting in raw, vertical bank, devoid of vegetation and matted protection. Cause appears to be localized eddying within the riffle.	SPA1-2
	12+30 to 12+60	Localized scour and bank erosion along right bank and a small portion of the left bank across the channel. Caused by high near bank stress from the diversion of flow around a recently removed beaverdam.	SPA2-1
	16+70 to 17+30	Right bank (including brush mattress and matting) separating and beginning to slump at beginning of outer meander bend from a combination of poor compaction and scour along the toe of bank.	SPA2-2

SPA2-2 – Right bank/brush mattress separating from poor compaction and scour along toe of bank (looking upstream from left bank to right bank)

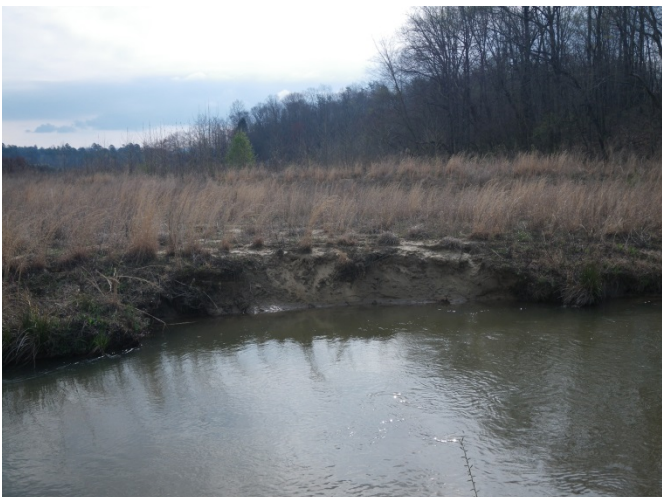
SPA2-3 consists of an area of localized scour along the right bank located downstream of an outer meander bend between station 12+30 and 12+60. Bank scour could potentially be a result of the lack of centering of the thalweg immediately downstream of the upstream meander bend (and was noted accordingly in Table 5a). As a result, some velocity vectors within the riffle have been redirected toward the right bank instead of being centered in the riffle, thereby increasing near bank stress and causing the bank to erode. The bank is vertical, exposed, devoid of vegetation and matted protection, and is mild to moderately eroded.

SPA2-3 – Localized scour along right bank within a riffle from the lack of thalweg centering downstream of a meander bend (looking across from left to right bank)

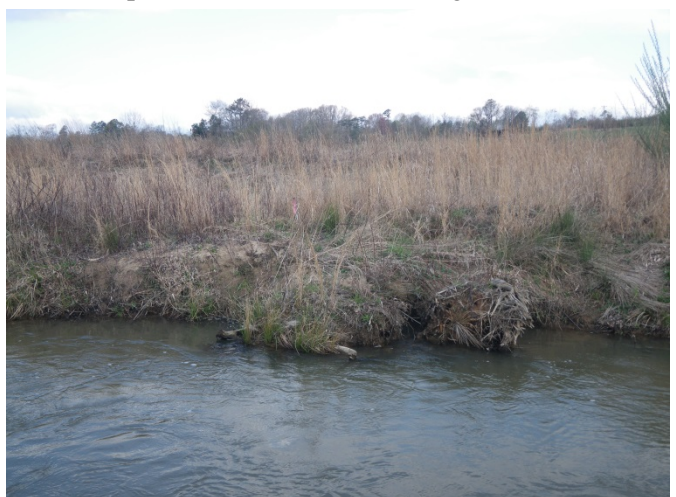
SPA3-1 is an area of erosion on the left bank between station 29+30 and 29+50. This area primarily consists of bank erosion upstream of and between rootwads and a log vane. Eddying water behind rootwads has eroded the bank. The rootwads and log vane are functioning correctly, but the area should be monitored to determine if repairs are needed.

SPA3-1 – Localized scour along left bank behind rootwads (looking across from right to left bank)

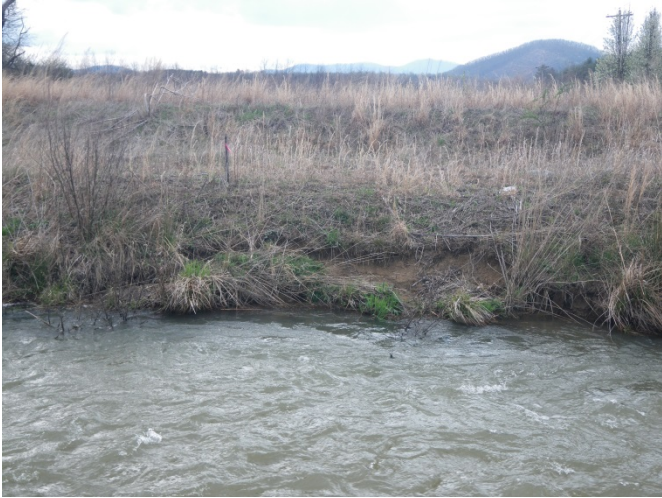
17+95 to 18+50	Localized scour along the right bank of a riffle resulting in raw, vertical bank, devoid of vegetation and matted protection. Appears to be caused by high near bank stress as the thalweg appears to have migrated toward the near bank third of the channel within the riffle (lack of centering of thalweg downstream of meander bend). Vegetation and rootmass along that portion of bank is sparse.	SPA2-3
	29+30 to 29+50	Localized scour along the left bank behind rootwads. Appears to be caused by high near bank stress during high water. Rootwads appear to be functioning and bank vegetation is sparse.	SPA3-1
	31+80 to 32+06	Localized scour along right bank downstream of Sain Rd. Bridge. Cause is due to high water velocities created by steep riffle just downstream of bridge.	SPA3-2

SPA3-2 – Localized scour along right bank downstream of Sain Rd. Bridge. Result of high shear stress caused by steep riffle (looking across from left to right bank)

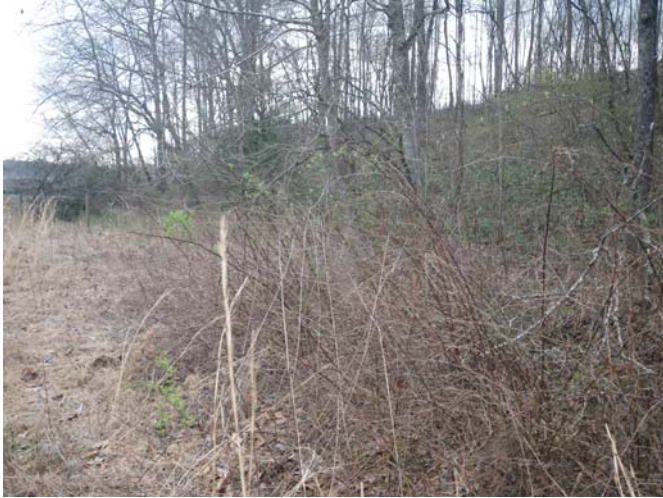
VPA1-1 – Multiflora Rose

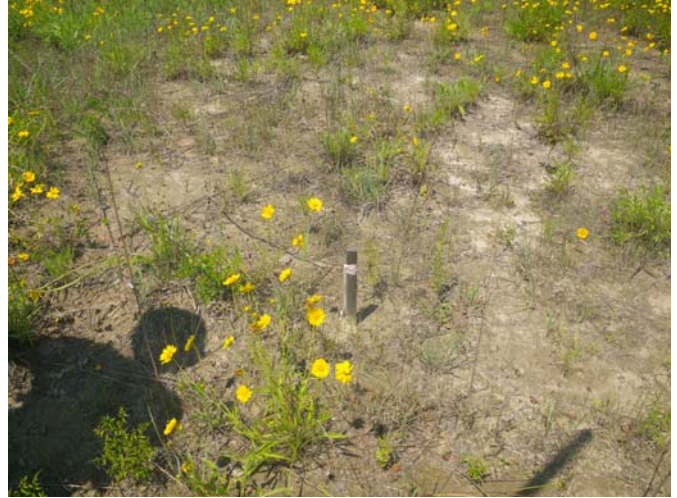
VPA1-2 – Trumpet vine persisting after treatment  
(photo from MY1)

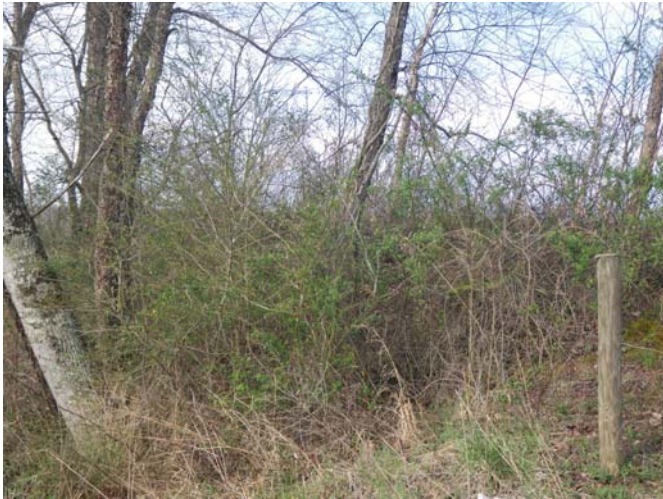
VPA1-3 – Multiflora Rose and Chinese Privet

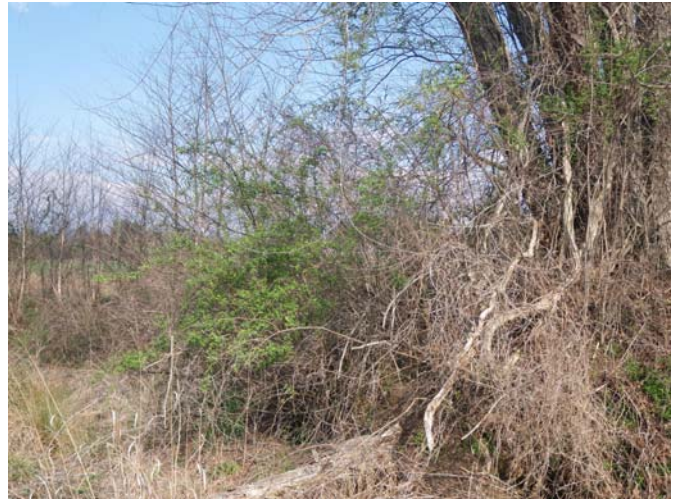
VPA1-4 – Multiflora Rose, Chinese Privet, Japanese  
Honeysuckle

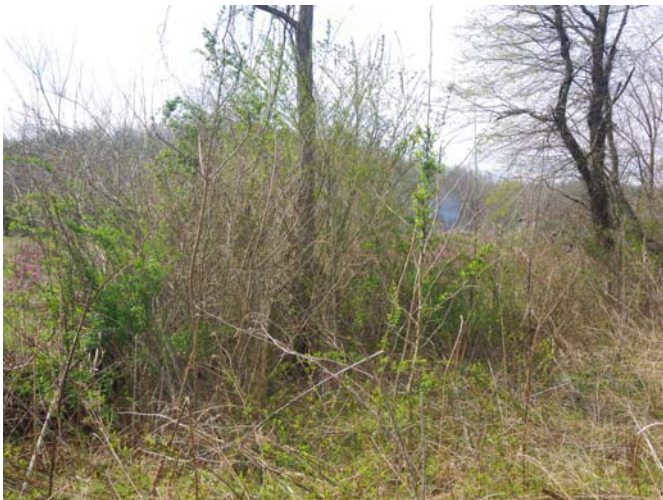
VPA1-5 - Multiflora Rose and Chinese Privet

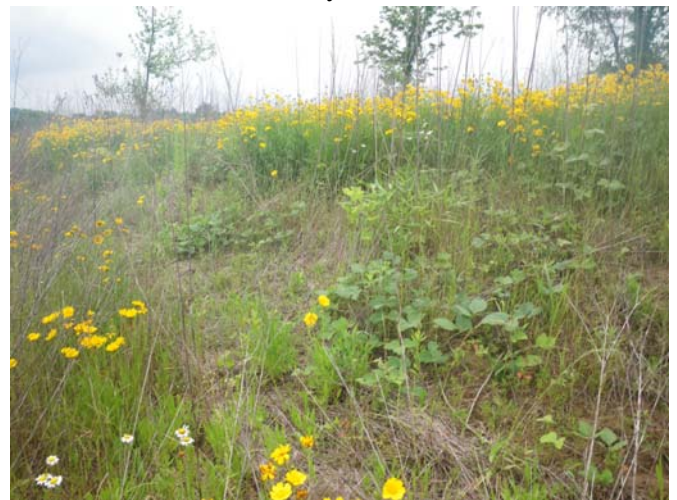
VPA1-6 – Kudzu persisting after treatment (photo from  
MY1)

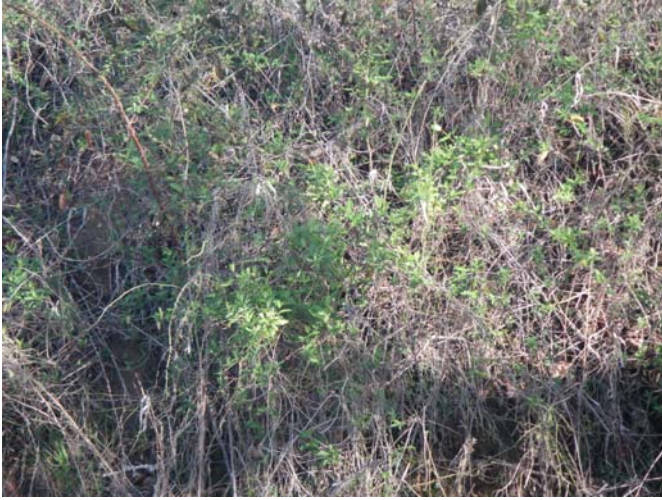
VPA1-7 - Multiflora Rose and Chinese Privet

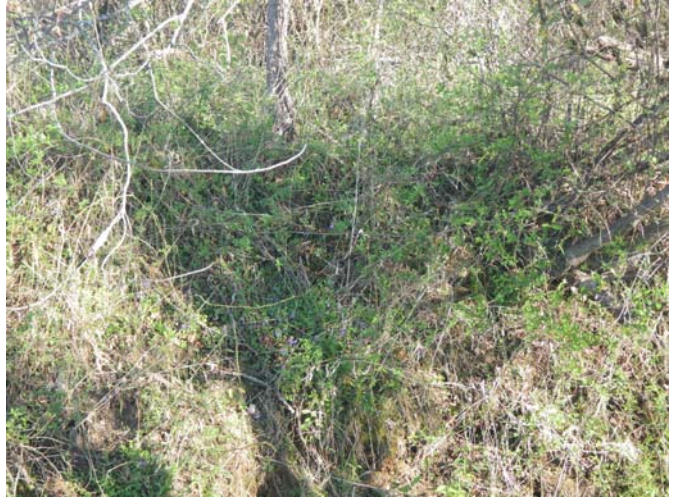
VPA1-8 – Japanese Honeysuckle

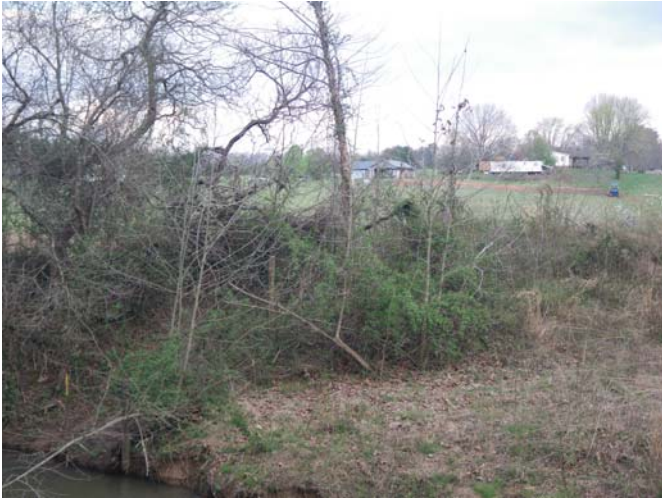
VPA2-1 - Multiflora Rose and Japanese Honeysuckle

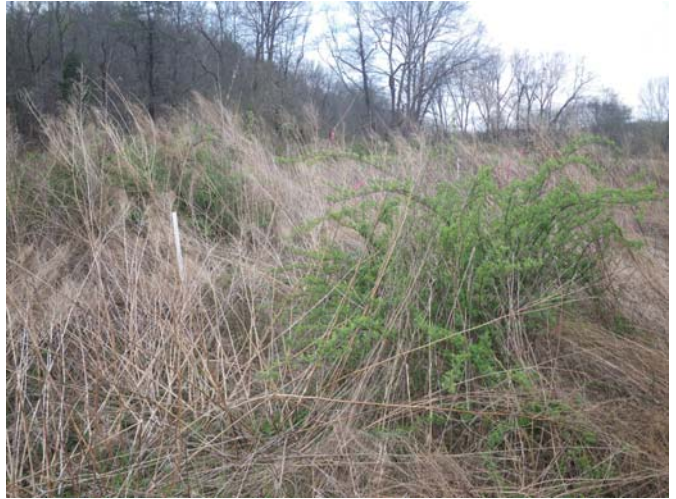
VPA2-2 – Multiflora Rose

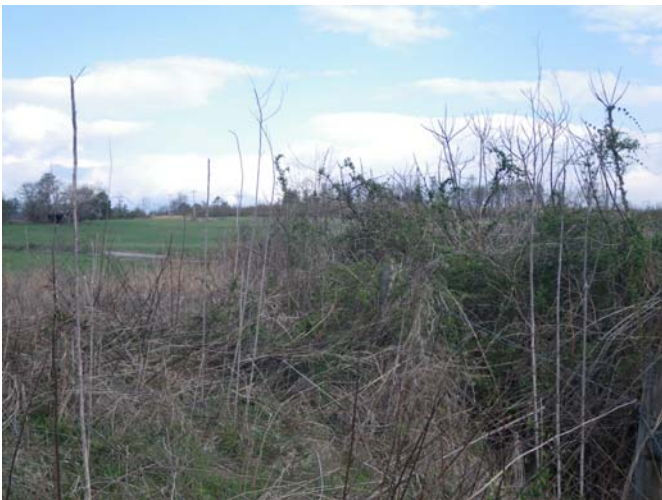
VPA2-3 - Multiflora Rose and Japanese Honeysuckle

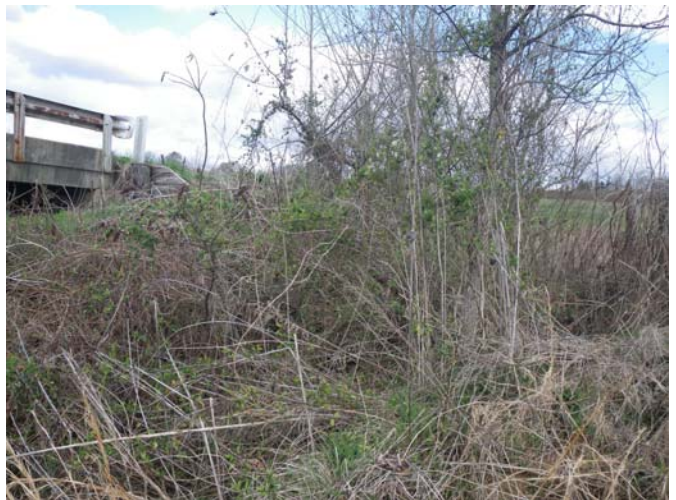
VPA2-4 – Japanese Honeysuckle

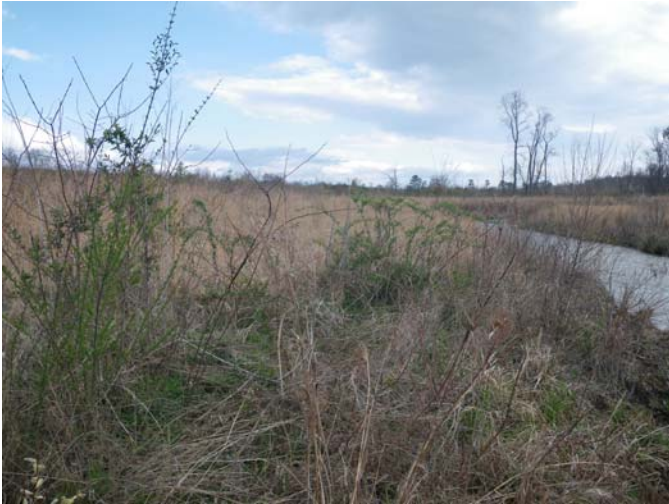
VPA2-5 - Multiflora Rose and Japanese Honeysuckle

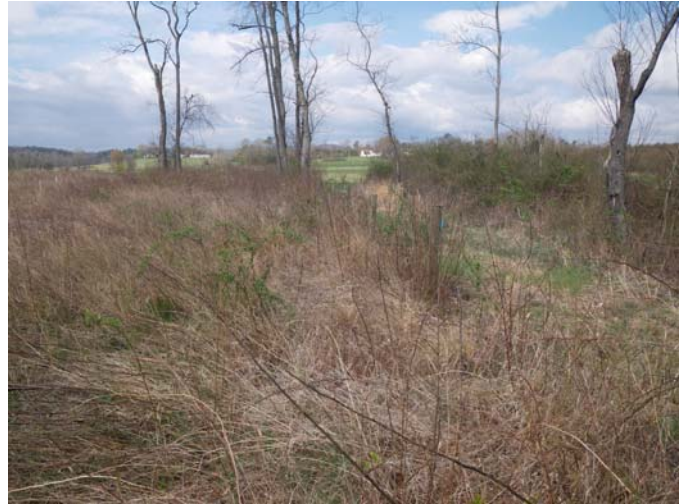
VPA2-6 – Multiflora Rose, Chinese Privet, Japanese Honeysuckle

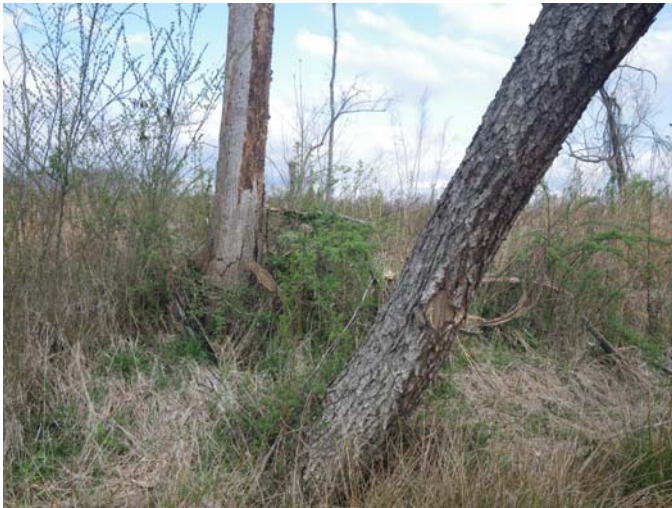
VPA2-7 - Multiflora Rose, Chinese Privet, Japanese Honeysuckle

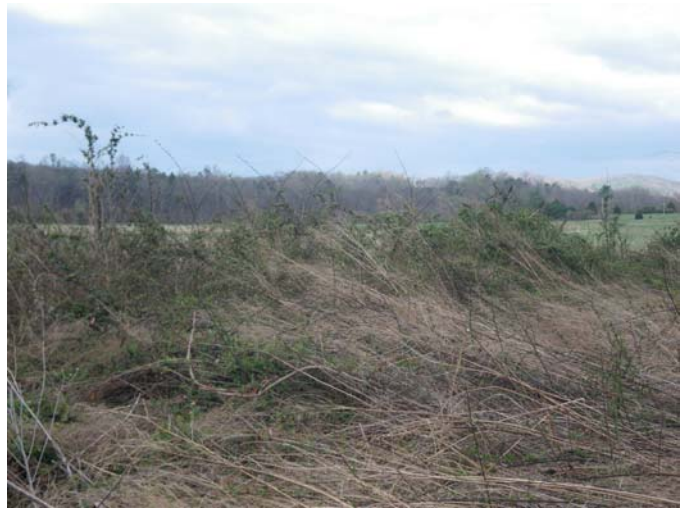
VPAs newly identified during this assessment (VPA3-1 through VPA3-4) were either composed of multiflora rose (*Rosa multiflora*) or Japanese honeysuckle (*Lonicera japonica*), or a combination of both invasive species. Multiflora rose is the most prevalent invasive species observed within the VPAs and is found in all four of the newly identified VPAs. VPA3-1 and VPA3-2 are the two largest new areas identified. Both of these areas extend along the Conservation Easement and fence line. Not only are these two VPA susceptible to the encroachment of invasives from outside the easement, they are also adjacent to previously identified VPAs that may provide a seed source. These two VPAs make up approximately 90 percent of the newly identified VPA acreage within the easement. VPA3-3 is a small but dense area consisting of multiflora rose and is located on the left terrace slope near vegetation plot 3. This VPA may be a result of an undisturbed soil matrix likely containing intact roots and seeds of multiflora rose. VPA3-4 also contains multiflora rose and is located on the right road bank on the downstream side of the Sain Road bridge.

VPA3-1 - Multiflora Rose and Japanese Honeysuckle

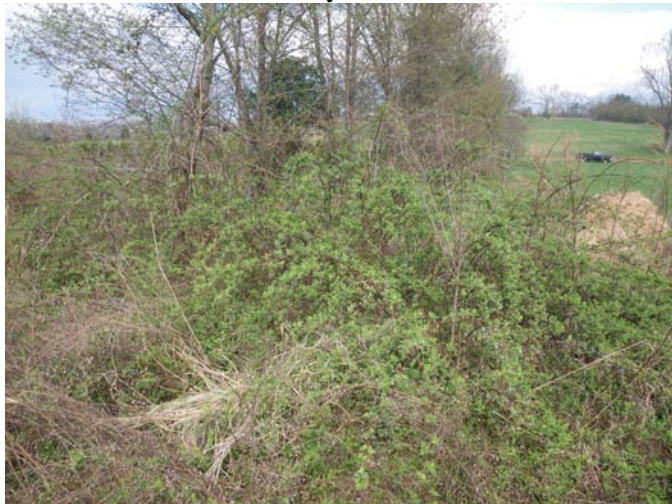
VPA3-2 - Multiflora Rose

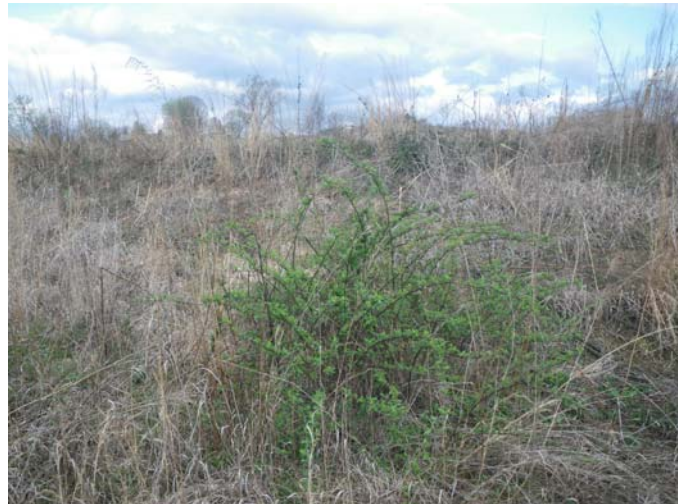
VPA3-3 – Multiflora Rose

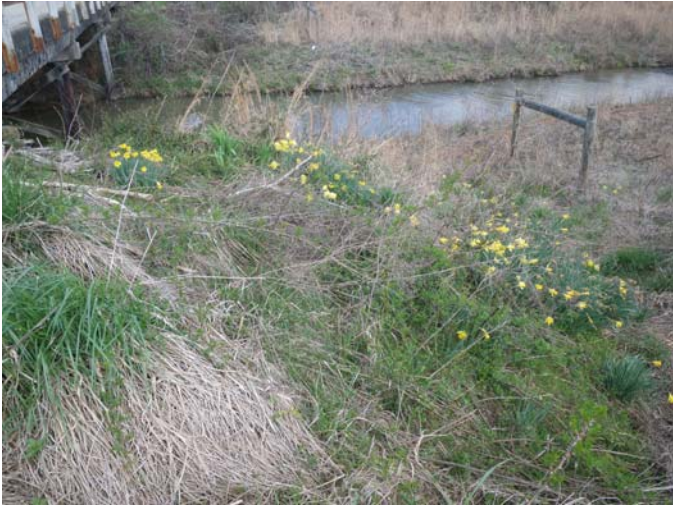
VPA3-4 - Multiflora Rose
