# South Muddy Creek Stream Restoration Project Year 4 Monitoring Report

**McDowell County, North Carolina**

**NCDMS Project Number – 737**

# **Site Assessment Report – Monitoring Year 4**

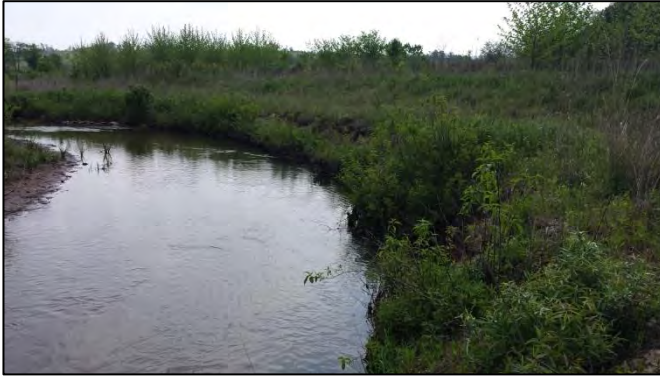
SPA1-1 – Right bank/brush mattress separating from poor compaction and scour along toe of bank (looking downstream). Appears to be stabilizing with vegetation.

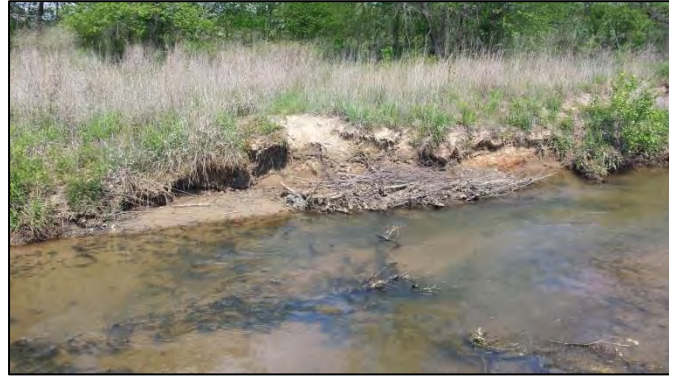
SPA1-2 – Localized scour along left bank from eddying within the riffle (looking downstream)

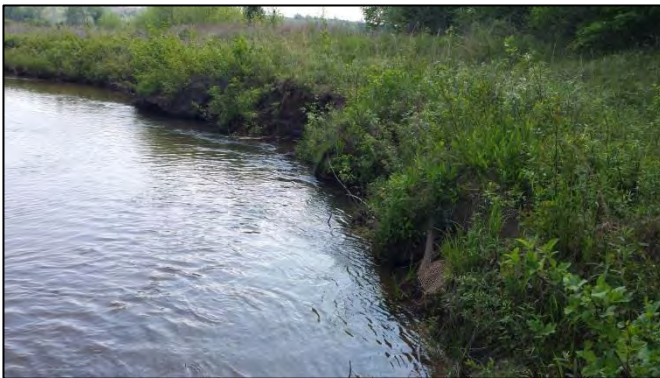
SPA2-2 consists of a 60 LF length of brush mattress compromised by an undercut bank between station 16+70 and 17+30. It is located along the right bank at the beginning of a meander bend. The brush mattress (and a portion of the staked and matted bank) appears to be separating from the right bank and hanging loosely away from the bank face. This is most likely resulting from a combination of poor soil compaction and scour along the toe of the bank. Some of the brush originally installed behind the matting to armor the bank has washed away leaving the bank exposed and vulnerable to subsequent erosion. The bank protection provided by the remaining length of brush mattress along the right bank may become compromised and less effective over time if the area (SPA2-2) is not stabilized and the scour (and instability) is allowed to continue to migrate further downstream by undermining the brush.

SPA2-2 – Right bank/brush mattress separating from poor compaction and scour along toe of bank (looking downstream from right bank)

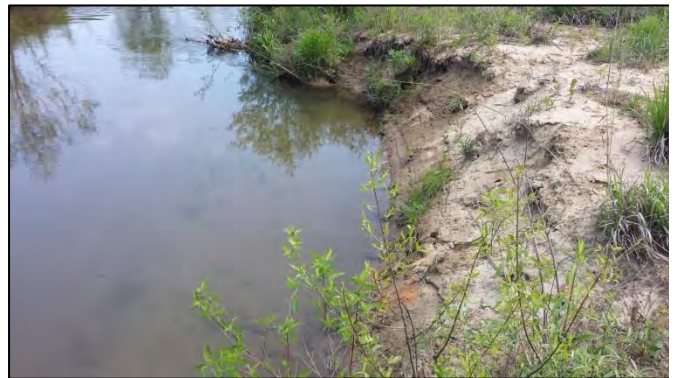
SPA2-3 consists of an area of localized scour along the right bank located downstream of an outer meander bend between station 12+30 and 12+60. Bank scour in this area is likely the result of the laterally migrating thalweg located immediately downstream of the upstream meander bend (and was noted accordingly in Table 5a). As a result, velocity vectors within

SPA2-3 – Localized scour along right bank within a riffle from the lack of thalweg centering downstream of a meander bend (looking downstream from right bank)

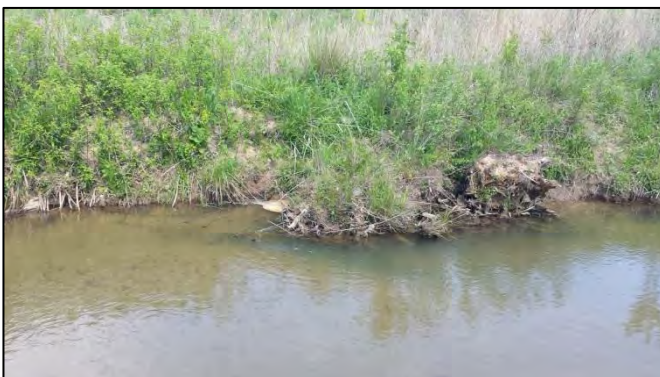
SPA3-1 is an area of erosion on the left bank between station 29+30 and 29+50. This area primarily consists of bank erosion upstream of and between rootwads and a log vane. Eddying water behind rootwads has eroded the bank. The rootwads and log vane are functioning correctly, but the area should be monitored to determine if repairs are needed. Native herbaceous vegetation is slowly populating the bank helping to stabilize the erosion.

SPA3-1 – Localized scour along left bank behind rootwads (looking across from right to left bank)

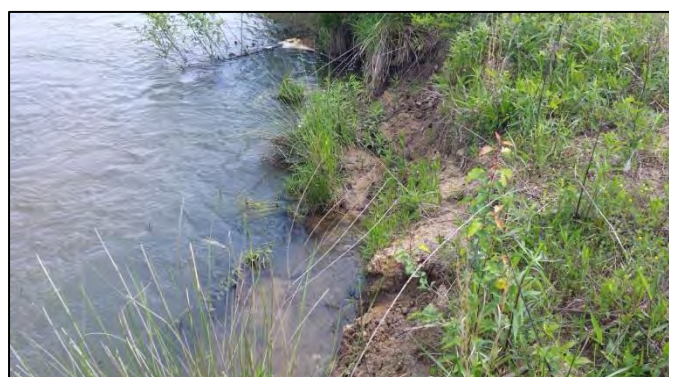
SPA3-2 – Localized scour along right bank downstream of Sain Rd. Bridge. Result of high shear stress caused by steep riffle (looking downstream from right bank)

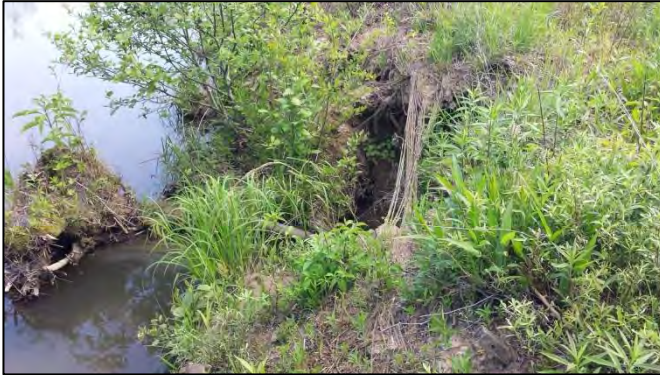
SPA4-1 is a localized area of bank erosion behind a rootwad on the right bank. The erosion is being caused by overbank flows scouring the area behind the rootwad. The rootwad is still functioning as moderate bank protection, but could become dislodged if further erosion occurs.

SPA4-1 – Localized scour along right bank behind rootwads (looking downstream from right bank)

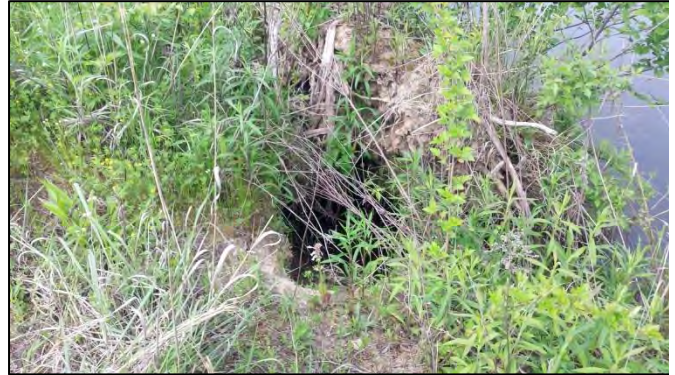
SPA4-2 is a localized area of bank erosion behind a rootwad on the right bank. The erosion appears to be caused by overbank flows scouring the area behind the rootwad. However, because of the uniform nature of the problem and the presence of beavers in the area this SPA may be a location of a beaver den. The rootwad is still functioning as bank protection. Filling the void and mounding behind the rootwad would remedy the issue.

SPA4-2 – Localized scour along right bank behind rootwads (looking downstream from right bank). Possibly caused by animals.

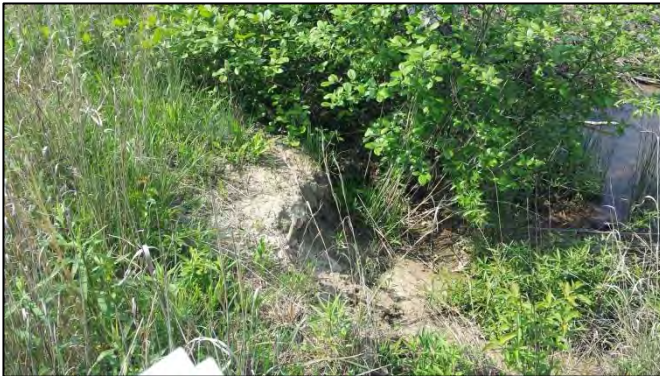
SPA4-3 – Area of right bank erosion caused by flow diversion around beaverdam.

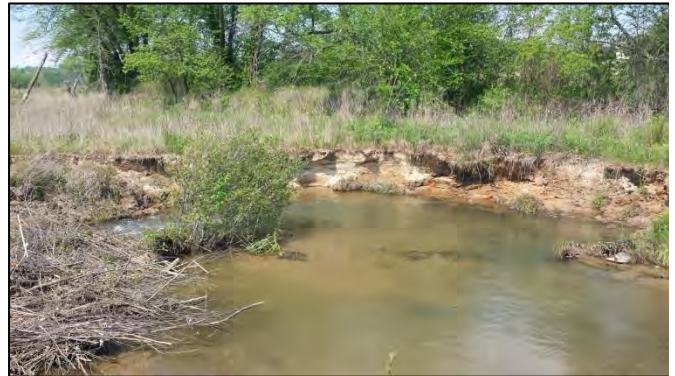
SPA4-4 is a large erosion area on the left bank between stations 28+40 and 28+90. The erosion is the direct result of a recently removed beaverdam. Flood flows were being directed around a beaverdam that was removed in May 2015 causing massive erosion on the left bank. If the problem area is not repaired further erosion and instability is imminent potentially causing structure failure and bridge abutment concerns.

28+40 to 28+90	Large area of bank erosion and scour on left bank. Cause is flow diversion around beaverdam during low and high flow events.	SPA4-4
	38 + 10	Remnant beaver dam that was removed in October 2015.	SPA4-5

SPA4-4 – Large area of left bank erosion caused by flow diversion around beaverdam.

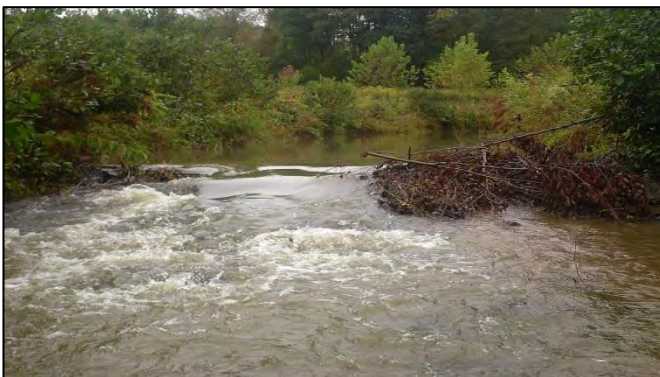
SPA4-5 – Remnant beaver dam that was removed in October 2015.

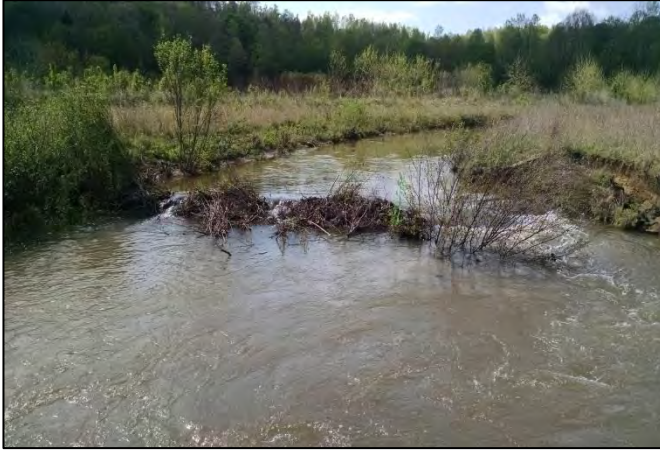
Location of beaver dam (prior to its removal) that caused approximately 60 linear feet of damage to the left bank along South Muddy Creek.

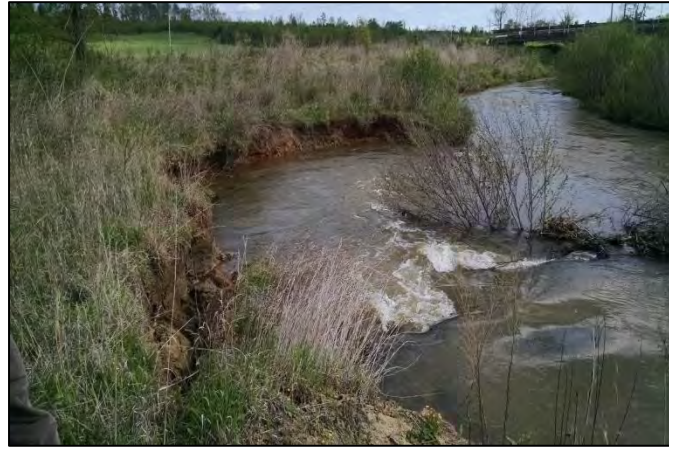
Area of bank erosion prior to implementation of maintenance work in November 2015.

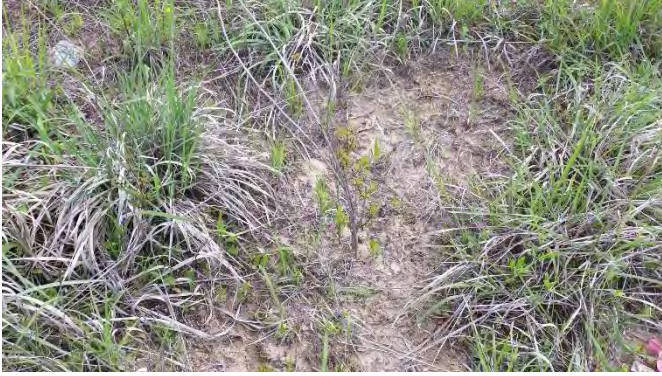
VPA1-2 was noted in the Year 3 visual assessment as including Trumpet Vine (*Campsis radicans*). During the Year 4 assessment Trumpet Vine was noted, but the size of the VPA had reduced in size. This VPA is caused by persistence of invasive species following treatment.

VPA1-2 – Trumpet vine persisting after treatment

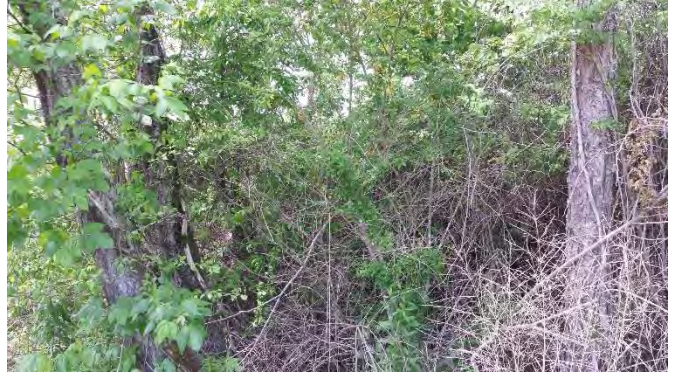
VPA1-3 – Multiflora Rose and Chinese Privet

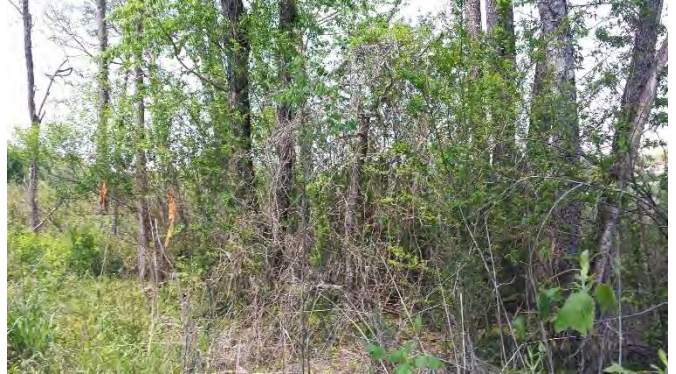
VPA1-5 was noted in the Year 3 visual assessment as including Kudzu (*Pueraria lobata*), Multiflora Rose (*Rosa multiflora*), and Chinese Privet (*Ligustrum sinense*). During the Year 4 visual assessment, Chinese Privet continued to persist around a patch of trees after treatment. The size of the invasive area has been reduced dramatically. This is either due to successful treatment of the invasives or a misidentification of plant species during previous year's assessments.

VPA1-5 - Chinese Privet

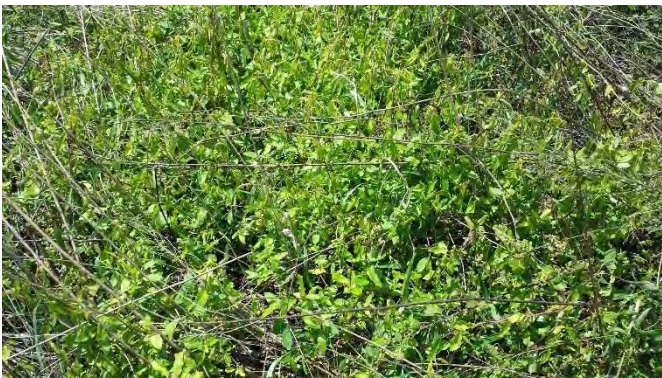
VPA2-1 - Multiflora Rose and Japanese Honeysuckle

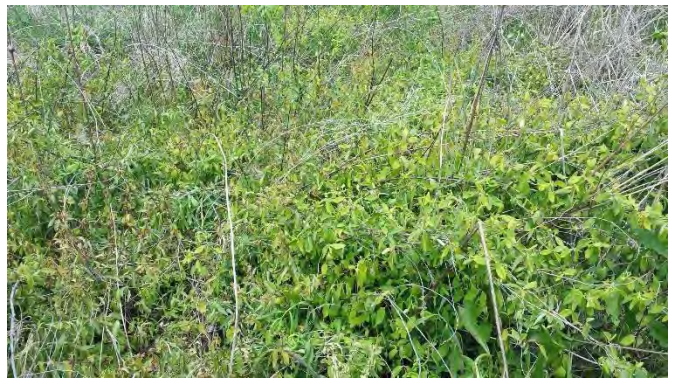
VPA2-3 - Japanese Honeysuckle

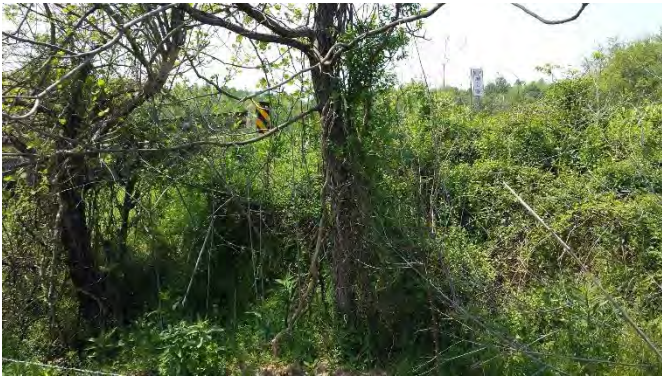
VPA2-4 – Japanese Honeysuckle

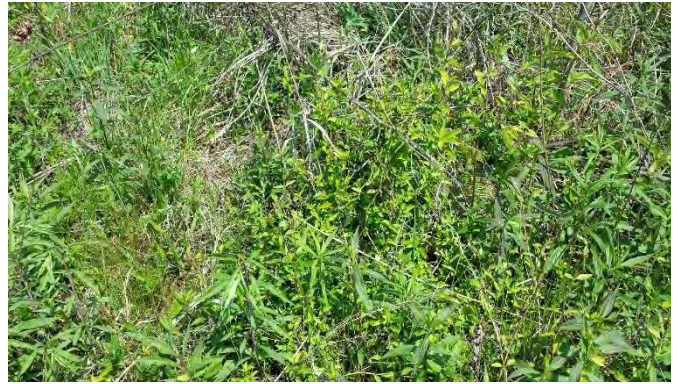
VPA2-6 – Chinese Privet and Japanese Honeysuckle

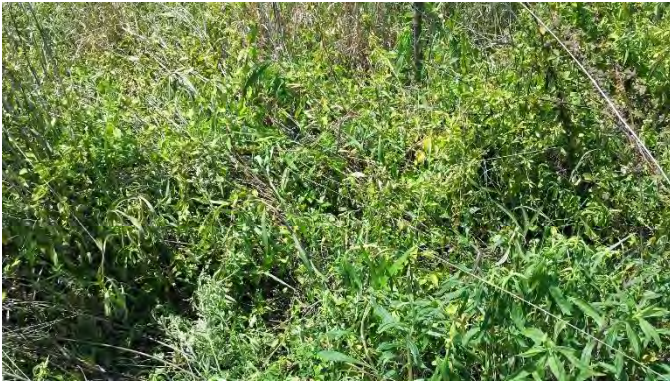
VPA3-2 was noted in the Year 3 visual assessment as including Multiflora Rose. During the Year 4 visual assessment Multiflora Rose and Chinese Privet were noted in this VPA and the size of the invasive area was noted smaller. Both Multiflora Rose and Chinese Privet have mostly likely persisted after treatment. The reduction in the size of the VPA could be attributed to successful invasive treatment or misidentification of invasive species in previous years.

VPA3-2 – Japanese Honeysuckle and sparse areas of Multiflora Rose

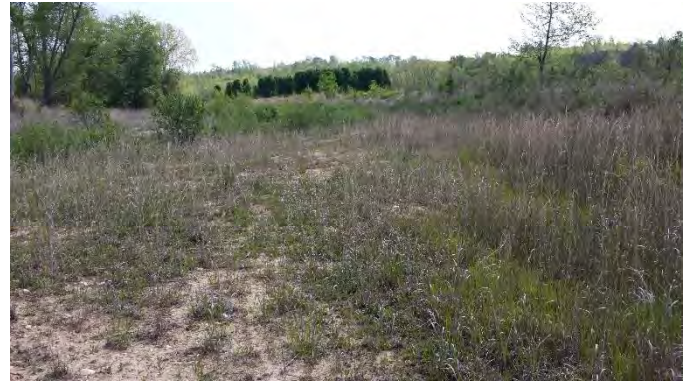
VPA 4-1 identified during the Year 4 visual assessment only included an area of sparse herbaceous cover. No new large areas of invasive species were noted during this assessment. This problem area only accounts for 0.11 acres or 0.8% of the planted acreage. It is unclear why this area exists. However, it may be present because of poor soil conditions in the area or high overbank flooding is carrying away seed sources.

VPA4-1 – Sparse herbaceous cover in right floodplain

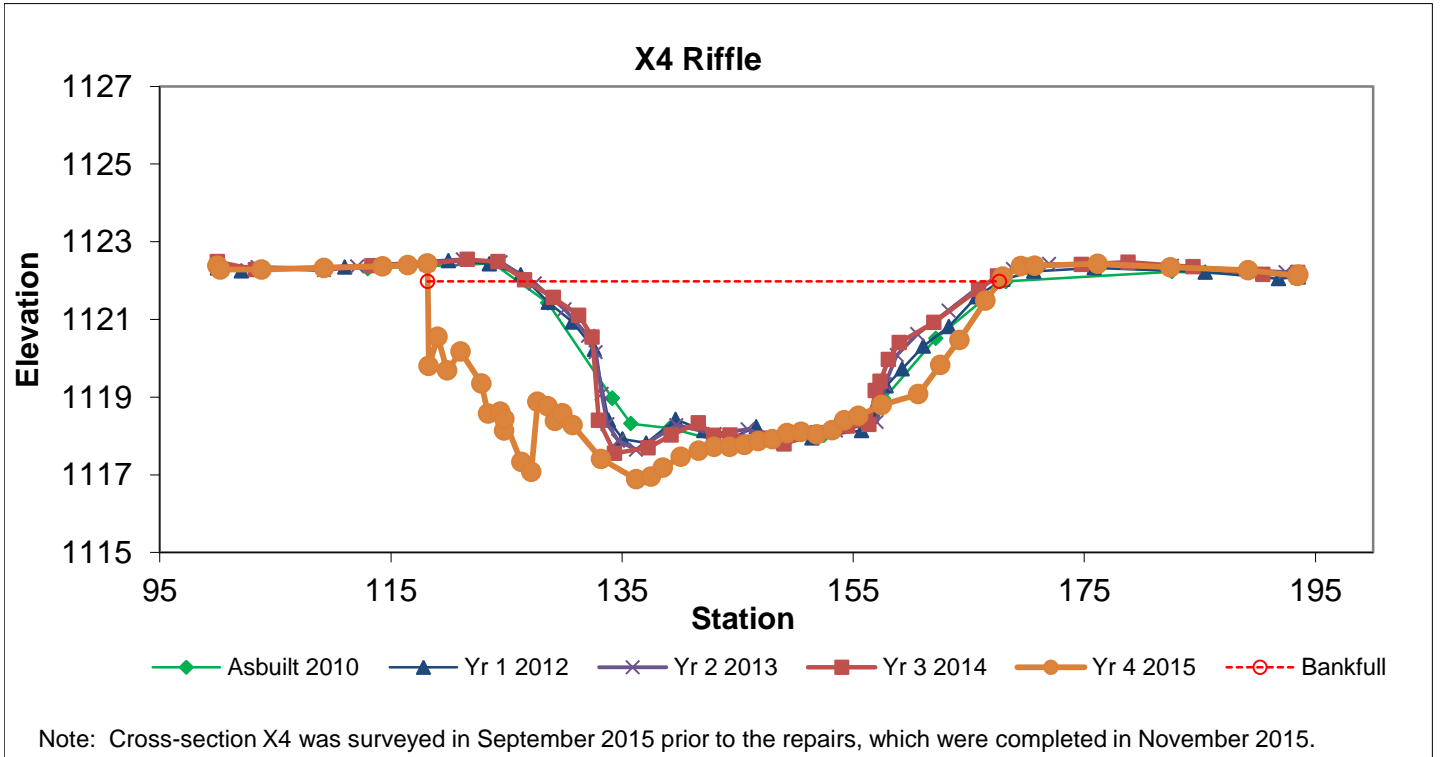
## Permanent Cross Section X4

Three of the four permanent cross-sections in Appendix D show that there has been little adjustment to stream dimension throughout the majority of the Project reach since construction. However, cross-section four reveals evidence of lateral bank erosion caused by high volume and velocity stream flows being directed around the beaver dam located upstream of the Sain Road bridge. This blockage resulted in approximately 60 linear feet of damage to the left bank of S. Muddy Creek in April 2015.

While the riffle material along cross-section X4 has coarsened up considerably in Year 4 to conditions that are more similar to the as-built sample, the profile downstream of cross-section X4 depicts the pools are filling with sediment. This is most likely caused from large storm events moving a high influx of sediment through the system as result of the previously mentioned area of lateral erosion. Therefore, subsequent monitoring during Year 5 should provide a better assessment as to whether or not the channel bed is aggrading.
