# South Muddy Creek Stream Restoration Project Year 5 Monitoring Report

**McDowell County, North Carolina**

**NCDMS Project Number – 737**

# **Site Assessment Report – Monitoring Year 5**

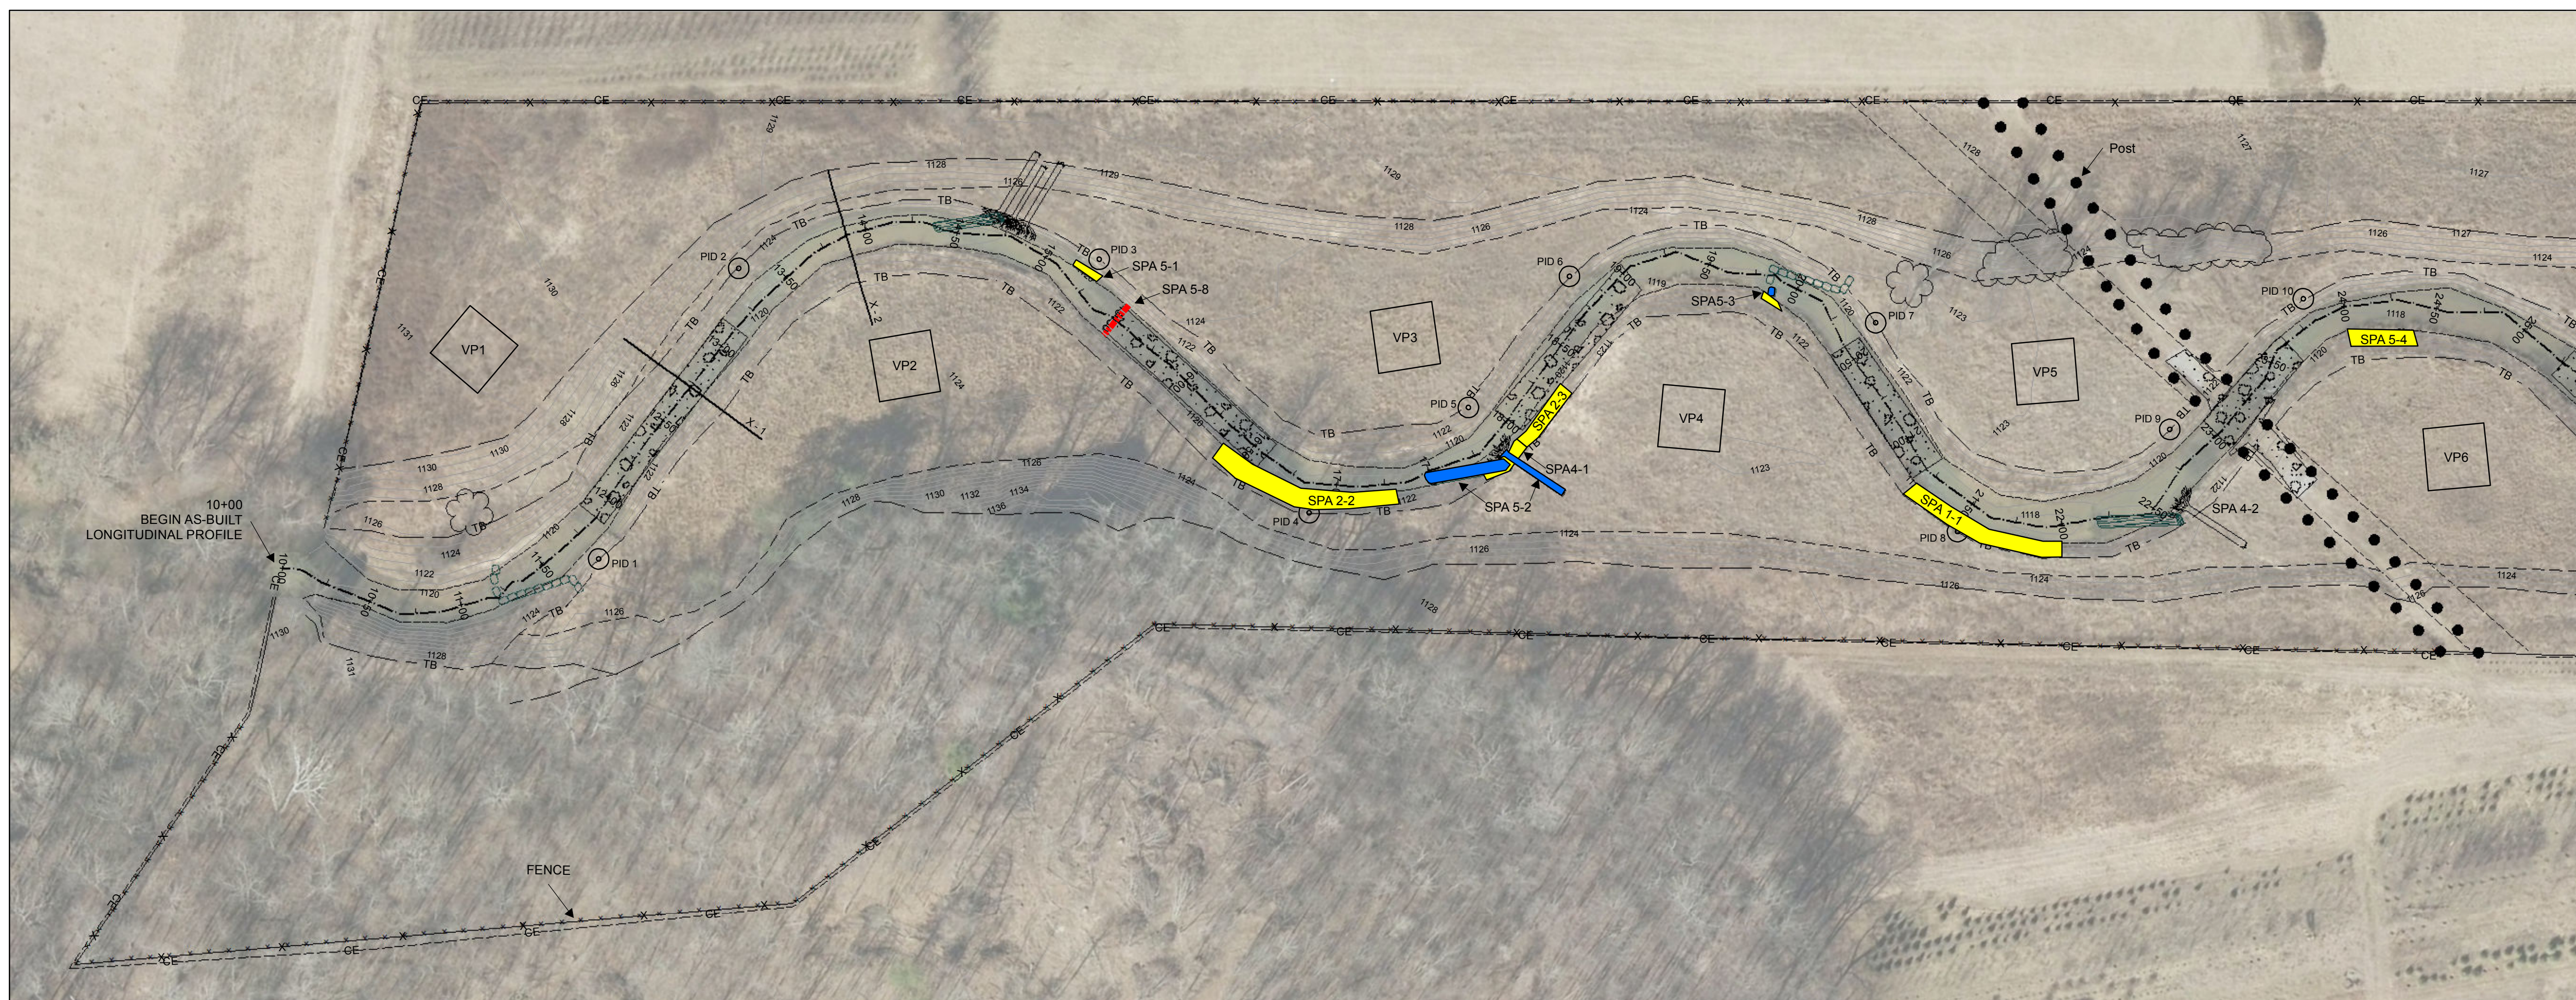
## SOUTH MUDDY CREEK CURRENT CONDITION PLAN VIEW YEAR 5 MONITORING STA. 10+00 - 25+00

SPA1-1 consists of a portion of undermined brush mattress along the right bank in an outer meander bend that has resulted in bank erosion with the potential for bank slump. The length of undercut and eroded bank along SPA1-1 is currently active and migrating downstream. The current length of scour and active erosion is approximately 110 LF, where as it was documented as 80 LF in Year 4. It is likely that lateral instability along this outer meander bend will continue migrating downstream, over time, and potentially lead to downstream structure failure.

SPA2-3 consists of an area of localized scour along the right bank located downstream of an outer meander bend between station 17+95 and 18+50. Bank scour could potentially be a result of the lack of centering of the thalweg immediately downstream of the upstream meander bend (and was noted accordingly in Table 5a). As a result, some velocity vectors within the riffle have been redirected toward the right bank instead of being centered in the riffle, thereby increasing near bank stress and causing the bank to erode. The bank is vertical, exposed, devoid of vegetation and matted protection.

SPA4-1 is a localized area of bank erosion behind a rootwad on the right bank. The erosion is likely caused by overbank flows scouring the area behind the rootwad. Erosion in this area has migrated upstream and caused separation of the root wad and log sill from the bank tie-in. Structure failure of the rootwad and log sill have occurred and are discussed in SPA5-2.

SPA4-2 is a localized area of bank erosion behind a rootwad on the right bank. The erosion appears to be caused by overbank flows scouring the area behind the rootwad. However, because of the uniform nature of the problem and the historic presence of beavers within the area, this SPA is likely a relic beaver den. The rootwad is still functioning as bank protection. Filling the void and mounding behind the rootwad would remedy the issue.

SPA5-1 is a small area of localized bank scour located on the left bank, downstream of a log sill / rootwad complex at the end of the meander bend. Upon review of the area, no distinct cause for the scour could be determined; however, due to its location along the bend, it has a potential to negatively impact the integrity of upstream structures if the area does not re-stabilize.

As previously discussed, scour from SPA4-1 has led to structure failure of both the rootwad and the log sill at SPA5-2. The root wad is no longer functioning and has separated from bank; however, it still seems to be tied into the bank. The log sill has separated completely from the bank and is now resting entirely upon the bed of the channel.

SPA5-3 is located on the right bank just downstream of rock j-hook boulder tie-in. Scour in this area has caused the boulder/bank tie-in to be breached. Currently flow velocities are skirting around the tie-in boulder and are directed toward the bank instead of flowing over the structure.

SPA5-4 is a localized scour pocket located on the inside of the meander bend at Station 24+00 to 24+35. Erosion in the area has resulted in the loss of woody vegetation into the stream. Though the area is actively eroding, no direct cause could be determined.

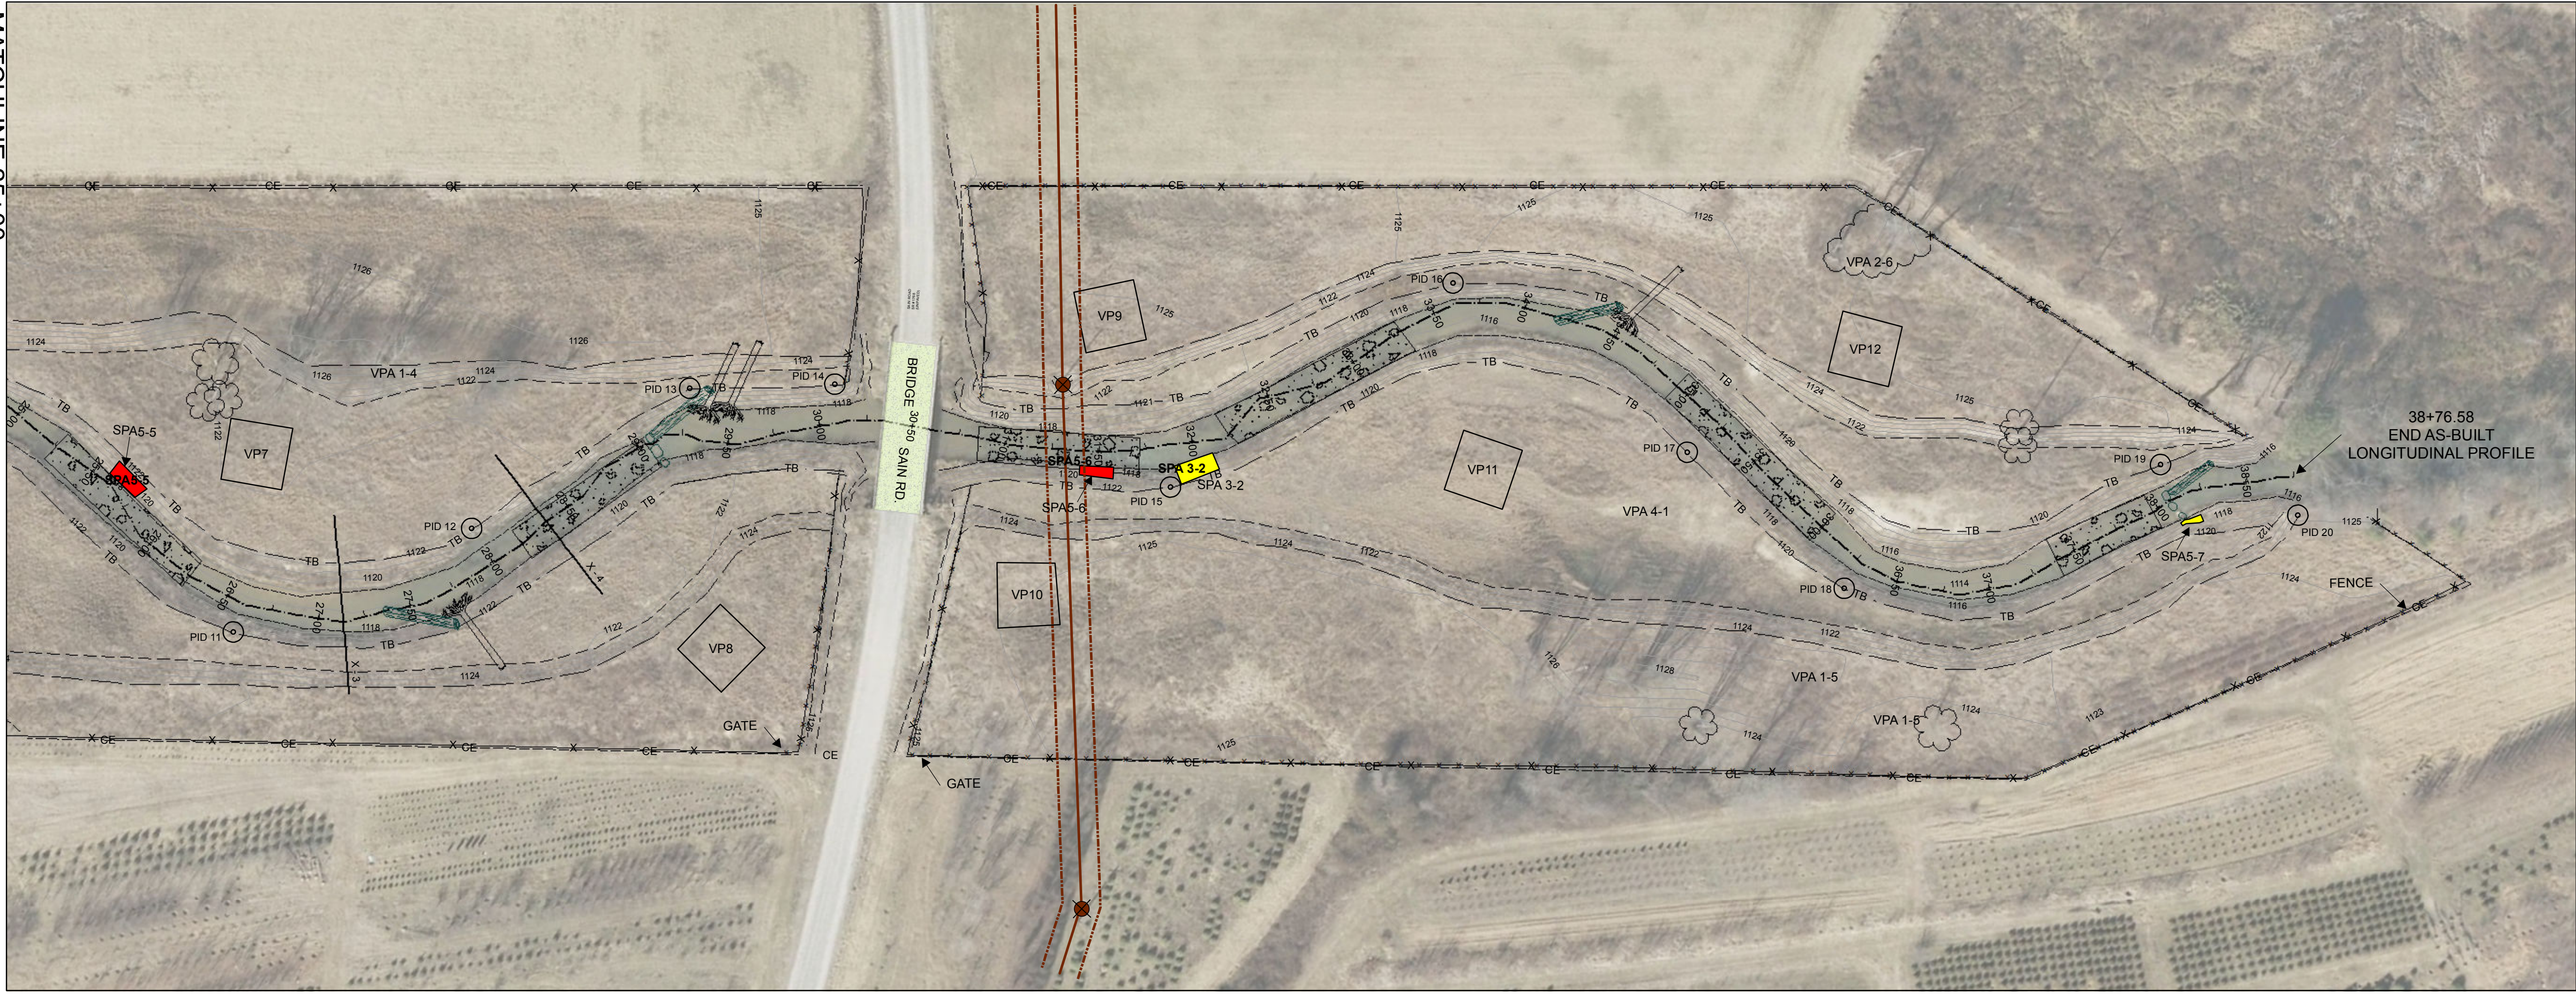
**SOUTH MUDDY CREEK  
CURRENT CONDITION PLAN VIEW  
YEAR 5 MONITORING  
STA. 25+00 - 38+77**

SPA5-6 consists of bank slump on right bank along riffle downstream of Sain Rd. Bridge. Cause is likely due to high water velocities created by steep riffle just downstream of bridge, as well as, the lack of vegetation along the bank and poor soil compaction.

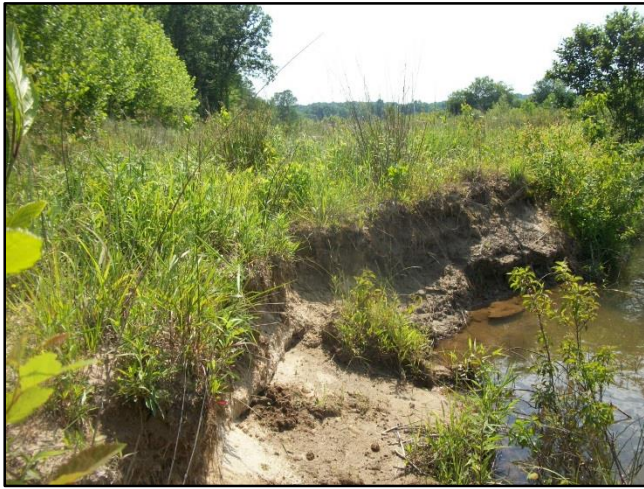
SPA1-1 – Right bank scour is migrating downstream along the outer meander bend (5-25-16).

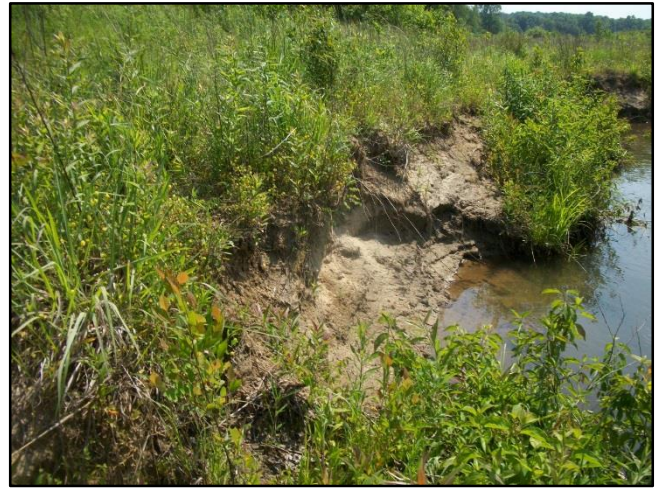
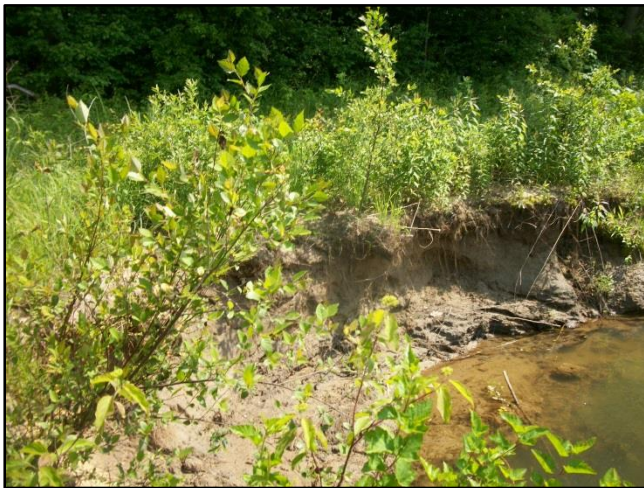
SPA2-2 – Right bank scour is migrating upstream from the outer meander bend up the tail of the upstream riffle. The downstream section of the meander bend seems to be slowly stabilizing with native vegetation (5-25-16).

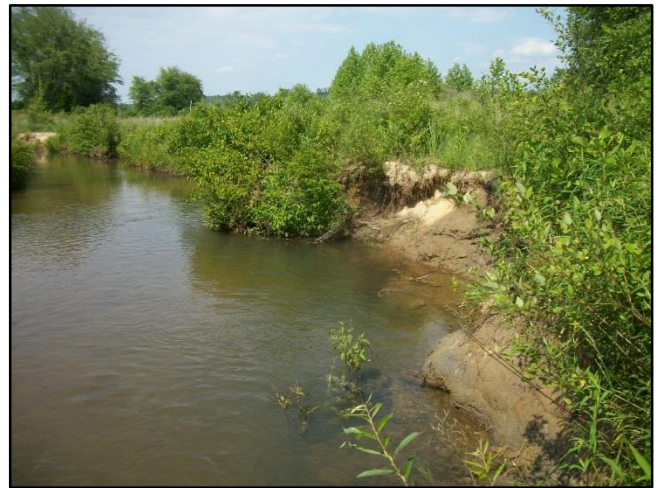
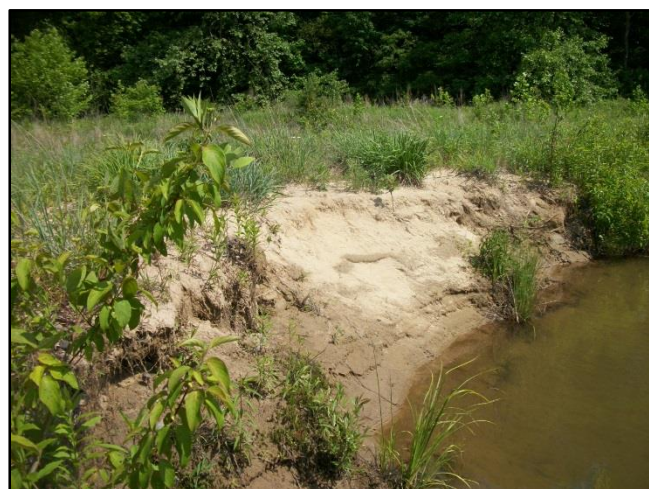
| South Muddy Creek (2,787 LF) | | | |
|--|---|--|---|
| | 17+95 to 18+50 | Localized scour along the right bank of a riffle resulting in raw, vertical bank, devoid of vegetation and matted protection. Appears to be caused by high near bank stress and poorly compacted soil. Vegetation and rootmass along that portion of bank is sparse. | SPA2-3 |

SPA2-3 – Localized scour along right bank along riffle from the lack of thalweg re-centering (5-25-16).

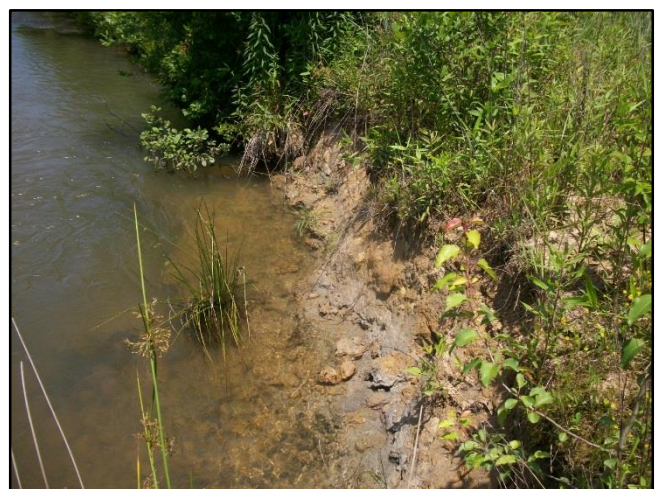
| South Muddy Creek (2,787 LF) | | | |
|--|---|--|---|
| | 31+90 to 32+10 | Localized scour along right bank downstream of Sain Rd. Bridge. Cause is due to high water velocities created by steep riffle just downstream of bridge. | SPA3-2 |

SPA3-2 – Localized scour along right bank downstream of Sain Rd. Bridge (5-25-26).

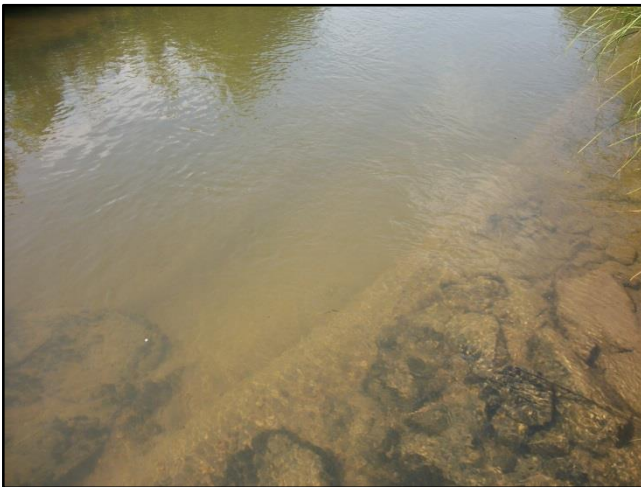
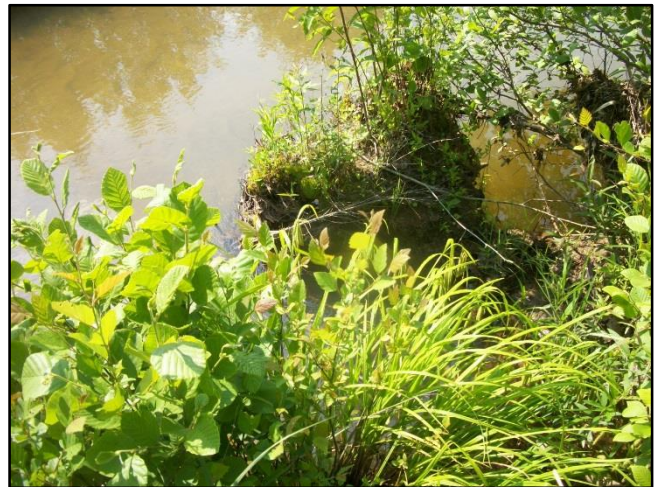
| South Muddy Creek (2,787 LF) | | | |
|--|---|--|---|
| Engineered Structures - Log Sill & Rootwad Failure | 17+75 to 17+95 | Scour from SPA4-1 has led to structure failure of both the rootwad and the log sill. The root wad is no longer functioning and has separated from bank; however, it still seems to be tied into the bank. The log sill has separated completely from the bank and is now resting entirely upon the bed of the channel. | SPA5-2 |

SPA5-2 – Scour from SPA4-1 has led to structure failure of both the rootwad and the log sill. The root wad is no longer functioning and has separated from bank; however, it still seems to be tied into the bank. The log sill has separated completely from the bank and is now resting entirely upon the bed of the channel (5-26-16).

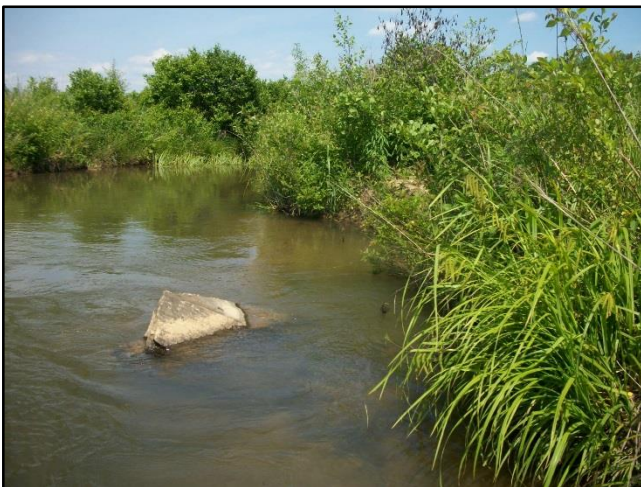
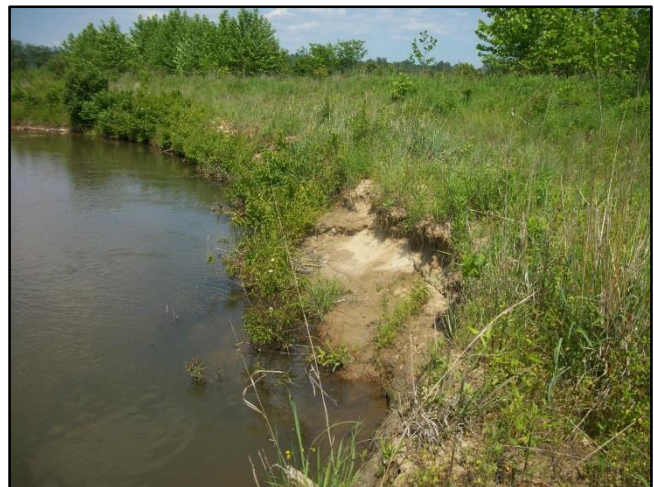
| South Muddy Creek (2,787 LF) | | | |
|--|---|--|---|
| Bank Scour and Engineered Structures - Rock J-Hook | 19+80 to 19+95 | Scour pocket on right bank just downstream of rock j-hook boulder tie-in has caused the boulder/bank tie-in to be breached. | SPA5-3 |

SPA 5-3 – Scour pocket on right bank just downstream of rock j-hook boulder tie-in has caused the boulder/bank tie-in to be breached (5-25-16)

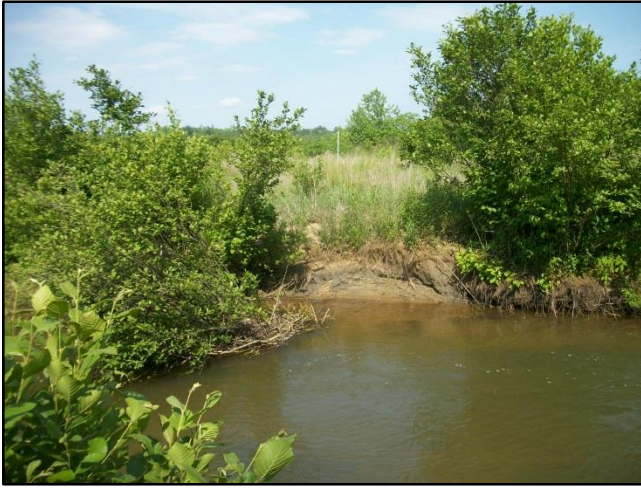
SPA 5-4 – Scour pocket causing a loss of stream bank vegetation on the right bank along the inside of the meander bend (5-25-16)

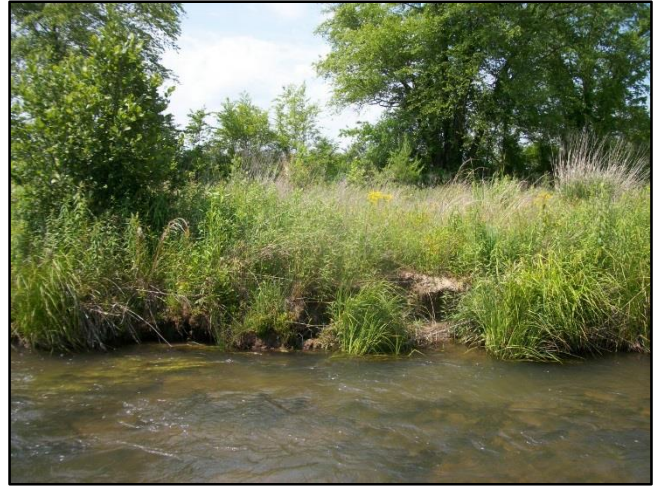
SPA 5-5 – Scour and bank slumping along left bank (5-25-16)

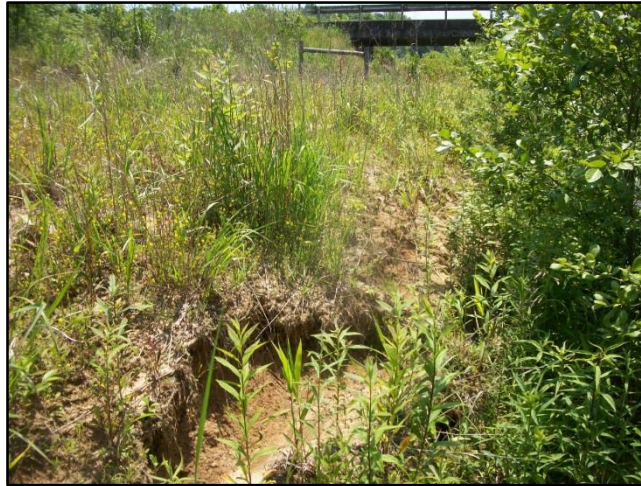
SPA 5-6 – Scour and bank slumping along right bank downstream of Sain Rd. Bridge (5-25-16).

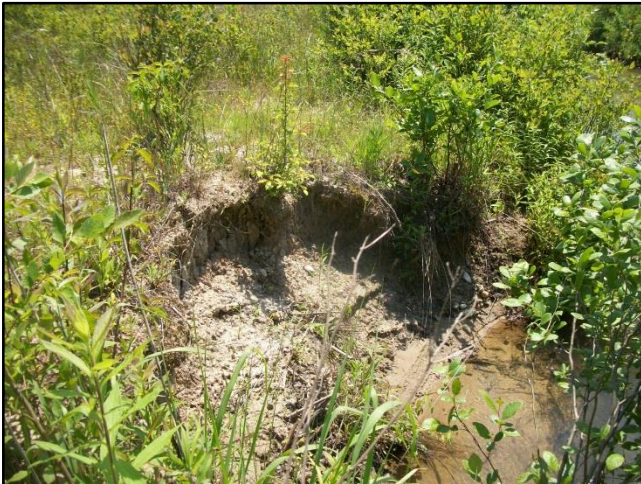
SPA5-7 consists of localized bank scour on right bank just downstream of a remnant beaver dam and the bank tie-in of rock J-hook. Cause unknown, but likely due to flow velocities being shifted towards right bank due to persisting debris along left bank from remnant beaver dam. Currently the boulder tie-in of the J-hook is not compromised.

SPA 5-7 – Scour on right bank just downstream of SPA 4-5, a remnant beaver dam (5-25-16)

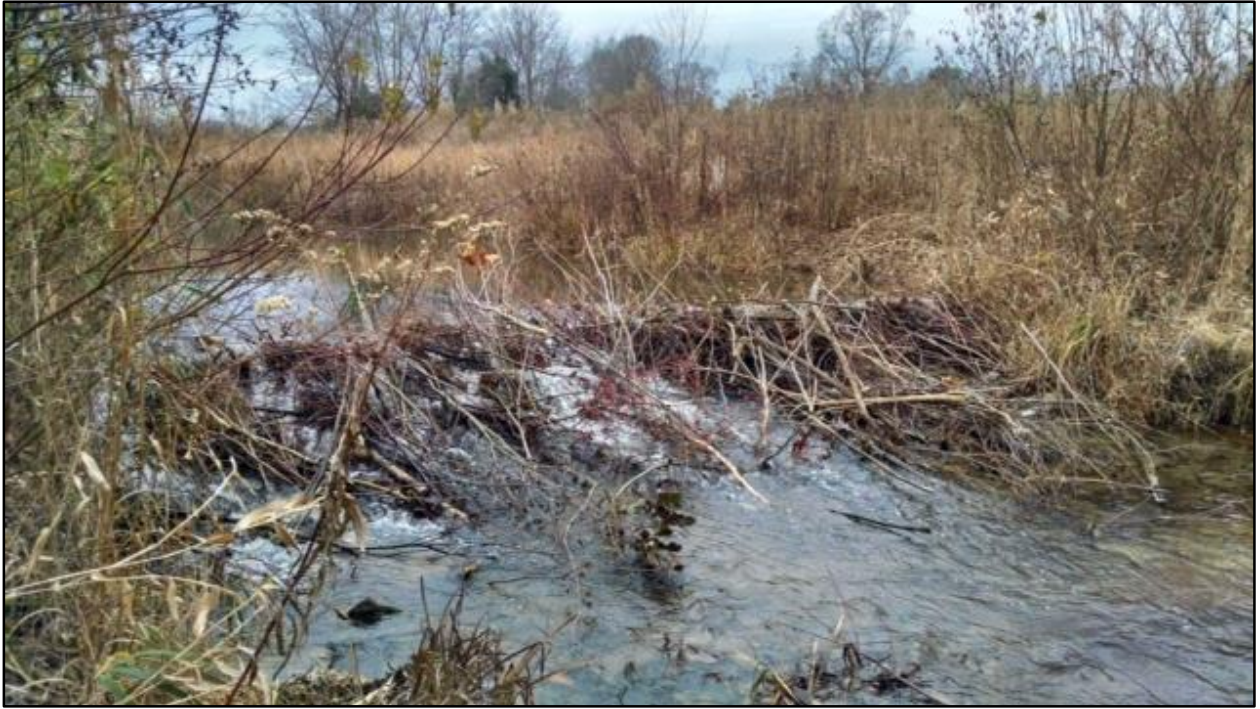
SPA 5-8 – Beaver dam located approximately at Station 15+50 (11-28-16)

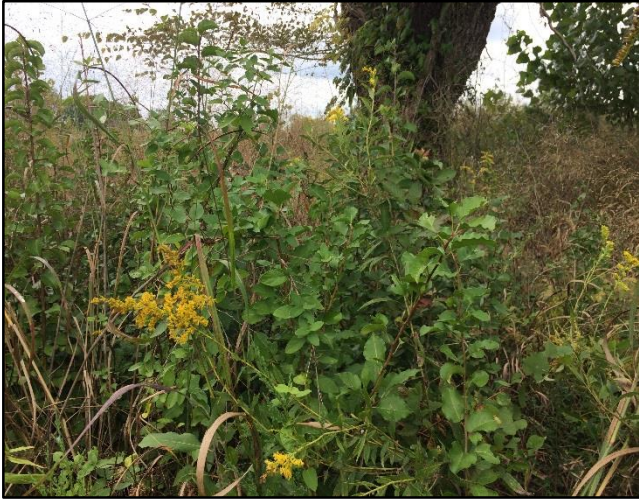
Isolated areas of *Pyrus calleryana* (Bradford pear) trees

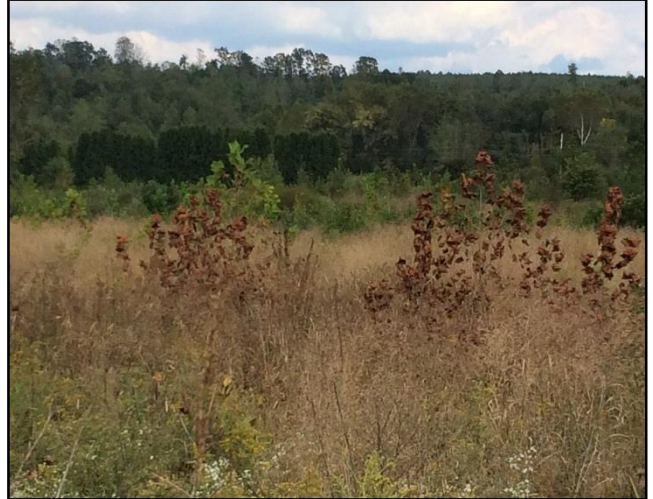
Herbicide spray evidence from utility easement

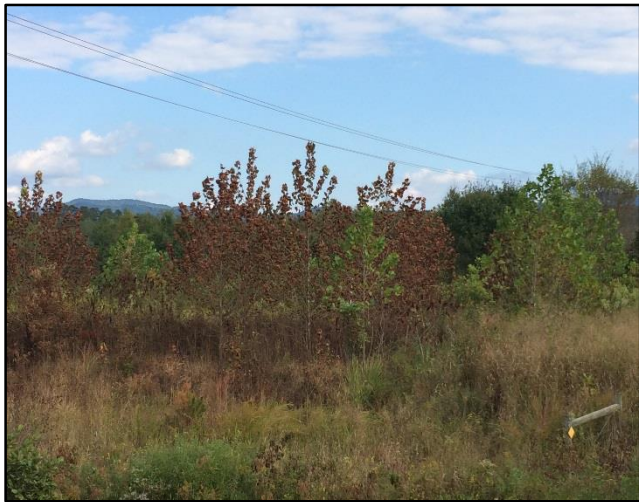
Herbicide spray evidence under utility line
