# **MUDDY RUN STREAM RESTORATION PROJECT**

## **MONITORING REPORT**

### **MONITORING YEAR 1**

DUPLIN COUNTY, NORTH CAROLINA, PROJECT # 95018

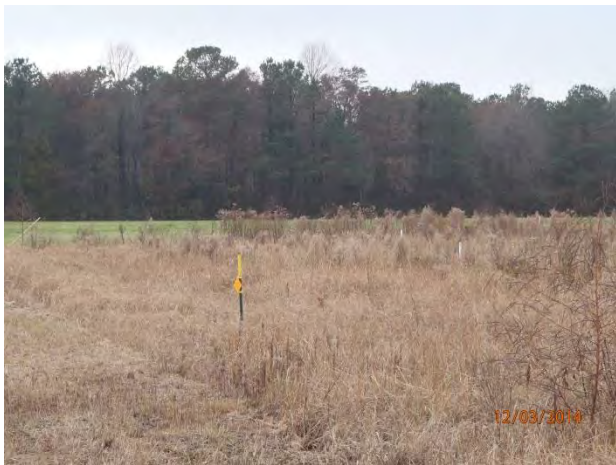
VP3- Missing outside rows of trees at Sta 2+00 – 10+00 (11/11/2014)

| <b>Feature Category</b> | <b>Station Numbers</b> | <b>Suspected Cause</b> | <b>Photo Number</b> |
|---|---|--|---|
| <b>Missing outside rows of trees</b> | Sta 2+00 - 10+100 | Improper planting due to damaged easement signage during construction. Recommend planting approximately 200 trees in two rows on outer edge of easement. | VP3 |
