MUDDY RUN STREAM RESTORATION PROJECT

MONITORING REPORT

MONITORING YEAR 2

DUPLIN COUNTY, NORTH CAROLINA, PROJECT # 95018

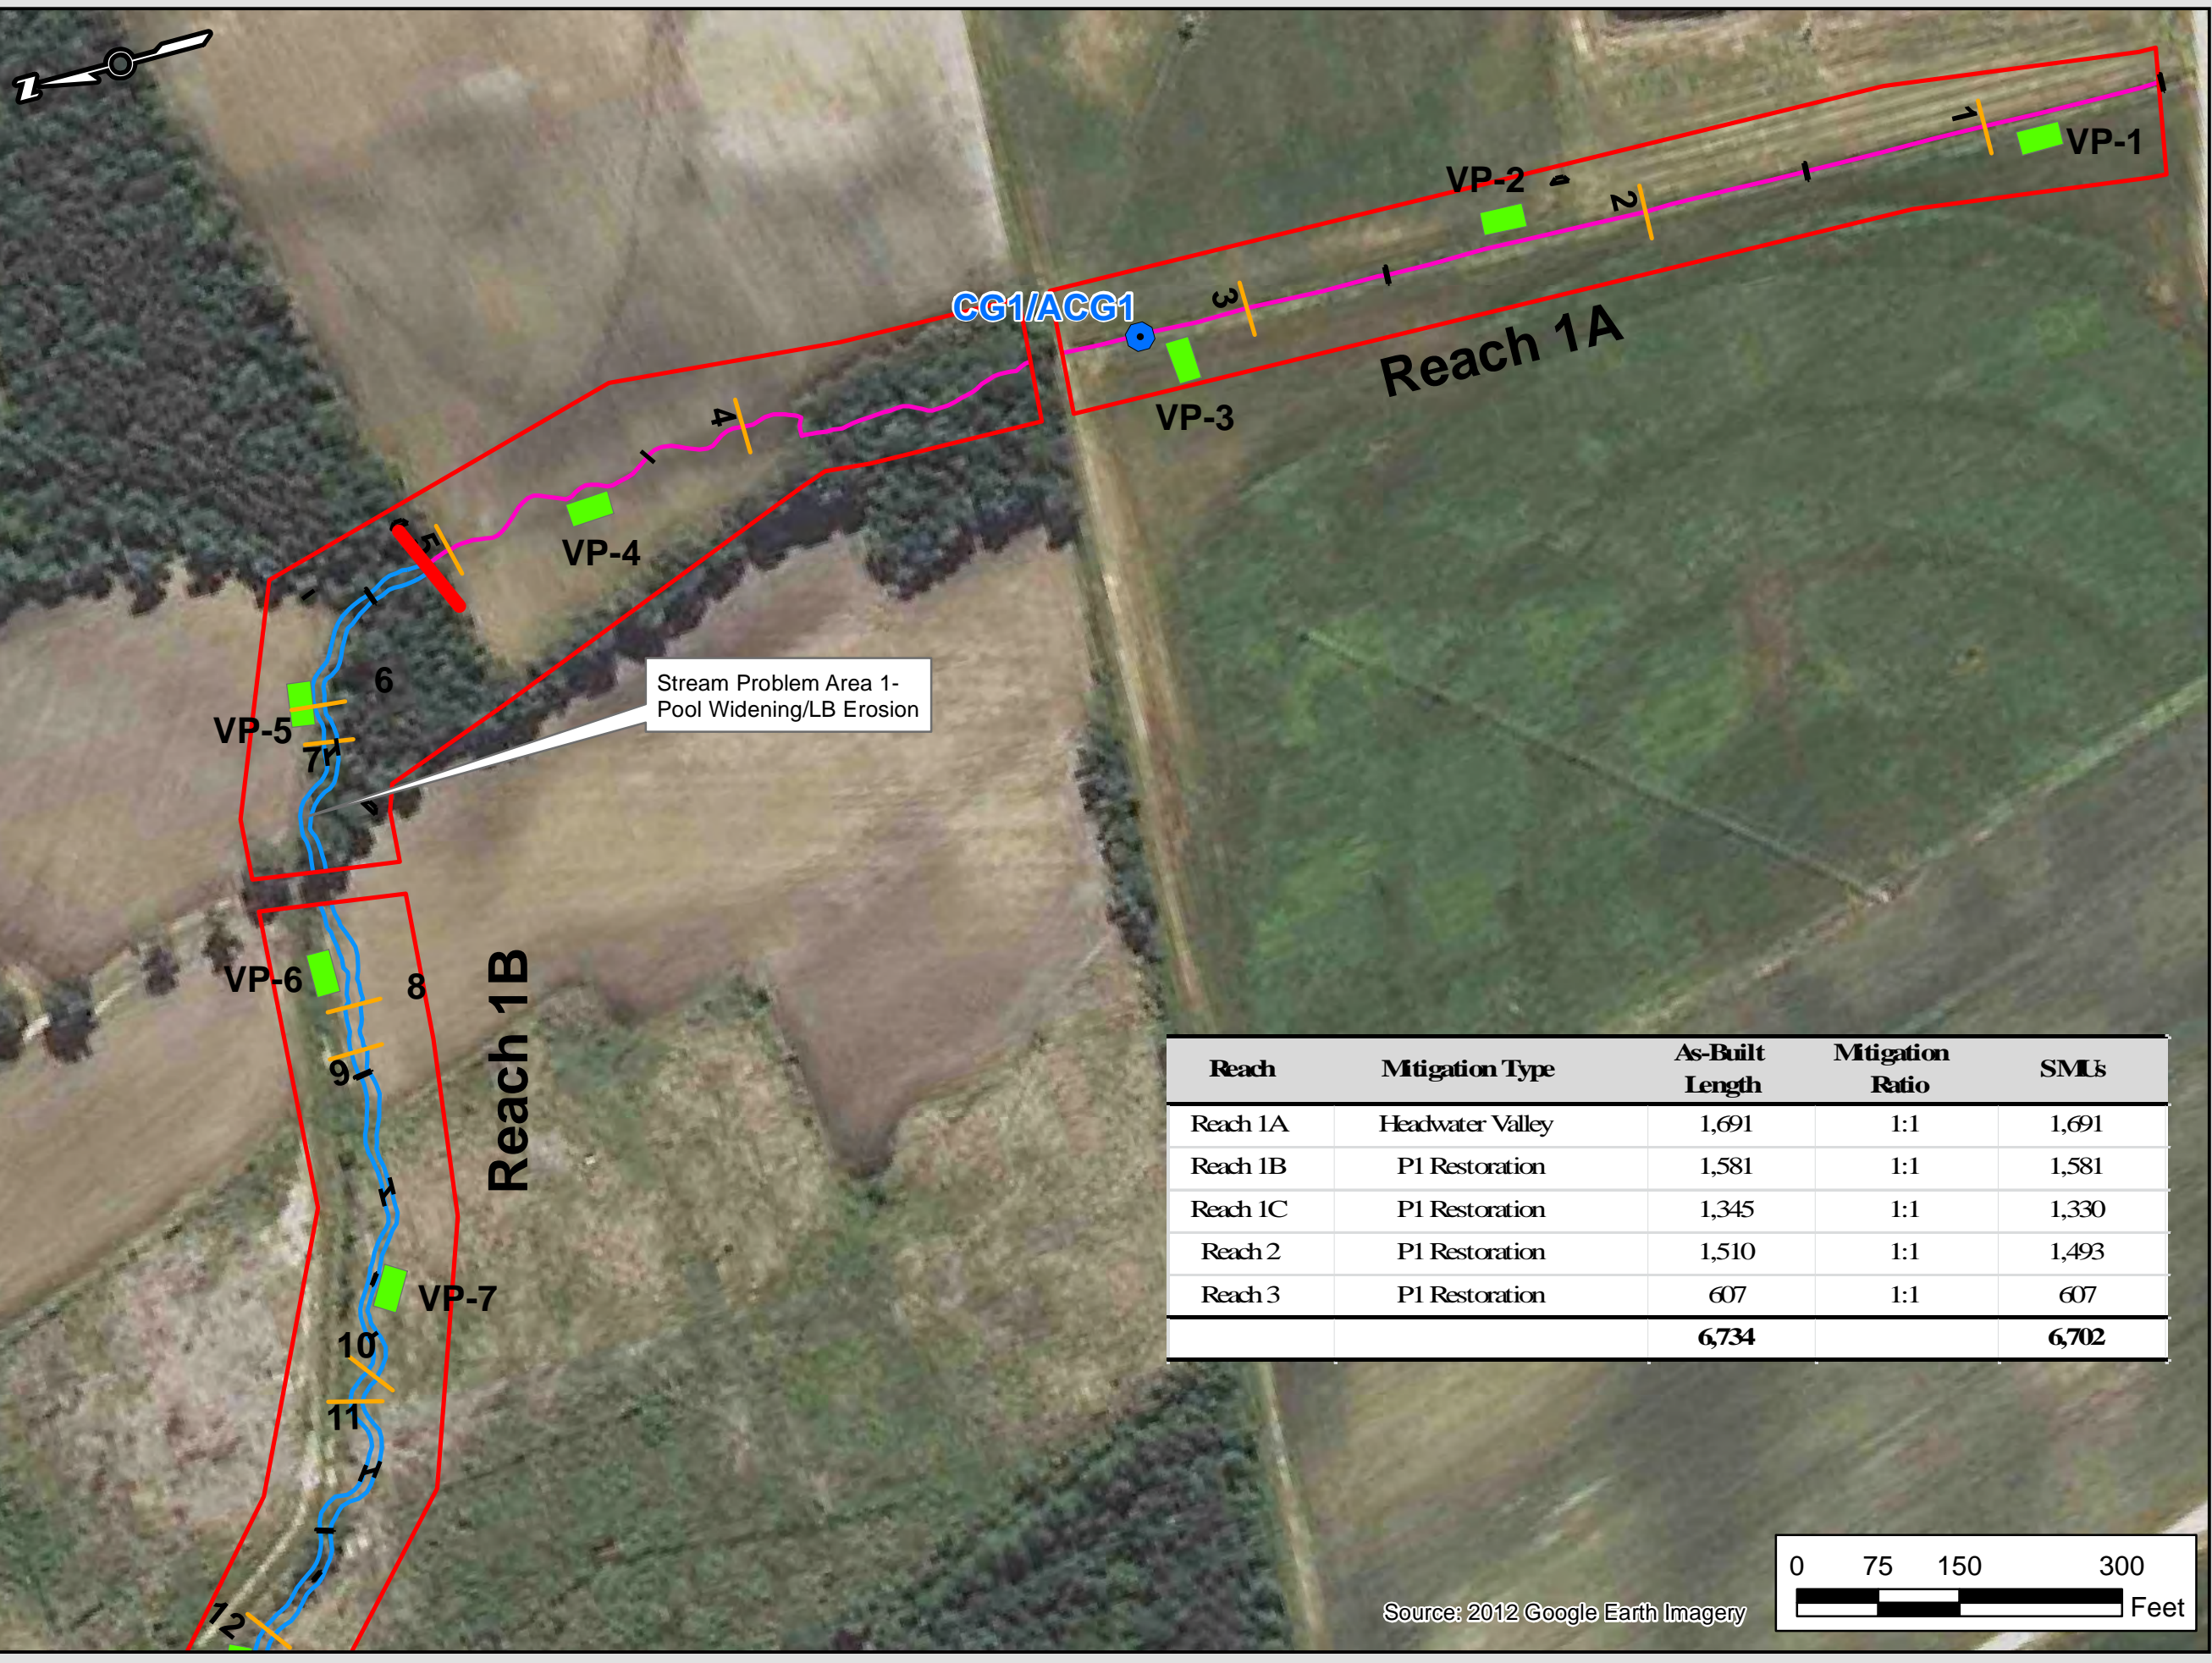
Figure 3a.
Muddy Run Mitigation Site
Current Conditions Map
Duplin County, NC

No major stream areas of concern were noted during the Year 2 monitoring period. Two areas of minor erosion were observed during Year 2 monitoring and have been mapped on the Current Conditions Plan View (CCPV). Minor erosion areas noted in Year 1 are now vegetated and exhibit no major concerns to the overall stream stability. Planting livestakes along the banks at stream problem area 1 is recommended to prevent future erosion and widening of the stream channel. Stream problem area 2 has not gotten worse in Year 2; however, these issues will continue to be monitored in subsequent years. These issues are described in more detail in **Appendix B**.

No major vegetation problem areas were identified during the Year 2 monitoring period. One minor problem areas was observed and has been mapped on the CCPV. Invasive Chinese privet was observed along a small portion of Reach 1B; continued clearing and stump treatment is recommended for this area in spring 2016. A supplemental planting occurred during April 2015 in two areas within the easement along Reach 2 which were sparsely vegetated and noted in the Year 1 Monitoring Report. These areas are no longer a problem and trees densities are well within the targeted success criteria; however, the invasive treatment area pose no threat to achieving the vegetation success criteria. The Muddy Run Site is on track to meet the Year 3 vegetation survival success criterion of 320 trees per acre as specified in the Mitigation Plan. The Year 2 vegetation issues are described in **Appendix B**.

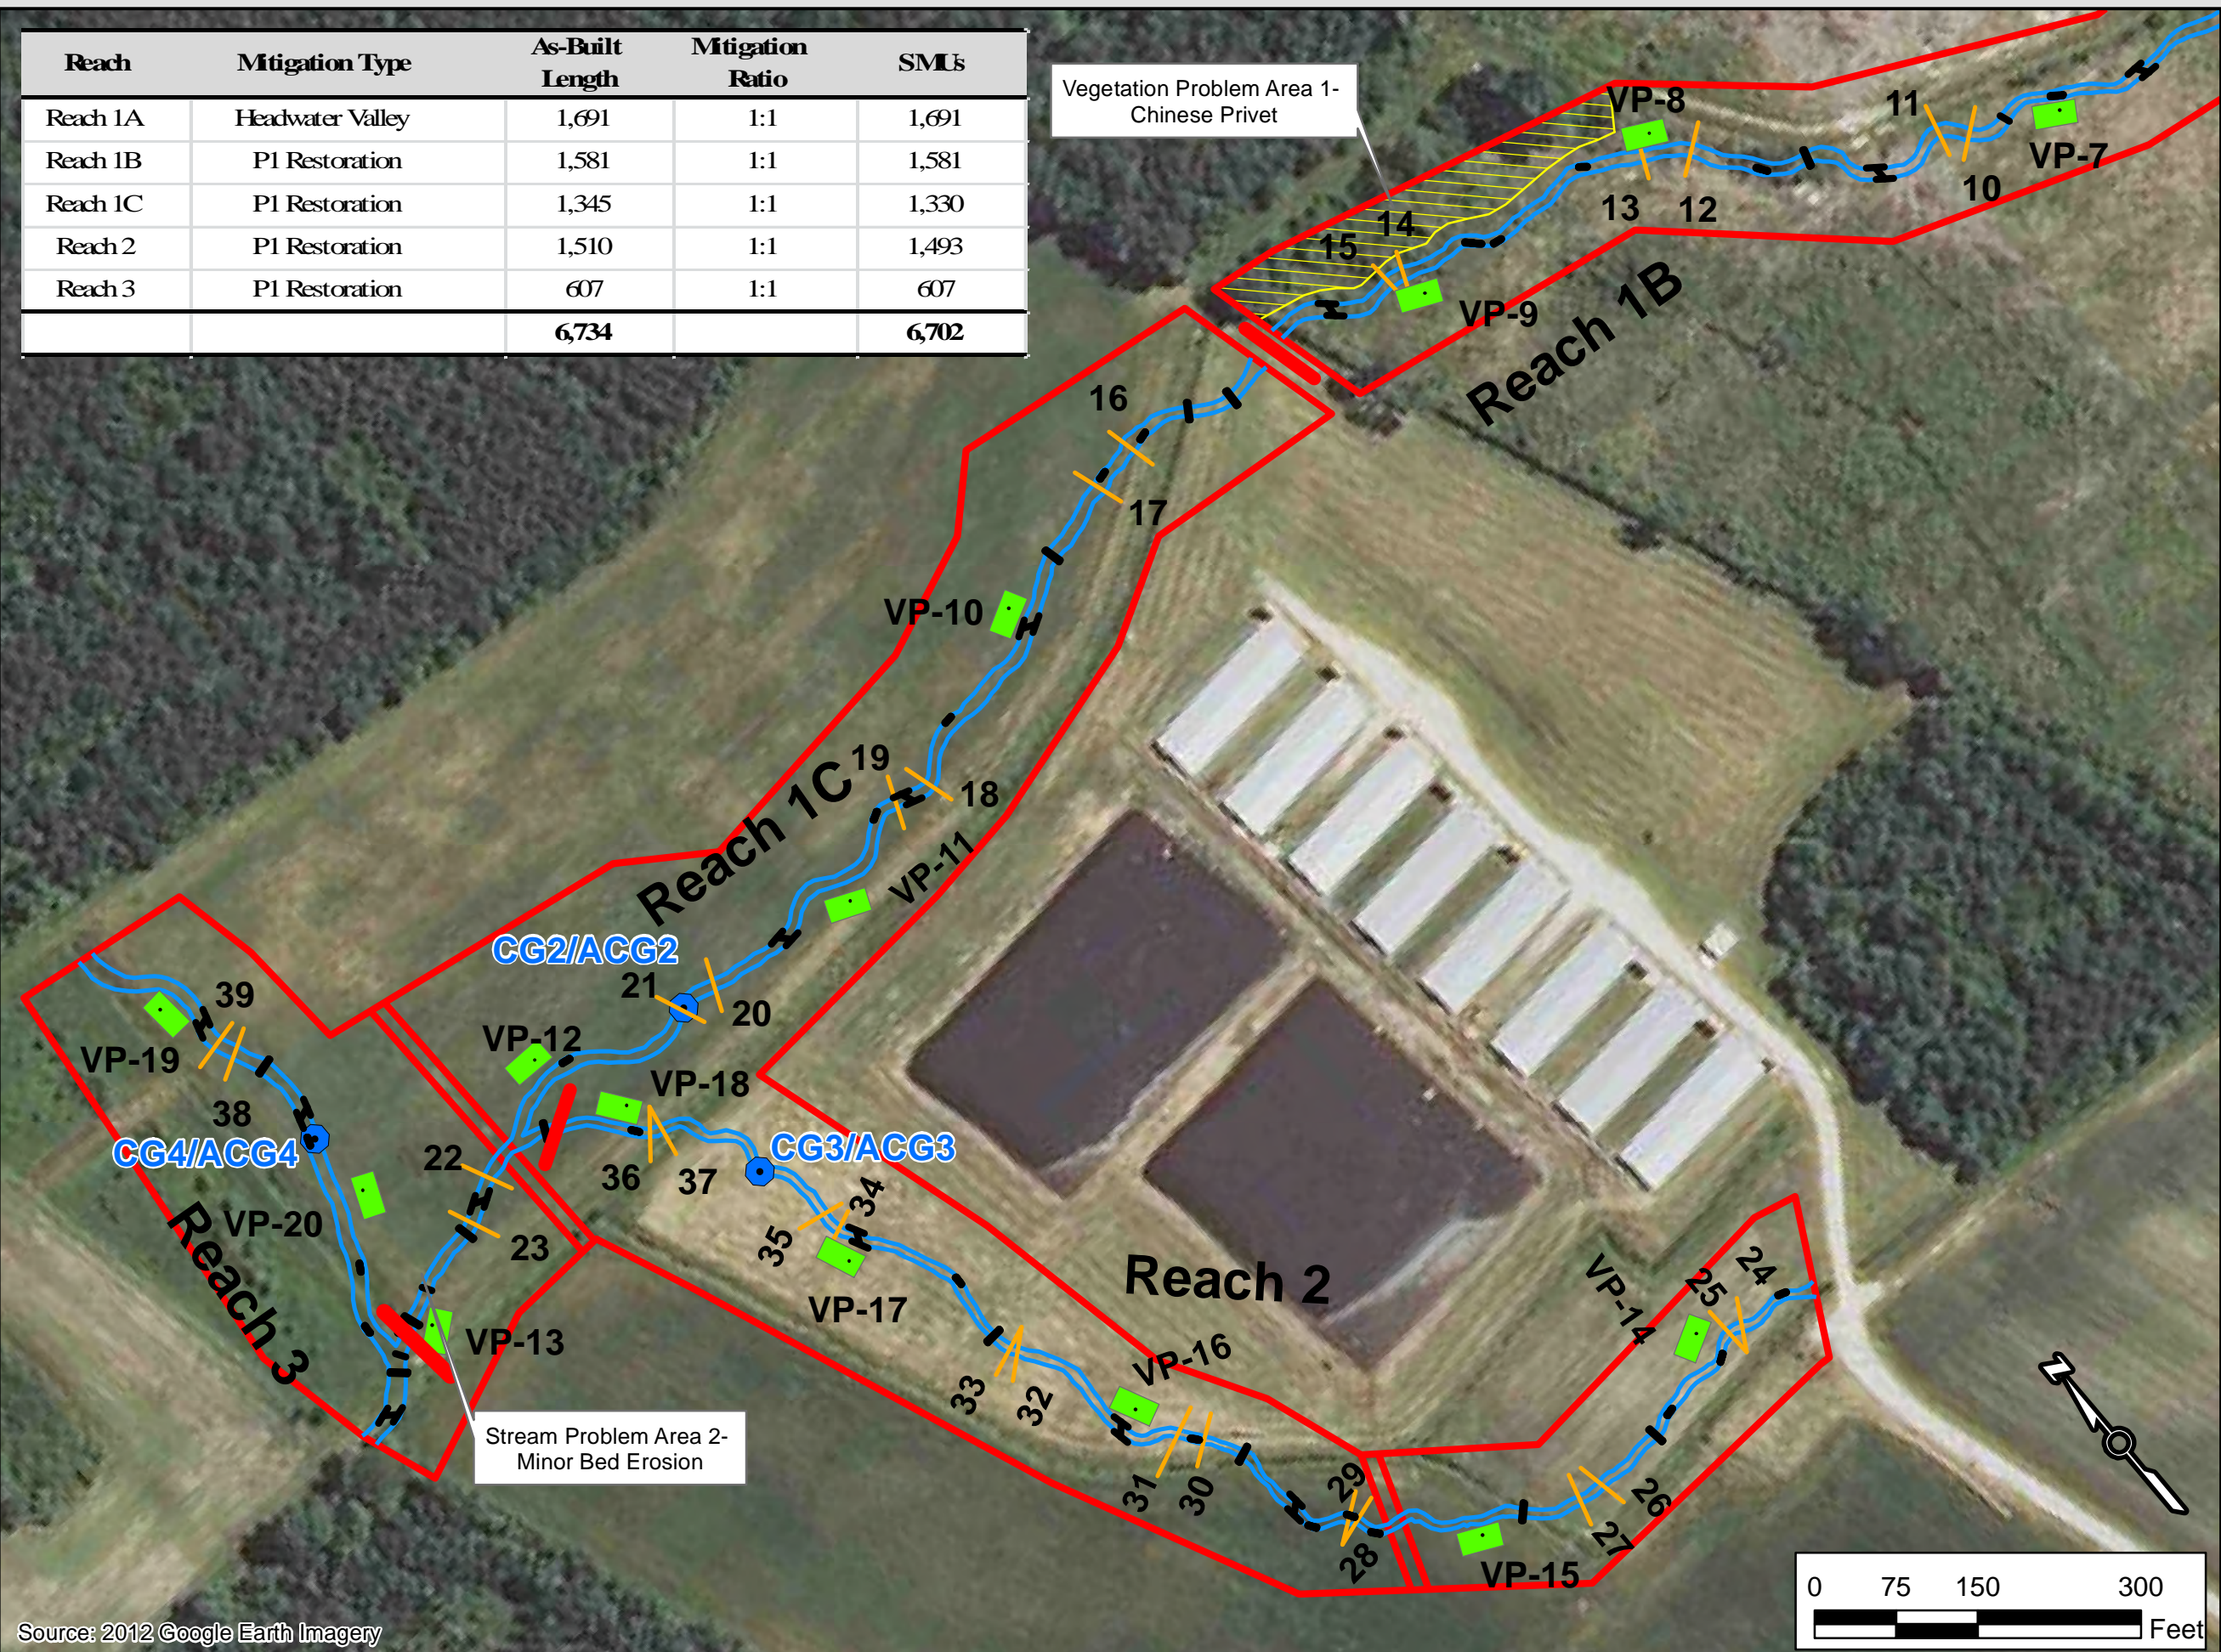
Figure 3b.
Muddy Run Mitigation Site
Current Conditions Map
Duplin County, NC

Table 7. Stream Problem Areas			
Muddy Run Stream Restoration Project - Project # 95018			
Feature Issue	Station # / Range	Suspected Cause	Photo Number
Pool Widening/ LB Erosion	20+90	Channel adjustment- minor erosion on banks; recommend livestaking.	SP1
Minor Bed Erosion	47+15 - 47+40	Log weir is undercut, but bed is stable; recommend monitoring	SP2

Table 8. Vegetation Problem Areas			
Muddy Run Stream Restoration Project - Project # 95018			
Feature Category	Station Numbers	Suspected Cause	Photo Number
Invasive/Exotic Populations	Reach 1B- See Plan View	Ligustrum: encroachment from outside easement. Recommend invasive treatment and removal.	VP1
