**MUDDY RUN STREAM RESTORATION PROJECT
MONITORING REPORT
MONITORING YEAR 3**

DUPLIN COUNTY, NORTH CAROLINA, PROJECT # 95018

December 2016

**Muddy Run
Duplin County, North Carolina
DMS Project ID 95018**

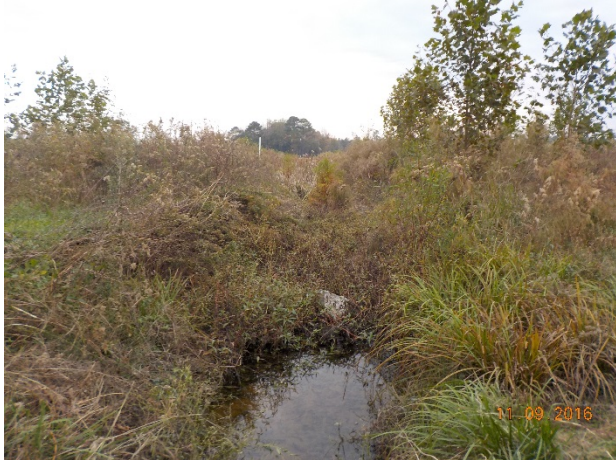
Reach 1A HWV – Looking Downstream - Sta. 1+00 MY3 (11/9/2016)

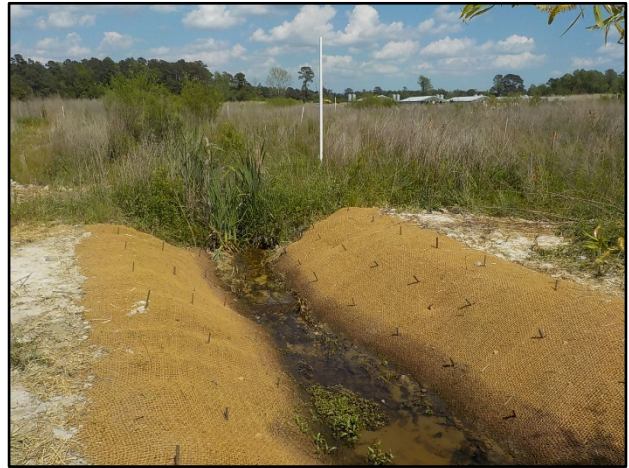
MY2-SP2 Minor Bed Erosion at Sta 47+15 - 47+45. (Repaired in April 2016)

No stream areas of concern were noted during the Year 3 monitoring period. The two areas of minor erosion that were identified during Year 2-2015 monitoring have been addressed with livestakes and matting during April 2016. Photo documentation of the repairs and CCPVs can be found in **Appendix B**.

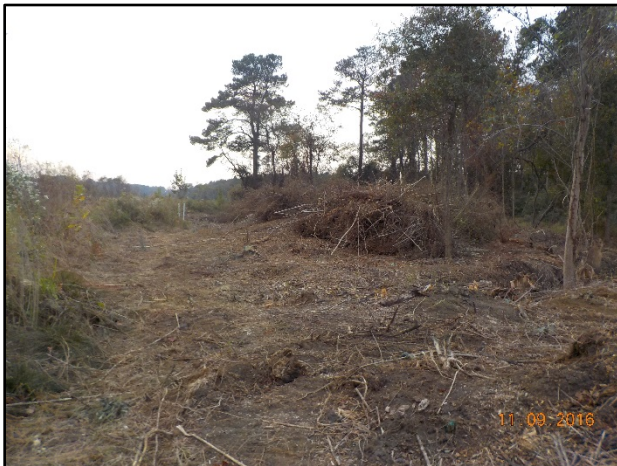
MY2-VP1- Invasive population: *Ligustrum* along Reach 1B (Invasive species control performed in October 2016)
