MUDDY RUN STREAM RESTORATION PROJECT
MONITORING REPORT
MONITORING YEAR 4
FINAL

DUPLIN COUNTY, NORTH CAROLINA
PROJECT NO. 95018

RE: Muddy Run Stream Restoration Site: MY4 Monitoring Report (NCDMS ID 95018)

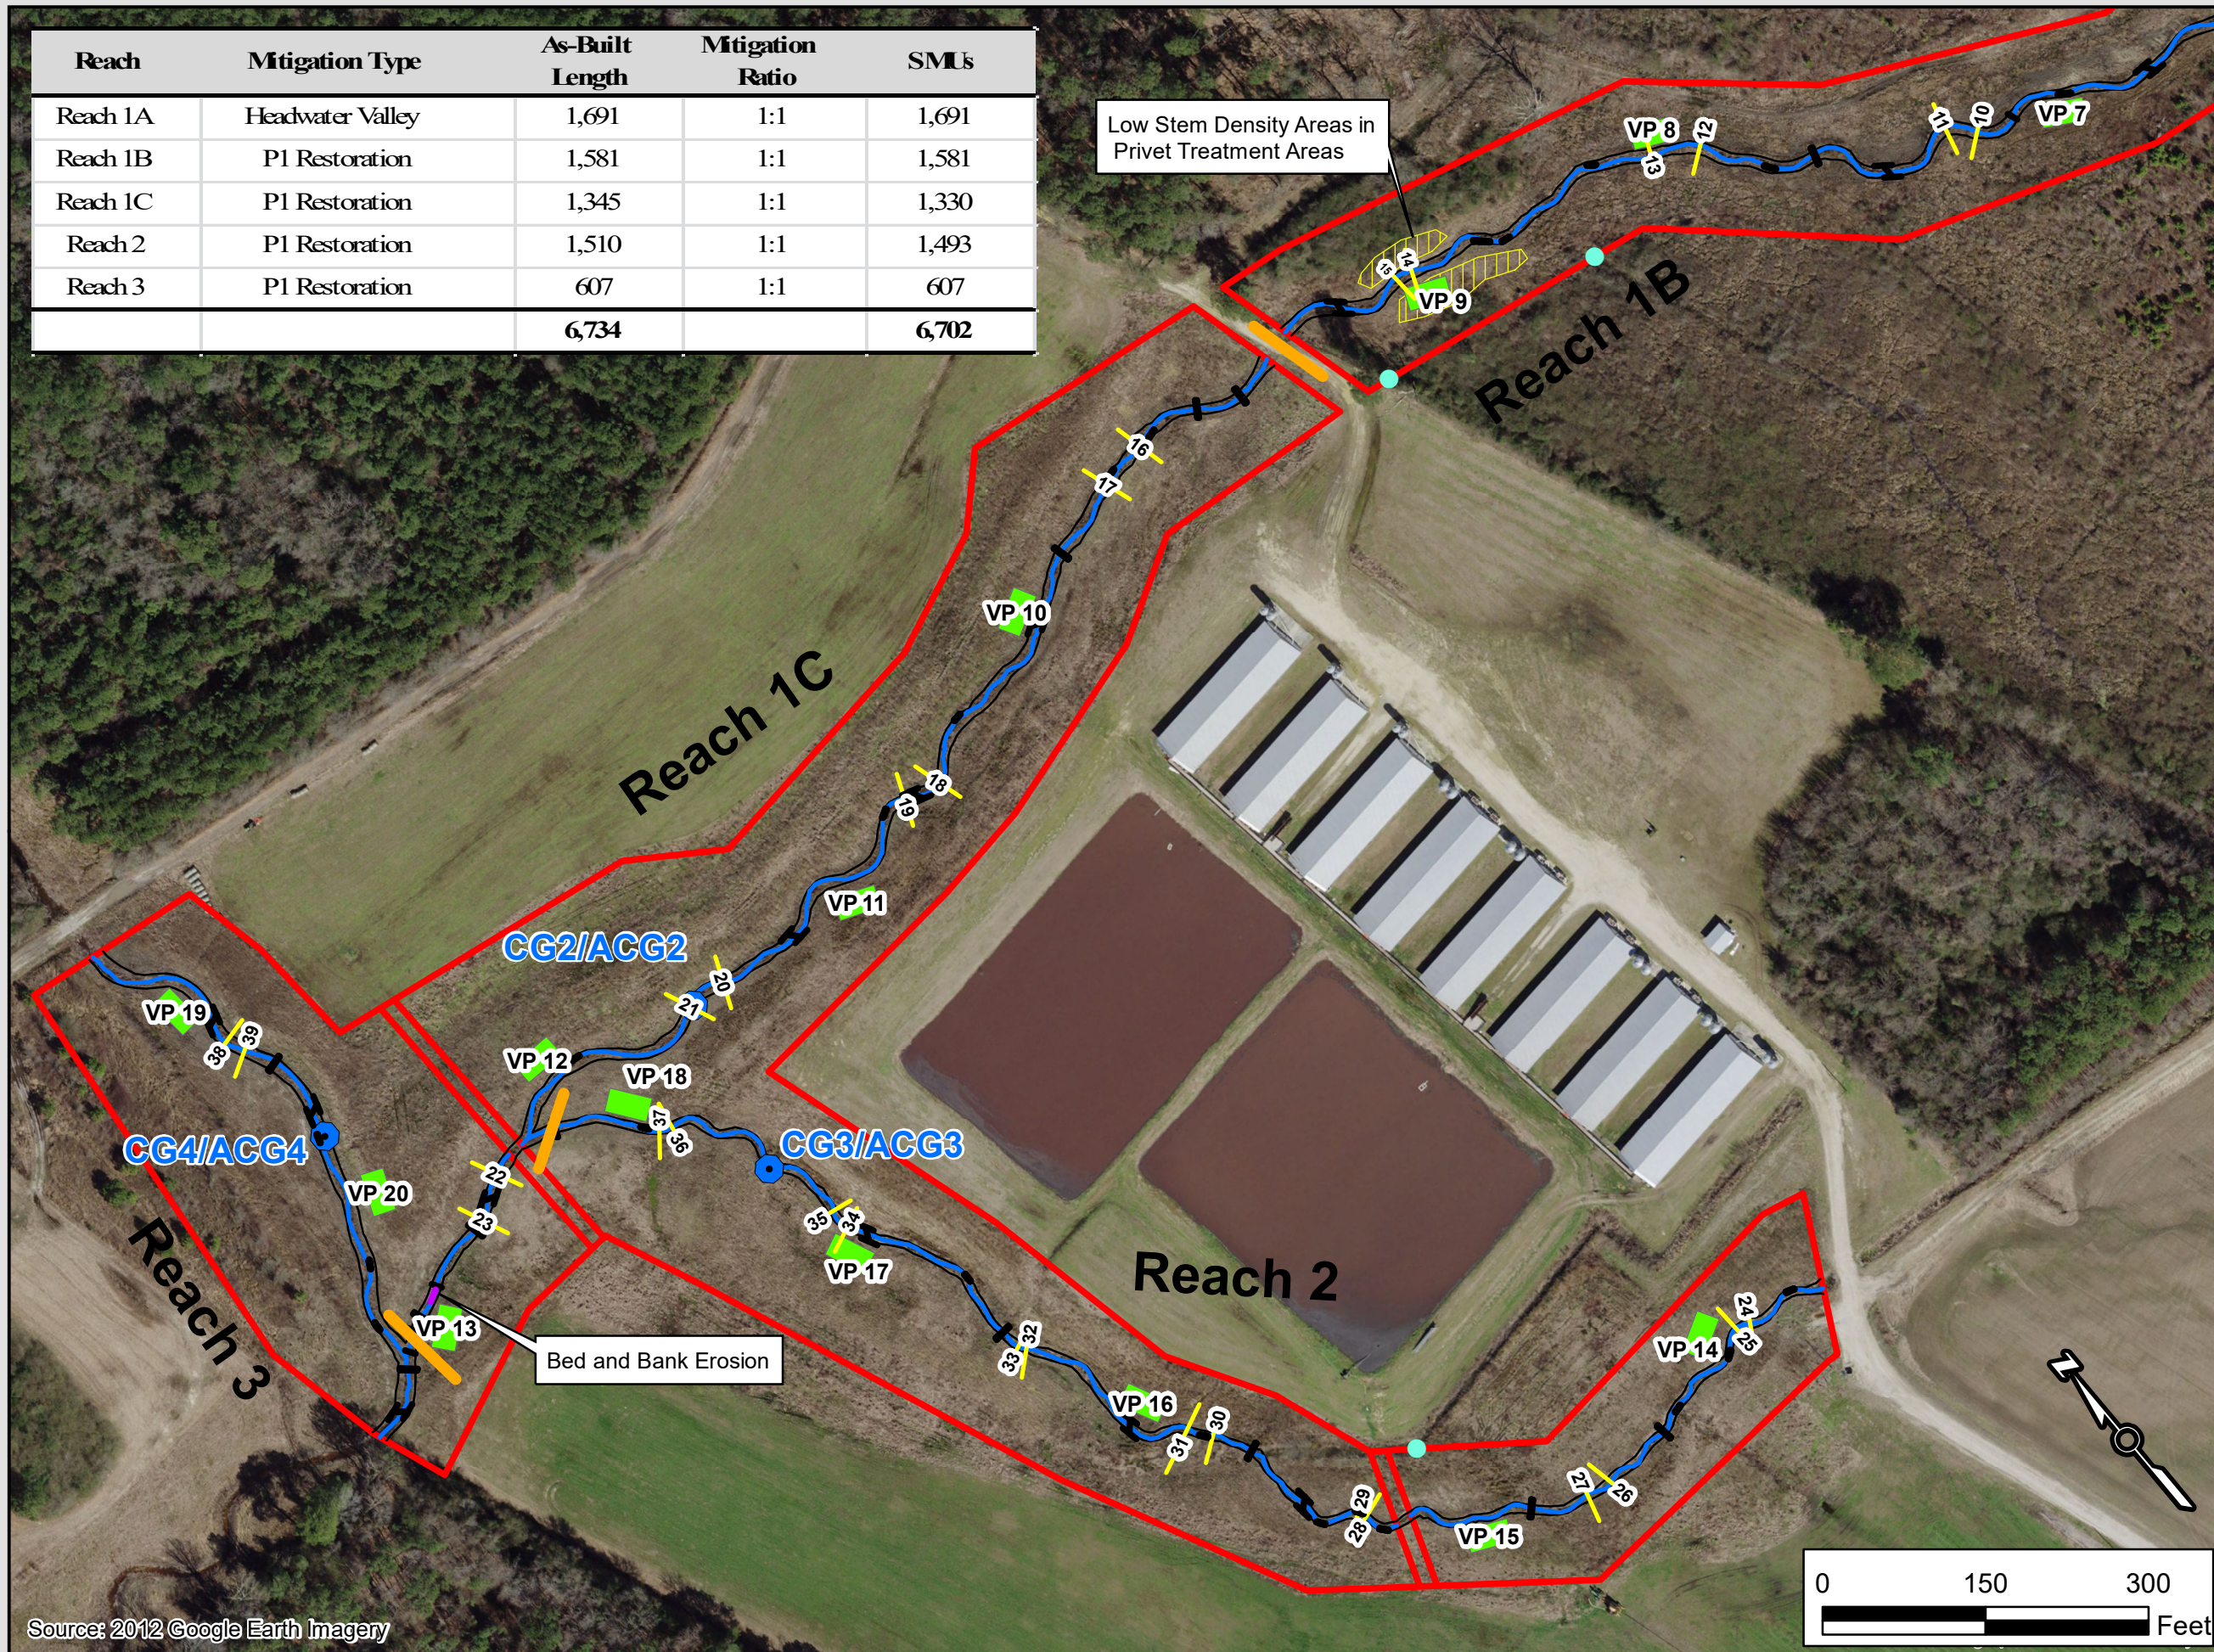
Figure 3c.
Muddy Run Mitigation Site
Current Conditions Map
Duplin County, NC
MY4 2017

One stream problem was identified during the Year 4 monitoring period and is mapped on the Current Conditions Plan View (CCPV), specifically Figure 3c. The problem was noted at the end of Reach 1C near VP13. This area has had some minor bed and bank erosion. The live stakes are taking and beginning to stabilize the problem. RES plans to continue to monitor this area to ensure it does not get worse.

Table 7. Stream Problem Areas			
Muddy Run Stream Restoration Project - Project # 95018			
Feature Issue	Station # / Range	Suspected Cause	Photo Number
Bed and Bank Erosion	Reach 1 at 47+50 to 17+70	Channel adjustment and sparse bank vegetation; but is stable; recommend monitoring	SPA1

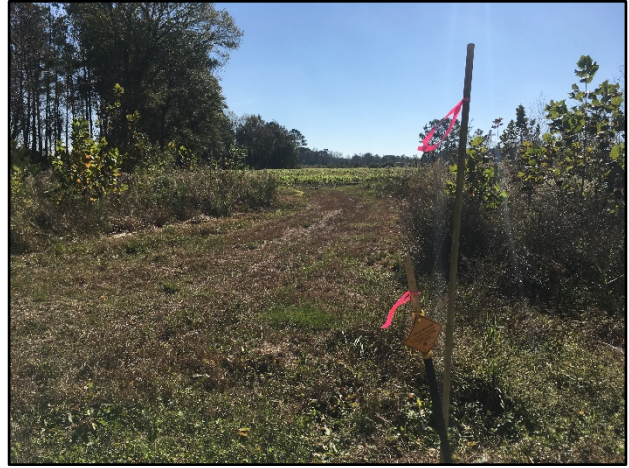
Table 8. Vegetation Problem Areas			
Muddy Run Stream Restoration Project - Project # 95018			
Feature Category	Station Numbers	Suspected Cause	Photo Number
Encroachment	Reach 1B Sta 21+50	Mowing and overspray of crossing	VPA1
Low Stem Density	Reach 1C Sta. 31+60 to 33 + 00	Weed competition and subsequent treatment; continue to monitor	VPA2

MY4-VPA1 Encroachment at Reach 1B Sta 21+50

Two vegetation problem areas were identified during the Year 4 monitoring period. These vegetation problem areas are mapped on the Current Conditions Plan View (CCPV) as part of the annual monitoring report. The first vegetation problem area (VPA1) consists an area of encroachment on Reach 1B. This problem area is approximately 0.05 acres. The other vegetation problem (VPA2) is a low stem density area that is approximately 0.11 acres on Reach 1C near VP9. This low stem density in this area is due to treatment of Chinese privet that adversely affected the planted trees in this area. RES plans to replant this area with 1-gallon containerized seedlings and will continue to monitor the success.
