**MUDDY RUN II STREAM AND WETLAND RESTORATION
PROJECT
FINAL-MONITORING REPORT
MONITORING YEAR 1**

DUPLIN COUNTY, NORTH CAROLINA, PROJECT # 95354

January 2015

**Muddy Run II
Duplin County, North Carolina
EEP Project ID 95354**

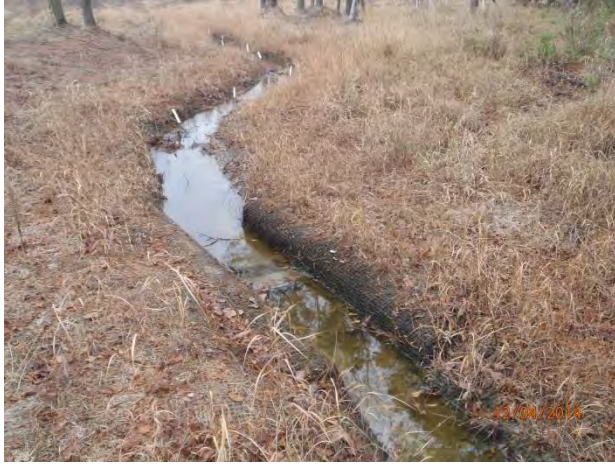
SPA1- Loose grade control toe log structure -
Reach 2 @ Sta 3+25

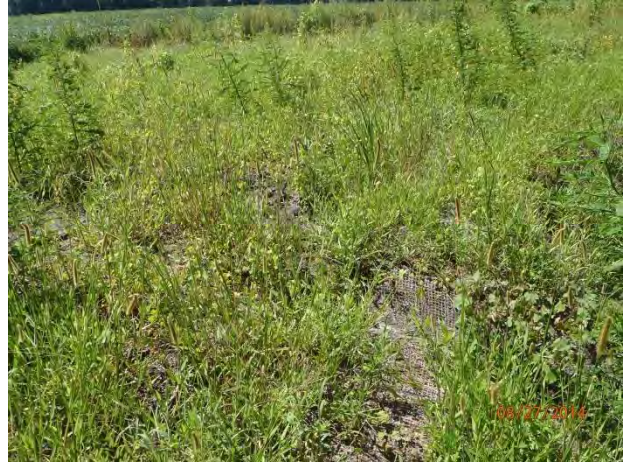
SPA2- Erosion around grade control log - Reach
3A @ Sta 0+25

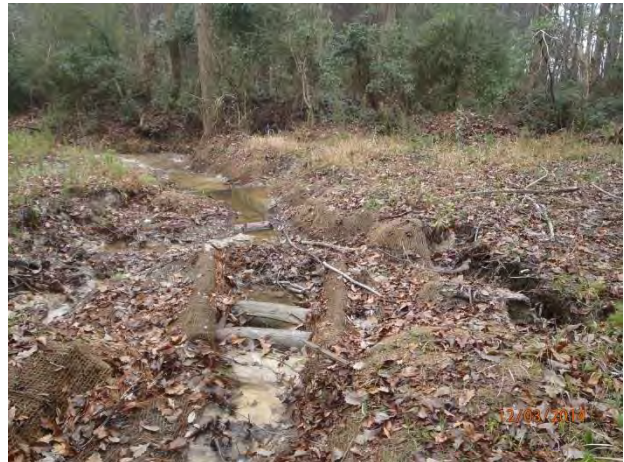
SPA4- Failed grade control structures- Reach 3B @
Sta 57+30 – 57+80

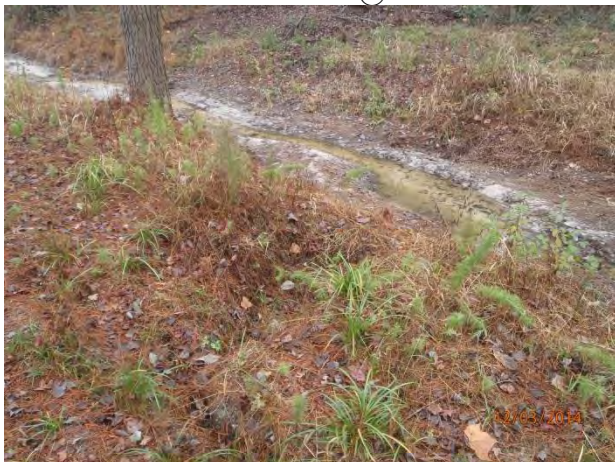
minor left bank erosion located at stations 60+00 and 61+00. These areas consist of two headcuts forming on the left bank and will be repaired by installing a coir log to divert concentrated flow from these areas. Reach 5A has the remaining three stream problem areas. Stream problem area six (SPA6) is a segment from station 13+25 to 16+50 where stream structures have failed and become unstable due to improper installation. This area has localized areas of bank erosion on both sides. To repair problem area 6, new rock/log structures will be installed and a floodplain bench will be created. After all repair work is completed, the area will be replanted and livestaked. Stream problem area 7 (SPA7) is an area with minor bank erosion located on the right bank at station 14+00. This stream problem is a small scour and will be repaired by installing a coir log to divert concentrated flow from this area. The last stream problem area (SPA8) on Reach 5A is a segment from station 16+50 to 19+50. Log structures along this portion are unstable and have failed due to improper installation. Both streambed and banks are eroding at a rapid pace due to sandy soil cohesion in this problem area. Repair work for problem area 8 will include installing new rock/log structures and re-grading the bed and banks. A floodplain bench will be created along with replanting and livestaking the banks. All stream problem areas have been mapped on the Current Conditions Plan View (CCPV) along with a table and photos for each area that are described in more detail in **Appendix B**. Stream problem areas requiring adaptive management occupy less than five percent of the total channel length. Overall the system is performing as designed and no systematic problems exist.

SPA5- Minor left bank erosion – Reach 3C @ Sta
60+00 and 61+00

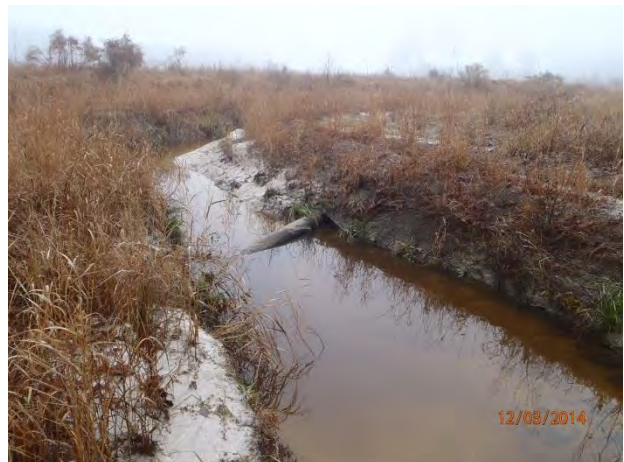
SPA6- Failed grade control structures and bank
erosion- Reach 5A @ Sta 13+25- Sta 16+50

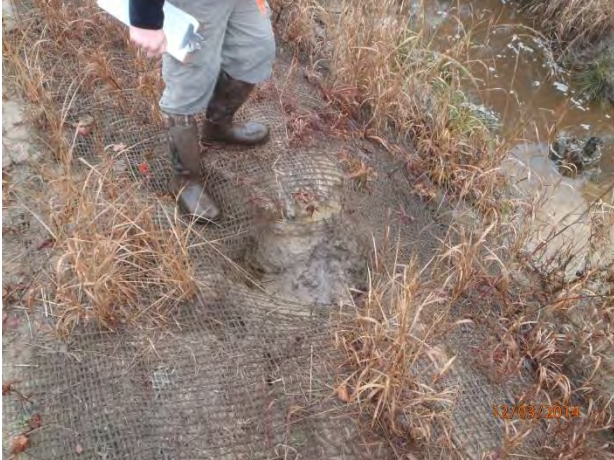
SPA7- Minor right bank erosion- Reach 5A @ Sta 14+00

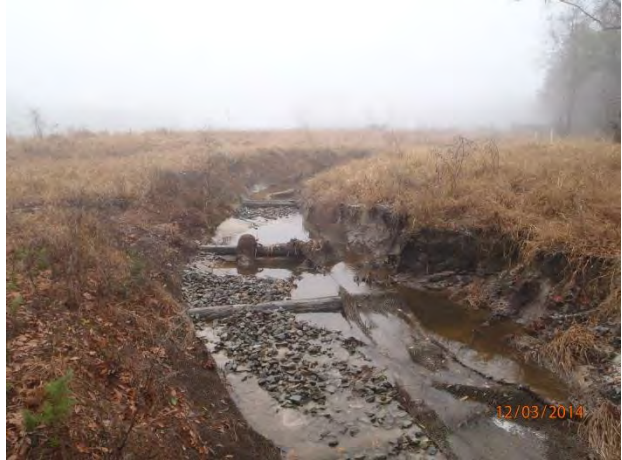
SPA8- Failed grade control structures, bed/bank erosion- Reach 5A @ Sta 16+50- 19+50

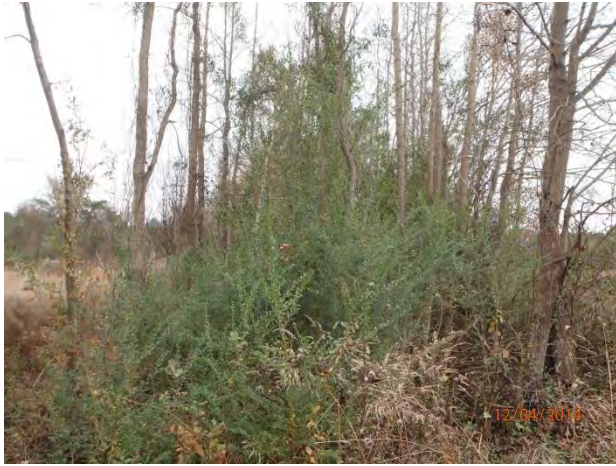
VPA1- Invasive population: *Ligustrum* along Reach 2 @ Sta 0+50 – Sta 3+00.

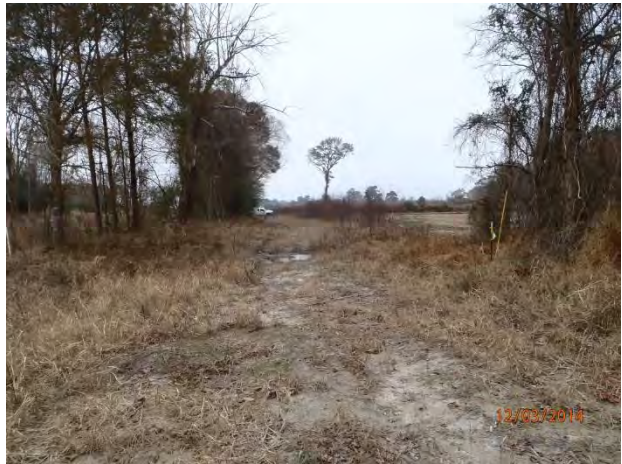
VPA4- Missing rows of trees and vehicles through easement along Reach 3a @ Sta 19+00 - Sta 23+00

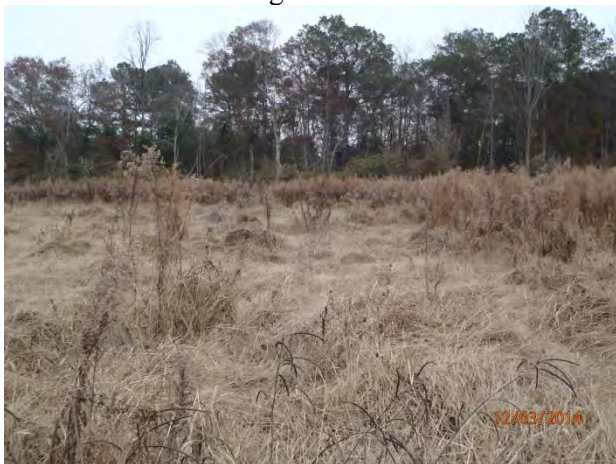
VPA5- Missing rows of trees along Reach 3a @ Sta 28+50 – Sta 33+75.

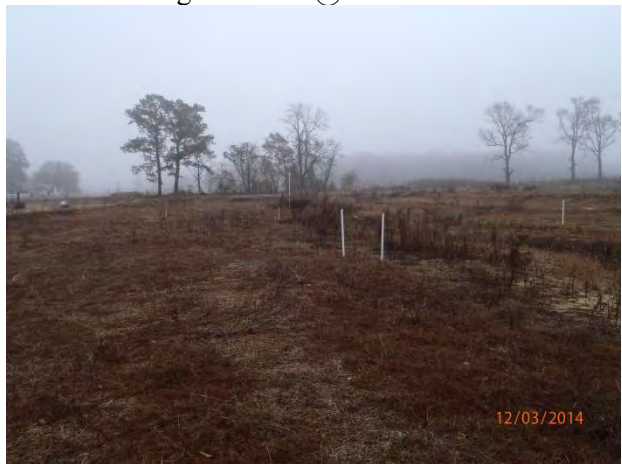
Sparse target community	Reach 3B @ Sta 38+50 - 42+00	Mortality due to low soil fertility, possibly due to compaction; Plant approximately 300 trees.	VPA6
Missing rows of trees	Reach 3B @ Sta 44+50 - 47+12	Low planting density; Plant approximately 250 trees.	VPA7
Invasive/Exotic Populations	Reach 3C- localized areas- see plan view	Ligustrum: encroachment from outside easement; Continued clearing and stump treatment.	VPA8
Sparse vegetation/ Easement encroachment	Reach 5A @ Sta 4+50 - 9+25	Vehicles driving in the easement; Plant approximately 80 trees in 2 rows and restrict vehicle access to the easement.	VPA9
Invasive/Exotic Populations	Reach 5B @ Sta 19+60 - 23+68	Ligustrum: encroachment from outside easement; Continued clearing and stump treatment.	VPA10

VPA6- Missing trees along Reach 3b @ Sta 38+50- Sta 42+00.

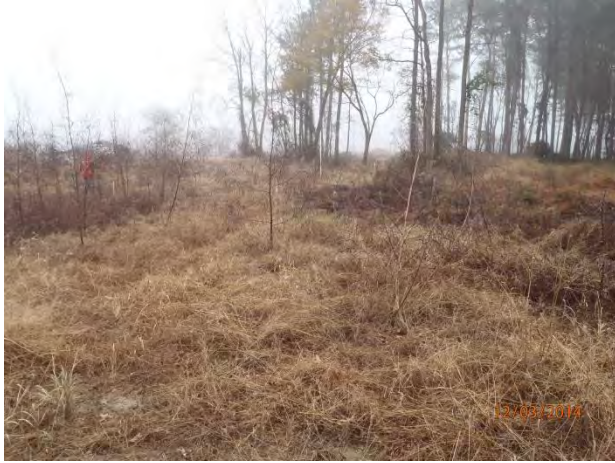
VPA7- Missing trees along Reach 3b @ Sta 44+50-
Sta 47+12.

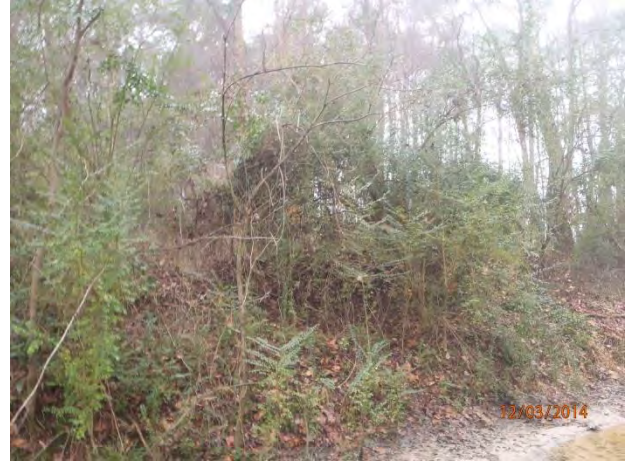
VPA8- Localized invasive populations: *Ligustrum*
along Reach 3c

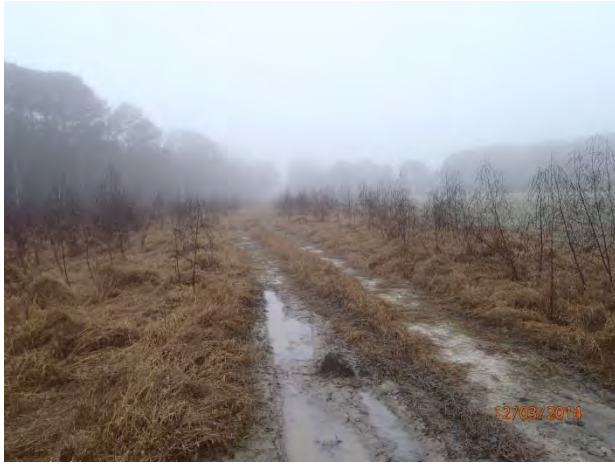
VPA9- Missing trees and vehicles through
easement along Reach 5a @ Sta 4+50 – Sta 9+25.

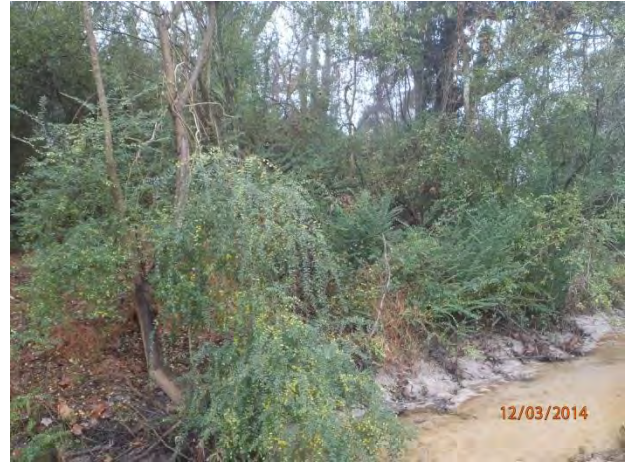
VPA10- Invasive population: *Ligustrum* along
Reach 5b @ Sta 19+60 – Sta 23+68.
