**MUDDY RUN II STREAM AND WETLAND RESTORATION  
PROJECT  
MONITORING REPORT  
MONITORING YEAR 2**

DUPLIN COUNTY, NORTH CAROLINA  
CONTRACT NO. 004632 - PROJECT # 95354

**Muddy Run II  
Duplin County, North Carolina  
DMS Project ID 95354**

**Resource Environmental Solutions  
302 Jefferson Street, Suite 110  
Raleigh, NC 27605  
919-829-9909**

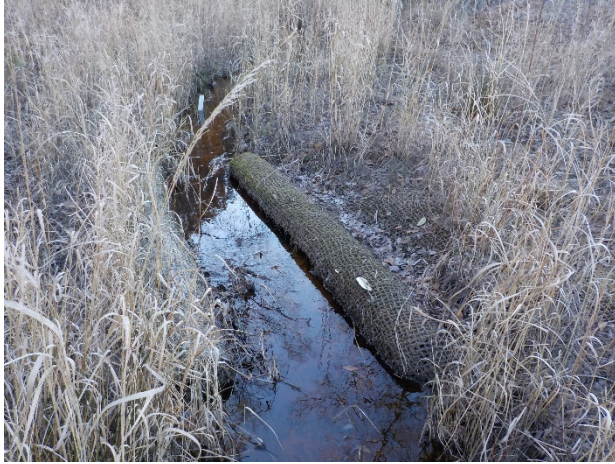
SPA1- Loose grade control toe log structure -  
Reach 2 @ Sta 3+25

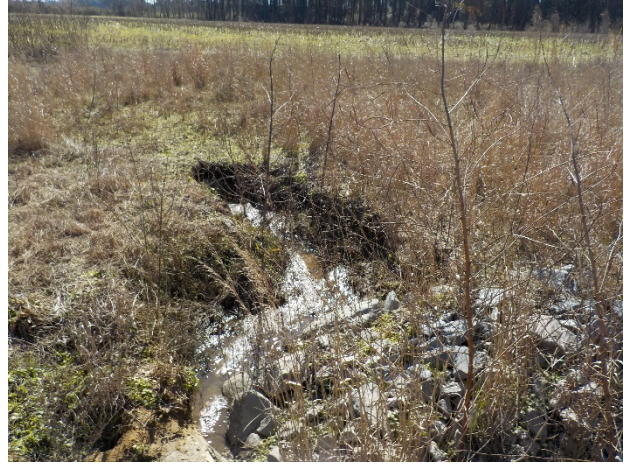
SPA2- Left bank erosion behind flow diversion  
structure - Reach 3b @ Sta 37+22

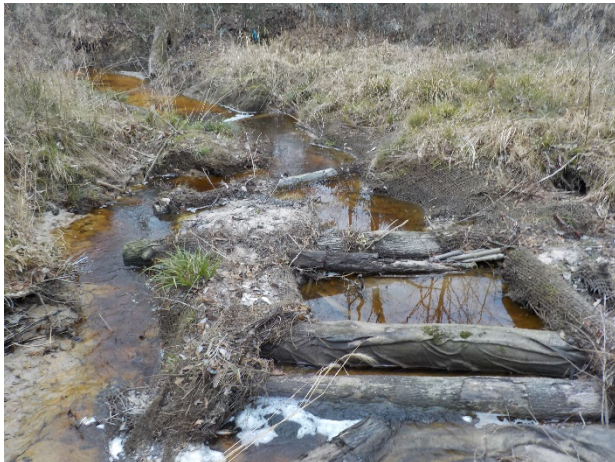
SPA3- Failed grade control structures- Reach 3B @  
Sta 57+30 – 57+80

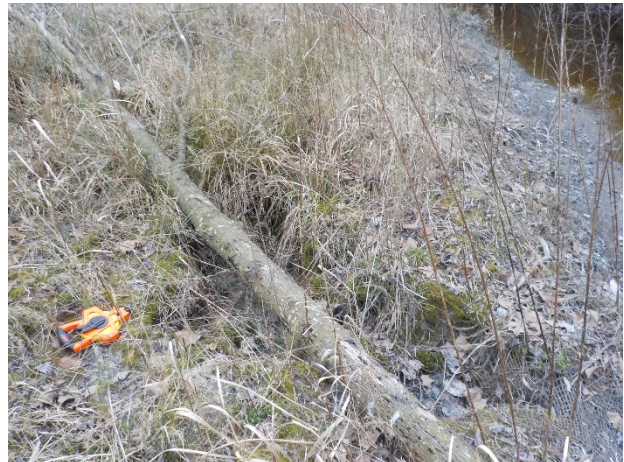
detailed plan sheets are outlined in the adaptive management plan (**Appendix F**). Reach 3C has one stream problem area, SPA4, with two minor headcuts forming on the left bank located at stations 60+00 and 61+00. SPA4 can easily be repaired by installing live stakes to armor the bank and divert concentrated flows; however, the banks are currently stable and has not gotten worse during monitoring year 2. SPA4 will continue to be monitored. The most prominent stream problem area (SPA5) is located along the downstream segment of Reach 5A from station 13+25 to 19+50. The Year 1 monitoring report had this area broken down into multiple problem areas, but for the purpose of this report the entire section has been lumped into one problem area. Throughout the length of this 575 linear-foot stream segment, log structures have failed and localized areas of bank and bed erosion are frequent on both sides of the channel. Log structures along this portion failed due to improper installation and sandy soil cohesion in this localized project area. To address SPA5, an adaptive management plan has been developed and will be implemented before monitoring year 3 (**Appendix F**). The adaptive management plan will include the installation of new log structures, re-grading the bed and banks, and the construction of a floodplain bench. After all repair work is completed, the area will be replanted and livestaked. Stream problem areas requiring adaptive management occupy less than five percent of the total channel length.

SPA4- Minor left bank erosion – Reach 3C @ Sta  
60+00 and 61+00

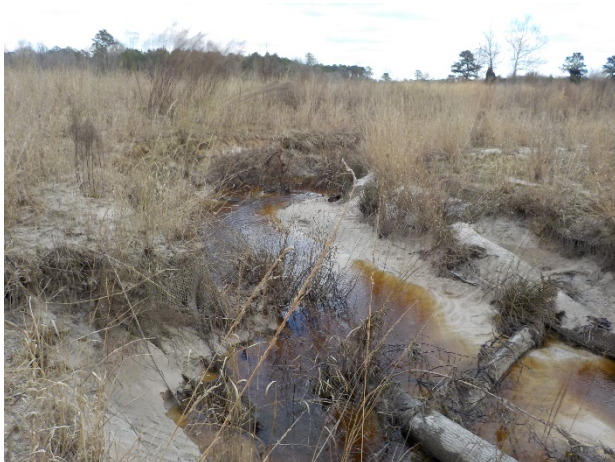
SPA5- Failed grade control structures and bank  
erosion- Reach 5A @ Sta 13+25- Sta 16+50

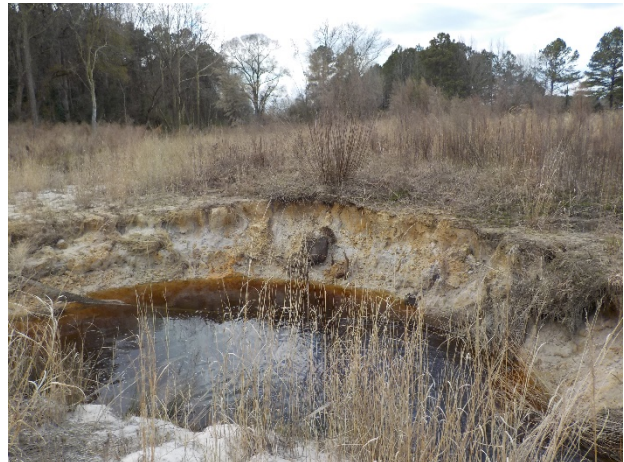
SPA5- Right bank erosion- Reach 5A @ Sta  
14+00

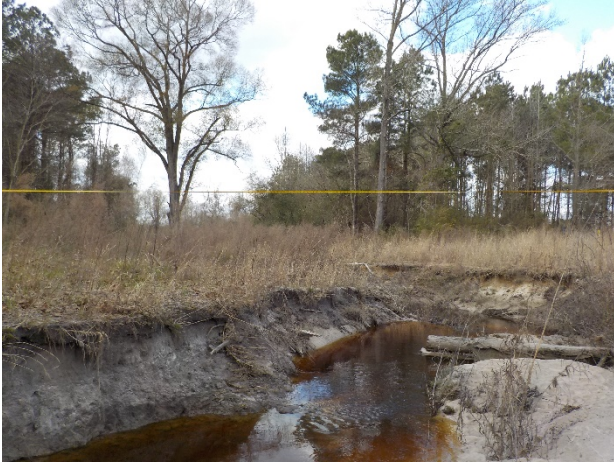
SPA5- Failed grade control structures, bed/bank erosion- Reach 5A @ Sta 16+50- 19+50

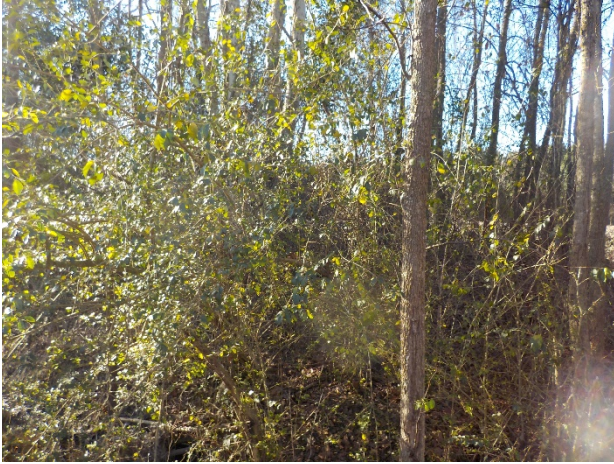
Eight vegetation problem areas were identified during the Year 2 monitoring period and have been mapped on the CCPV. Invasive Chinese privet was observed along portions of Reach 2, Reach 3a, Reach 3c, and Reach 5b (VPA1, VPA2, VPA3, VPA6, and VPA8); management will consist of continued clearing and stump treatment for these areas. Three other problem areas (VPA4, VPA5, and VPA7) were noted for low stem densities, having stem counts less than the MY3 vegetative success criteria of 320 stems/acre. VPA4 and VPA5 areas will be planted with approximately 100 trees and VPA7 area will be planted with approximately 200 trees. Accelerated growing species will be planted to ensure the site stays on track to meet vegetative success criteria. Two encroachment areas that were noted in the Year 1 monitoring season, were addressed during the Year 2 season. These 2 areas were replanted and vehicle access has been restricted from the easement. Landowner notification was achieved to aid in the prevention of future easement encroachment issues. Three other low density planting areas were replanted in Year 2 and are now on track and trending towards success. All vegetation issues are described in **Appendix B**.

VPA1- Invasive population: *Ligustrum* along Reach 2 @ Sta 1+50 – Sta 2+50.
