**MUDDY RUN II STREAM AND WETLAND RESTORATION  
PROJECT  
MONITORING REPORT  
MONITORING YEAR 3**

DUPLIN COUNTY, NORTH CAROLINA  
CONTRACT NO. 004632 - PROJECT # 95354

**Muddy Run II  
Duplin County, North Carolina  
DMS Project ID 95354**

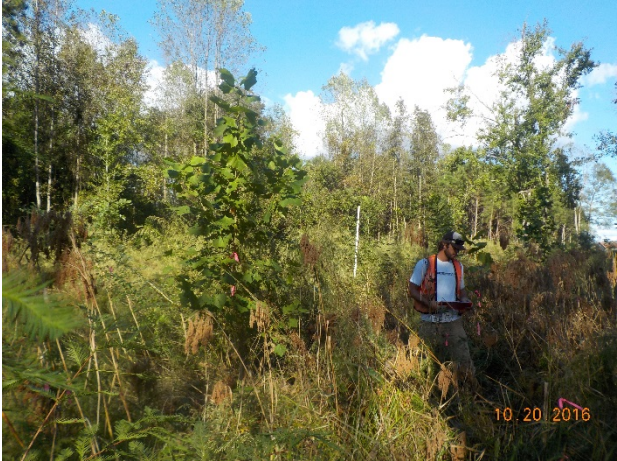
One vegetation problem area was identified during monitoring Year 3 activities and is mapped on the CCPV figures. The problem area (VPA1) was noted for low stem densities, having stem counts less than the MY3 vegetative success criteria of 320 stems/acre. It should be noted that this area meets requirements when considering volunteer species towards the success criteria survival. During last year's 2015 monitoring activities, eight vegetation problem areas were identified. Invasive Chinese privet was observed along portions of Reach 2, Reach 3a, Reach 3c, and Reach 5b. Invasive species management was performed in these areas in October 2016 and consisted of clearing and stump treatment. Three other problem areas were noted during MY2 for low stem densities, having stem counts less than the MY3 vegetative success criteria of 320 stems/acre. These areas were replanted in conjunction with Reach 3B/5A stream repairs and planting activities. Vegetation problem area 1 (VPA1) identified during MY3 will be closely monitored by RES to determine if a replant is necessary before the end of 2017-MY4. This problem area is small and does not pose a threat to vegetation success criteria being met. All vegetation issues are described in **Appendix B**.

VPA1 - Low stem density: Reach 4 @ Sta 1+00 – Sta 2+00

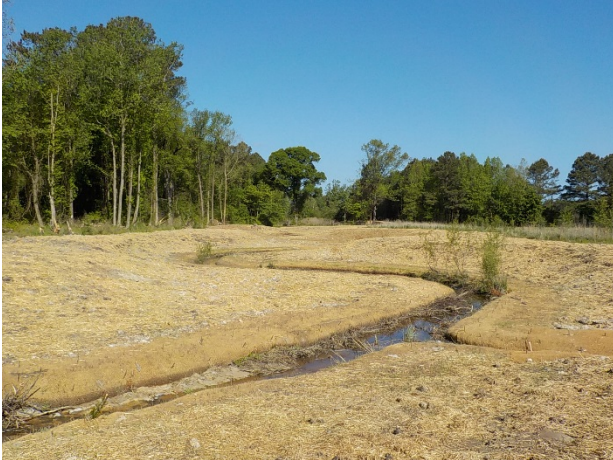
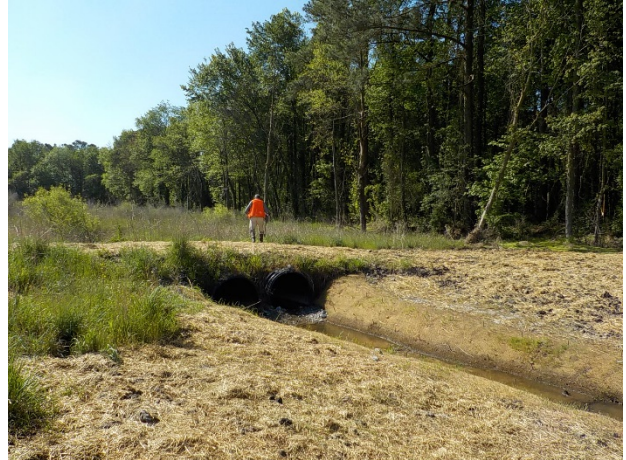
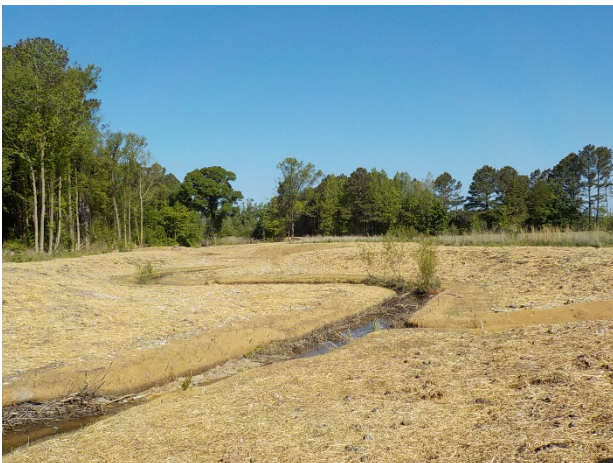
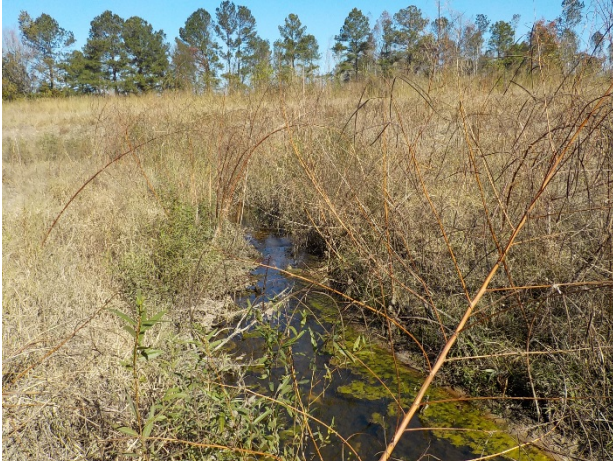
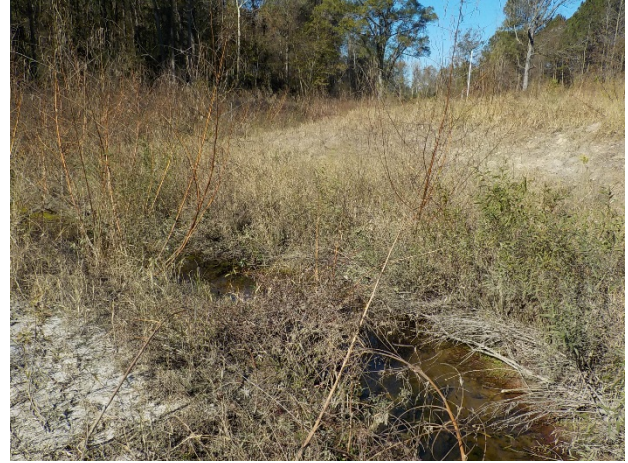
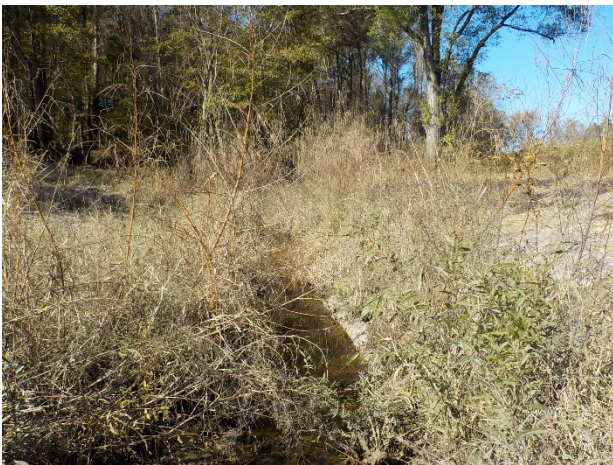
SPA5-MY2-2015 Reach 5A Repairs (4/26/2016)

SPA5-MY2-2015 Reach 5A Repairs (11/8/2016)

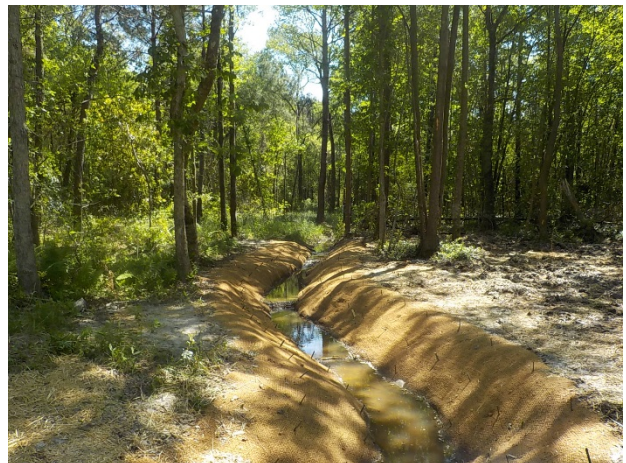
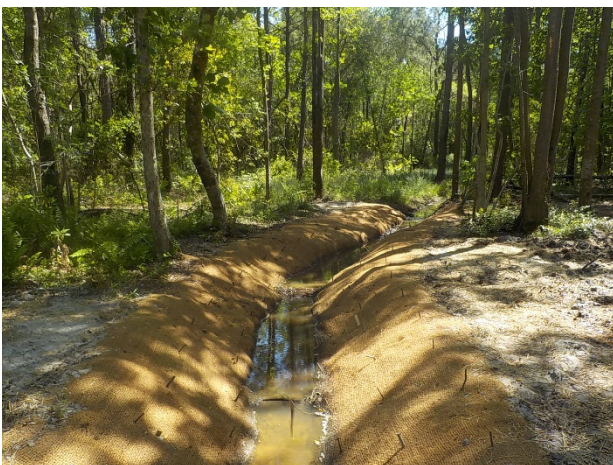
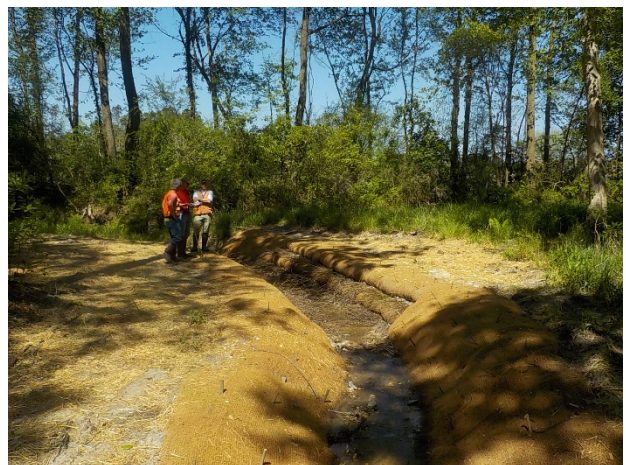
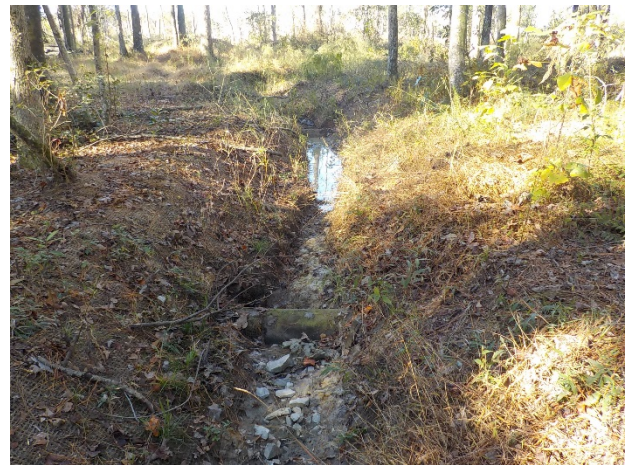
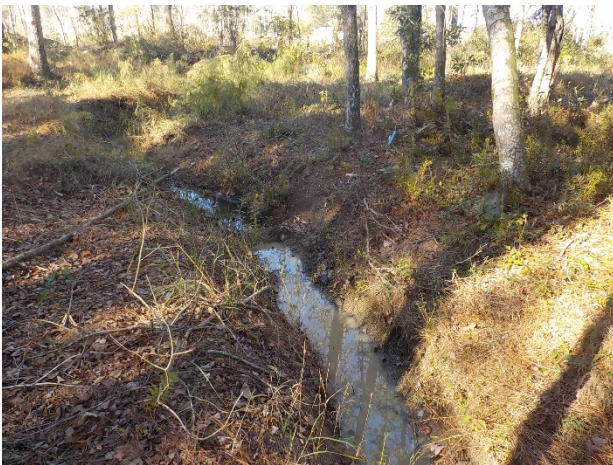
SPA2-MY2-2015 Repaired Structures (4/26/2016)

SPA2-MY2-2015 Repaired Structures (11/8/2016)
