**MUDDY RUN II STREAM AND WETLAND RESTORATION  
PROJECT  
MONITORING REPORT  
MONITORING YEAR 4  
FINAL**

DUPLIN COUNTY, NORTH CAROLINA  
CONTRACT No. 004631 - PROJECT No. 95354

February 2018

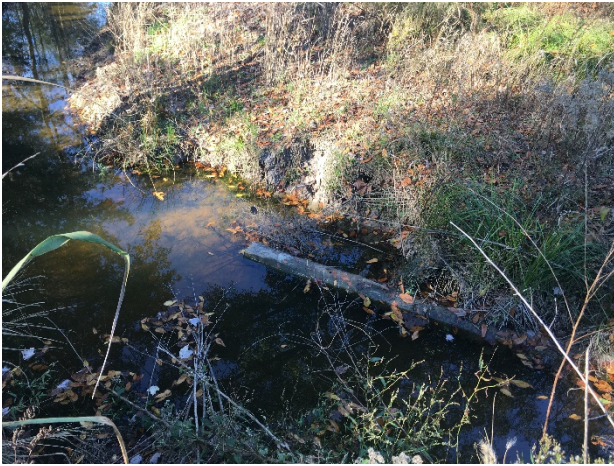
During the Year 4 monitoring activities, one stream problem area was documented. This area (SPA1) is located on Reach 5A at station 19+50 and consists of right bank erosion caused by a dislodged structure from the toe of the bank. This area is mapped on the CCPV figure in **Appendix B**. Stream problem area 1 (SPA1) will be addressed by adding rip rap behind the dislodged structure and livestaking the bank to reduce further erosion. Stream problem areas identified during MY3 were inspected during MY4. Formerly SPA1, is now considered a vegetation problem area (see VPA2 below). The stream problem area is localized and the overall condition of the project streams on site are stable. Stream issues are described in **Appendix B**.

<b>Table 7. Stream Problem Areas</b>			
<b>Muddy Run II Stream and Wetland Restoration Project - Project # 95354</b>			
<b>Feature Issue</b>	<b>Station # / Range</b>	<b>Suspected Cause; Repair</b>	<b>Photo Number</b>
<b>Right Bank Erosion</b>	Reach 5A @ Sta. 19+50	Structure from drainage feature dislodged causing water to flow behind it and scour the right bank; continue to monitor	SPA1

MY4 – SPA1 – Right Bank Erosion on Reach 5A at  
Sta. 19+50

As RES explained and we discussed in the field, there will need to be a strategy for repairing the isolated bank and floodplain scour on Reach 5A, including ensuring the encroachment is eliminated as soon as possible.

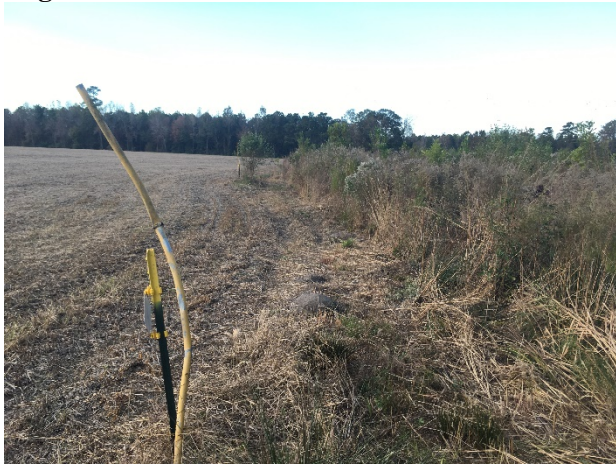
MY4 – VPA1 – Encroachment on Reach 1 & 3A at Sta. 1+00 to 9+97 (Reach 1) & 3+00 to 18+73 (Reach 3A)

What is RES doing to address the minor encroachment noted on the report? Update to describe.

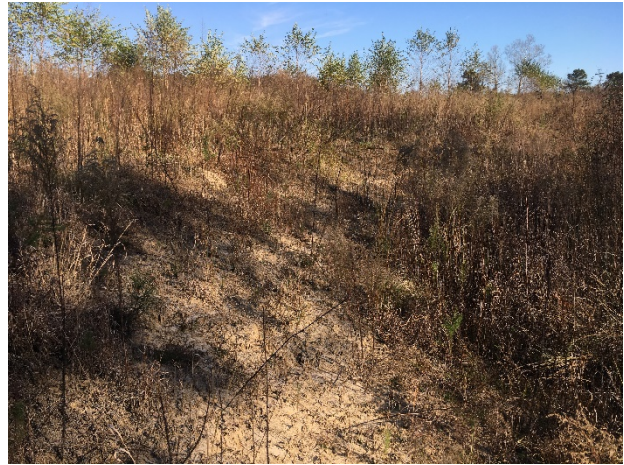
<b>Table 8. Vegetation Problem Areas</b>			
<b>Muddy Run II Stream and Wetland Restoration Project - Project # 95354</b>			
<b>Feature Category</b>	<b>Station Numbers</b>	<b>Suspected Cause; Repair</b>	<b>Photo Number</b>
<b>Encroachment</b>	Reach 1 & 3A at Sta. 1+00 to 9+97 (Reach 1) & 3+00 to 18+73(Reach 3A)	Apparent mowing behind easement markers; continue to monitor and notify landowner	VPA1
<b>Bare Area/Head Cut Erosion</b>	Reach 5A at Sta. 14+50 to 18+00	Slopes are sandy, and the area lacks substantial herbaceous vegetation; seed area and/or establish live stakes to minimize additional erosion.	VPA2

MY4 – VPA2 – Bare Area/ Head Cut Erosion Reach 5A at Sta. 14+50 to 18+00

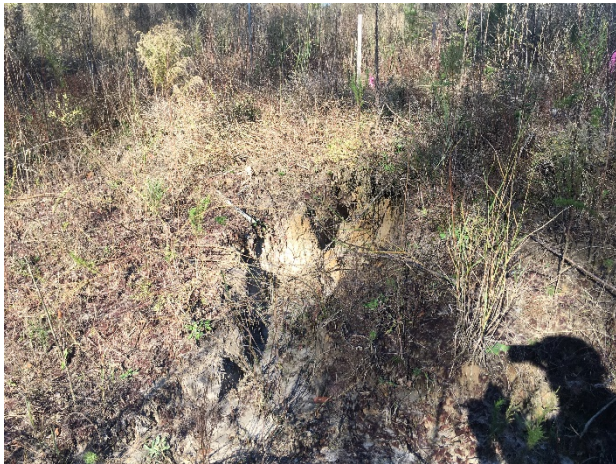
MY4 – VPA2 – Bare Area/ Head Cut Erosion Reach 5A at Sta. 17+40
