**MUDDY RUN II STREAM AND WETLAND RESTORATION
PROJECT
MONITORING REPORT
MONITORING YEAR 5
FINAL**

DUPLIN COUNTY, NORTH CAROLINA
DMS CONTRACT No. 004631 – DMS PROJECT No. 95354
SAW-2011-02191
DWR 2013-0653

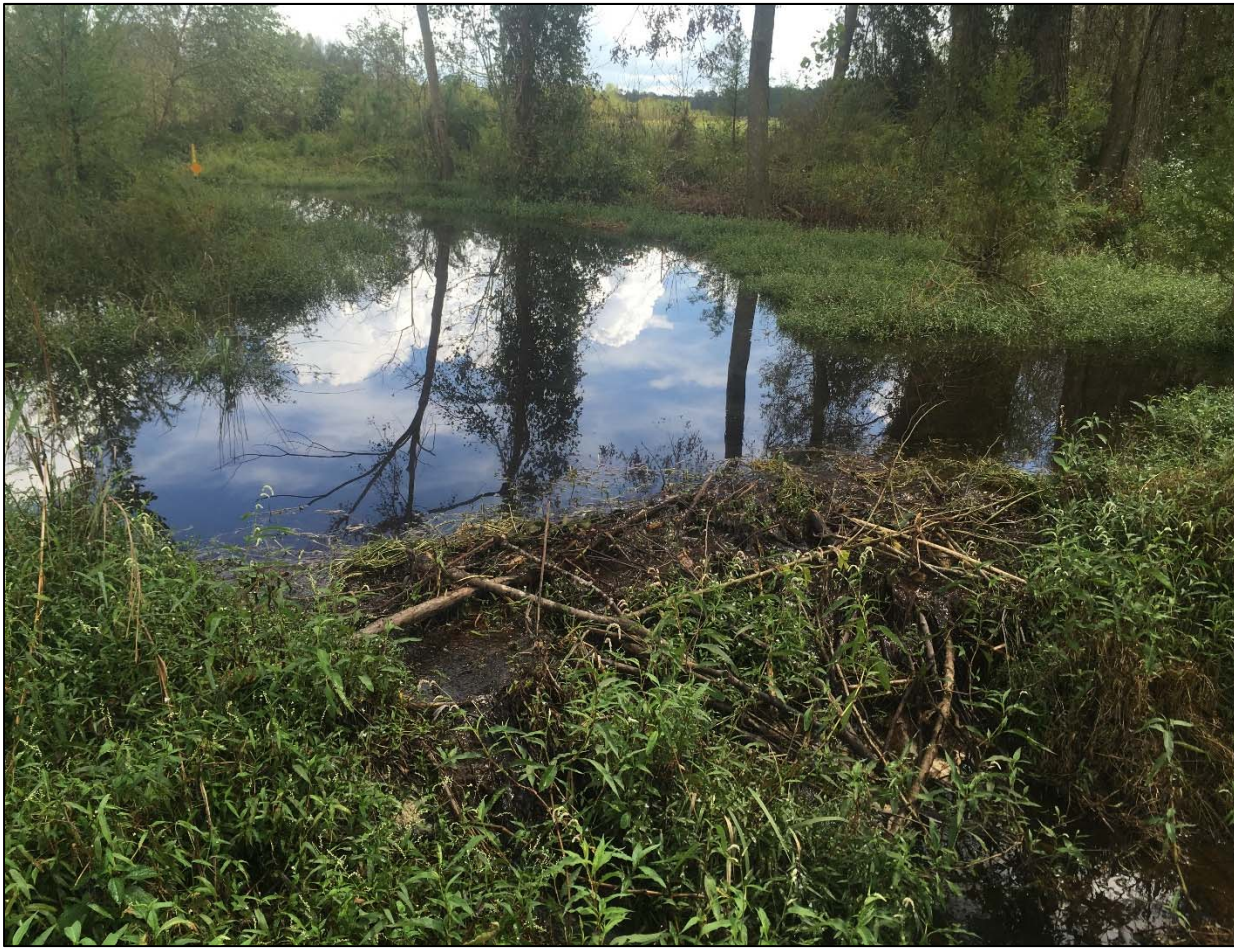
During the Year 5 monitoring activities, one stream problem area was documented. There is a series of beaver dams on Reach 5A right where it enters Muddy Run II from Muddy Run. Beaver management will be performed in 2019. The dislodged structure reported in Year 4 was repaired in June 2018. Stream issues are described in **Appendix B**.

MY5 – SPA1 – Beaver dam top of Reach 5a

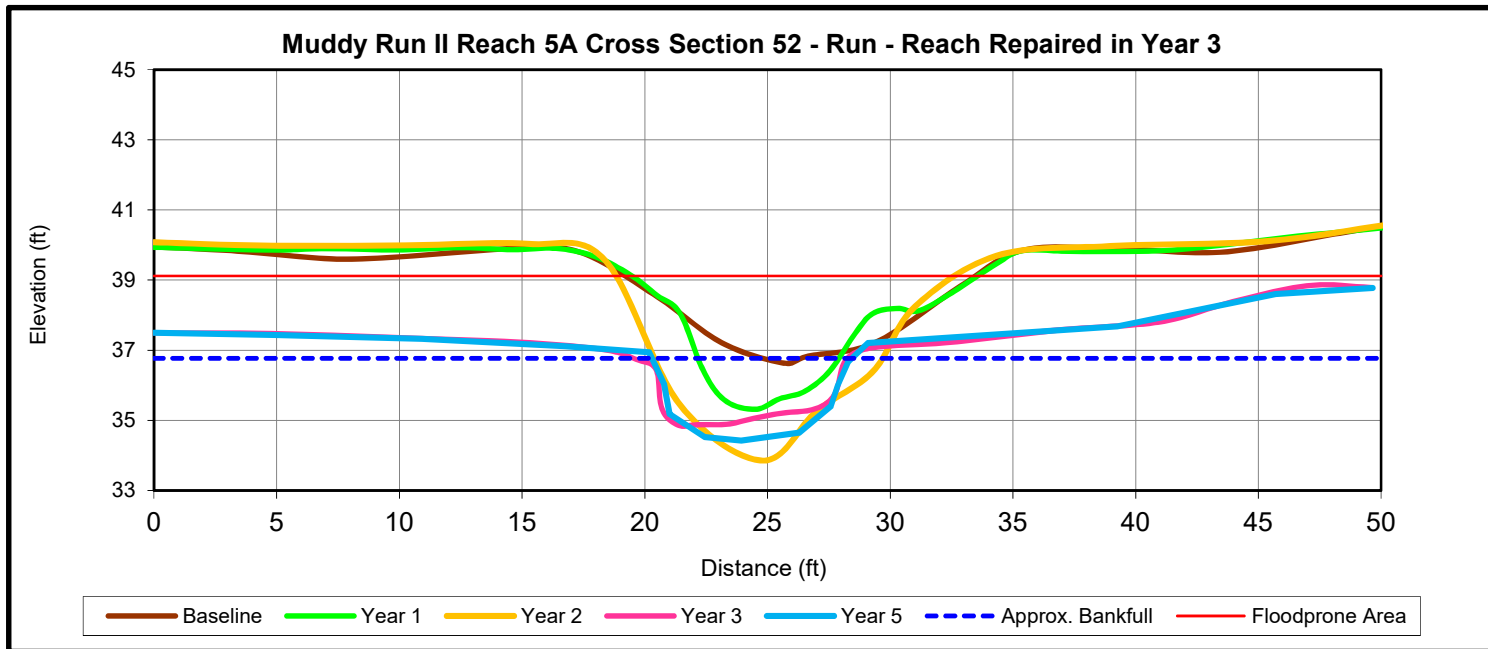
Need to document that channel was repaired for reach 5b to explain x-sections 52, 54, and 55 in the report. During the site visit, the stream appeared stable and was holding grade after large storm events in 2018. Please add footnotes to cross-sections as applicable to explain report discrepancies.

MYS+ based on fixed baseline cross sectional area*	Cross Section 52 (Run)						
	Base	MY1	MY2	MY3*	MY5	MY7	MY+
Record elevation (datum) used	39.8	39.8	39.8	37.0	36.8		
Bankfull Width (ft)	17.7	17.8	19.3	10.6	8.1		
Floodprone Width (ft)	50.0	50.0	50.0	50.0	50.0		
Bankfull Mean Depth (ft)	1.8	2.1	2.7	1.4	1.8		
Bankfull Max Depth (ft)	3.1	4.5	5.9	2.1	2.3		
Low Bank Height (ft)	-	-	-	-	2.5		
Bankfull Cross Sectional Area (ft ²)	31.8	36.9	52.3	14.6	14.6		
Bankfull Width/Depth Ratio	9.9	8.6	7.1	7.7	4.5		
Bankfull Entrenchment Ratio	>2.2	>2.2	>2.2	>2.2	>6.1		
Bankfull Bank Height Ratio	1.0	1.0	1.0	1.0	1.1

[The repair is documented in 5.1.1 Dimension and notes have been added to the Cross Section Plots in Appendix D.](#)

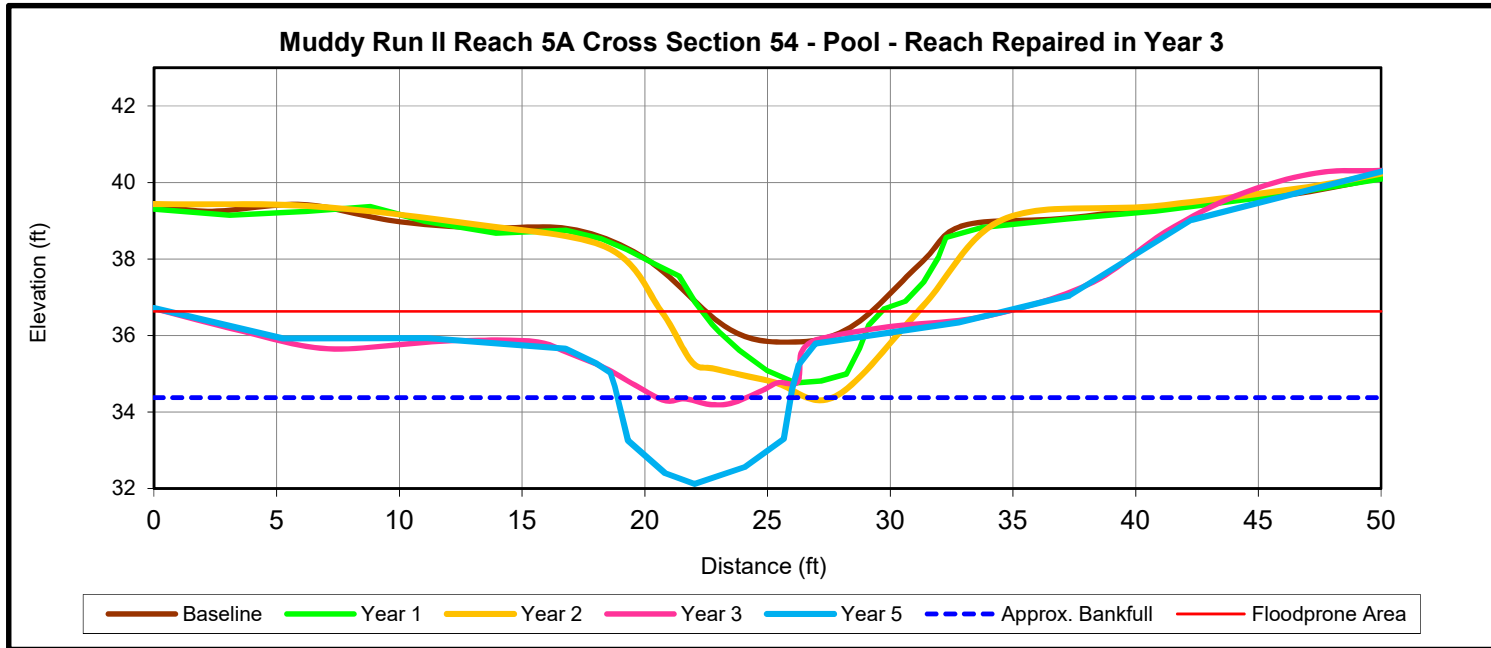
MYS+ based on fixed baseline cross sectional area*	Cross Section 54 (Pool)						
	Base	MY1	MY2	MY3*	MY5	MY7	MY+
Record elevation (datum) used	38.8	38.8	38.8	35.9	34.4		
Bankfull Width (ft)	15.7	16.7	20.3	11.5	7.0		
Floodprone Width (ft)	50.0	50.0	50.0	50.0	34.0		
Bankfull Mean Depth (ft)	1.7	2.0	2.2	1.0	1.7		
Bankfull Max Depth (ft)	2.9	4.0	4.4	1.7	2.3		
Low Bank Height (ft)	-	-	-	-	N/A		
Bankfull Cross Sectional Area (ft ²)	26.1	32.7	45.2	11.7	11.7		
Bankfull Width/Depth Ratio	9.5	8.5	9.1	11.3	4.2		
Bankfull Entrenchment Ratio	>2.2	>2.2	>2.2	>2.2	N/A		
Bankfull Bank Height Ratio	1.0	1.0	1.0	1.0	N/A

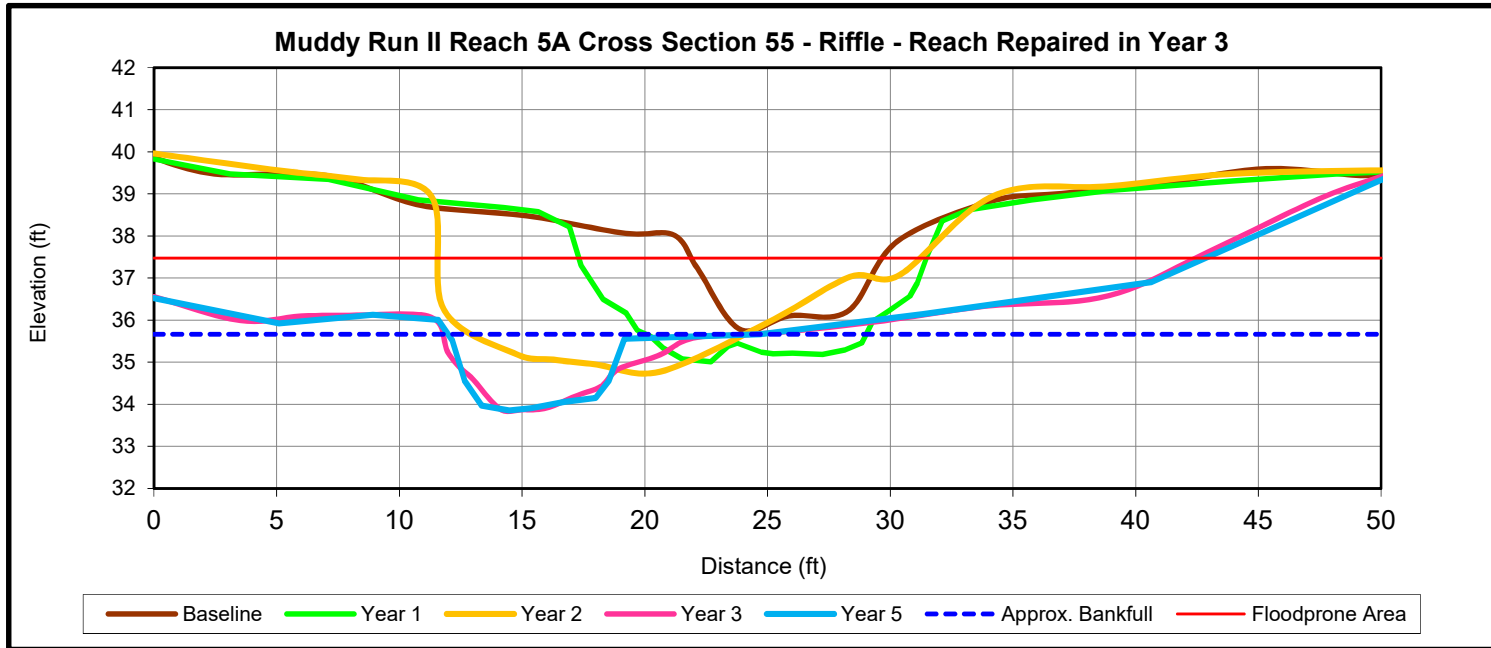
MYS+ based on fixed baseline cross sectional area*	Cross Section 55 (Riffle)						
	Base	MY1	MY2	MY3*	MY5	MY7	MY+
Record elevation (datum) used	38.0	38.0	38.0	35.6	35.7		
Bankfull Width (ft)	9.7	14.8	20.8	10.2	12.7		
Floodprone Width (ft)	50.0	50.0	50.0	50.0	43.0		
Bankfull Mean Depth (ft)	1.4	2.2	2.1	1.0	0.8		
Bankfull Max Depth (ft)	2.2	3.0	3.3	1.7	1.8		
Low Bank Height (ft)	-	-	-	-	1.7		
Bankfull Cross Sectional Area (ft ²)	13.6	33.3	44.4	10.5	10.5		
Bankfull Width/Depth Ratio	7.0	6.6	9.7	9.9	15.4		
Bankfull Entrenchment Ratio	>2.2	>2.2	>2.2	>2.2	>3.4		
Bankfull Bank Height Ratio	1.0	1.0	1.0	1.0	0.9
