**MUDDY RUN II STREAM AND WETLAND RESTORATION
PROJECT
MONITORING REPORT
MONITORING YEAR 6
FINAL**

DUPLIN COUNTY, NORTH CAROLINA
DMS CONTRACT No. 004631 – DMS PROJECT No. 95354
SAW-2011-02191
DWR 2013-0653

January 2020

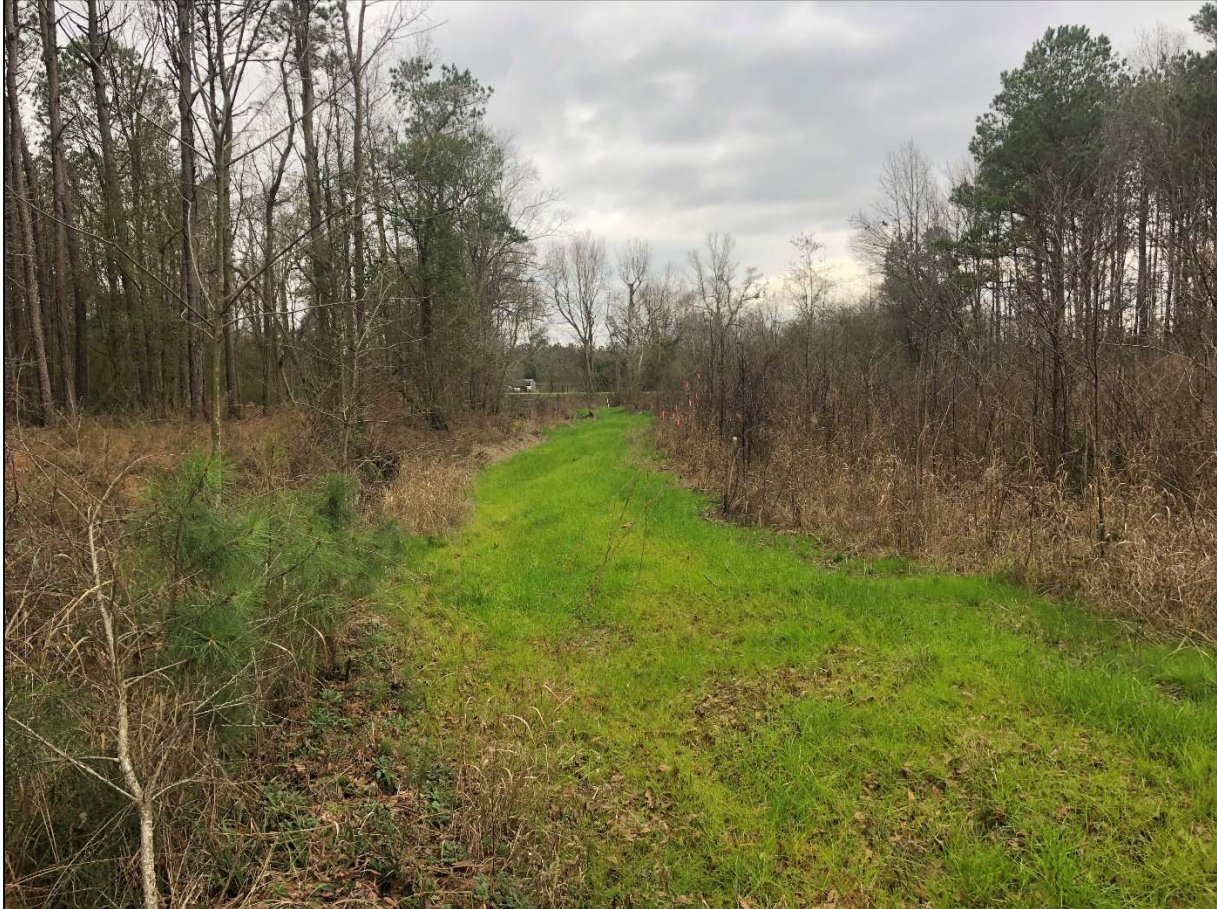
Table 8. Vegetation Problem Areas			
Muddy Run II Stream and Wetland Restoration Project - Project # 95354			
Feature Category	Station Numbers	Suspected Cause; Repair	Photo Number
Encroachment	RB Reach 5b	Fire plow; Natural regeneration	VPA1
Encroachment	WA	Mowing; Physical barrier	VPA2

Encroachment along the right bank of Reach 5b

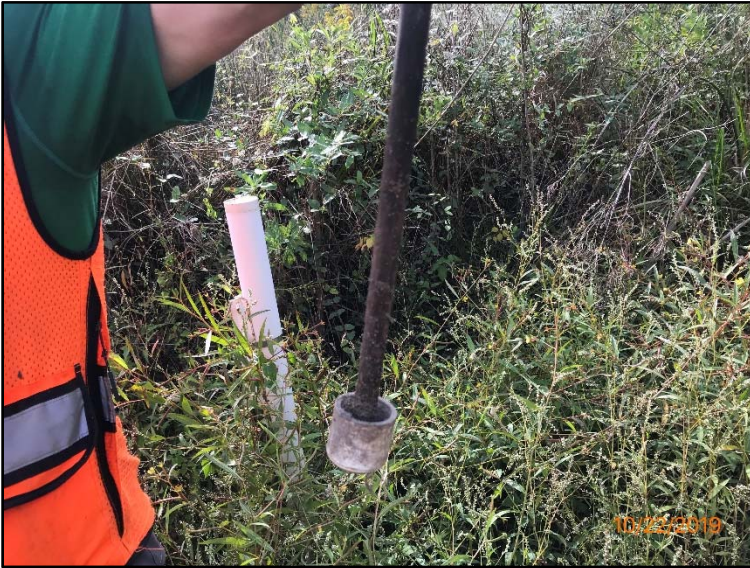
Four sets of continuous stage recorders were installed on the site, one along Reach 2, one along Reach 3a, one along Reach 3b, and one along Reach 5b. Two of the four stage recorders documented bankfull events during the Year 6 monitoring period. Stage Recorder 2, which is located on Reach 3a, documented 1 bankfull event during MY6 with a highest reading of 0.63 feet. Stage Recorder 4 (Reach 5b) logged 5 bankfull events during MY6 with a reading of 2.4 feet above bankfull elevation. Stage recorder summary data and photo documentation of the bankfull events can be found in **Appendix D**.

Photo 1. Crest Gauge 2 (Reach 3a – 0.63 ft. – 9/5/2019)

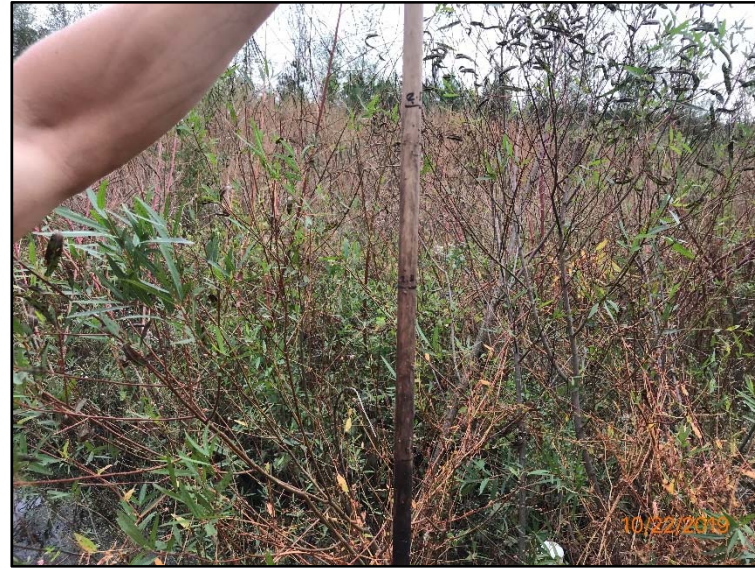
Photo 2. Crest Gauge 4 (Reach 5b – 2.40 ft. – 9/5/2019)
