**MUDDY RUN II STREAM AND WETLAND RESTORATION
PROJECT
MONITORING REPORT
MONITORING YEAR 7
FINAL**

DUPLIN COUNTY, NORTH CAROLINA
DMS CONTRACT No. 004631 – DMS PROJECT No. 95354
SAW-2011-02191
DWR 2013-0653

March 2021

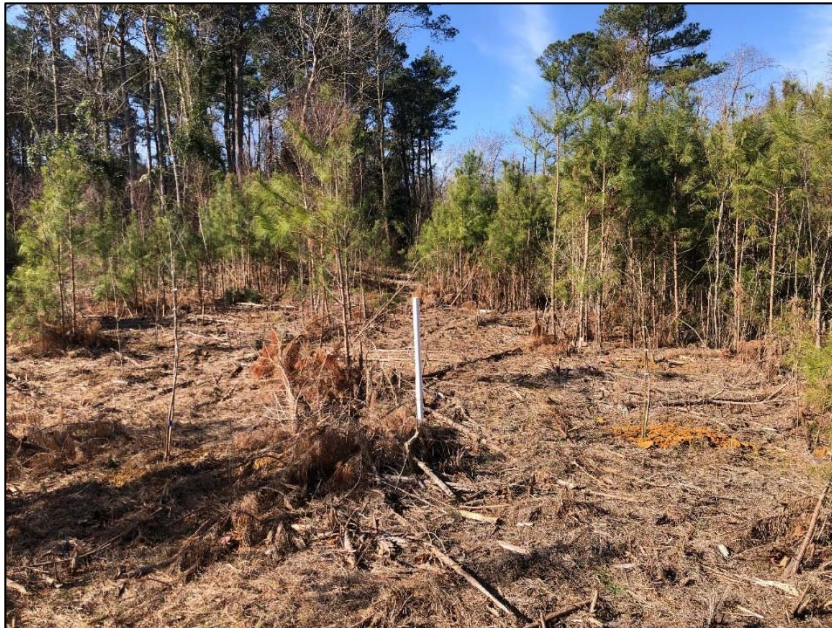
There were three methods of pine thinning performed in three separate areas on site. Along Reach 1 stump cut was used to cut pine trees down (0.28 acres), along Reach 3b the area was mulched with a skid-steerer (0.23 acres), and along Reach 5a the pine trees were girdled (0.25 acres). The areas along Reach 1 and Reach 3b required supplemental plantings which were performed in January 2021 and consisted of 160 3-gallon trees (sycamore, river birch, willow oak, and overcup oak). The two encroachment areas on Reach 3a were caused by missing easement poles and mowing which were repaired in January 2021. These areas total about 0.13 acres and were planted with 60 3-gallon trees (sycamore, river birch, willow oak, and overcup oak). The other encroachment area, Reach 5a, was an area where ATVs were cutting across the easement. This area (0.03 acres) was repaired and replanted in January 2021 (15 3-gallon sycamore, river birch, willow oak, and overcup oak). As of March 2021, no further encroachment has occurred.

Photo 2 – Pine Thinning Area - LB Reach 3b (Replanted January 2021)

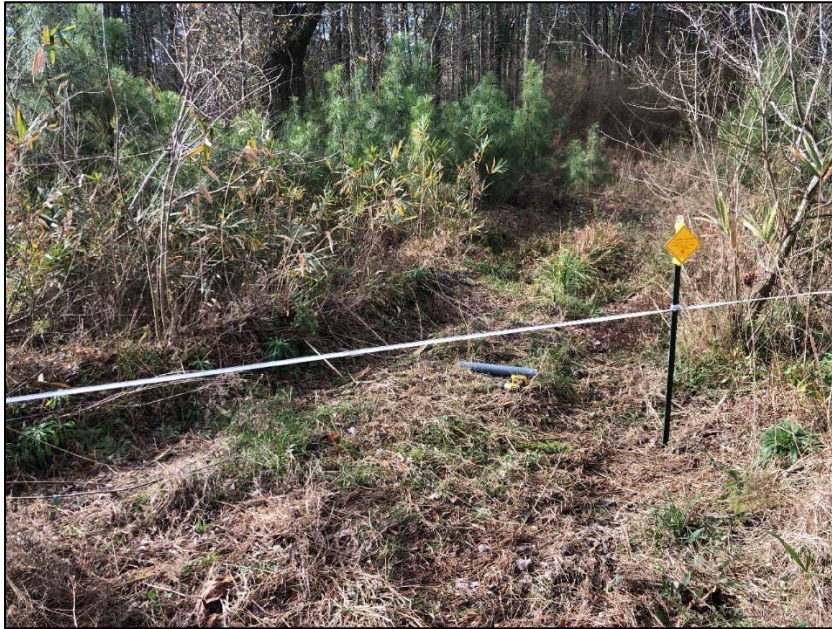
These areas total about 0.13 acres and were planted with 60 3-gallon trees (sycamore, river birch, willow oak, and overcup oak). The other encroachment area, Reach 5a, was an area where ATVs were cutting across the easement (Photo 3). This area (0.03 acres) was repaired and replanted in January 2021 (15 3-gallon sycamore, river birch, willow oak, and overcup oak). As of March 2021, no further encroachment has occurred. Additionally, there was a low stem density area where the fire plow went through the easement in 2019 along Reach 5b (Photo 1). This area totaled 0.06 acres and was planted with container trees in January 2021 (30 3-gallon sycamore, river birch, willow oak, and overcup oak).

Photo 3 – Encroachment - Top of Reach 5b (Repaired/Replanted January 2021)

RES has replaced all damaged/missing easement signs. There has been no further encroachment since the addition of the t-posts/signs on Reach 5b and there is evidence of ATV traffic across the crossing/easement break upstream on Reach 5a.

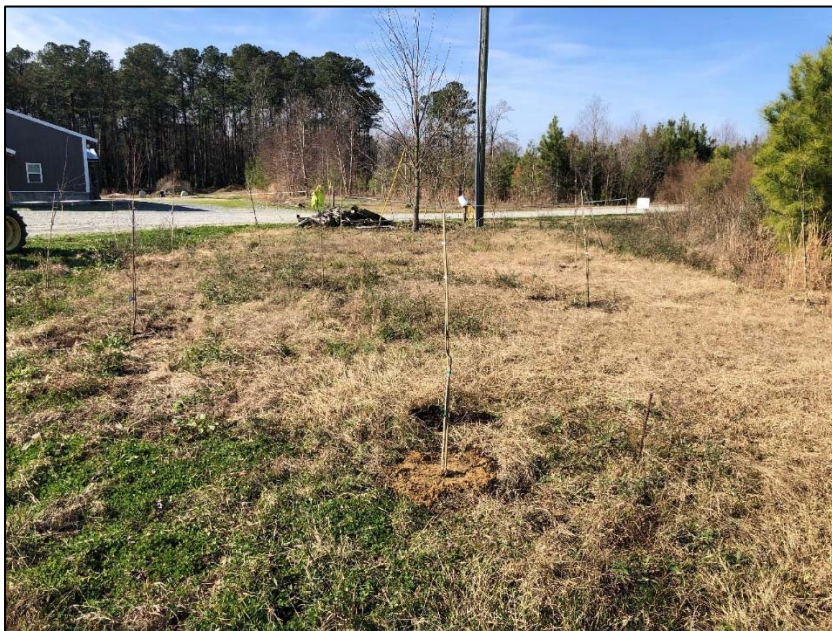
Photo 4 – Encroachment – Reach 3 (Repaired/Replanted January 2021)

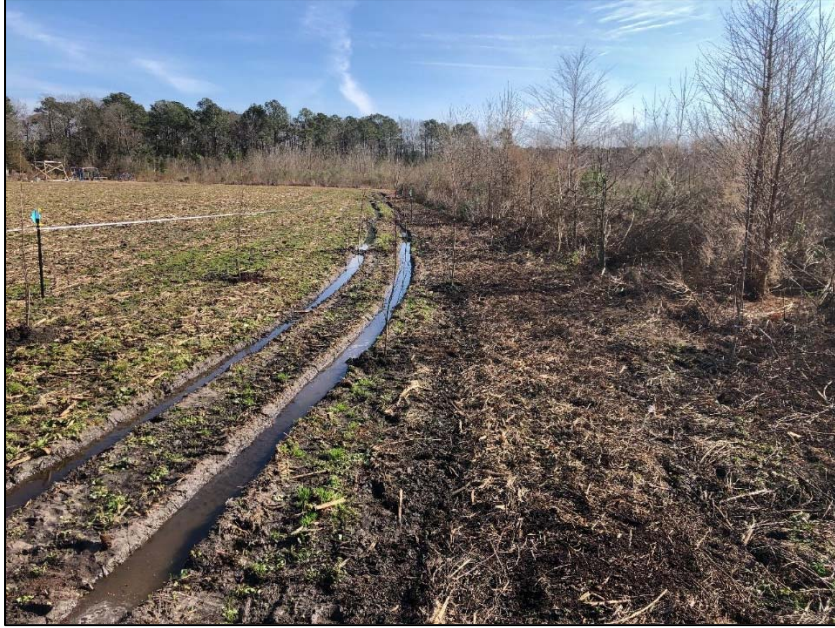
Photo 5 – Encroachment – Reach 3 (Repaired/Replanted January 2021)

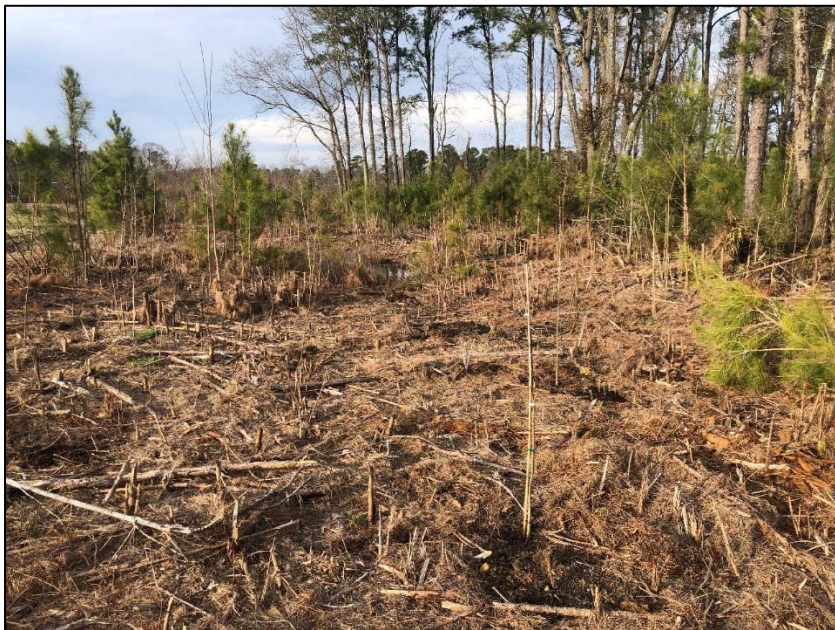
Photo 6 – Pine Thinning – Reach 1 (Replanted January 2021)
