FINAL
AS-BUILT BASELINE
MONITORING REPORT
MUD LICK CREEK MITIGATION SITE
Chatham County, North Carolina

NCDMS Project No. 93482
Contract No. 7683
USACE Action ID No. SAW-2014-00736 & DWR Project No 2014-1127
SCO No. 1209857-01
Data Collection: July 2018
Submission: September 2018

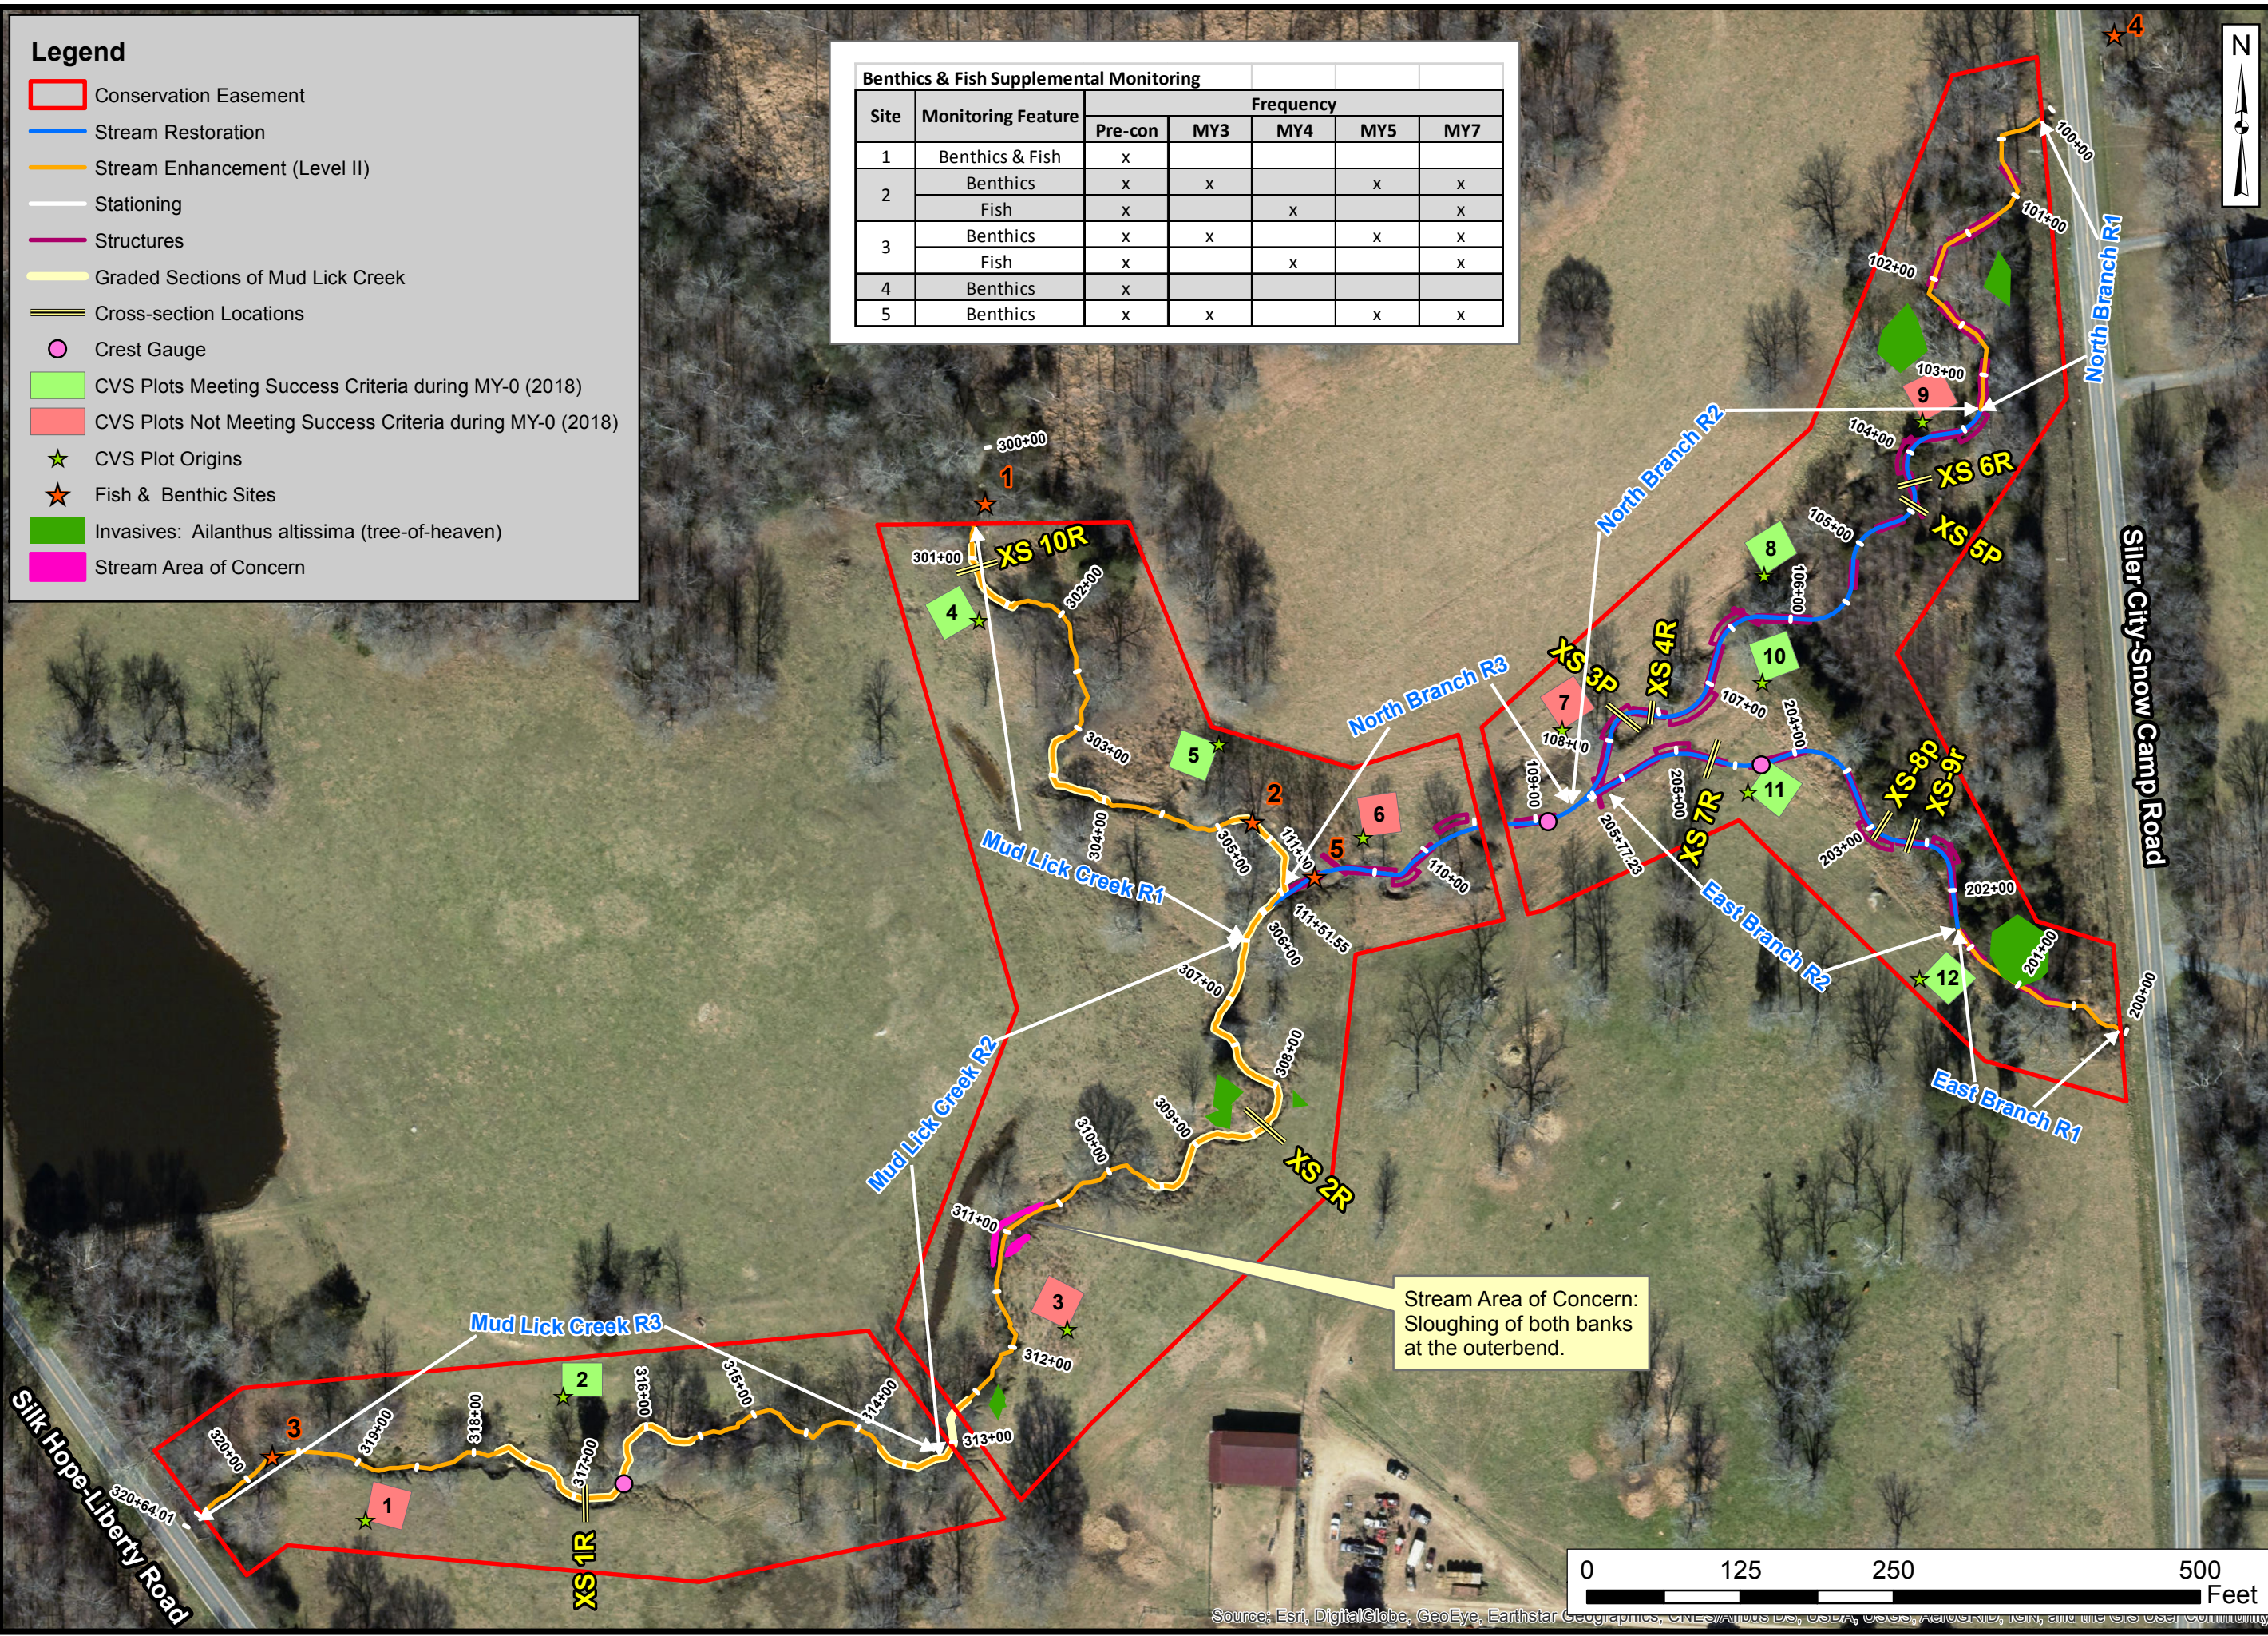
Title:
CURRENT CONDITIONS PLAN VIEW

One stream area of concern was observed along a large bend in Mud Lick Creek Reach 2 (Figure 2, Appendix B). Approximately 50 feet of the right bank and 20 feet of the left bank have eroded to the point of bank sloughing. This area currently appears relatively unstable, and it will be closely monitored during year 1.

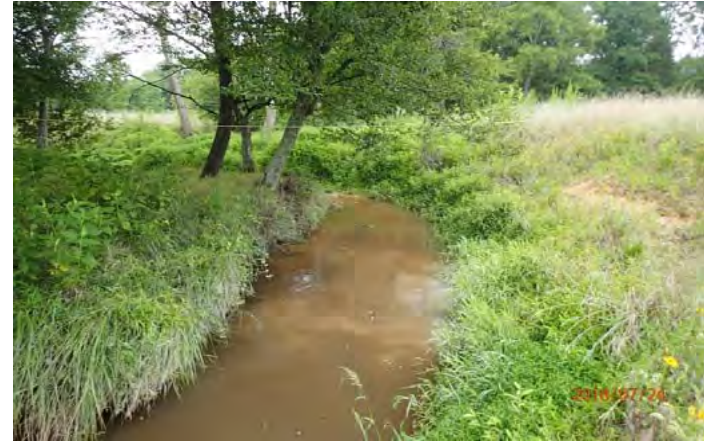
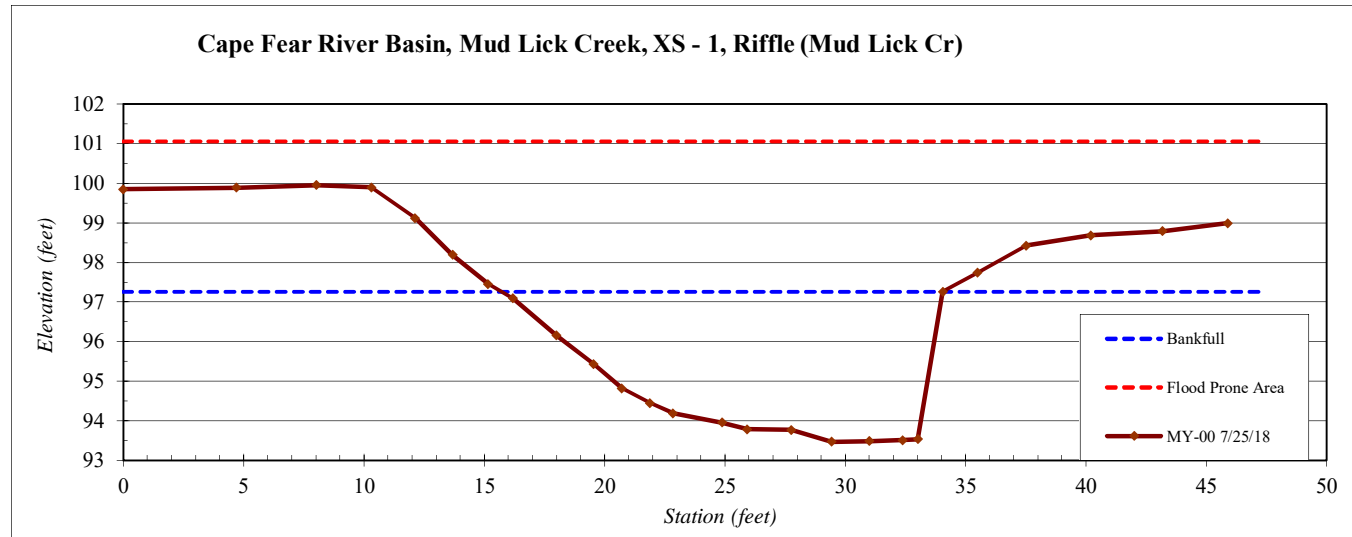
River Basin:	Cape Fear
Site Name	Mud Lick Creek
XS ID	XS - 1, Riffle (Mud Lick Cr)
Drainage Area (sq mi):	3.64
Date:	7/25/2018
Field Crew:	Perkinson, Smith

SUMMARY DATA	
Bankfull Elevation:	97.3
Bankfull Cross-Sectional Area:	49.8
Bankfull Width:	18.3
Flood Prone Area Elevation:	101.1
Flood Prone Width:	100.0
Max Depth at Bankfull:	3.8
Mean Depth at Bankfull:	2.7
W / D Ratio:	6.7
Entrenchment Ratio:	5.5
Bank Height Ratio:	1.3

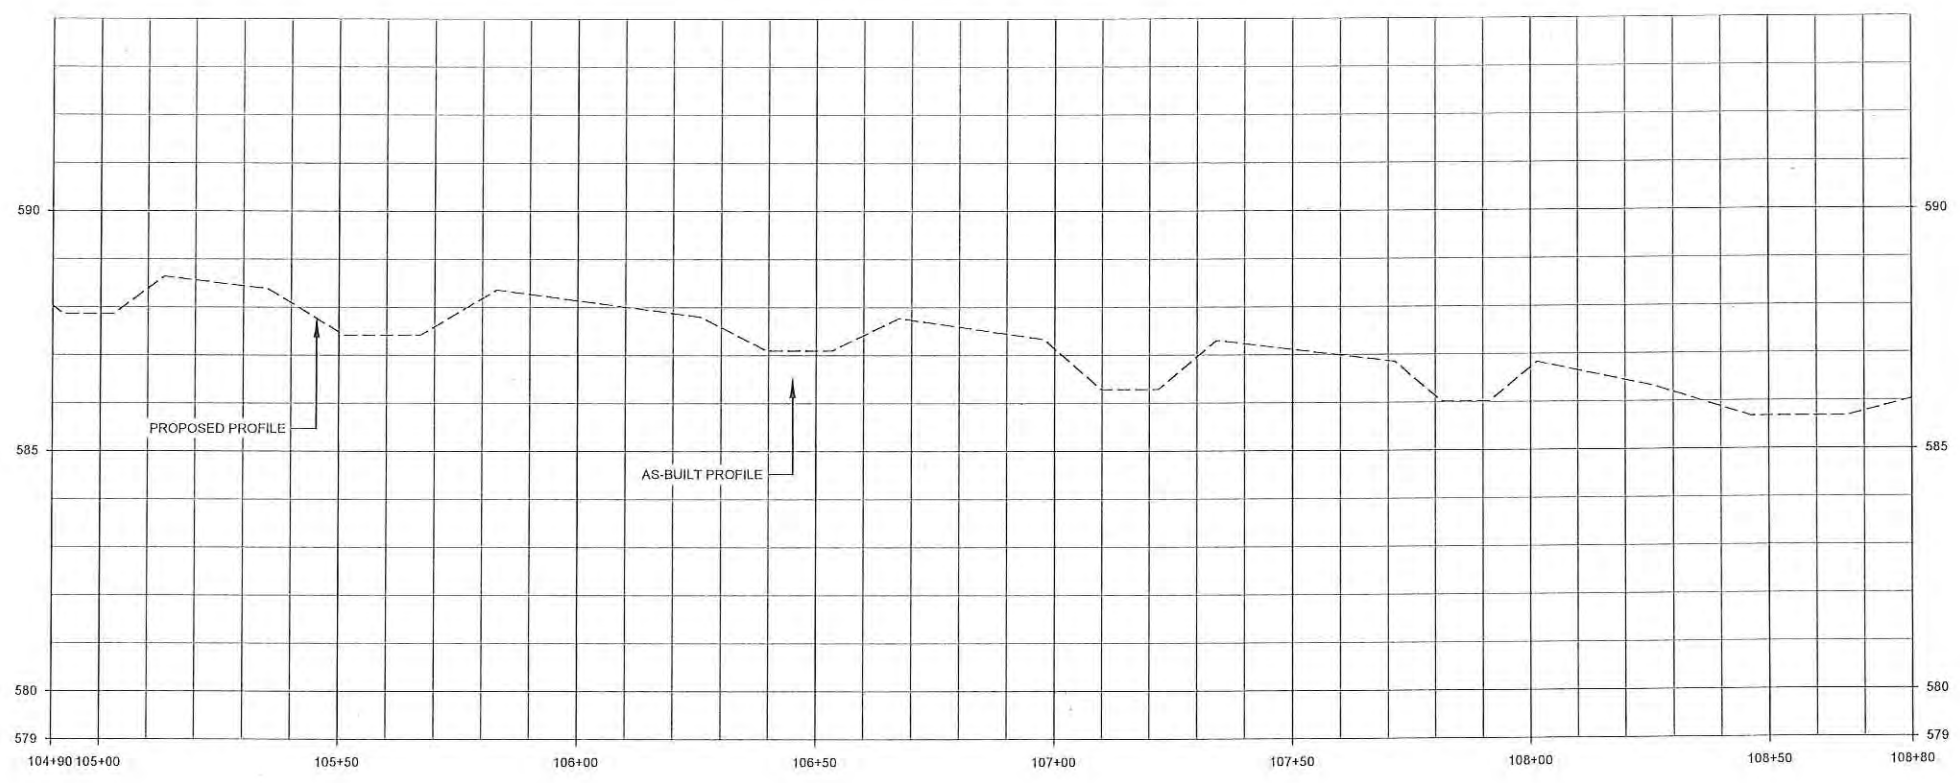
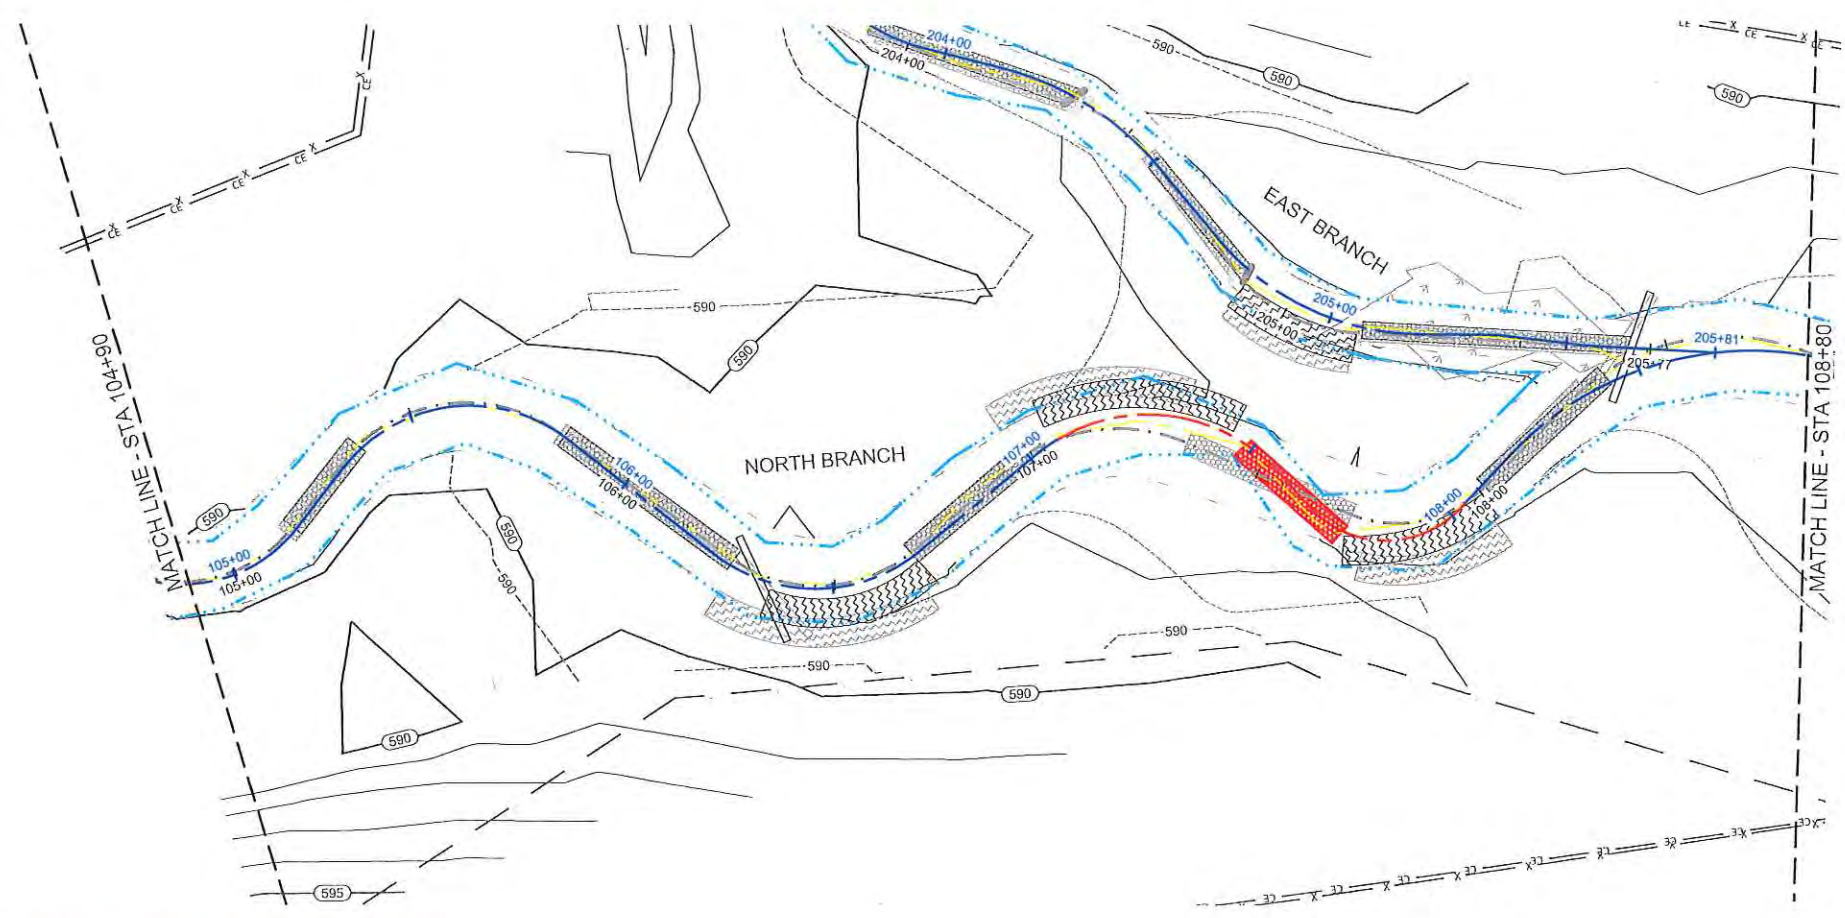
NOTE: FROM NORTH BRANCH STA. 107+55 TO STA. 107+86, PROPOSED STREAM ALIGNMENT REALIGNED IN ORDER TO AVOID EXISTING BEDROCK.

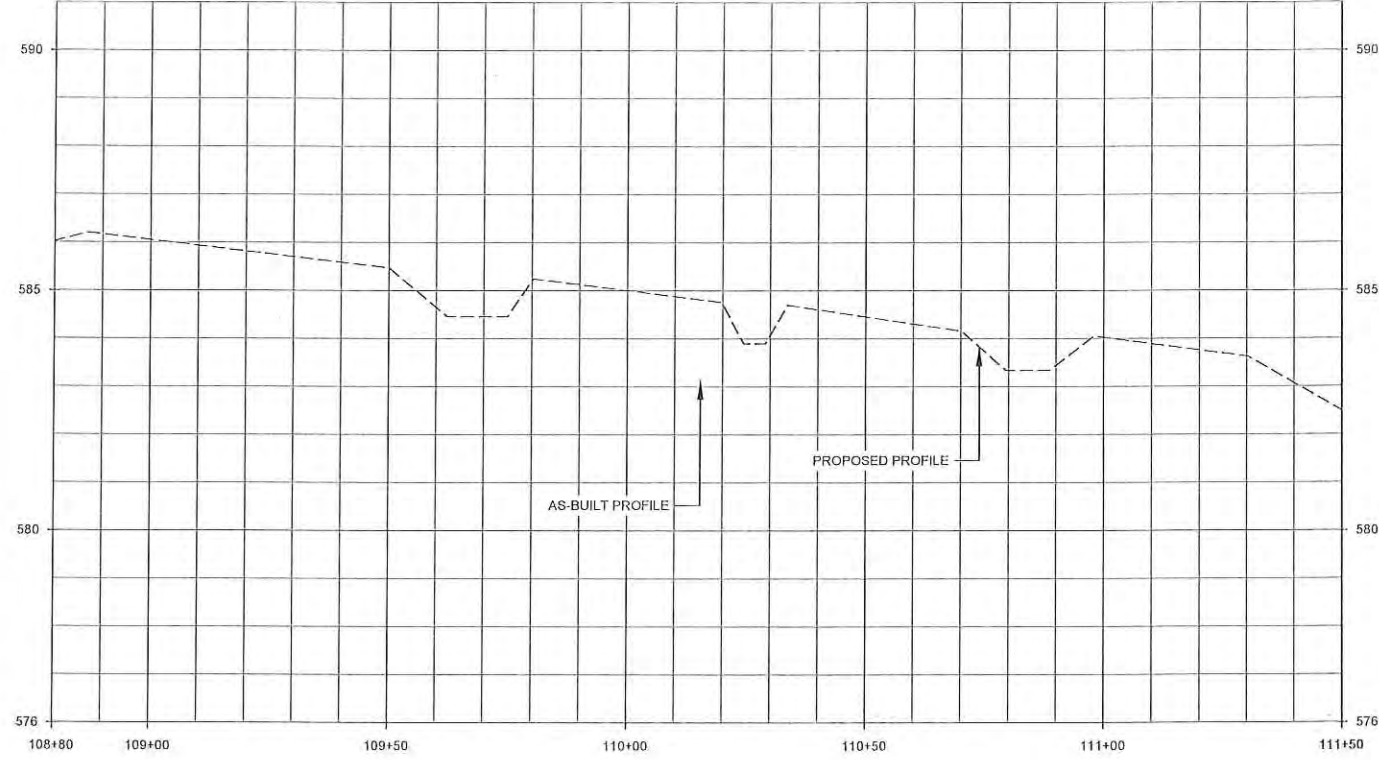
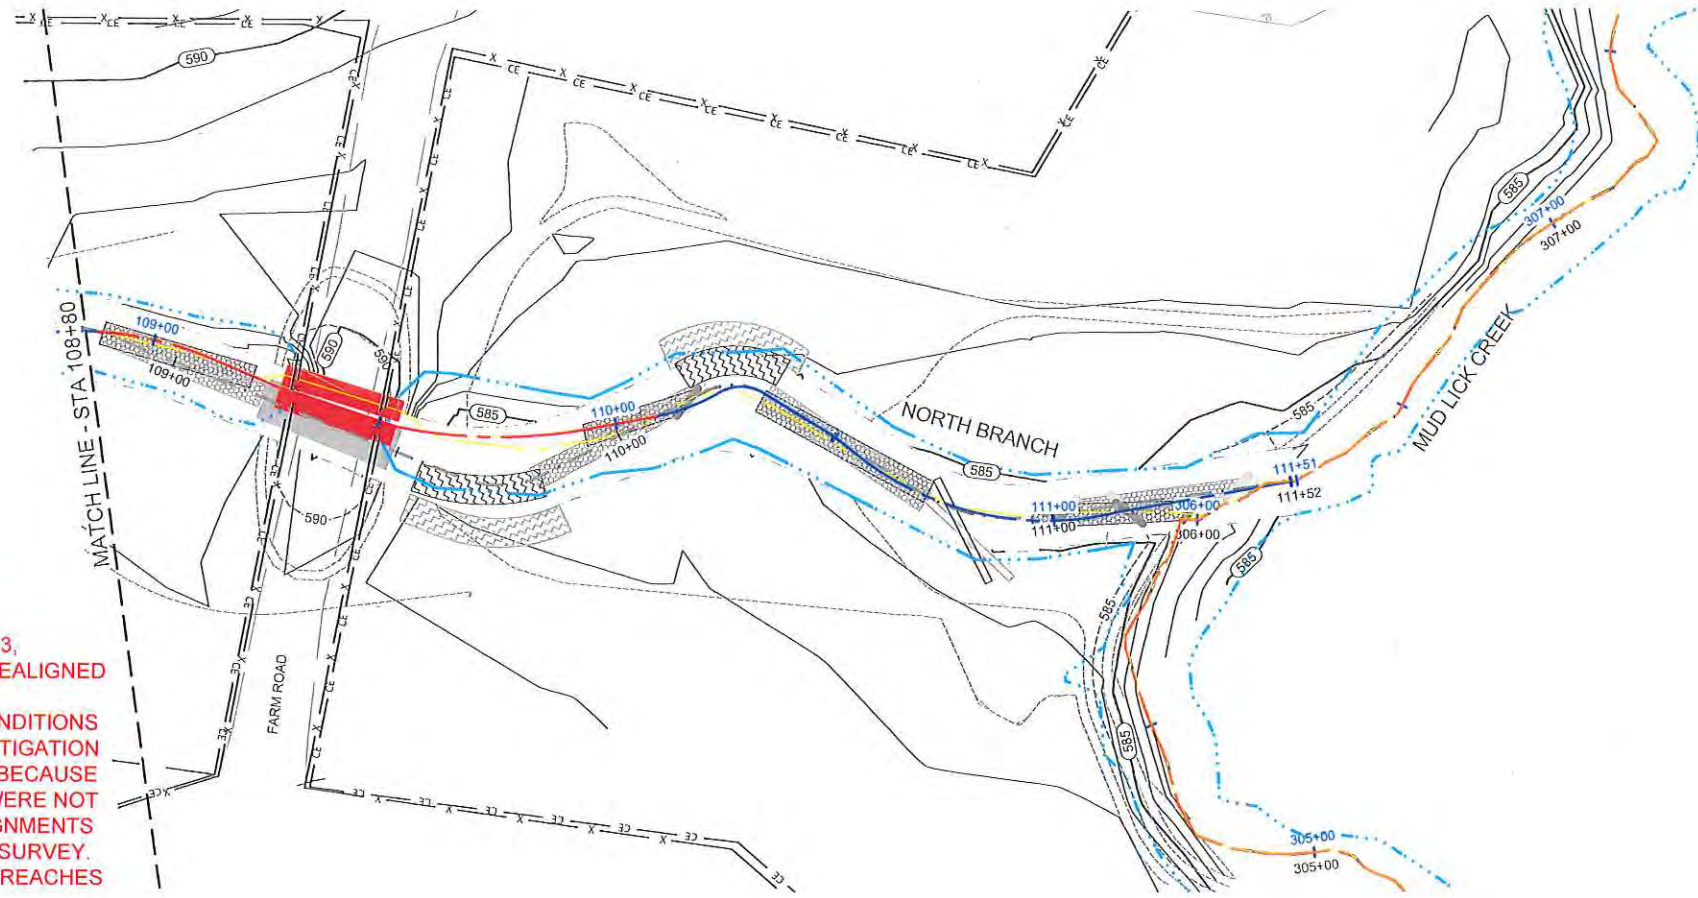
- NOTES:**
1. FROM NORTH BRANCH STA. 108+82 TO STA. 110+03, PROPOSED STREAM ALIGNMENT AND CULVERT REALIGNED IN ORDER TO AVOID EXISTING BEDROCK.
 2. FOR ENHANCEMENT REACHES, THE EXISTING CONDITIONS THALWEG WAS USED TO DEVELOP PROPOSED MITIGATION CREDITS AS OUTLINED IN THE MITIGATION PLAN. BECAUSE THE ALIGNMENTS OF ENHANCEMENT REACHES WERE NOT ALTERED DURING CONSTRUCTION, AS-BUILT ALIGNMENTS ARE ALSO BASED ON THE EXISTING CONDITIONS SURVEY.
 3. AS-BUILT BANKFULL LINES FOR ENHANCEMENT II REACHES ARE BASED ON EXISTING CONDITIONS SURVEY.
