FINAL
MONITORING REPORT
YEAR 1 (2018)
MUD LICK CREEK MITIGATION SITE

Chatham County, North Carolina

NCDMS Project No. 93482

Data Collection: December 2018

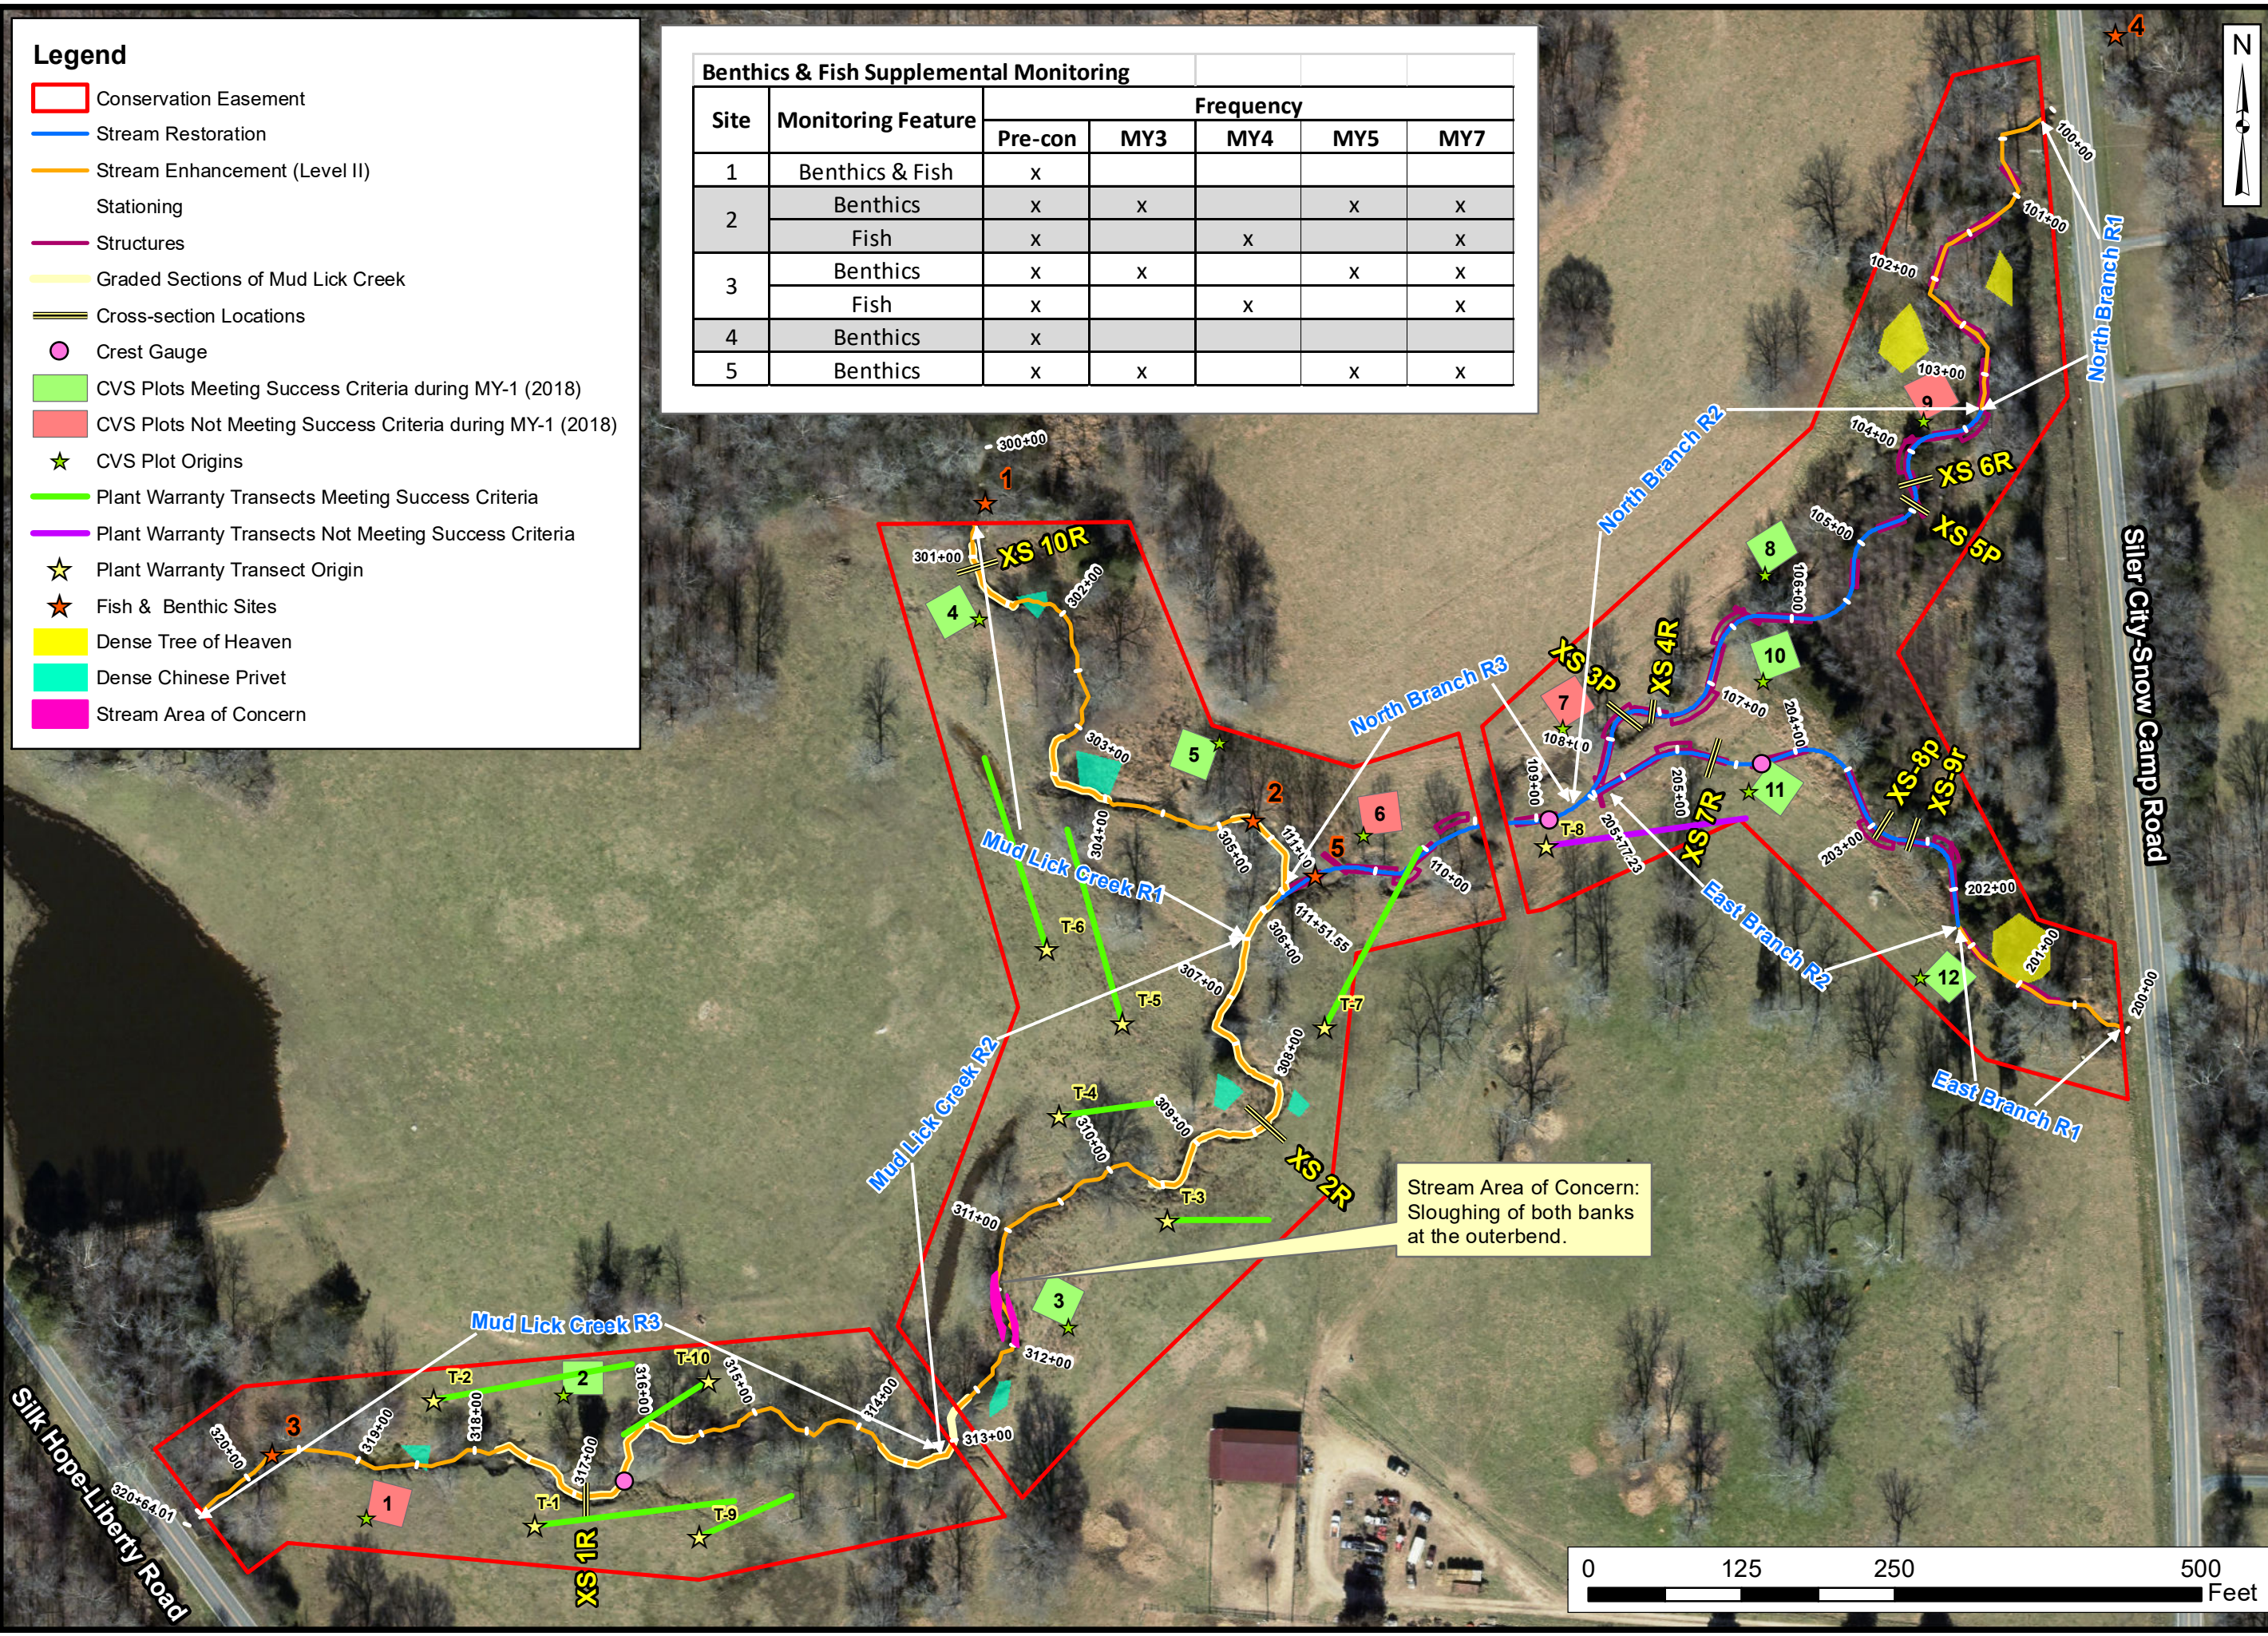
Title:
**CURRENT
 CONDITIONS
 PLAN
 VIEW**

One stream area of concern was observed along a large bend in Mud Lick Creek Reach 2 (Figure 2, Appendix B). Approximately 50 feet of the right bank and 20 feet of the left bank have eroded to the point of bank sloughing due to several historical storm events during MY-01. This area is relatively unstable,

additional erosion and sloughing will be documented during subsequent visits throughout the monitoring period.

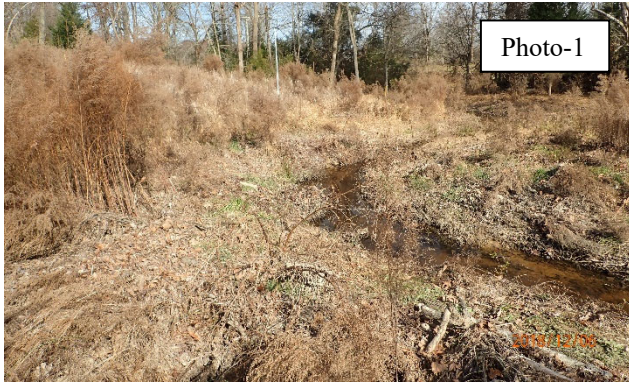
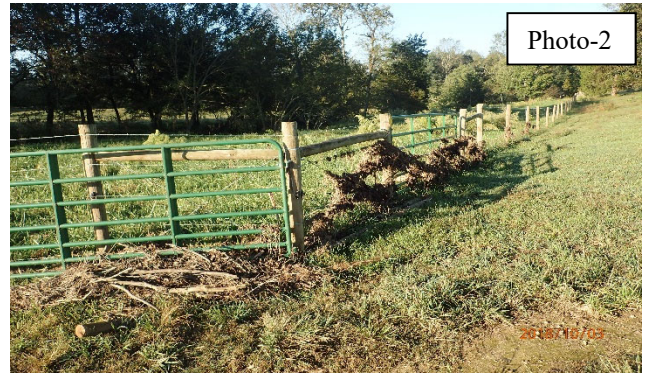
Date of Data Collection	Date of Occurrence	Method	Photo (if available)
12-06-2018	October 16-17, 2018	Observations throughout flood plain and crest gauge indicate a bankfull event after 4.61 inches of rain fell over 48 hours.	1-2
