FINAL
MONITORING REPORT
YEAR 2 (2019)
MUD LICK CREEK MITIGATION SITE

Chatham County, North Carolina

NCDMS Project No. 93482

Submission: January 2020

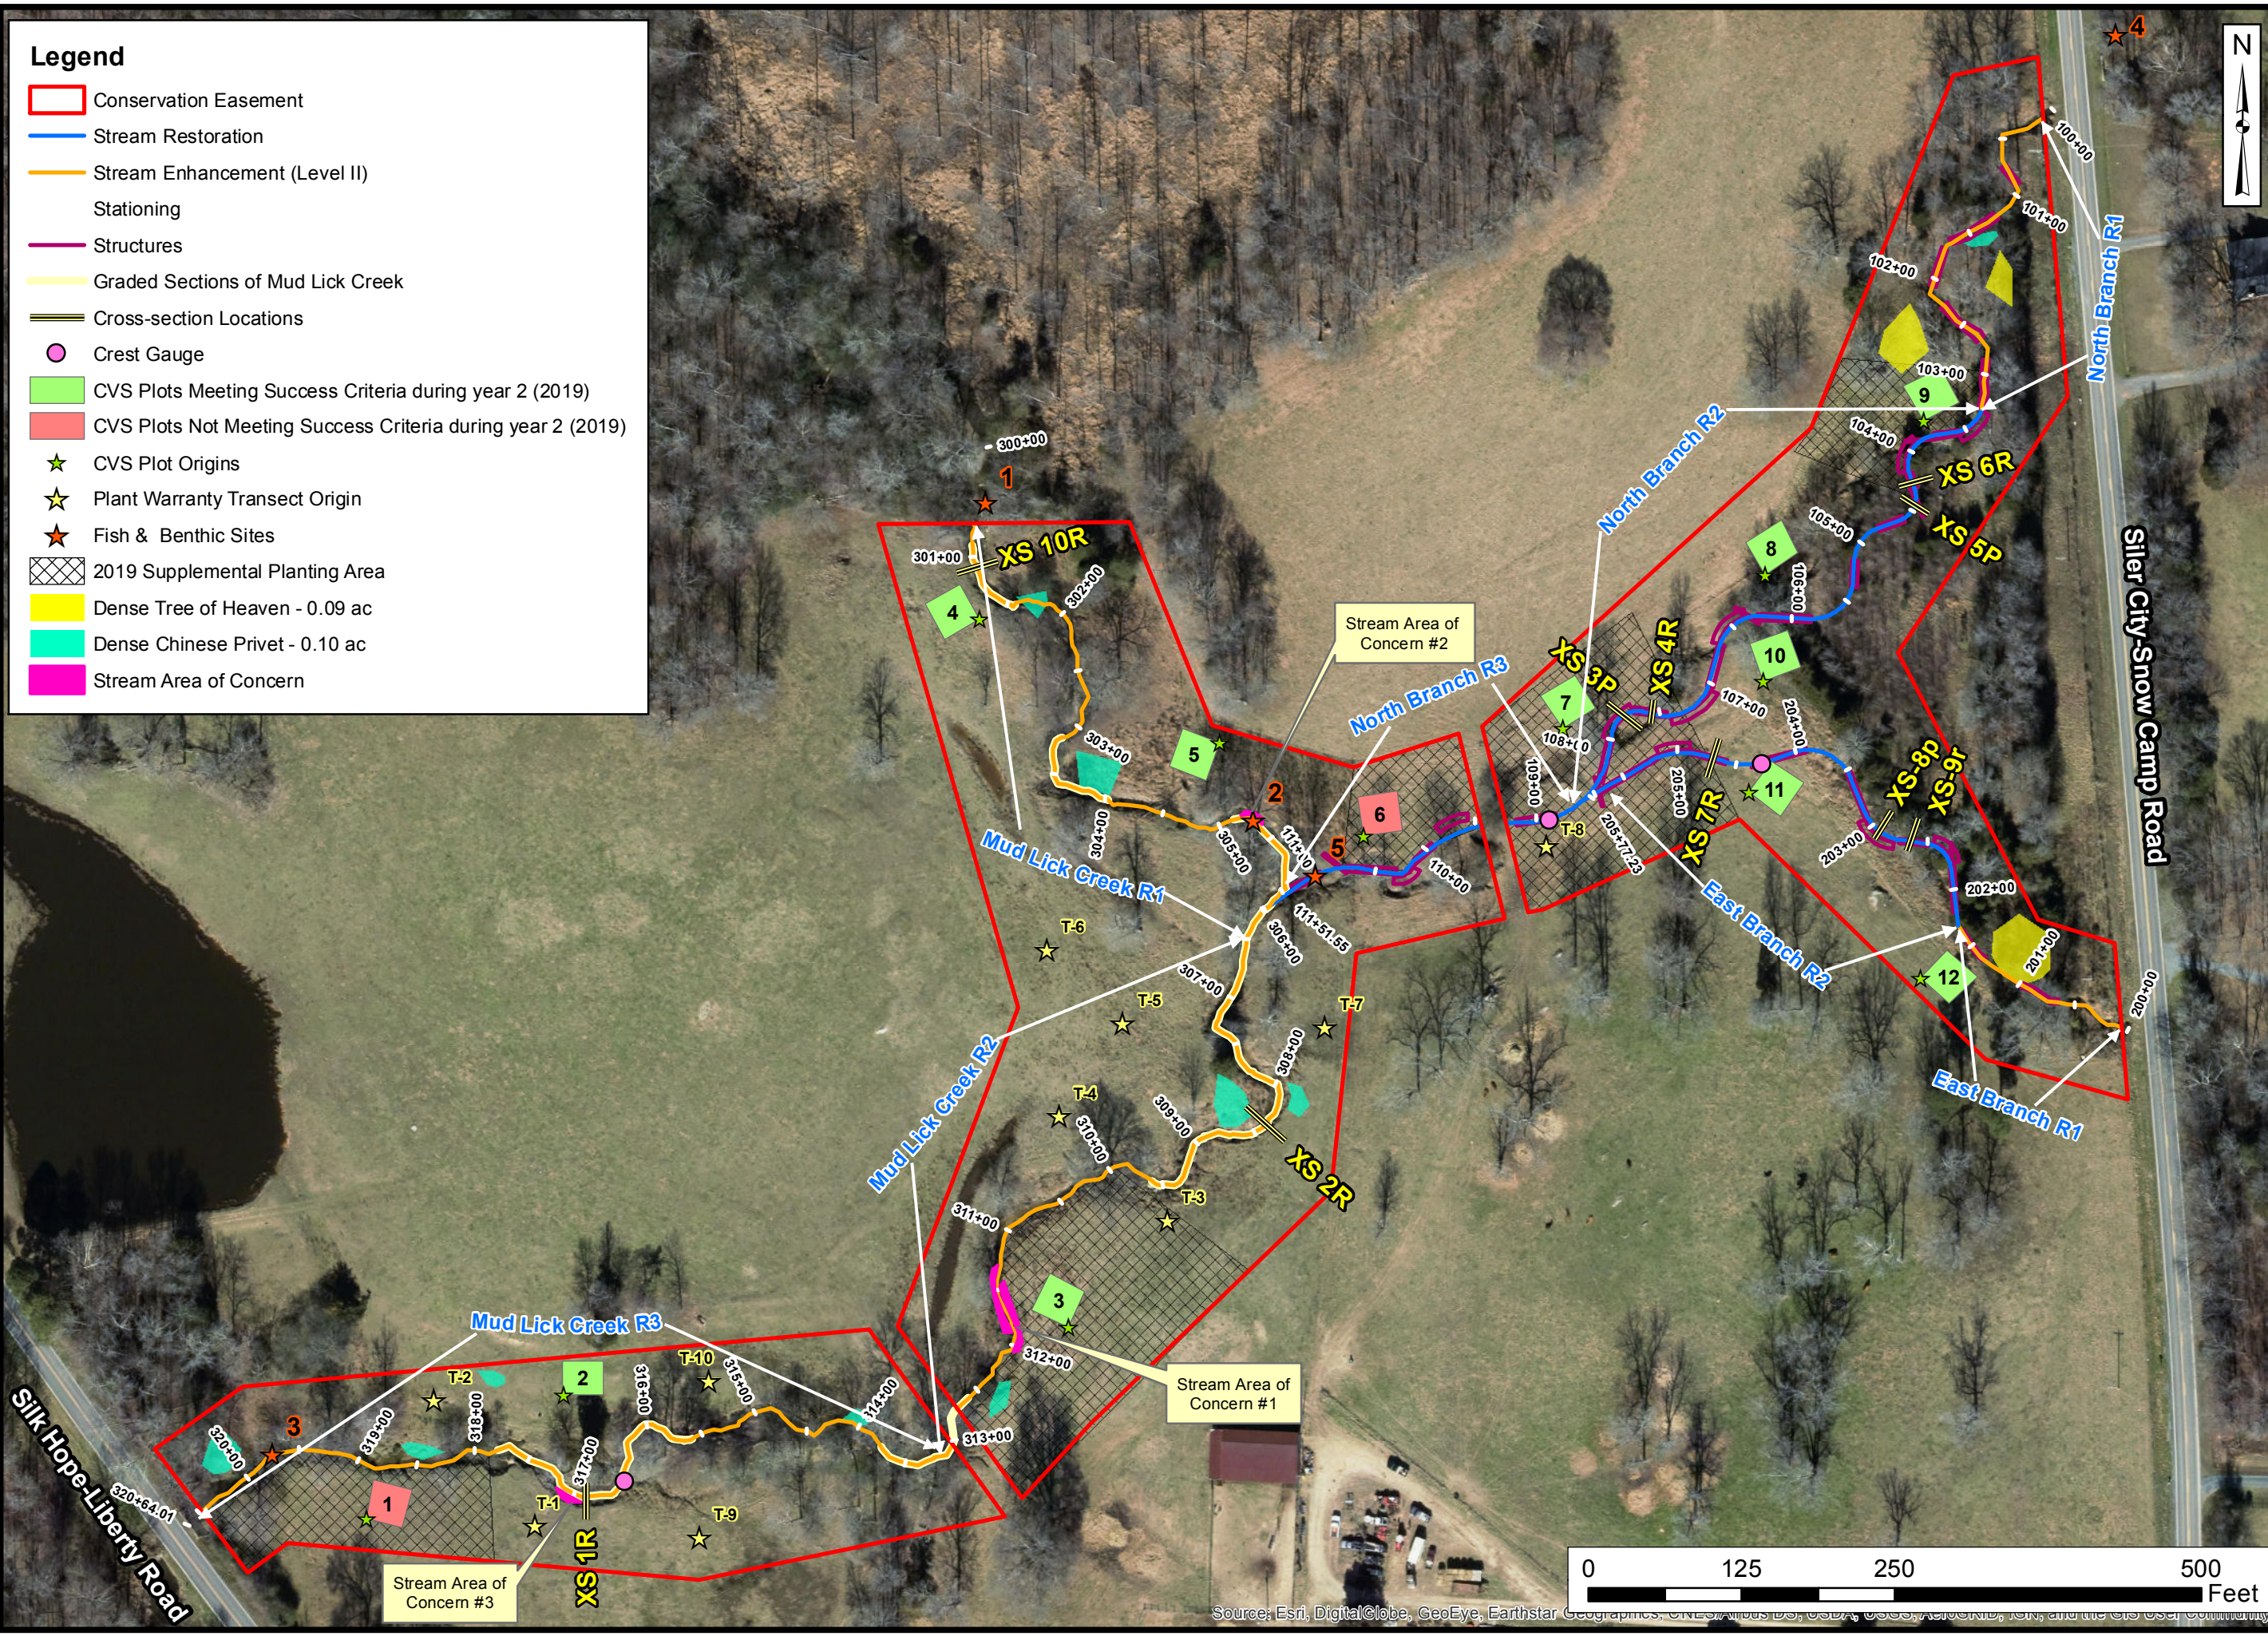
FIGURE
2

Three stream areas of concern were observed during monitoring year 2 (2019). Stream Area of Concern #1 was previously documented during year 1 (2018) along Mud Lick Creek R2 where approximately 50

feet of the right bank and 20 feet of the left bank had eroded to the point of bank sloughing. This area remains unchanged from year 1 (2018). Two additional areas of instability were documented during a site visit early in year 2 (2019). Area of Concern #2 was confined to approximately ten feet of an outer bend in the lower portion of Mud Lick Creek R1 that has sloughed, this area remains relatively unchanged from the previous site visit. Area of Concern #3 consists of scour and sloughing along an outer bend immediately downstream of cross-section 1. These areas of instability can be attributed to the impacts from storm events during the fall of 2018 (year 1). Stream areas of concern were only observed within enhancement II stream reaches; stream reaches generating restoration credit were stable throughout and functioning as designed. These areas are depicted on Figure 2 in Appendix B.

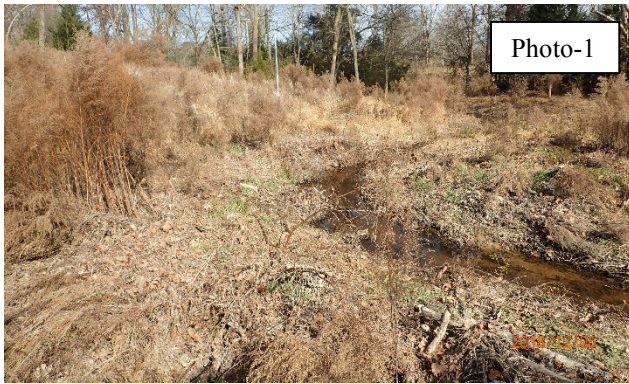
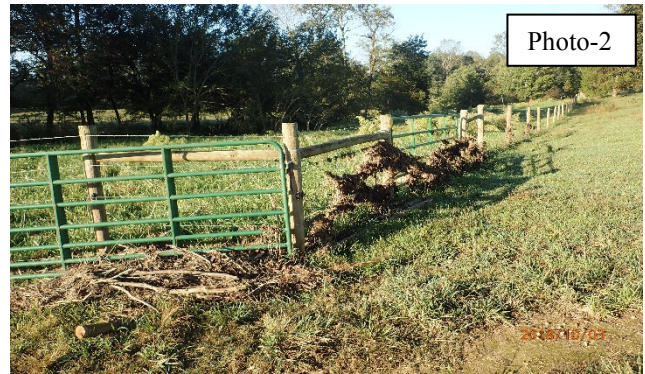
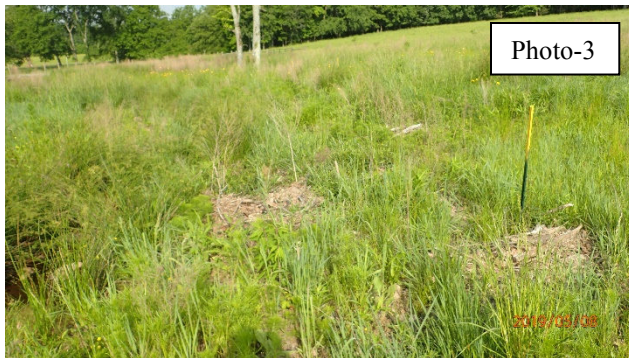
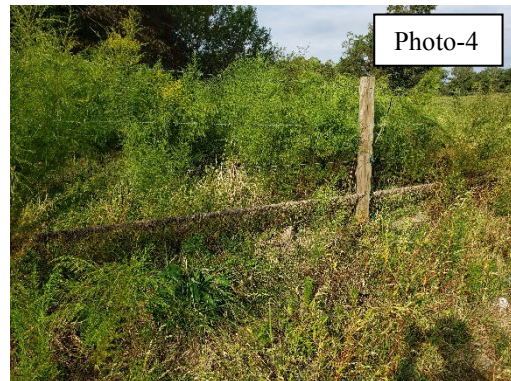
Date of Data Collection	Date of Occurrence	Method	Photo (if available)
December 6, 2018	October 16-17, 2018	Observations throughout floodplain and crest gauge indicate a bankfull event after 4.61 inches of rain fell over 48 hours.	1-2
May 8, 2019	February 24, 2019	Observation of wrack in floodplain and crest gauge data indicate a bankfull event after 2.27 inches of rain fell over 48 hours.	3
September 18, 2019	July 24, 2019	Observation of wrack on floodplain fences and crest gauge data indicate a bankfull event after 3.02 inches of rain fell over 48 hours.	4
