FINAL
MONITORING REPORT
YEAR 3 (2020)
MUD LICK CREEK MITIGATION SITE

Chatham County, North Carolina

NCDMS Project No. 93482

Data Collection: September 2020

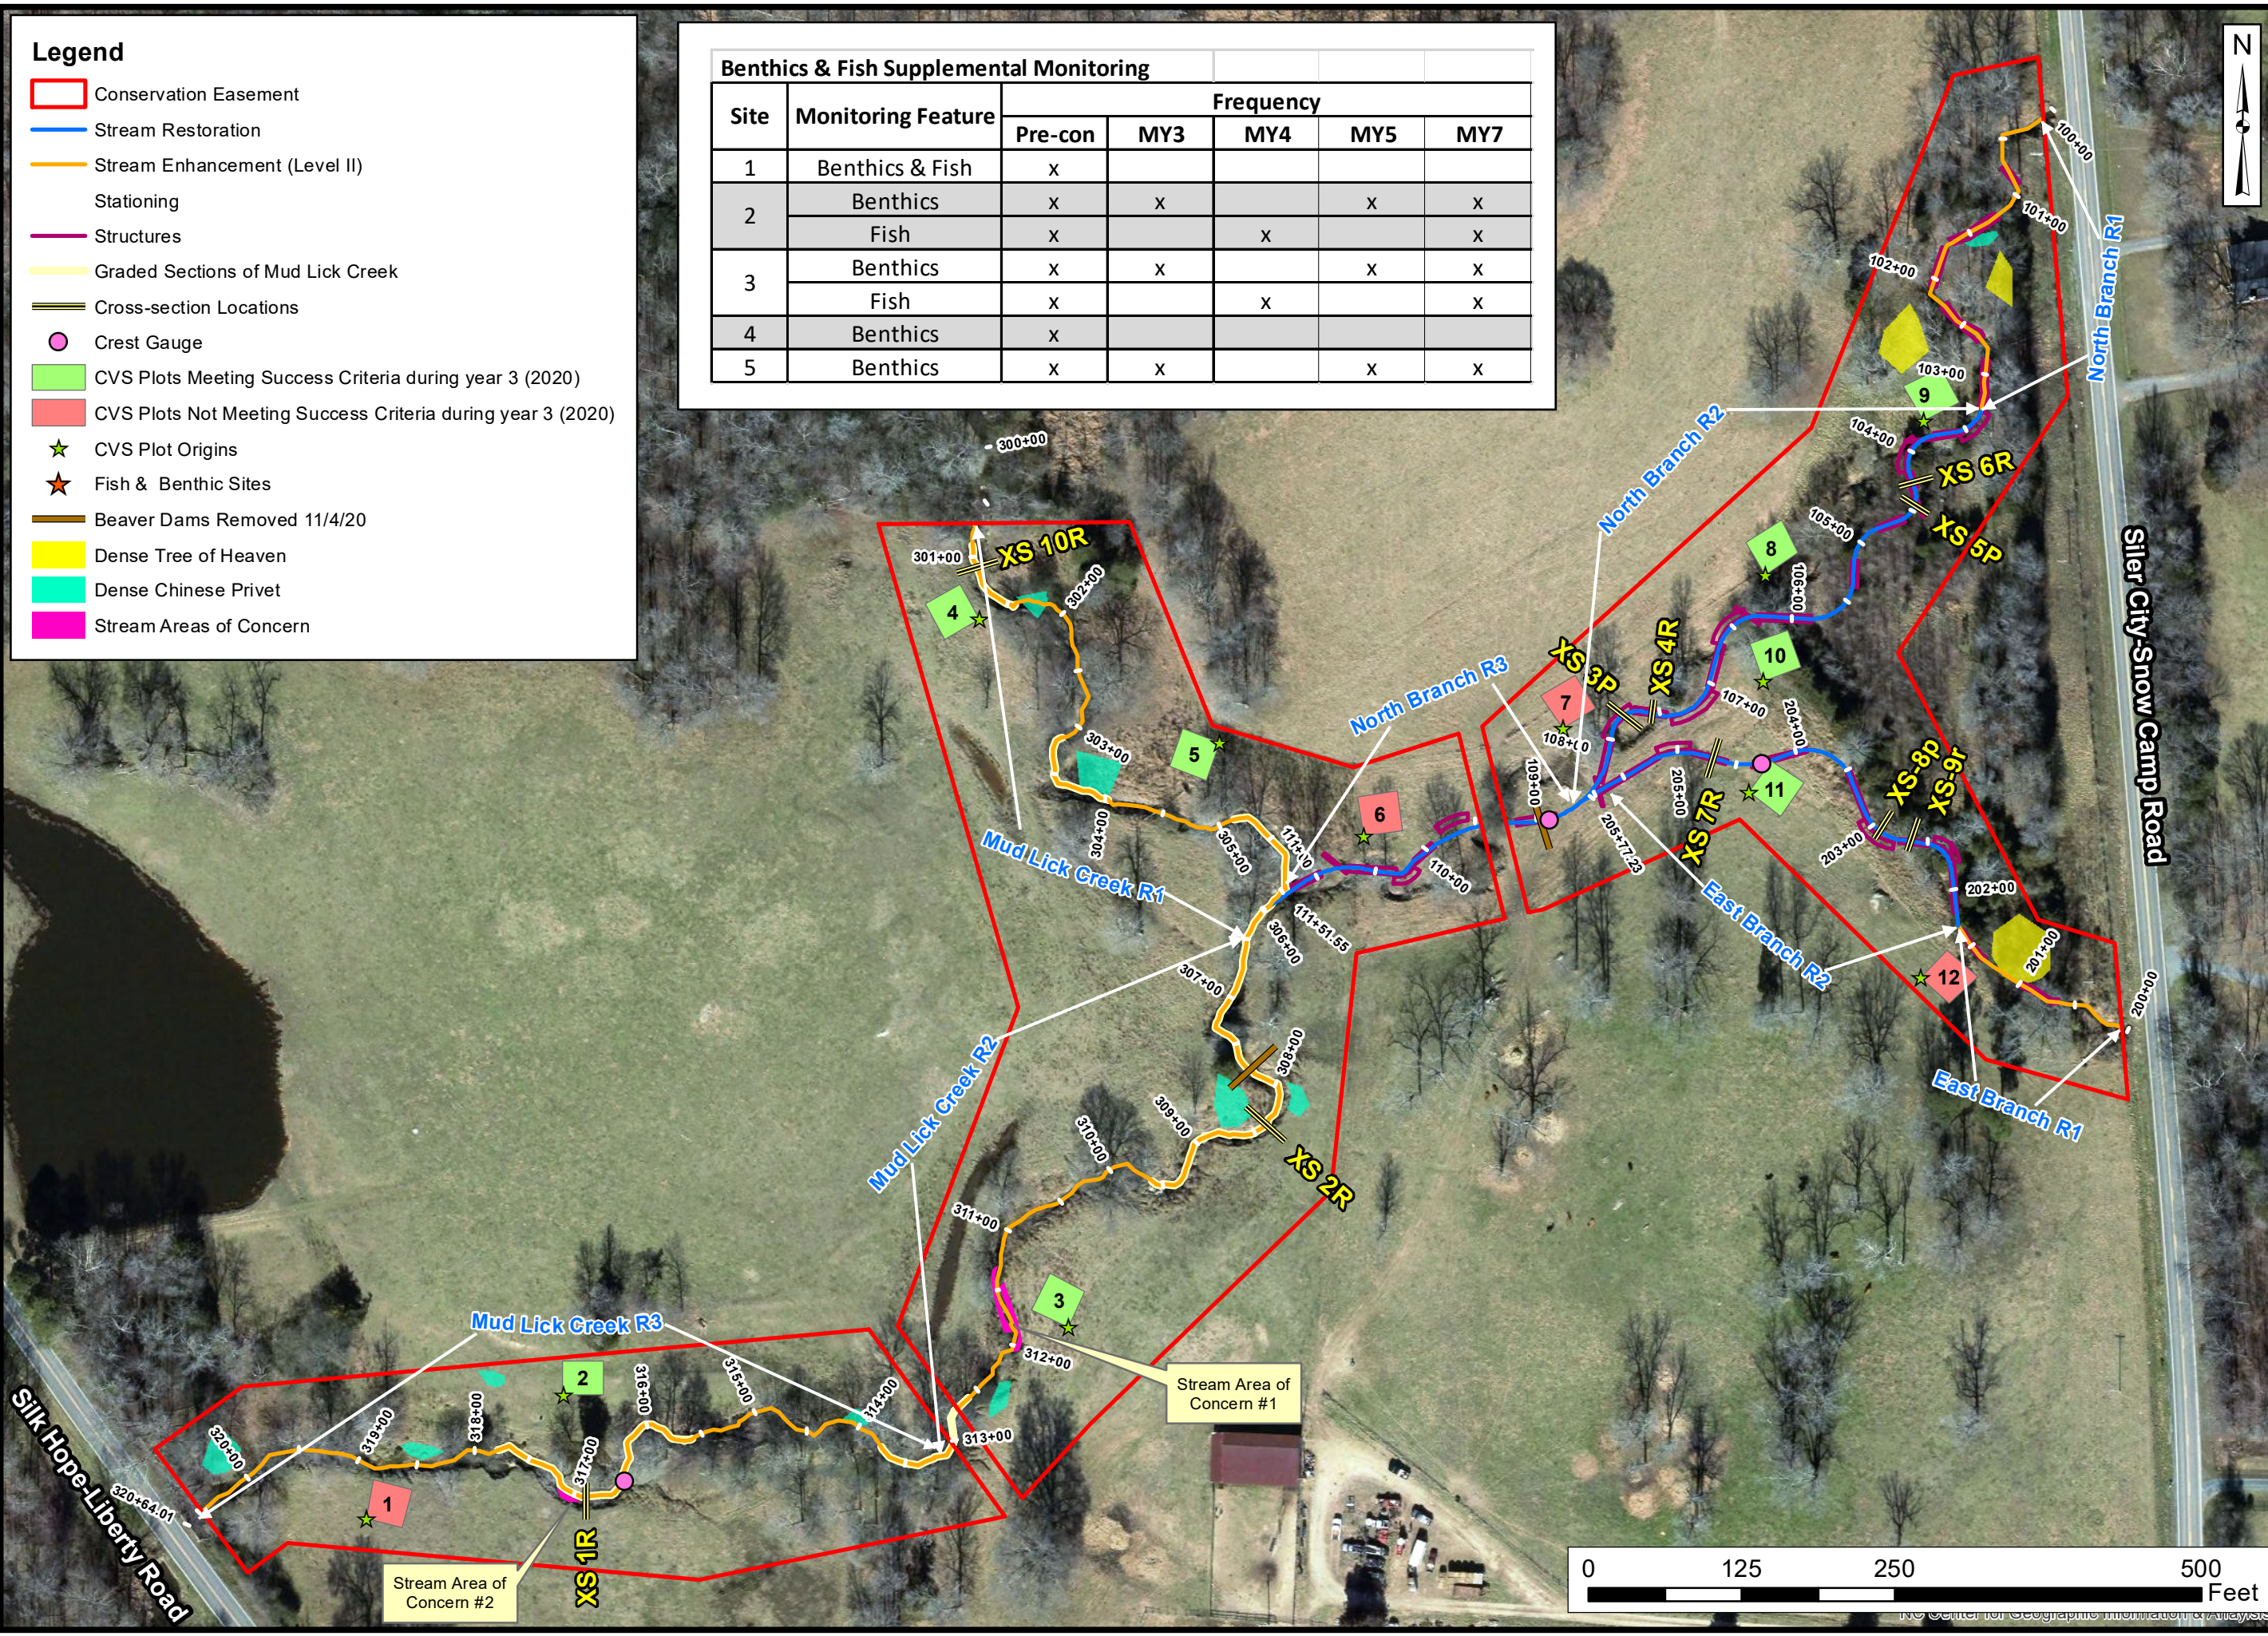
Title:
**CURRENT
 CONDITIONS
 PLAN
 VIEW**

Two stream areas of concern were observed during monitoring year 3 (2020). Stream Area of Concern #1 was previously documented during years 1 and 2 (2018 and 2019) along Mud Lick Creek R2 where

approximately 50 feet of the right bank and 20 feet of the left bank had eroded to the point of bank sloughing. This area remains unchanged from year 1 (2018); however, with the establishment of some herbaceous vegetation, appears relatively stable. Stream Area of Concern #2 consists of scour and sloughing along an outer bend along Mud Lick Creek R3, immediately downstream from cross-section 1. It was noted during year 3 (2020) that the material that had sloughed from the bank was stable and well-vegetated. Both stream areas of concern were observed within enhancement II stream reaches; stream reaches generating restoration credit were stable throughout and functioning as designed. These areas are depicted on Figure 2 in Appendix B.

During year 3 (2020) monitoring, onsite beaver activity was observed including a dam along North Branch R3, a dam along Mud Lick Creek R2, and several smaller dams throughout the Site. In response, on November 4, 2020, USDA trapped beaver and removed six dams. Beaver activity will continue to be closely monitored throughout the remaining monitoring period. The locations of the two major removed dams are depicted on Figure 2 (Appendix B).

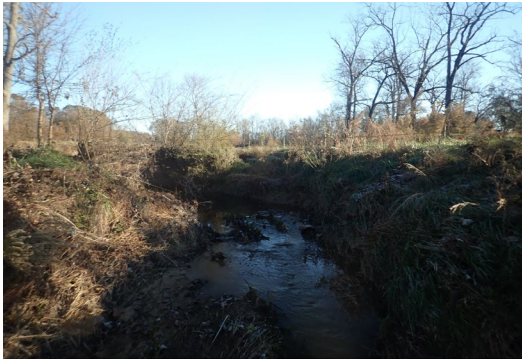
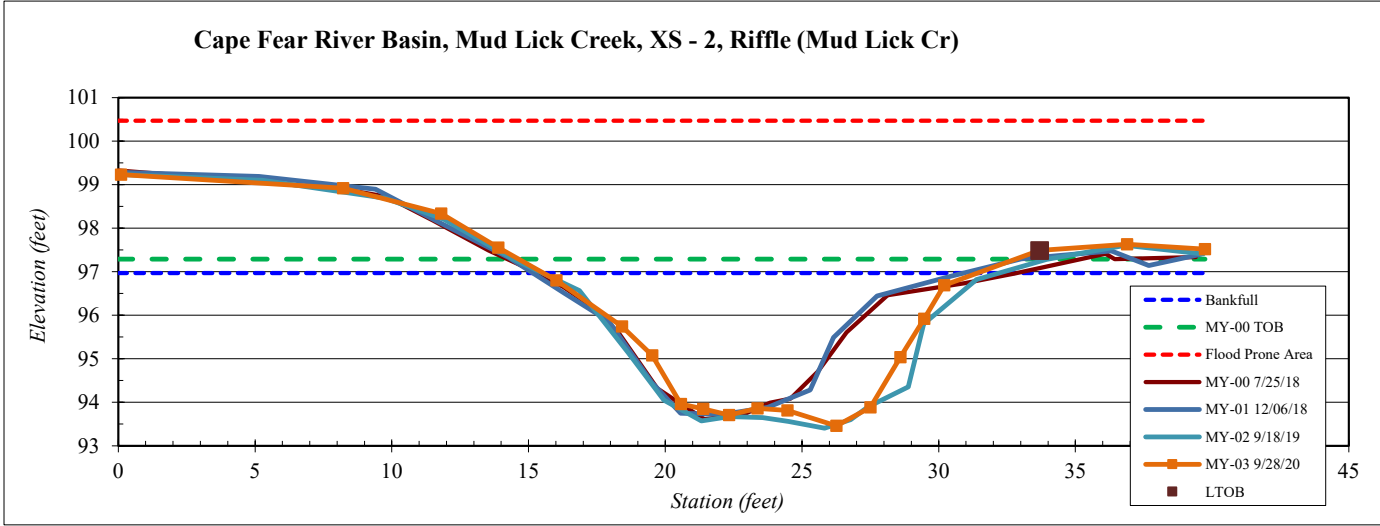
River Basin:	Cape Fear
Site Name	Mud Lick Creek
XS ID	XS - 2, Riffle (Mud Lick Cr)
Drainage Area (sq mi):	3.64
Date:	9/28/2020
Field Crew:	Perkinson, Keith

Scouring on the right bank of this cross-section is apparent, however this is an EII reach and localized at this location.
