FINAL
MONITORING REPORT
YEAR 5 (2022)
MUD LICK CREEK MITIGATION SITE

Chatham County, North Carolina

NCDMS Project No. 93482

AXIOM ENVIRONMENTAL, INC.
218 SNOW AVENUE
RALEIGH, NORTH CAROLINA 27603

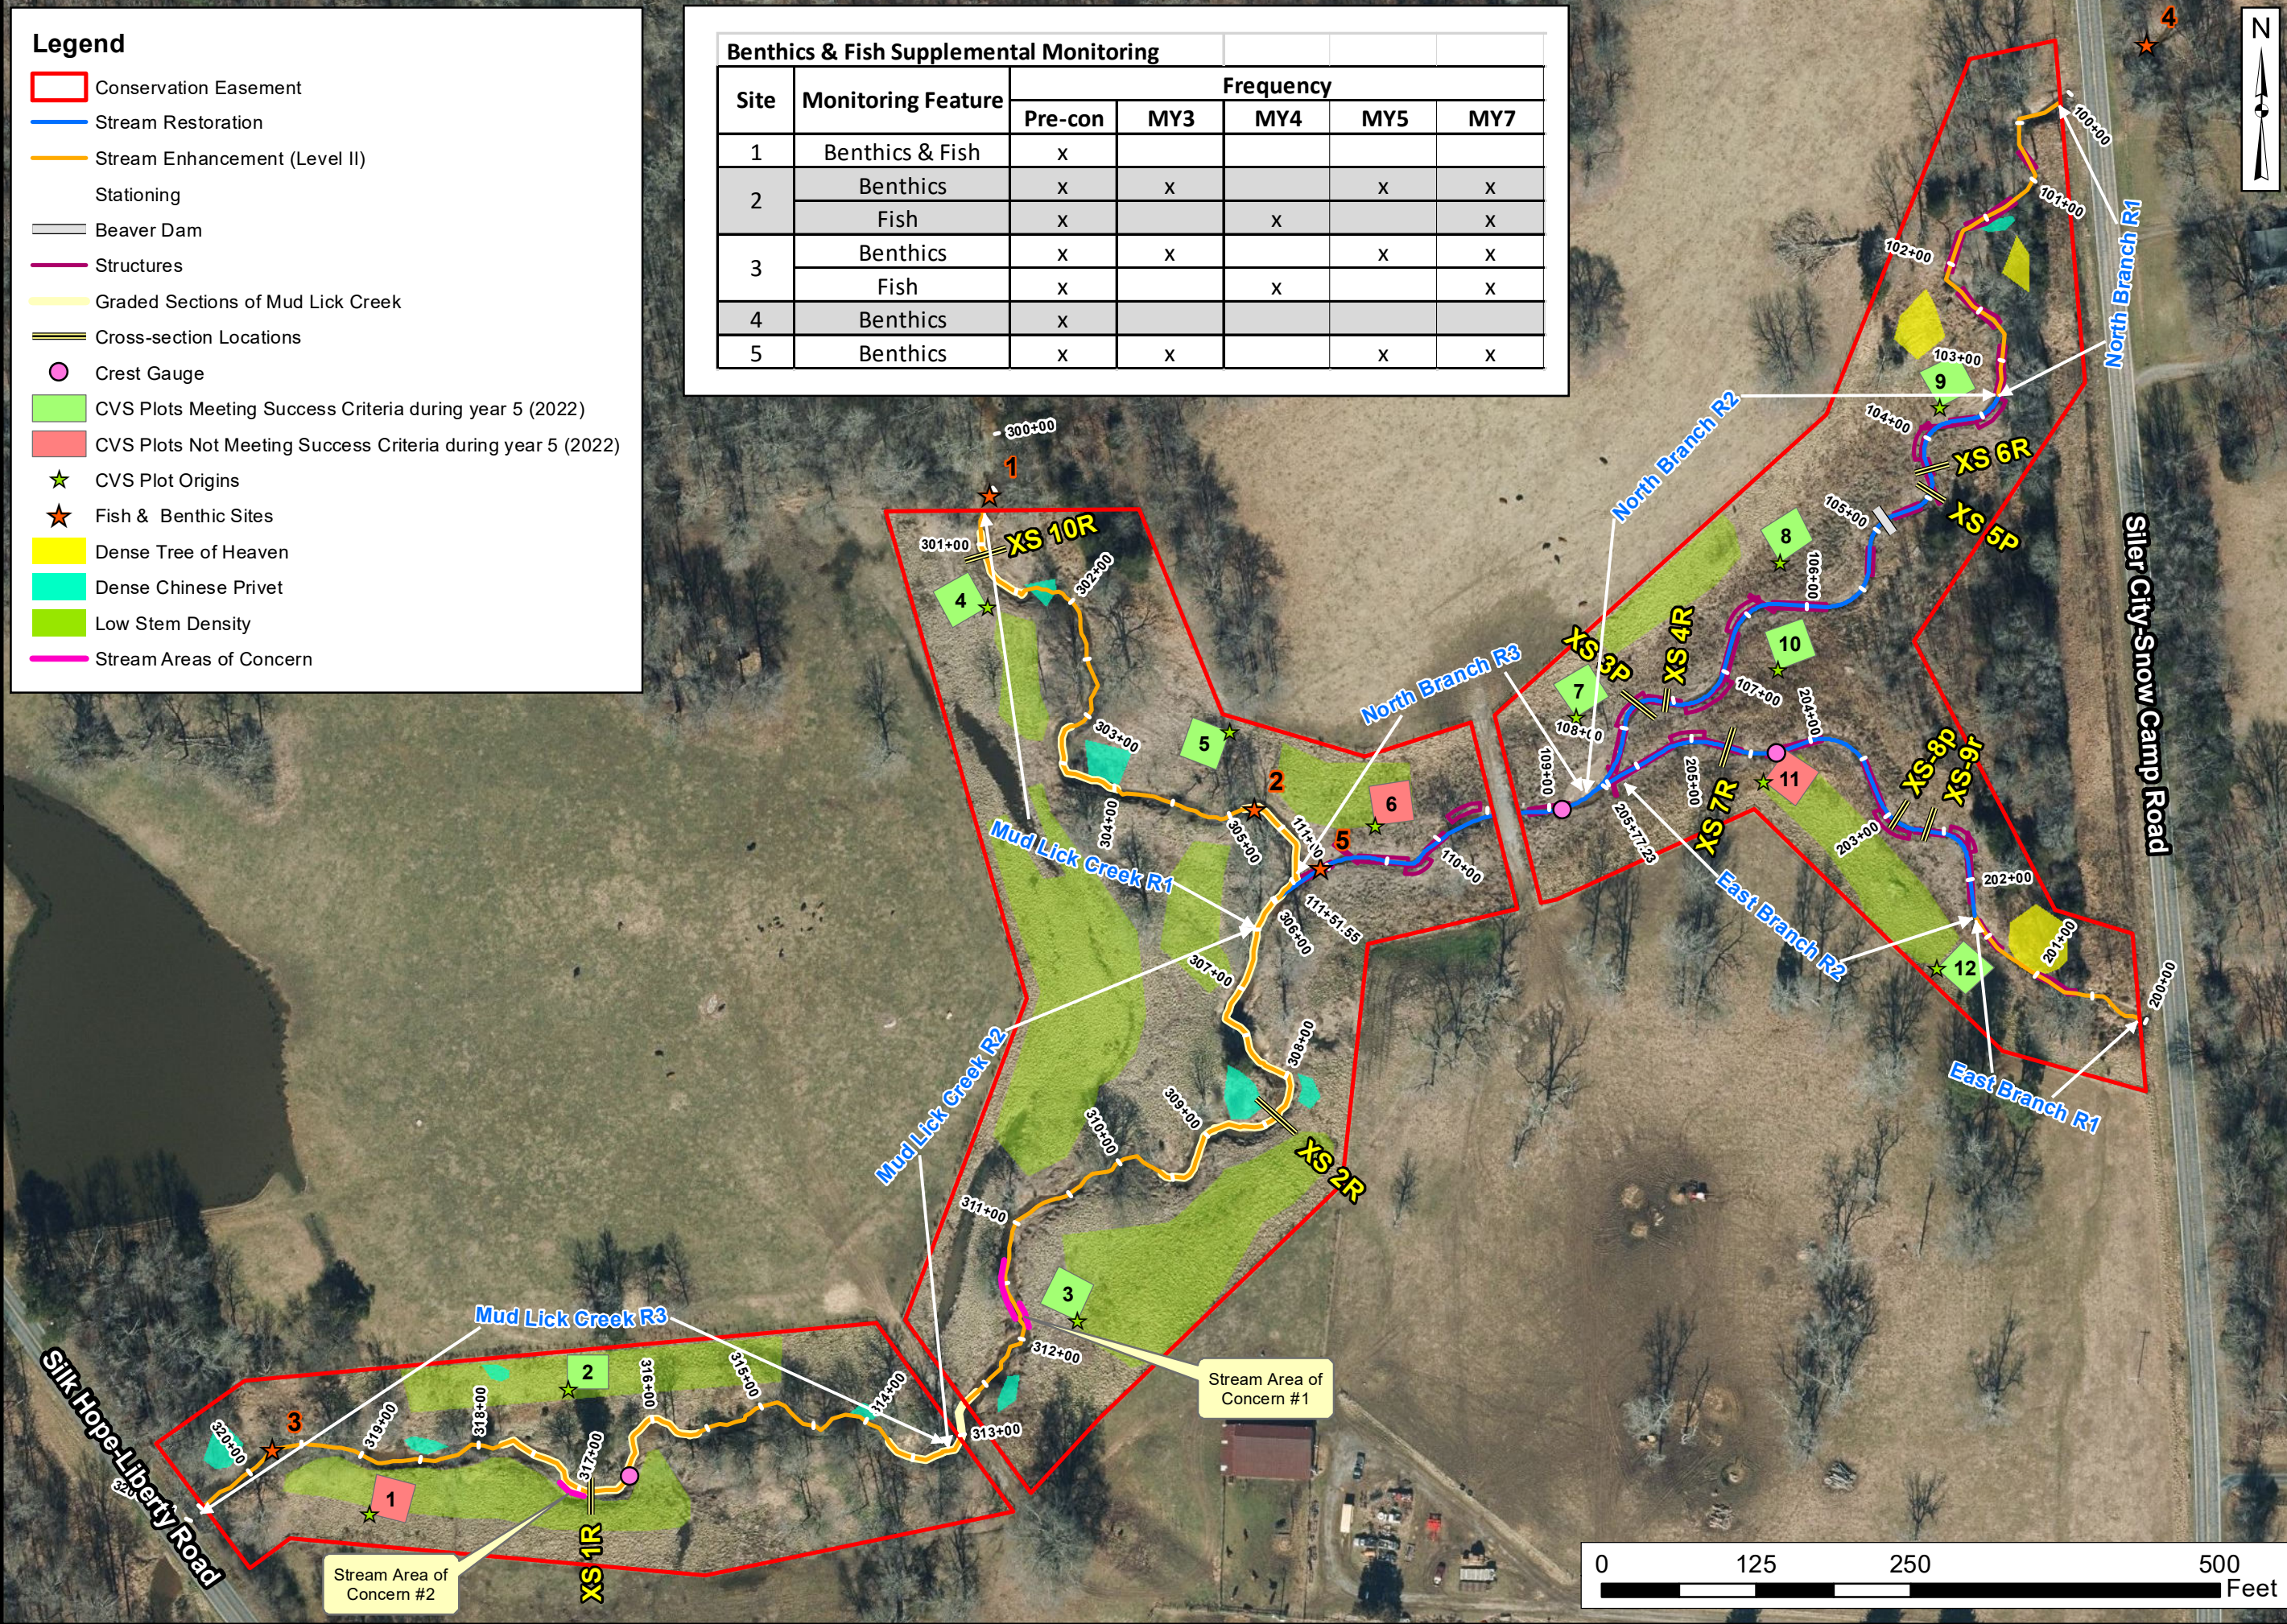
Title:
**CURRENT
 CONDITIONS
 PLAN
 VIEW**

Two stream areas of concern were observed during monitoring year 5 (2022); both were documented during previous monitoring years. Stream Area of Concern #1 is located along Mud Lick Creek R2 where approximately 50 feet of the right bank and 20 feet of the left bank have eroded to the point of bank sloughing. This area remains relatively unchanged from year 1 (2018); the establishment of dense herbaceous vegetation and lack of high discharge events have allowed this area to continue to stabilize. Stream Area of Concern #2 consists of scour and sloughing along an outer bend along Mud Lick Creek R3, immediately downstream from cross-section 1. Material that had sloughed from the bank remains stable and herbaceous vegetation is vigorous. Both stream areas of concern are located within enhancement II stream reaches; all stream reaches generating restoration credit are stable throughout and functioning as designed. Stream areas of concern are depicted on Figure 2 in Appendix B.

vegetation data collection an abundance of deer browse was documented in all permanent CVS plots. Additionally, several populations of dense Chinese privet (*Ligustrum sinense*) and tree of heaven (*Ailanthus altissima*) were observed scattered throughout the Site. Although invasive treatments have been ongoing, these areas are relatively unchanged from previous years. Invasive populations are depicted on Figure 2 (Appendix B).

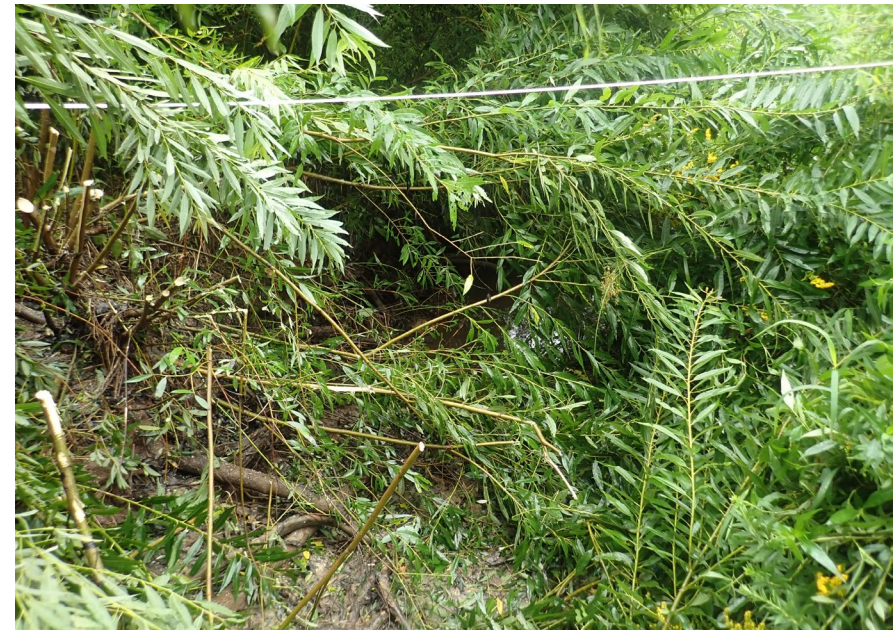
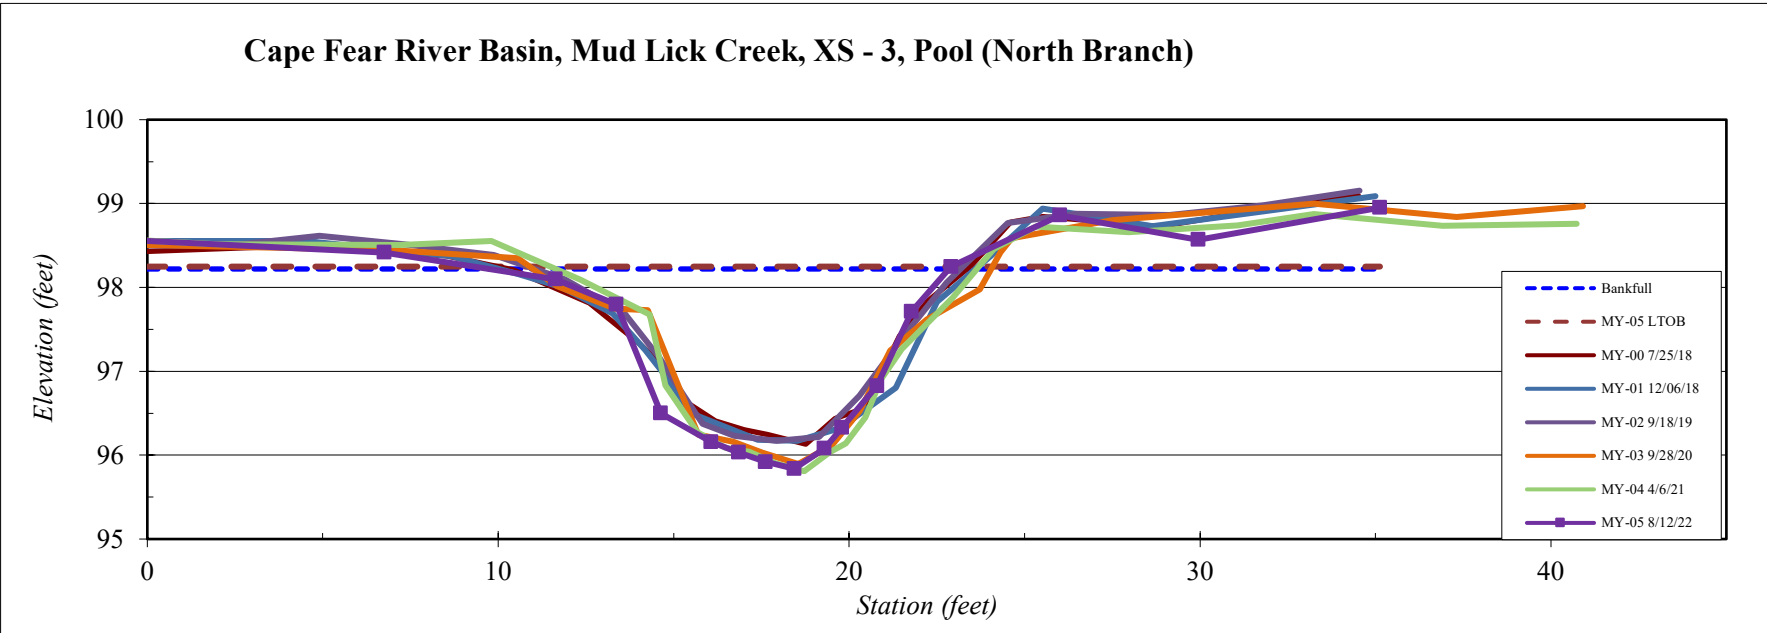
River Basin:	Cape Fear
Site Name	Mud Lick Creek
XS ID	XS - 3, Pool (North Branch)
Drainage Area (sq mi):	0.65
Date:	8/12/2022
Field Crew:	Adams, Fleming, Lance, D. Lewis

Scouring on the right bank of this cross-section is apparent, however this is an EII reach and localized at this location.
