FINAL
MONITORING REPORT
YEAR 6 (2023)
MUD LICK CREEK MITIGATION SITE

Chatham County, North Carolina

NCDMS Project No. 93482

Data Collection: April-September 2023

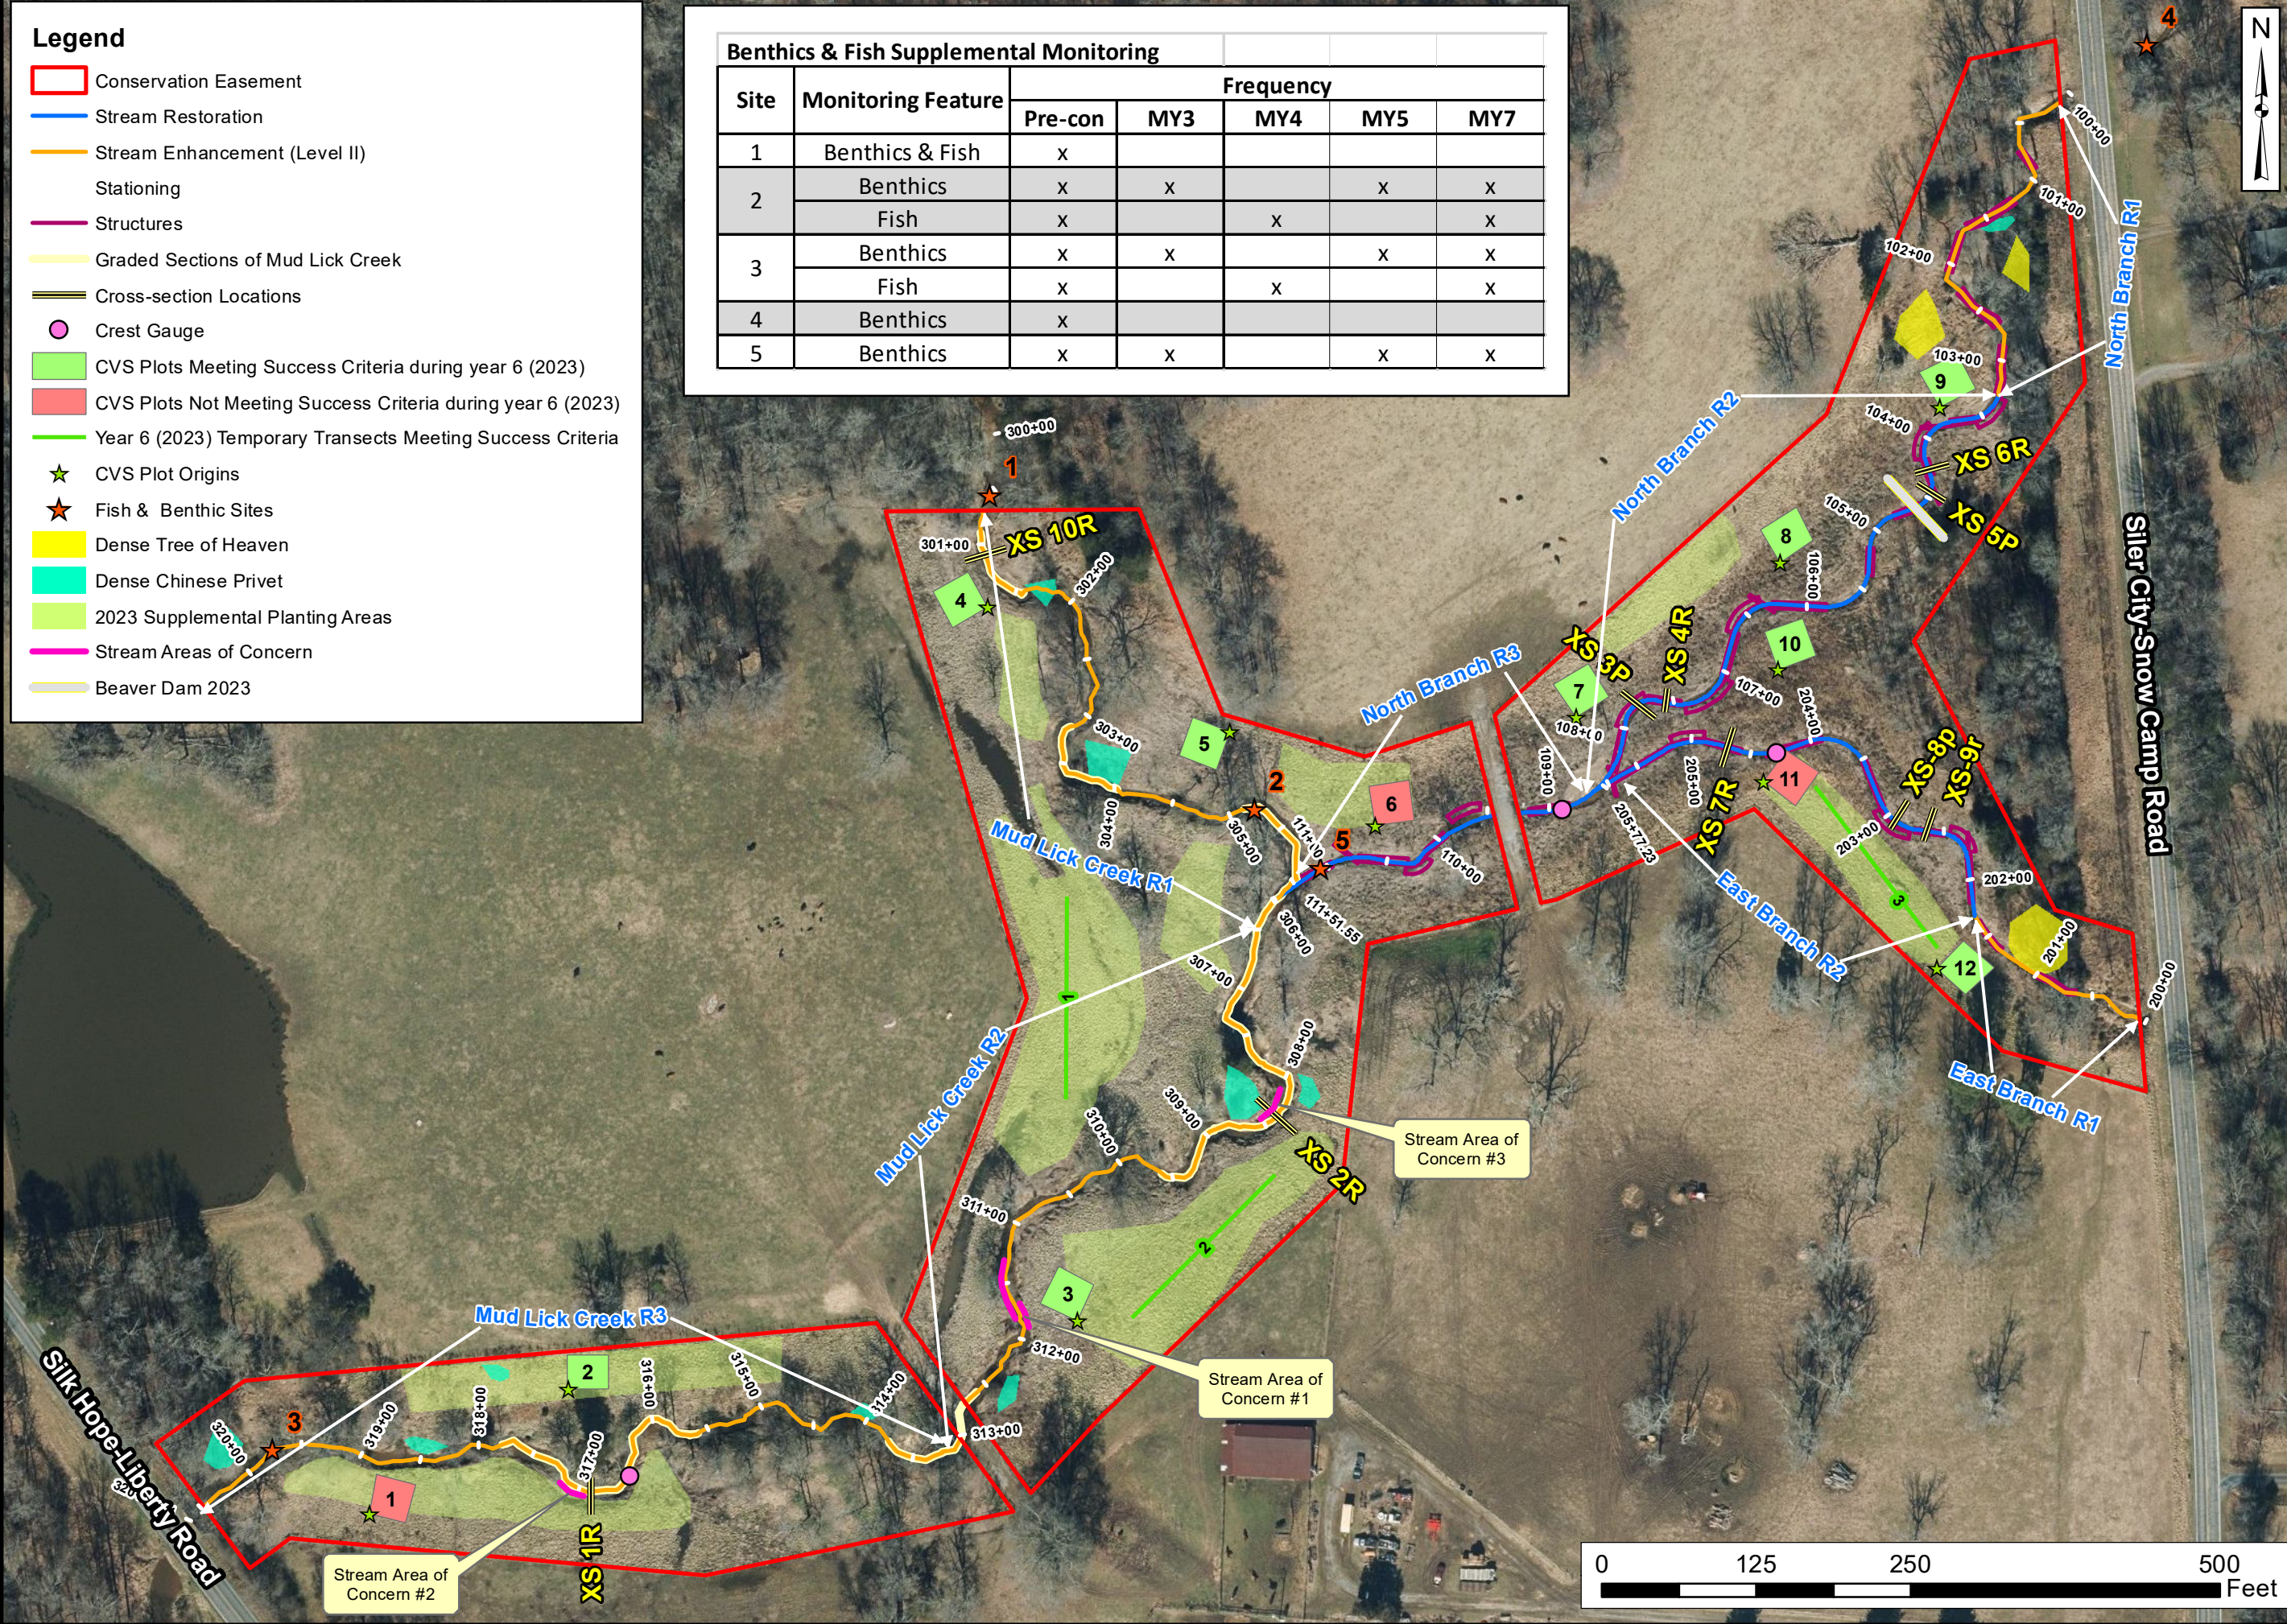
Title:
**CURRENT
 CONDITIONS
 PLAN
 VIEW**

Three stream areas of concern were observed during monitoring year 6 (2023), two of which were documented during previous monitoring years. Stream Area of Concern #1 is located along Mud Lick Creek R2 where approximately 50 feet of the right bank and 20 feet of the left bank have eroded to the point of bank sloughing. This area has only slightly increased in size due to the erosive nature of the soils, lack of woody vegetation, and continued storm flows. Stream Area of Concern #2 consists of scouring and sloughing along an outer bend along Mud Lick Creek R3, immediately downstream from cross-section 1. This was initially attributed to significant storm events that occurred during 2018, however, subsequent high discharge events have continued to erode the outer bend. Stream area of Concern #3 consists of the aforementioned scour on the inner bend at cross-section 2; approximately 30 feet in total. All stream areas of concern are located within enhancement II reaches. No areas of erosion or instability were observed in restoration reaches of North and East Branch. All structures were stable and banks were well-vegetated with live stakes and herbaceous vegetation. All stream reaches generating restoration credit are functioning as designed and are stable throughout. Stream areas of concern are depicted on Figure 2 in Appendix B.

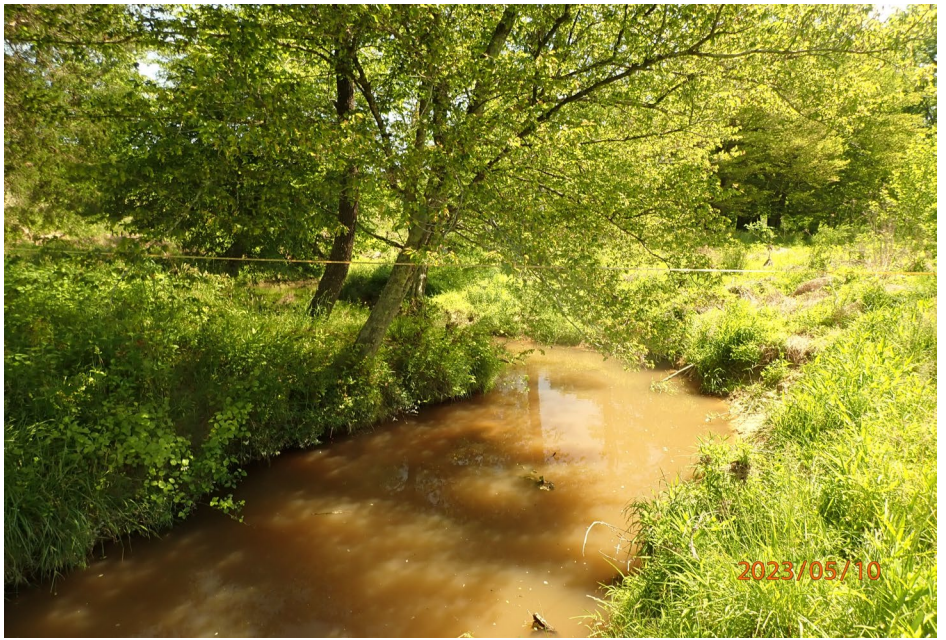
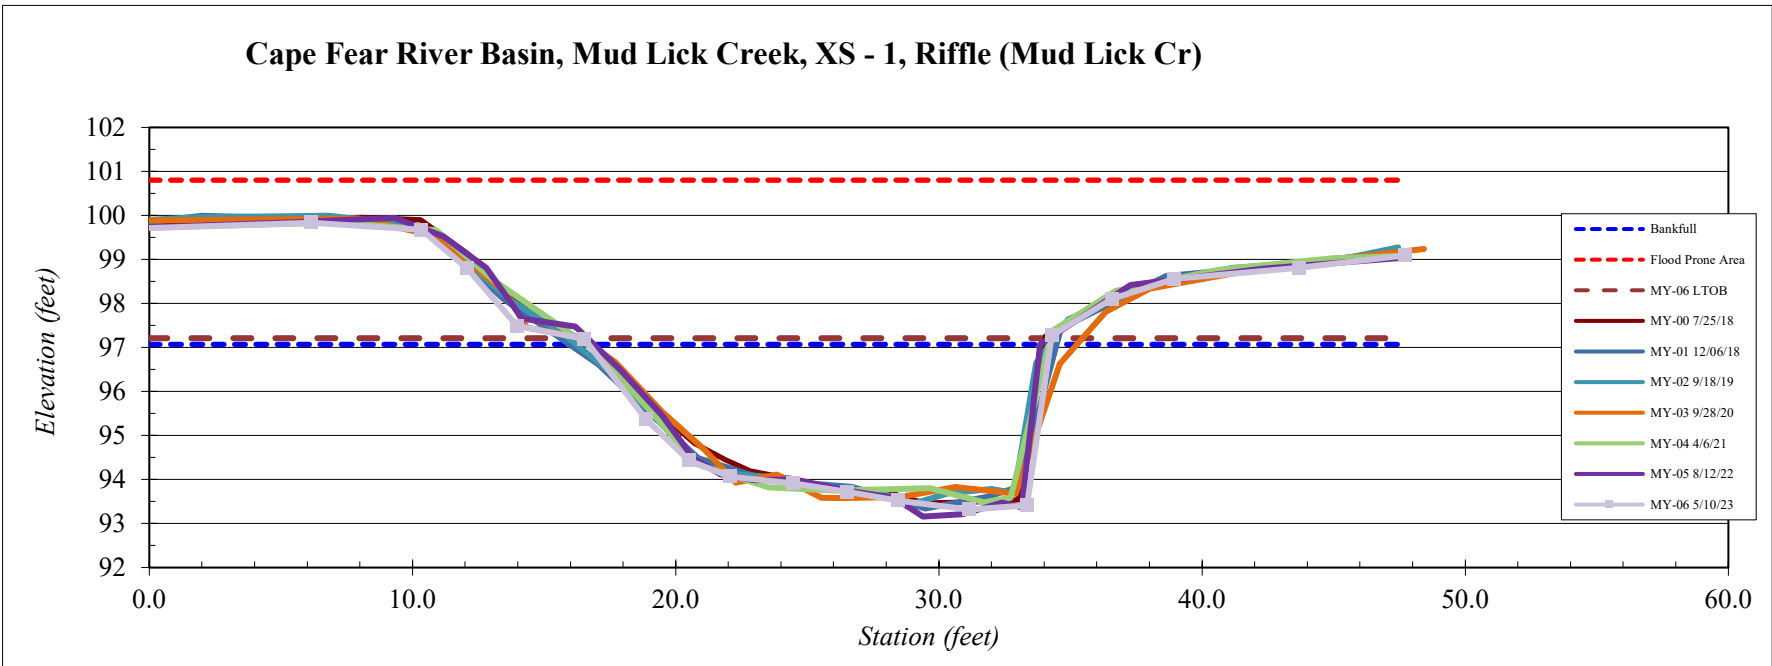
River Basin:	Cape Fear
Site Name	Mud Lick Creek
XS ID	XS - 1, Riffle (Mud Lick Cr)
Drainage Area (sq mi):	3.64
Date:	5/10/2023
Field Crew:	P. Perkinson, K. Jernigan

SUMMARY DATA	
Bankfull Elevation:	97.1
Bankfull Cross-Sectional Area:	49.8
Area at Low Bank:	52.3
Bankfull Width:	17.5
Flood Prone Area Elevation:	100.8
Flood Prone Width:	100.0
Max Depth at Bankfull:	3.7
Low Bank Height:	3.9
Mean Depth at Bankfull:	2.8
W / D Ratio:	6.2
Entrenchment Ratio:	NA
Bank Height Ratio:	1.04

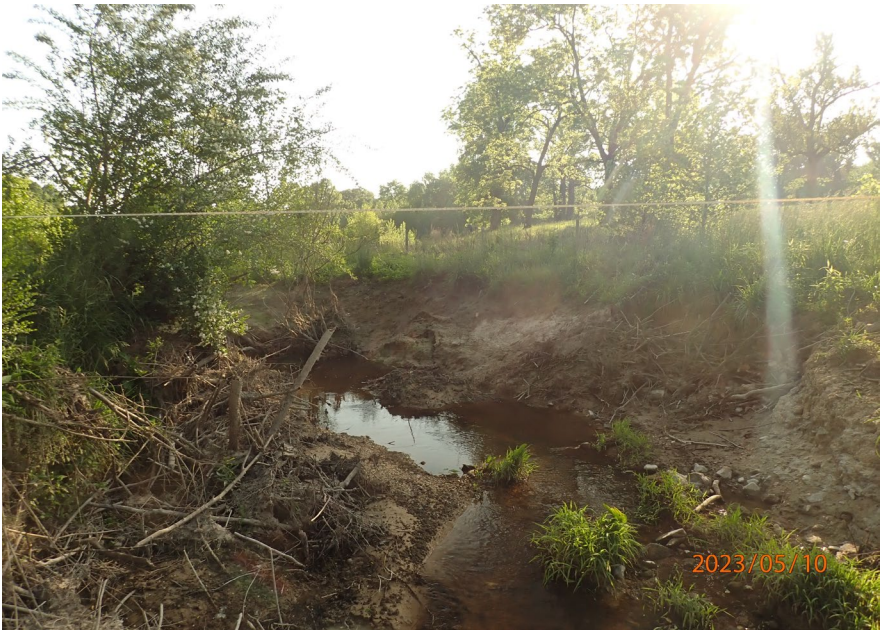
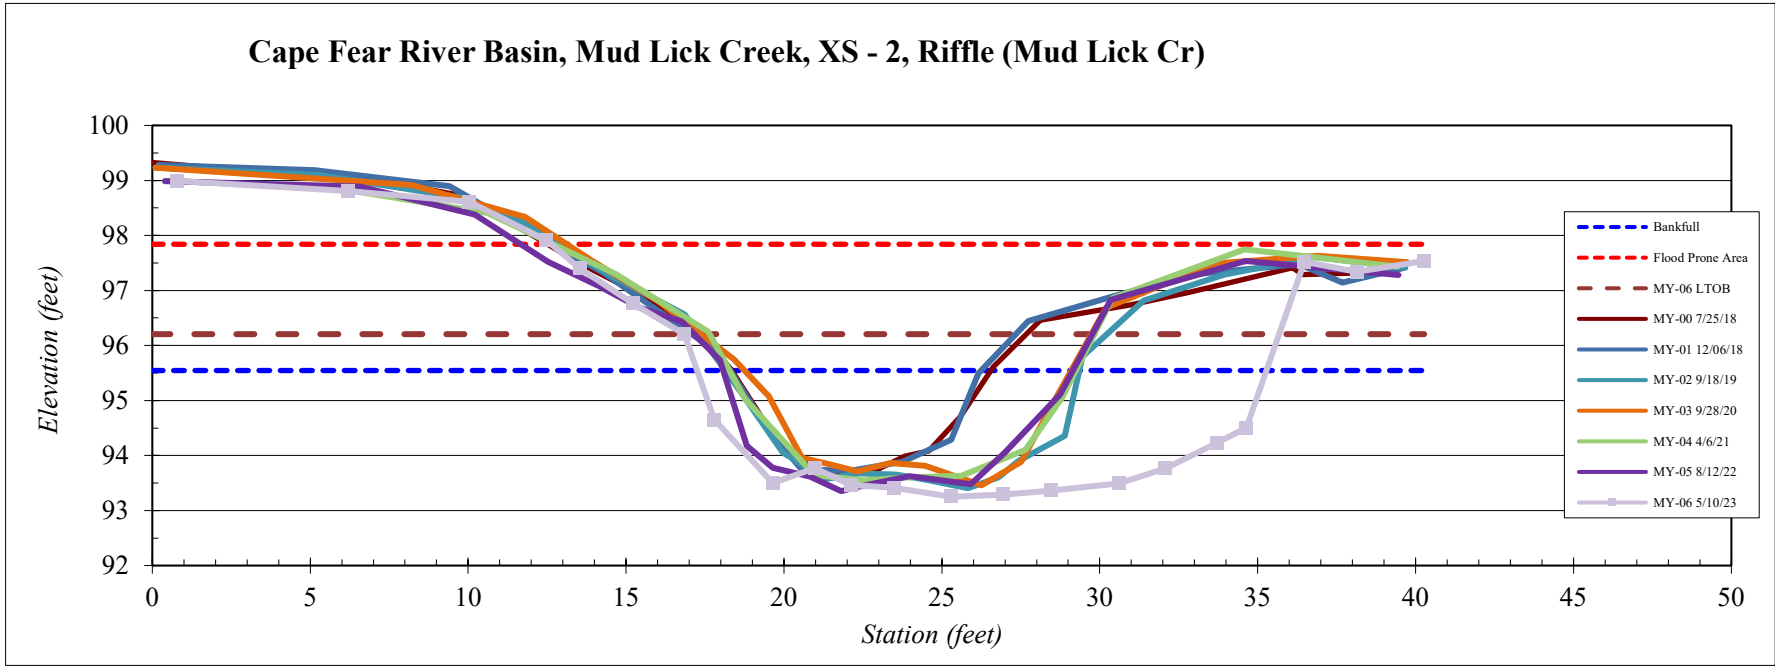
River Basin:	Cape Fear
Site Name	Mud Lick Creek
XS ID	XS - 2, Riffle (Mud Lick Cr)
Drainage Area (sq mi):	3.64
Date:	5/10/2023
Field Crew:	P. Perkinson, K. Jernigan

Year 6 cross-section data indicate little change from as-built conditions and that the streams are functioning as designed, overall, with the exception of cross-section 2, a riffle on Mud Lick Creek. Pool cross-sections,

SUMMARY DATA	
Bankfull Elevation:	95.5
Bankfull Cross-Sectional Area:	33.0
Area at Low Bank:	45.2
Bankfull Width:	18.0
Flood Prone Area Elevation:	97.8
Flood Prone Width:	100.0
Max Depth at Bankfull:	2.3
Low Bank Height:	3.0
Mean Depth at Bankfull:	1.8
W / D Ratio:	9.8
Entrenchment Ratio:	NA
Bank Height Ratio:	1.29

Scouring on the right bank of this cross-section is apparent, however this is an EII reach and localized at this location.

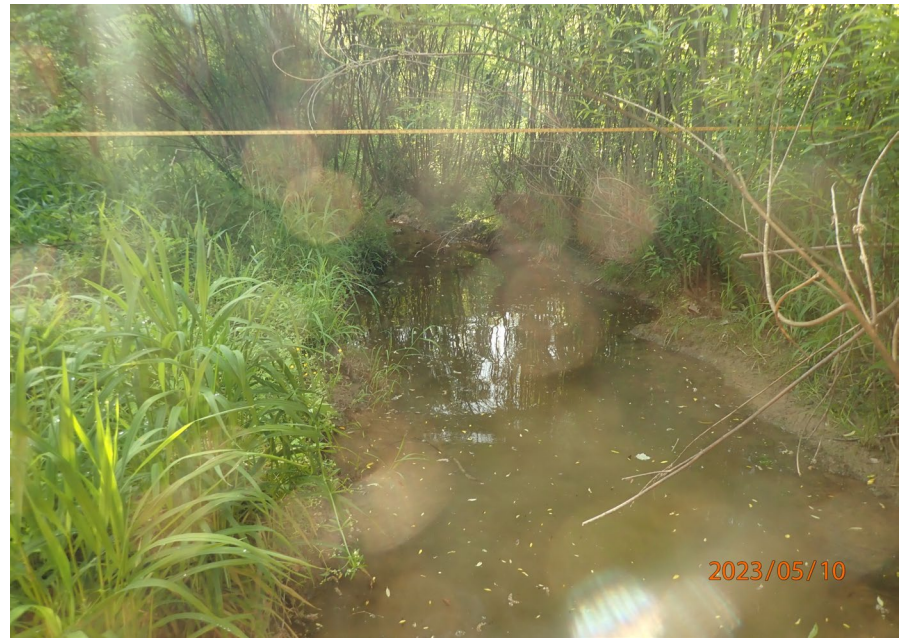
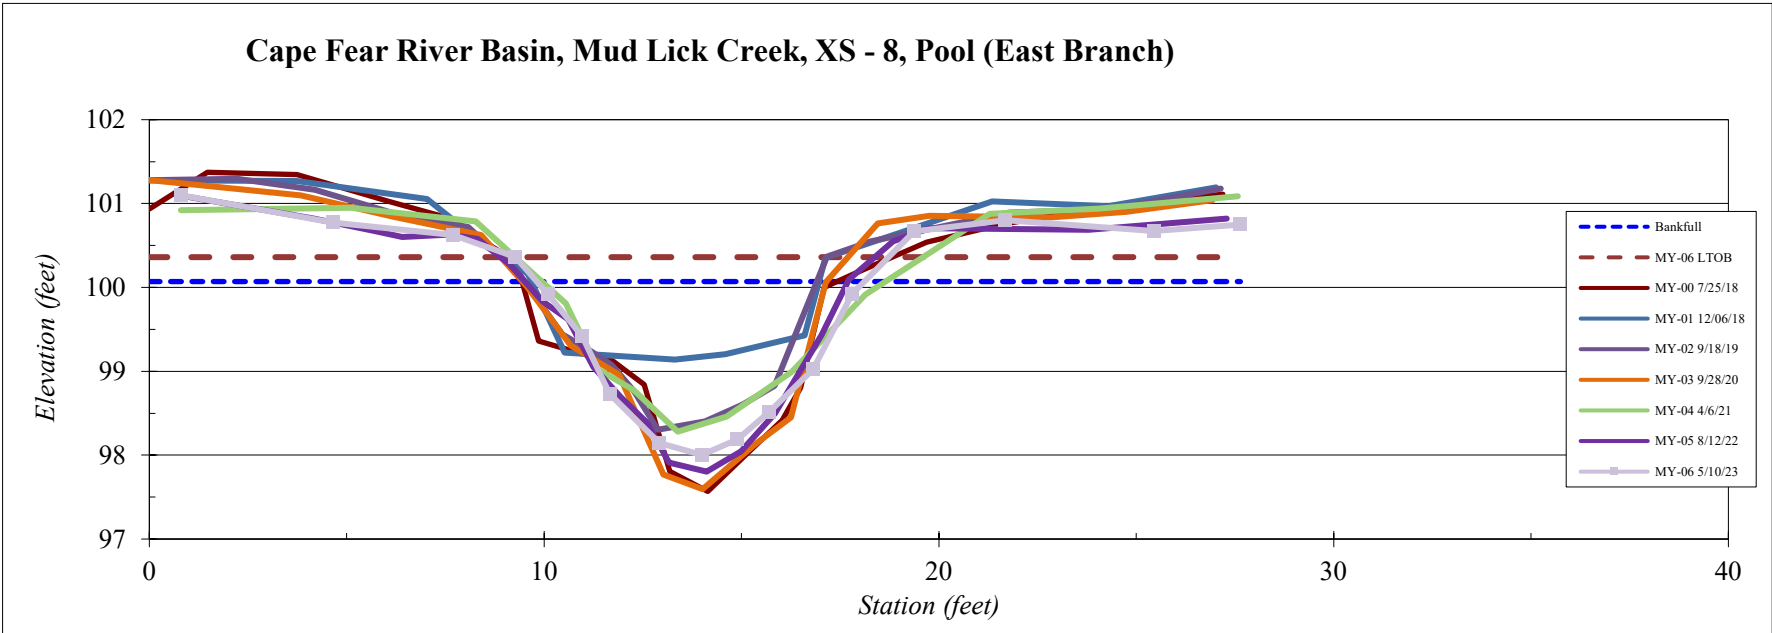
River Basin:	Cape Fear
Site Name	Mud Lick Creek
XS ID	XS - 8, Pool (East Branch)
Drainage Area (sq mi):	0.27
Date:	5/10/2023
Field Crew:	P. Perkinson, K. Jernigan

such as cross-section 8, are typically not monitored for bank-height-ratio because they are naturally sediment storage and transport areas within a stream. This is apparent in review of the varying D_{max} and LBH values exhibited by cross-section 8 throughout the monitoring period. Bank erosion has not been noted within or adjacent to cross-section 8, and overall, the reach appears stable. Cross-section 1 has been characterized by increased bank height ratio for the past several monitoring years. It is located within an Enhancement (Level II) reach of stream that has scoured in previous years; however, the scour appears to have been minimized and the channel has reformed natural top-of-bank indicators within the dimensional parameters of the channel. Cross-section 1 has remained relatively consistent and stable for the past 3 monitoring years. Cross-section 2 has an increased bank-height ratio of 1.29 due to heavy scouring along the inner bend (right bank). This scour was first observed during year 2 (2019) but remained stable through year 5 (2022). It appears the scour was increased by beaver activity during year 6, and it is now considered an area of concern. All site cross-sections, except for cross-section 2, meet success criteria during year 6 (2023).

SUMMARY DATA	
Bankfull Elevation:	100.1
Bankfull Cross-Sectional Area:	10.5
Area at Low Bank:	13.1
Bankfull Width:	8.3
Flood Prone Area Elevation:	NA
Flood Prone Width:	NA
Max Depth at Bankfull:	2.1
Low Bank Height:	2.4
Mean Depth at Bankfull:	1.3
W / D Ratio:	NA
Entrenchment Ratio:	NA
Bank Height Ratio:	NA
