Naked Creek Stream Restoration

Wilkes County, North Carolina

2008 Year 1 Monitoring Report

EEP Project Number: 261

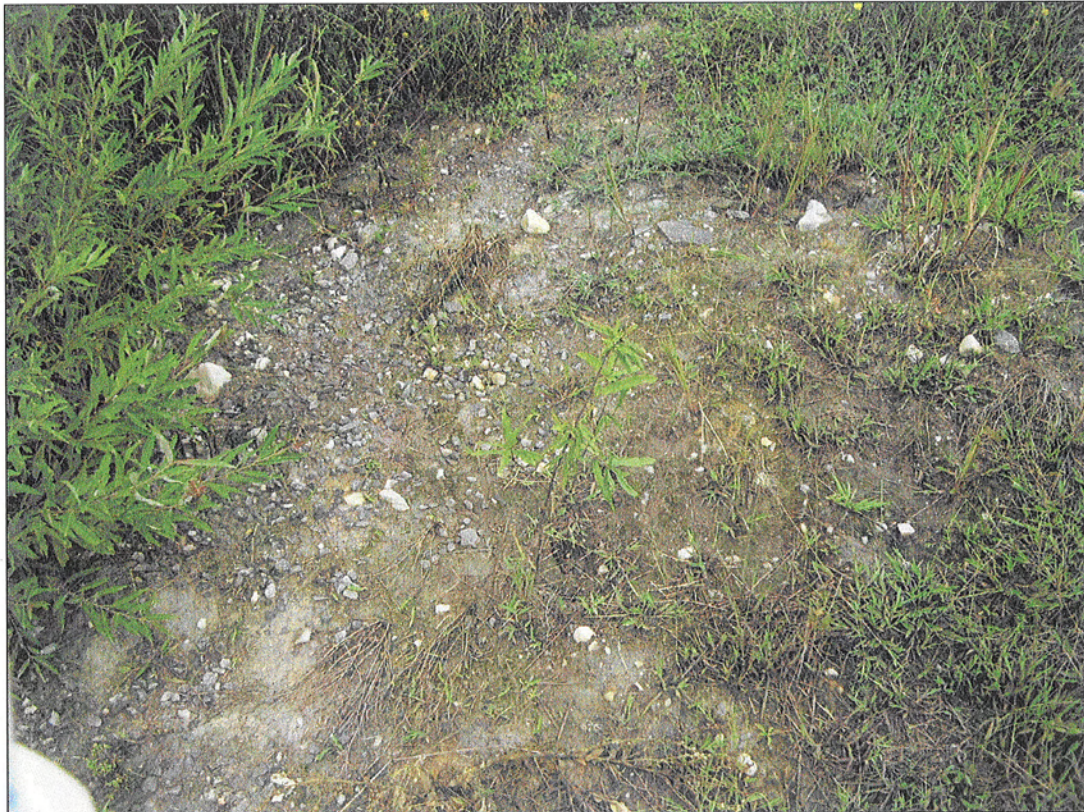
Two areas along the floodplain were noted to be bare and lacked vegetation therefore exposing the soil. It appears these areas are a result of runoff and poor site soils. A limited amount of vegetation is growing within the bare floodplain areas. It is possible that vegetation may thrive and subsequently fill in these bare floodplain areas as time progresses.

VEGETATION PROBLEM AREA 1: STATION 17+50 - 18+00.

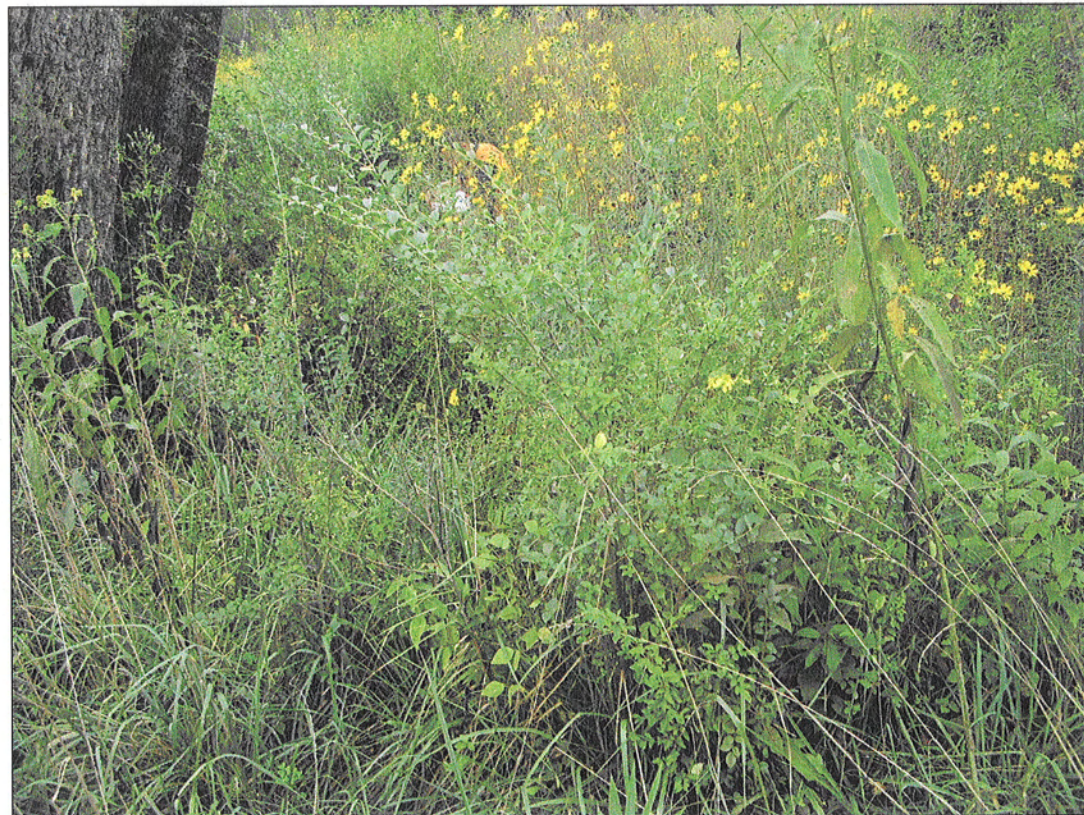
There are areas in which invasive populations have encroached into Naked Creek. Patches of Chinese privet (*Ligustrum sinense*) and silktree (*Albizia julibrissin*) were noted.

VEGETATION PROBLEM AREA 2: LIGUSTRUM SINENSE ENCROACHMENT.

all exotic and invasive vegetation needs to be treated to prevent it from spreading throughout the buffer. Future annual maintenance should include periodic invasive/exotic vegetation control. The in-channel vegetation along the upper portion of the stream should only be removed if lateral and/or vertical instability persists at Monitoring Year 5.

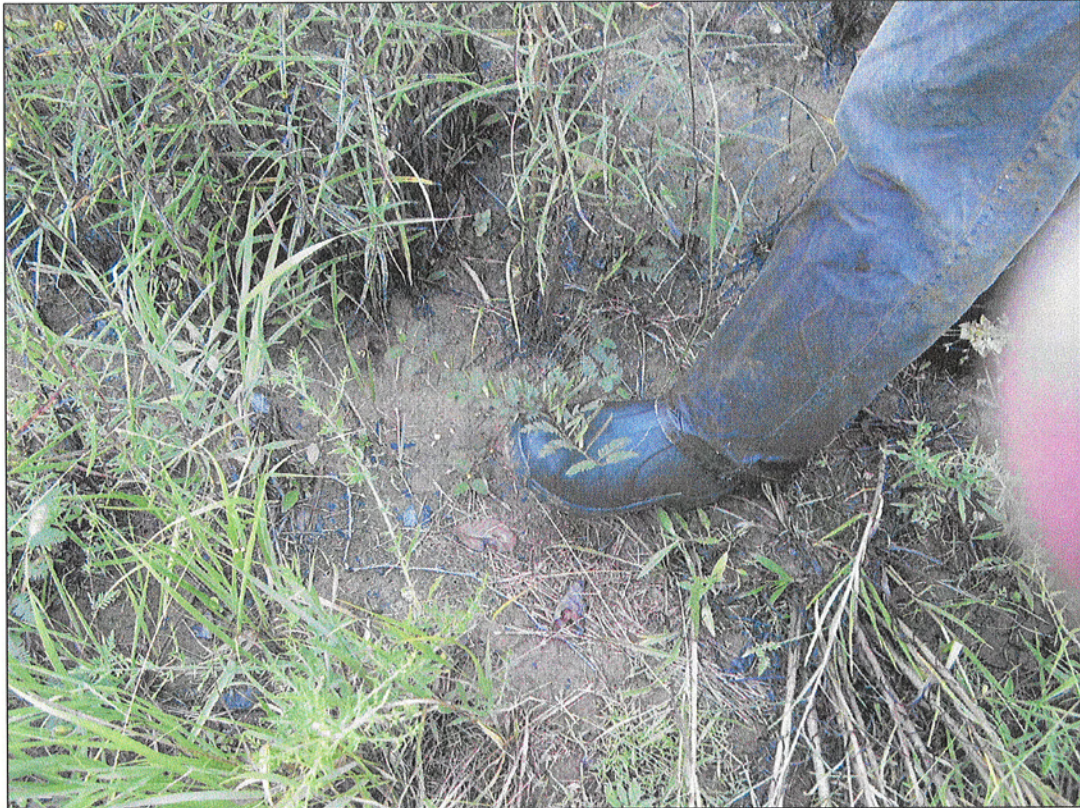
VEGETATION PROBLEM AREA 3: ALBIZIA JULIBRISSIN ENCROACHMENT.

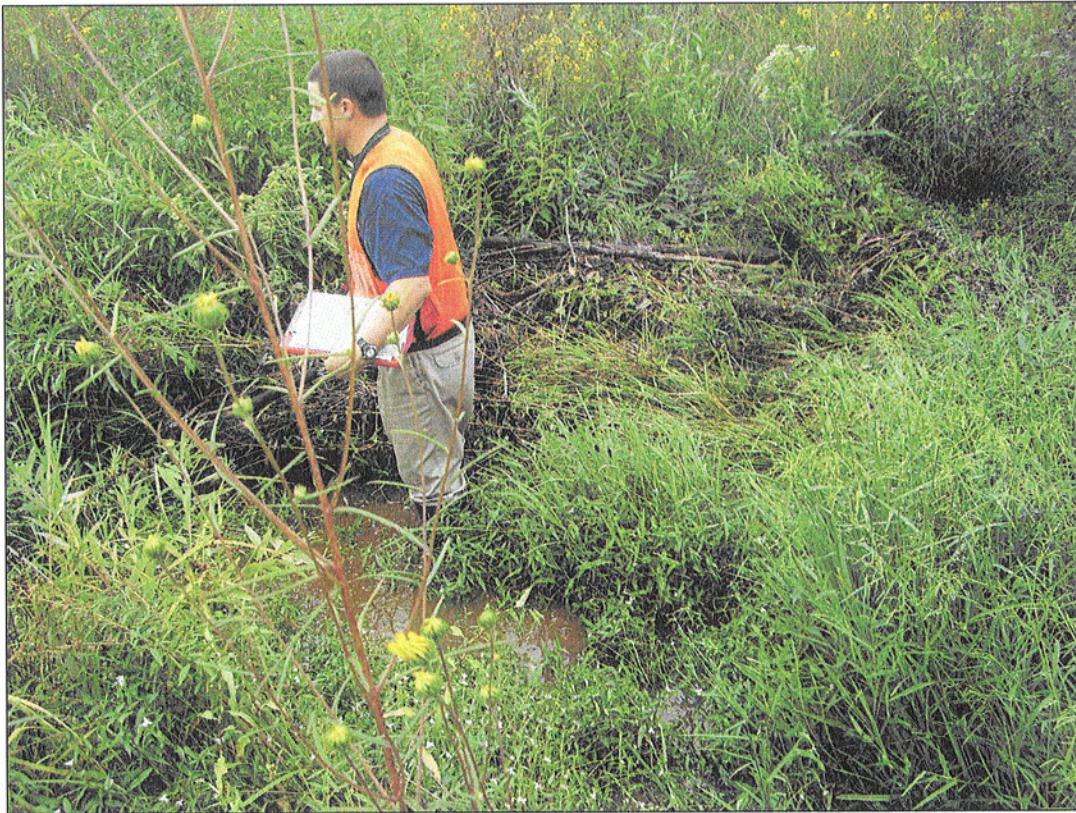
In upstream areas, the stream channel contains thick vegetation in the riffle sections which may be due to over seeding. Channel morphology has been influenced by the thick vegetation causing flow patterns within the channel to be altered. Over time, the vegetation may cause lateral migration of the thalweg which would cause minor lateral instability.

VEGETATION PROBLEM AREA 4: THICK HERBACEOUS GROWTH WITHIN STREAM CHANNEL.

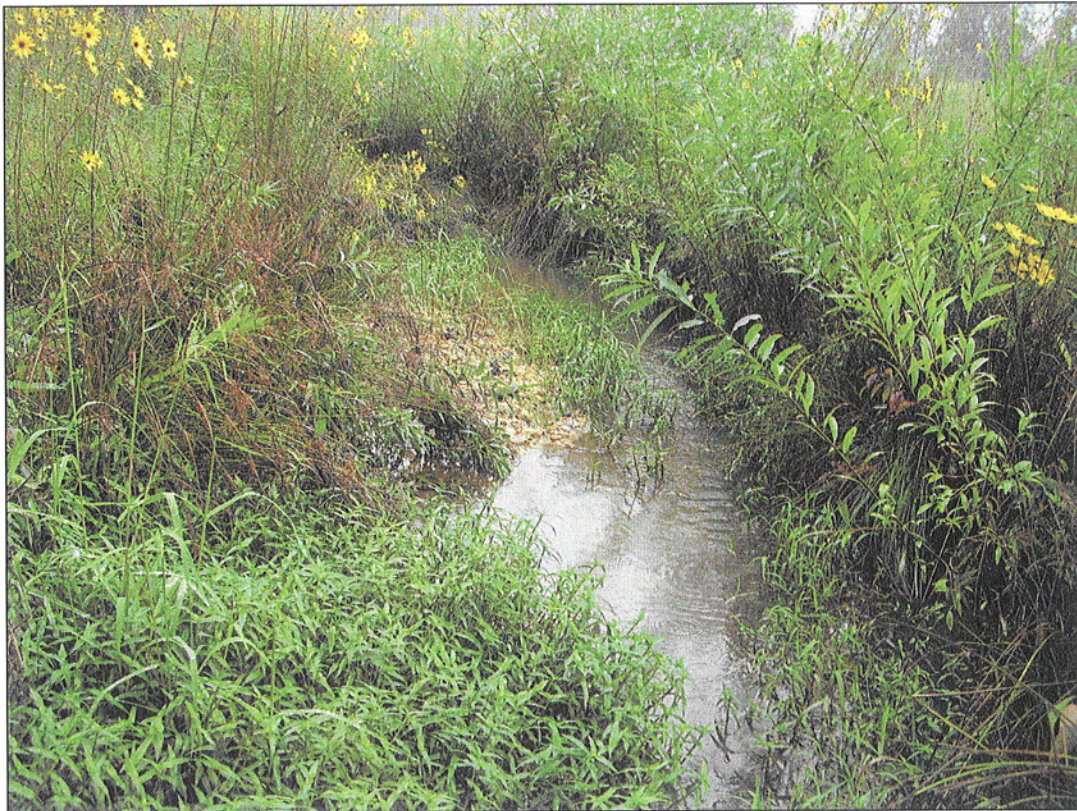
STREAM PROBLEM AREA 1: SIDE CHANNEL BAR AT STATION 33+20.

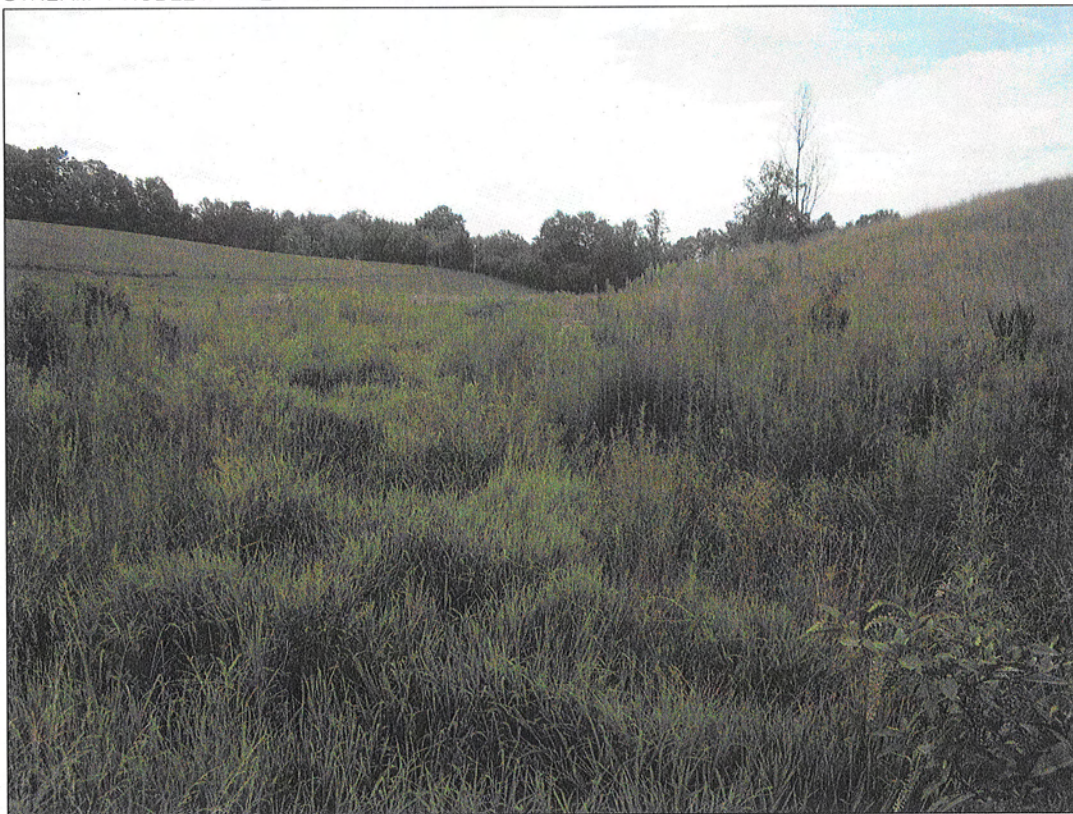
The single largest problem that could affect lateral stability is excessive vegetation in the channel. Excessive vegetation was observed between stations 11+00 and 18+00. Based on the prior year comparison using longitudinal profile data, it appears that minor systemic aggradation has occurred throughout the reach. Minor “piping” through a cross vane arm was observed at the structure located at station 34+67. It appeared as if a repair had been made using hand tools/labor and it is possible that this problem may fix itself over time. Structure failure was not imminent.

STREAM PROBLEM AREA 2: THICK HERBACEOUS GROWTH WITHIN STREAM CHANNEL FROM STATION 11+00 TO 18+00.

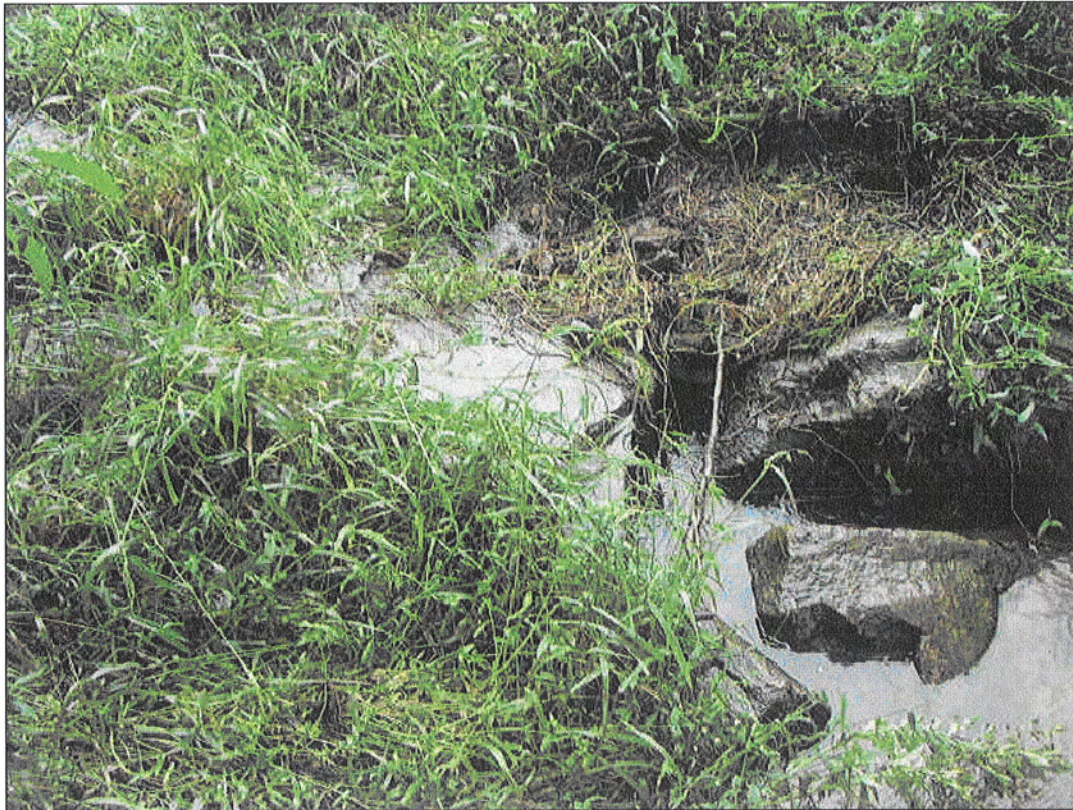
STREAM PROBLEM AREA 3: PIPING AT STRUCTURE LOCATED AT STATION 34+67.
