FINAL
YEAR 2 (2017) ANNUAL
MONITORING REPORT

**NEIGHBORS BRANCH/WALTON CRAWLEY BRANCH
STREAM & WETLAND RESTORATION SITE**

NCDMS Project No. 92872
Contract No. D09023S
USACE Action ID No. SAW-2009-917 & NCDWR Project No. 10-0122
SCO No. 08-07308-01
McDowell County, North Carolina

Data Collection: May-November 2017
Submission: December 2017

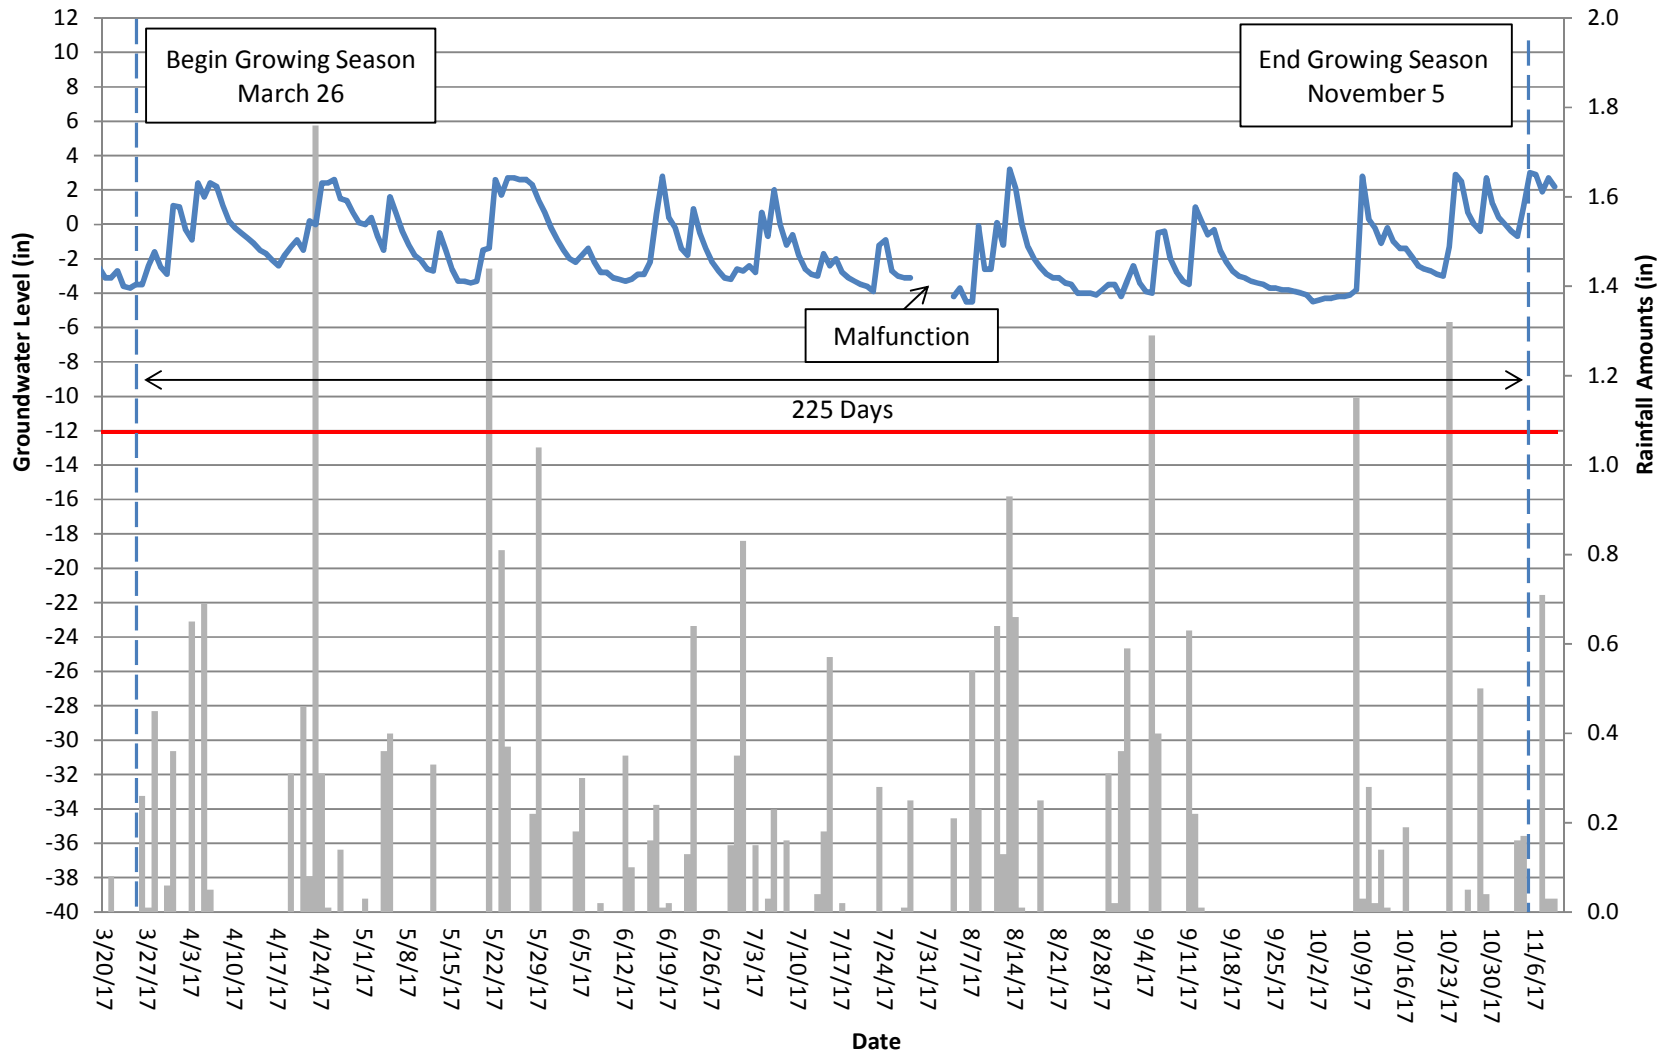
Neighbors Branch Groundwater Gauge 1 Year 2 (2017 Data)

- Wetland Hydrology: Report indicates that Gauge 1 malfunctioned during the growing season. Has the gauge been replaced or repaired? Please add a statement in this section stating the corrective action and that the gauge is functioning correctly.
The wetland hydrology discussion was updated to read as follows: "Gauge 1 malfunctioned for 6 days (July 29 to August 3, 2017) during the growing season. It is unclear why the gauge was not taking measurements during this time, but it appeared to be functioning properly before and after the malfunction, and it was checked and reset at the time of the next data download. The gauge had no more issues for the remainder of the growing season. Based on precipitation data as well as data from Gauge 2, it is expected that this gauge would have continued to be saturated/inundated during this 6 day period."
