FINAL
YEAR 3 (2018) ANNUAL
MONITORING REPORT

**NEIGHBORS BRANCH/WALTON CRAWLEY BRANCH
STREAM & WETLAND RESTORATION SITE**

NCDMS Project No. 92872
Contract No. D09023S
USACE Action ID No. SAW-2009-917 & NCDWR Project No. 10-0122
SCO No. 08-07308-01
McDowell County, North Carolina

Data Collection: May-November 2018
Submission: November 2018

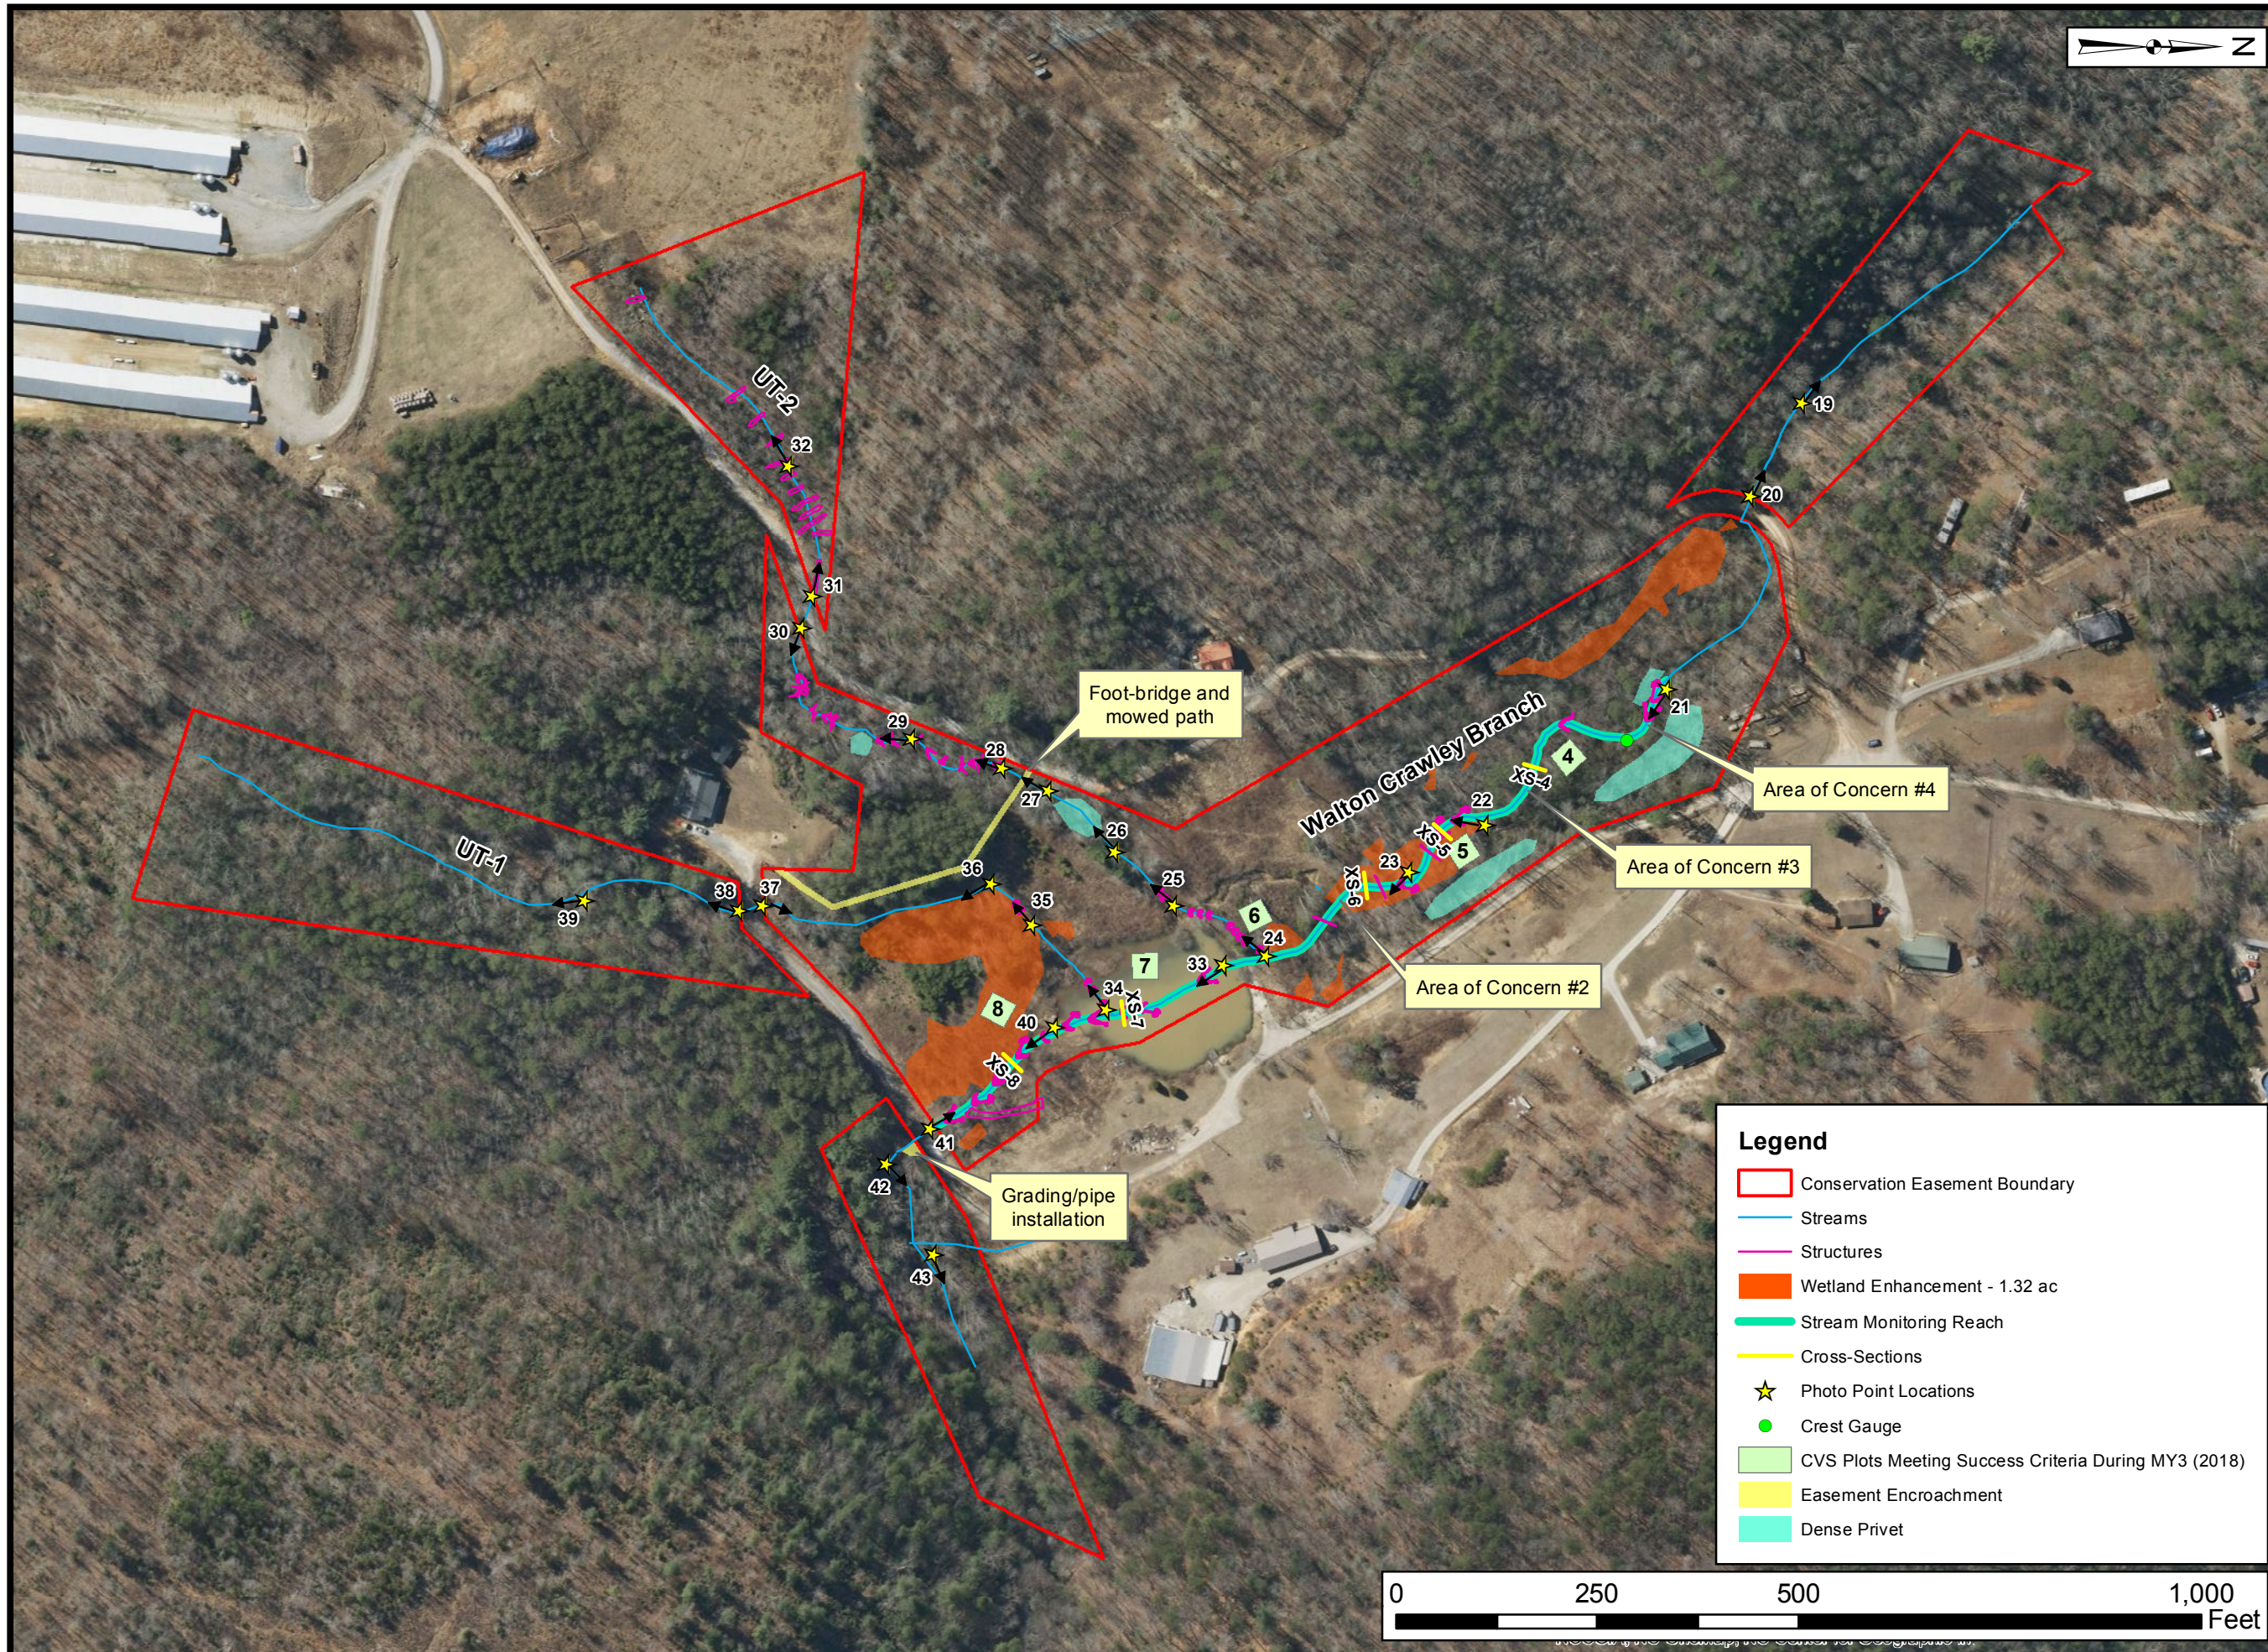
FIGURE
2B

Several dense populations of Chinese privet (*Ligustrum sinense*) were observed along Walton Crawley Branch (Figure 2B, Appendix B). Some additional privet and multiflora rose (*Rosa multiflora*) was observed scattered throughout Site restoration reaches in quantities below mapping threshold. NCDMS plans to treat invasive species during year 4 (2019), and Axiom will monitor these areas to determine the success of the treatments.
