FINAL
YEAR 4 (2019) ANNUAL
MONITORING REPORT

**NEIGHBORS BRANCH/WALTON CRAWLEY BRANCH
STREAM & WETLAND RESTORATION SITE**

NCDMS Project No. 92872
Contract No. D09023S
USACE Action ID No. SAW-2009-917 & NCDWR Project No. 10-0122
SCO No. 08-07308-01
McDowell County, North Carolina

Data Collection: May-November 2019
Submission: January 2020

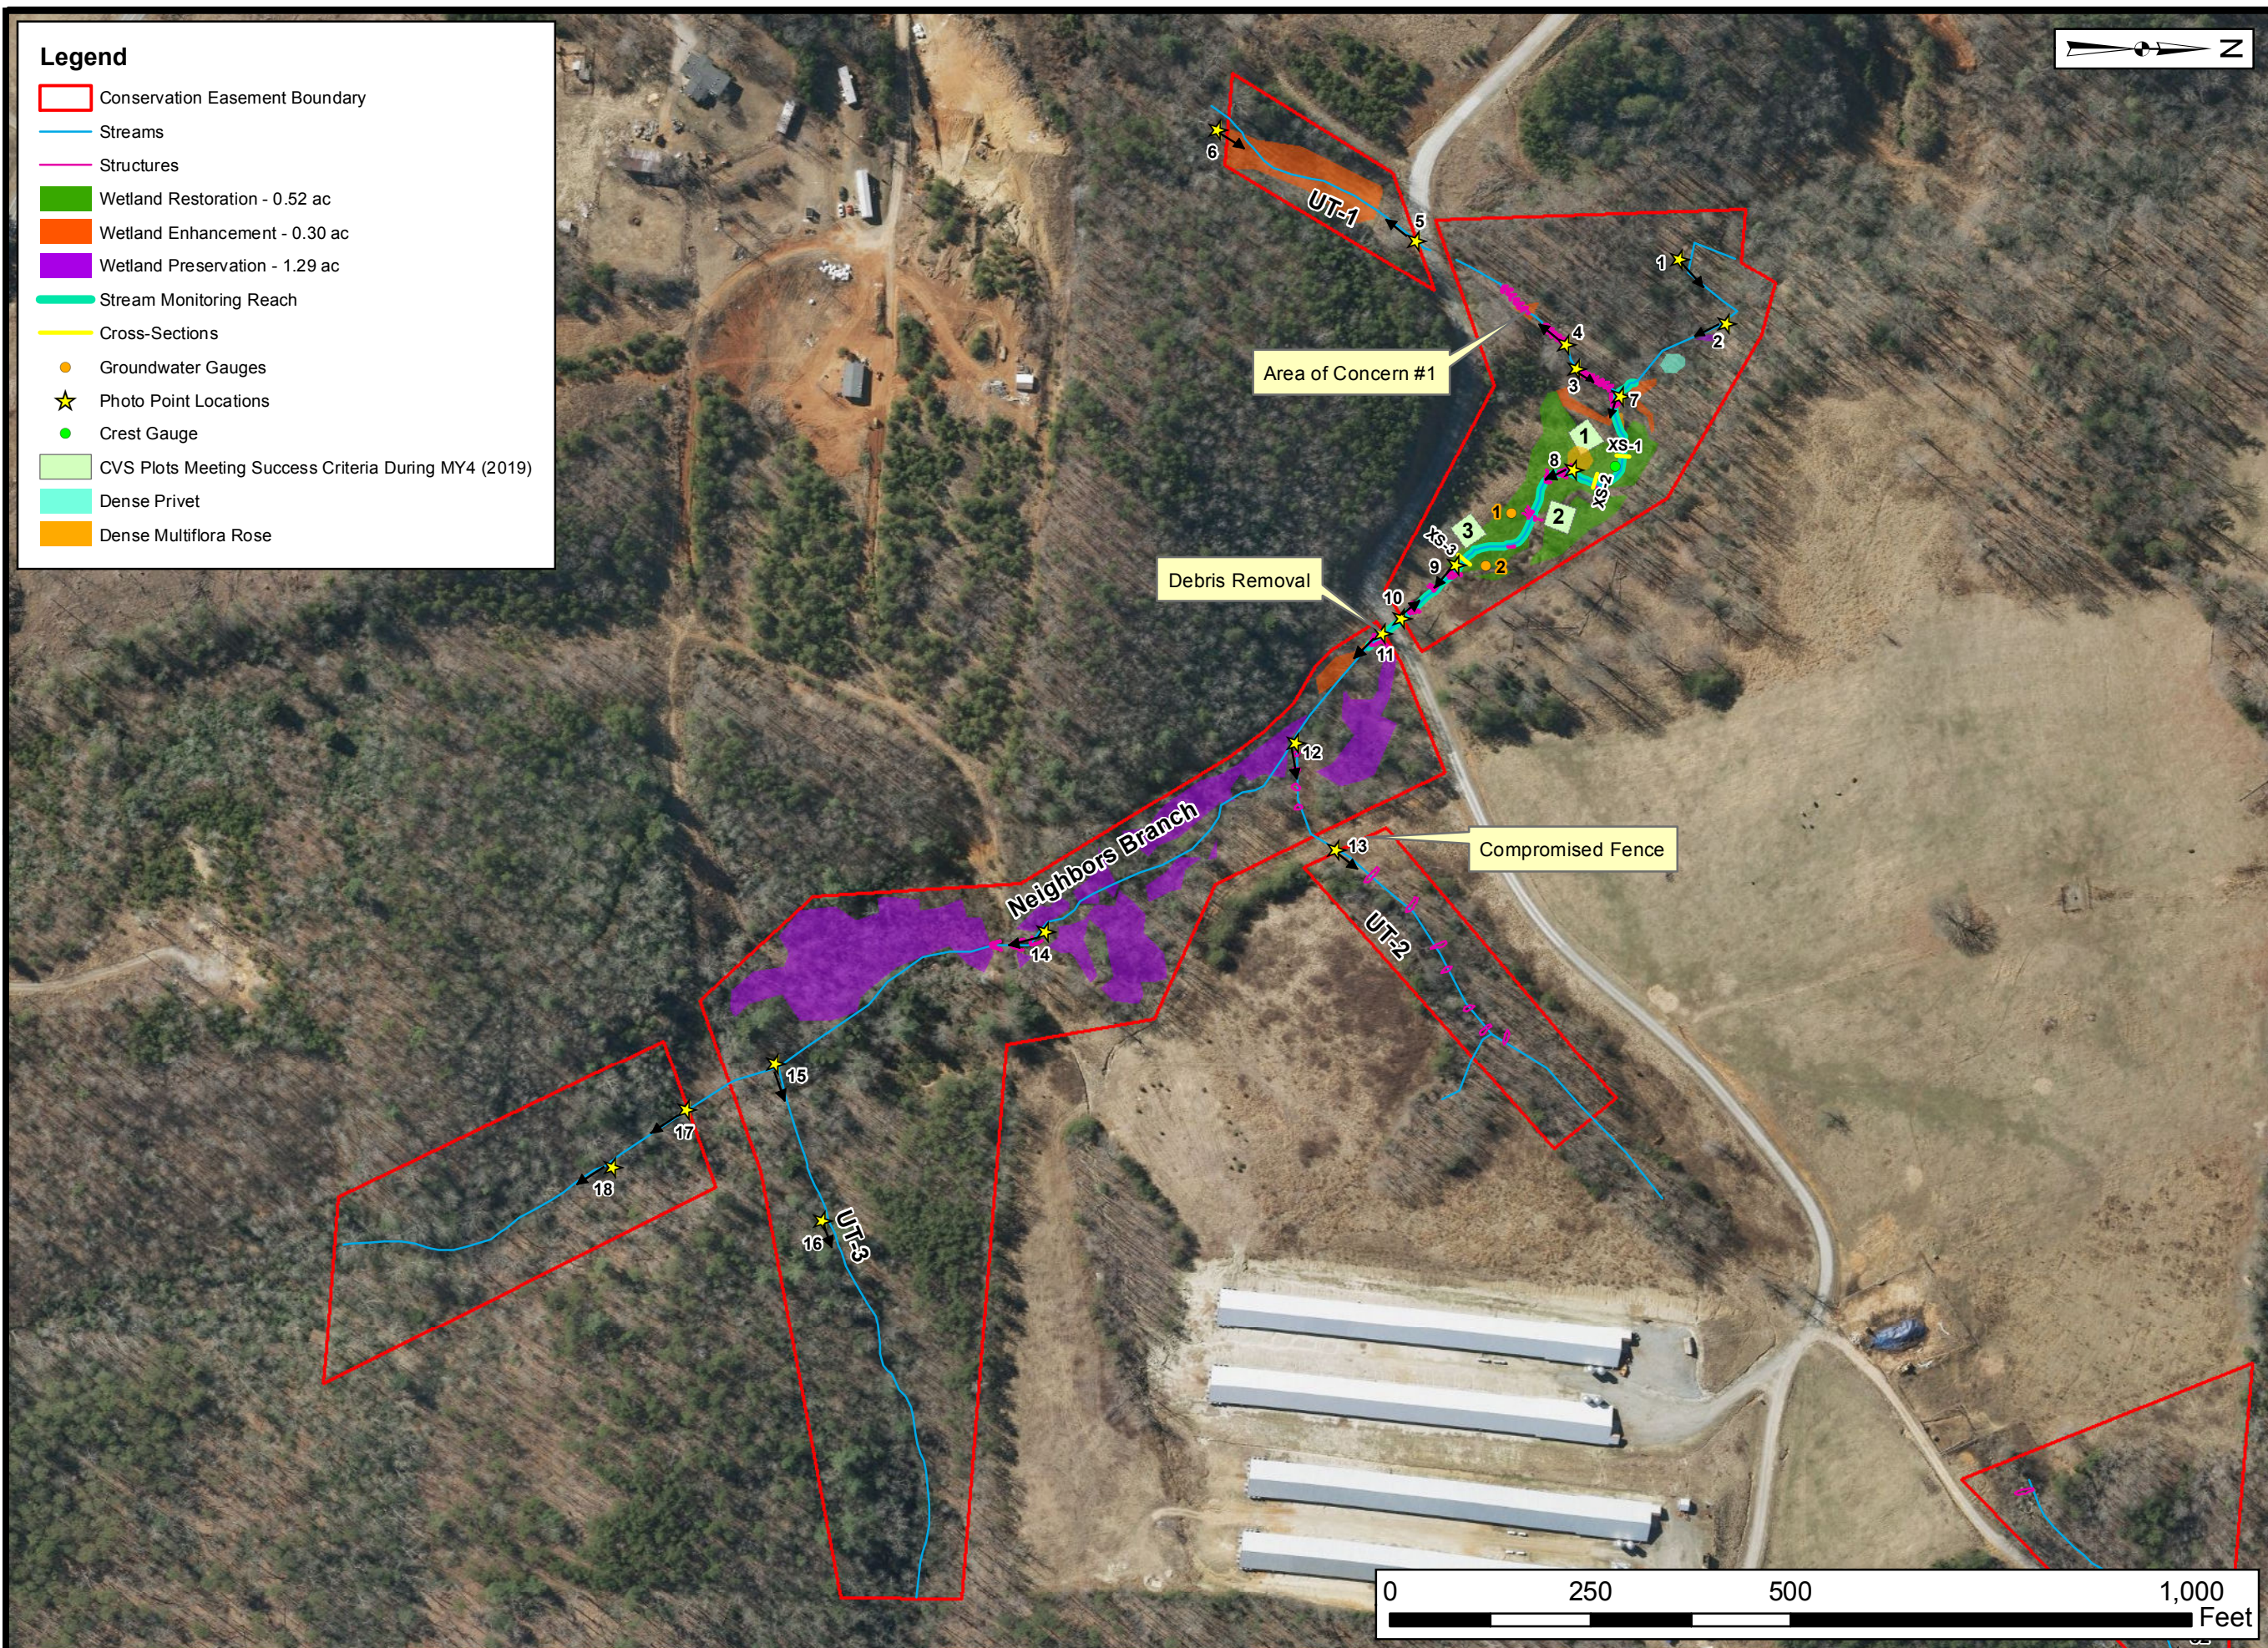
FIGURE
2A

Two groundwater monitoring gauges were installed to take measurements after hydrological modifications were performed at the Site. Hydrological sampling will occur during the growing season (March 26 to November 5). Approximate locations of gauges are depicted on Figure 2A (Appendix B) and hydrology data can be found in Appendix E.

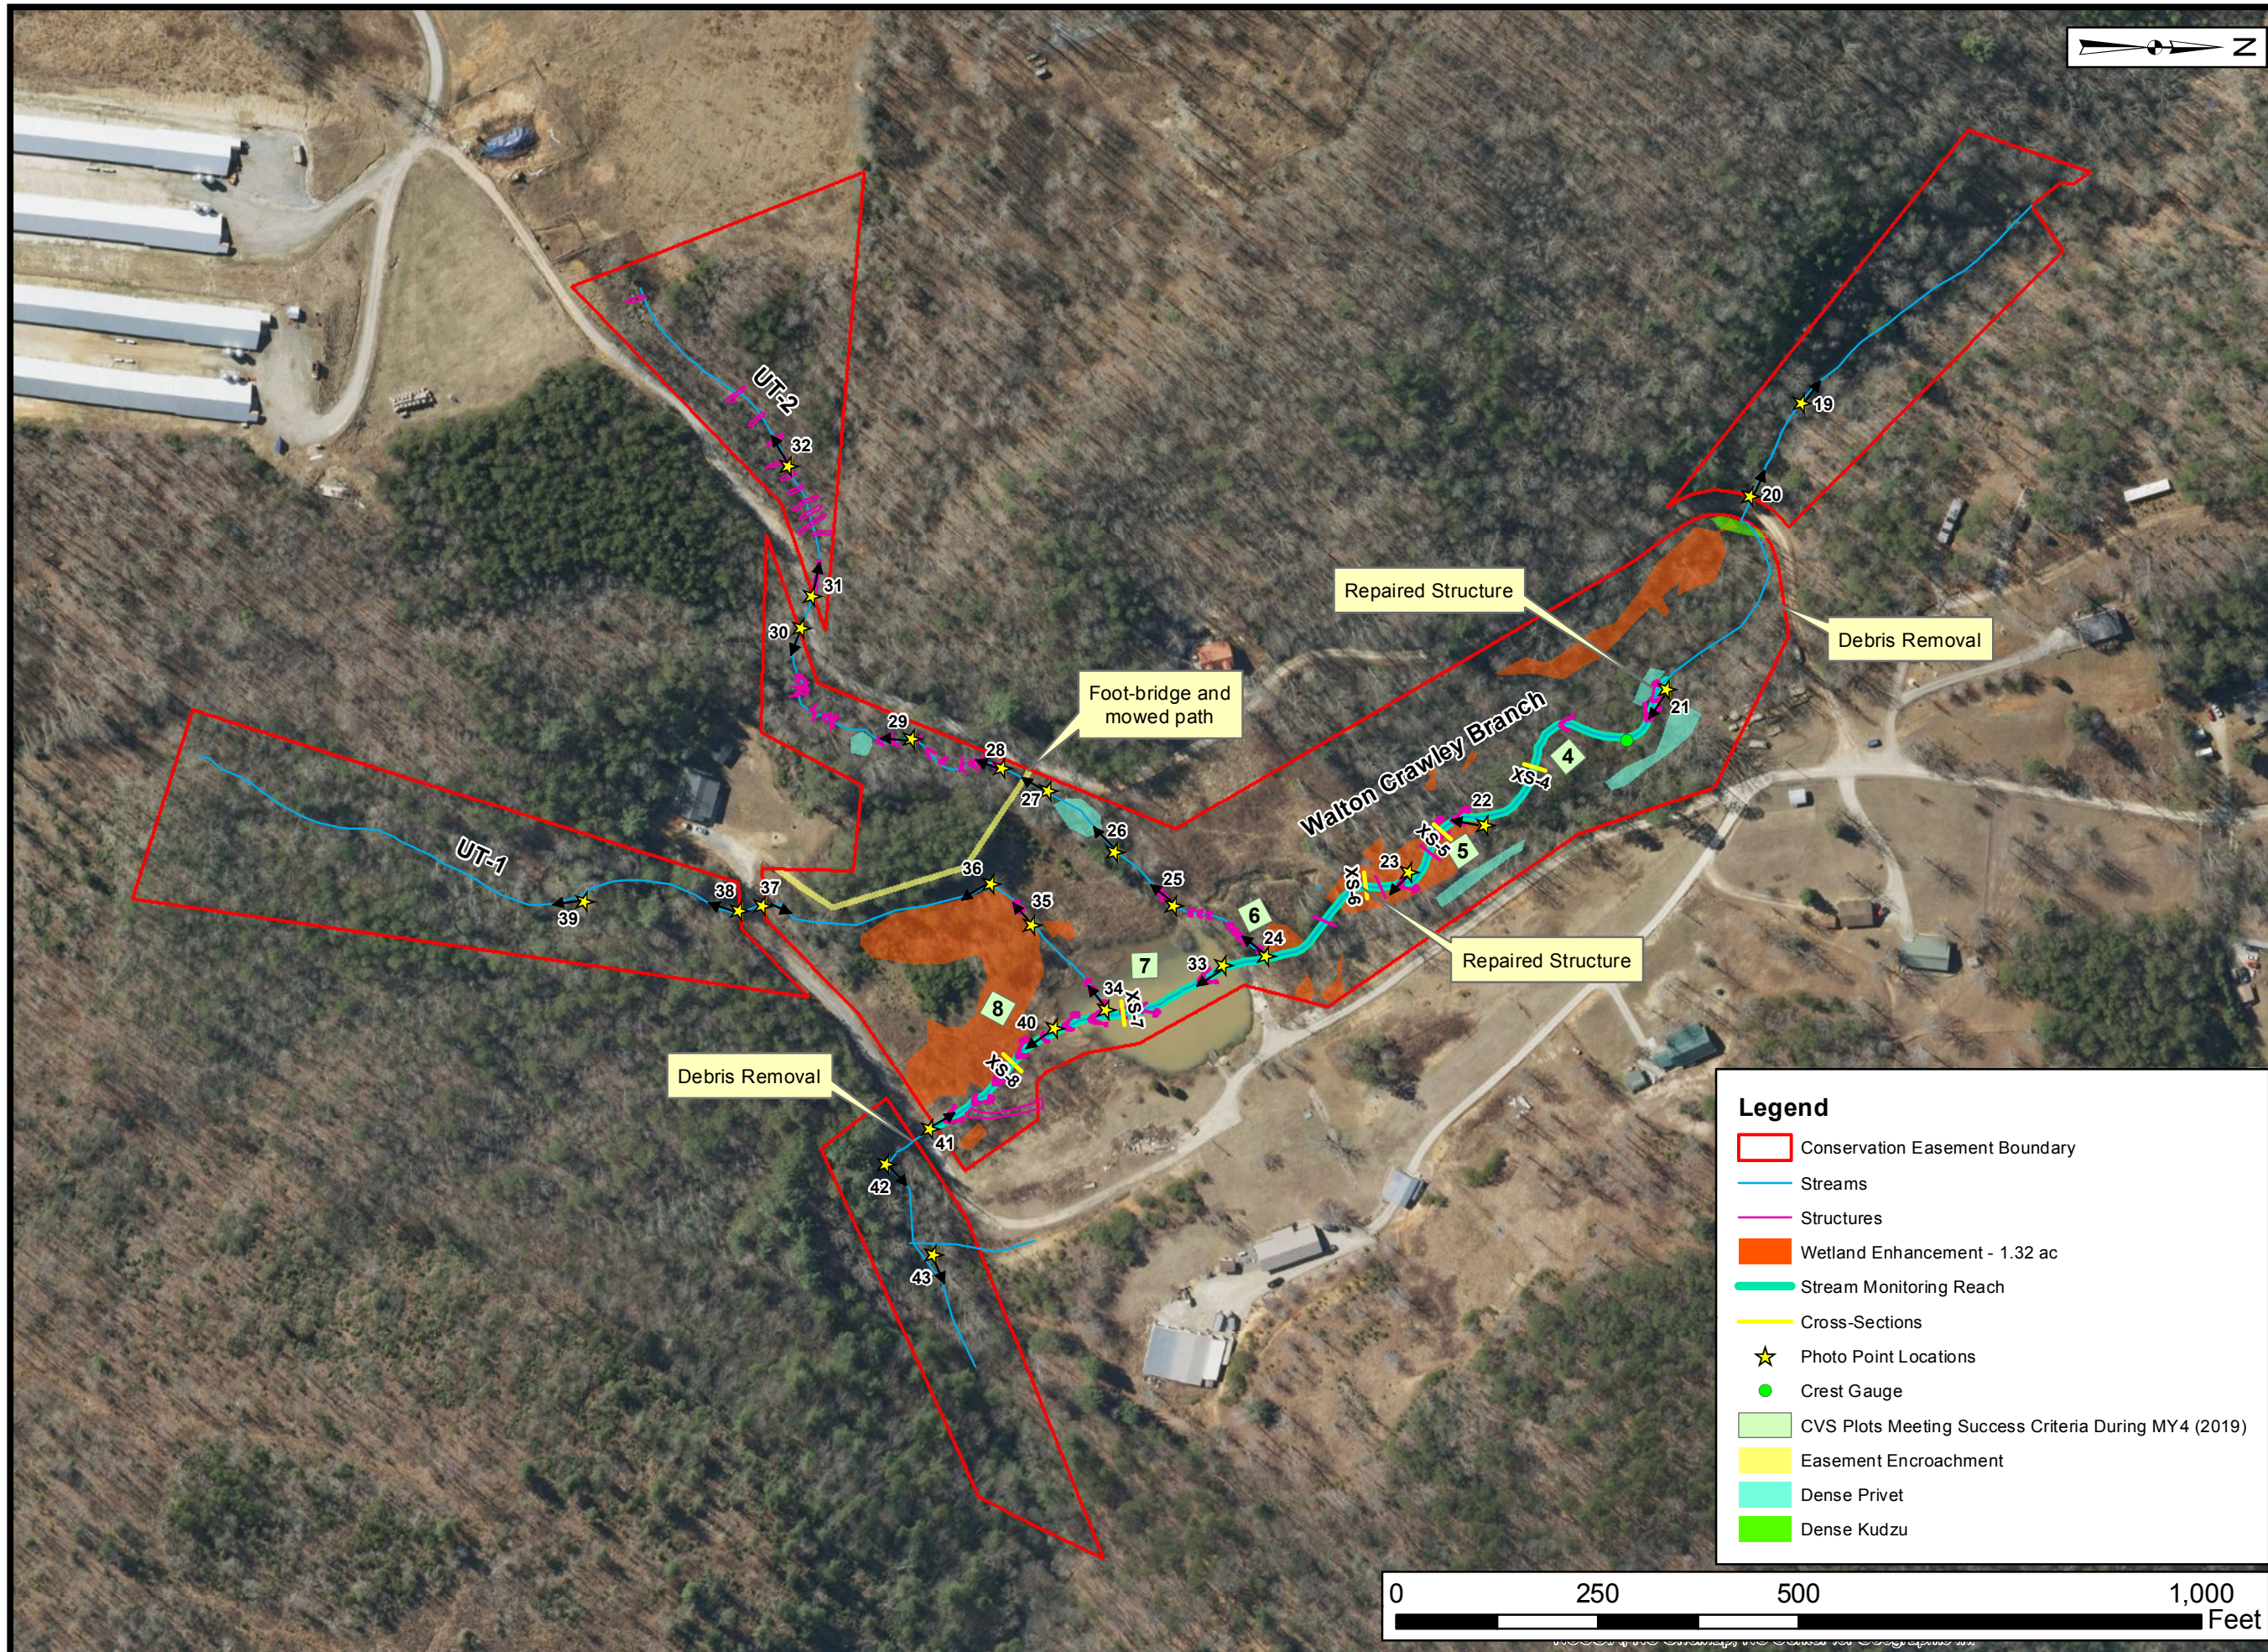
**FIGURE
 2B**

Several dense populations of Chinese privet (*Ligustrum sinense*) were observed along Walton Crawley Branch (Figure 2B, Appendix B). Additional populations of privet and multiflora rose (*Rosa multiflora*) was observed scattered throughout Site restoration reaches in quantities below mapping thresholds. NCDMS currently has implemented an invasive management plan and is under contract for the remaining monitoring period. During the last site visit invasive treatment areas were closely inspected, currently

Several areas of compromised easement integrity were observed during year 4 (2019). The fence on the northeast side of the crossing over UT-2 to Neighbors Brach has been compromised by large amounts of sediment during several high flow events. DMS has notified and is working with the landowner to repair the downed fence. Additionally, the footpath and foot-bridge identified in MY3 that extends through the conservation easement just north of UT-1 remains. DMS and DEQ Stewardship worked with the landowner to limit the width of the path to a minimum cutting for foot traffic only. This foot path will continue to be monitored to ensure no additional vegetation is disturbed. These areas are depicted on Figures 2A-B (Appendix B), and NCDMS is working with the landowner to resolve these issues.

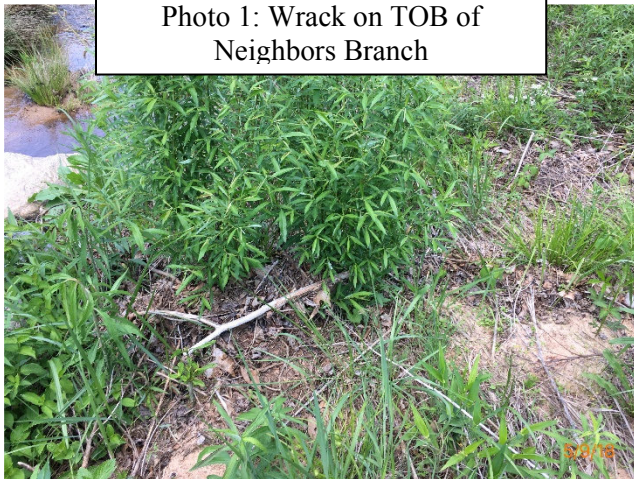
Photo 1: Wrack on TOB of Neighbors Branch

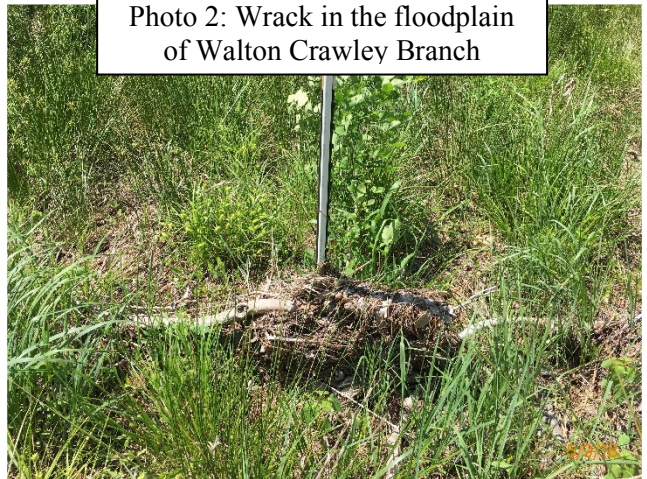
Photo 2: Wrack in the floodplain of Walton Crawley Branch

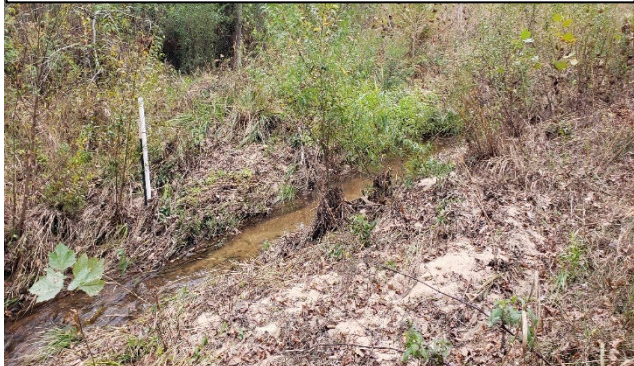
Photo 3: Wrack, sediment, and laid back vegetation in the floodplain of Neighbors Branch

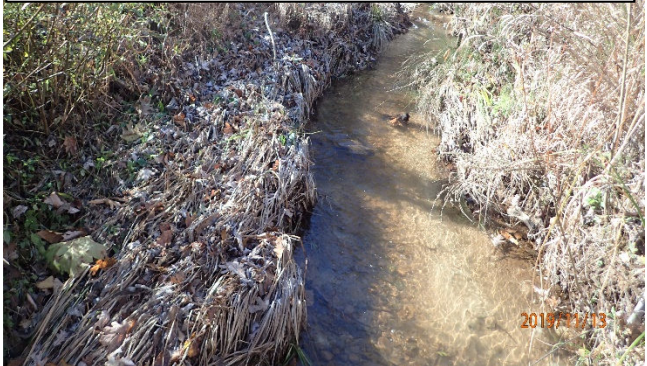
Photo 4: Reclining vegetation in the floodplain of Neighbors Branch
