FINAL
YEAR 5 (2020) ANNUAL
MONITORING REPORT

**NEIGHBORS BRANCH/WALTON CRAWLEY BRANCH
STREAM & WETLAND RESTORATION SITE**

NCDMS Project No. 92872
Contract No. D09023S
USACE Action ID No. SAW-2009-917 & NCDWR Project No. 10-0122
SCO No. 08-07308-01
McDowell County, North Carolina

Data Collection: May-November 2020
Submission: January 2021

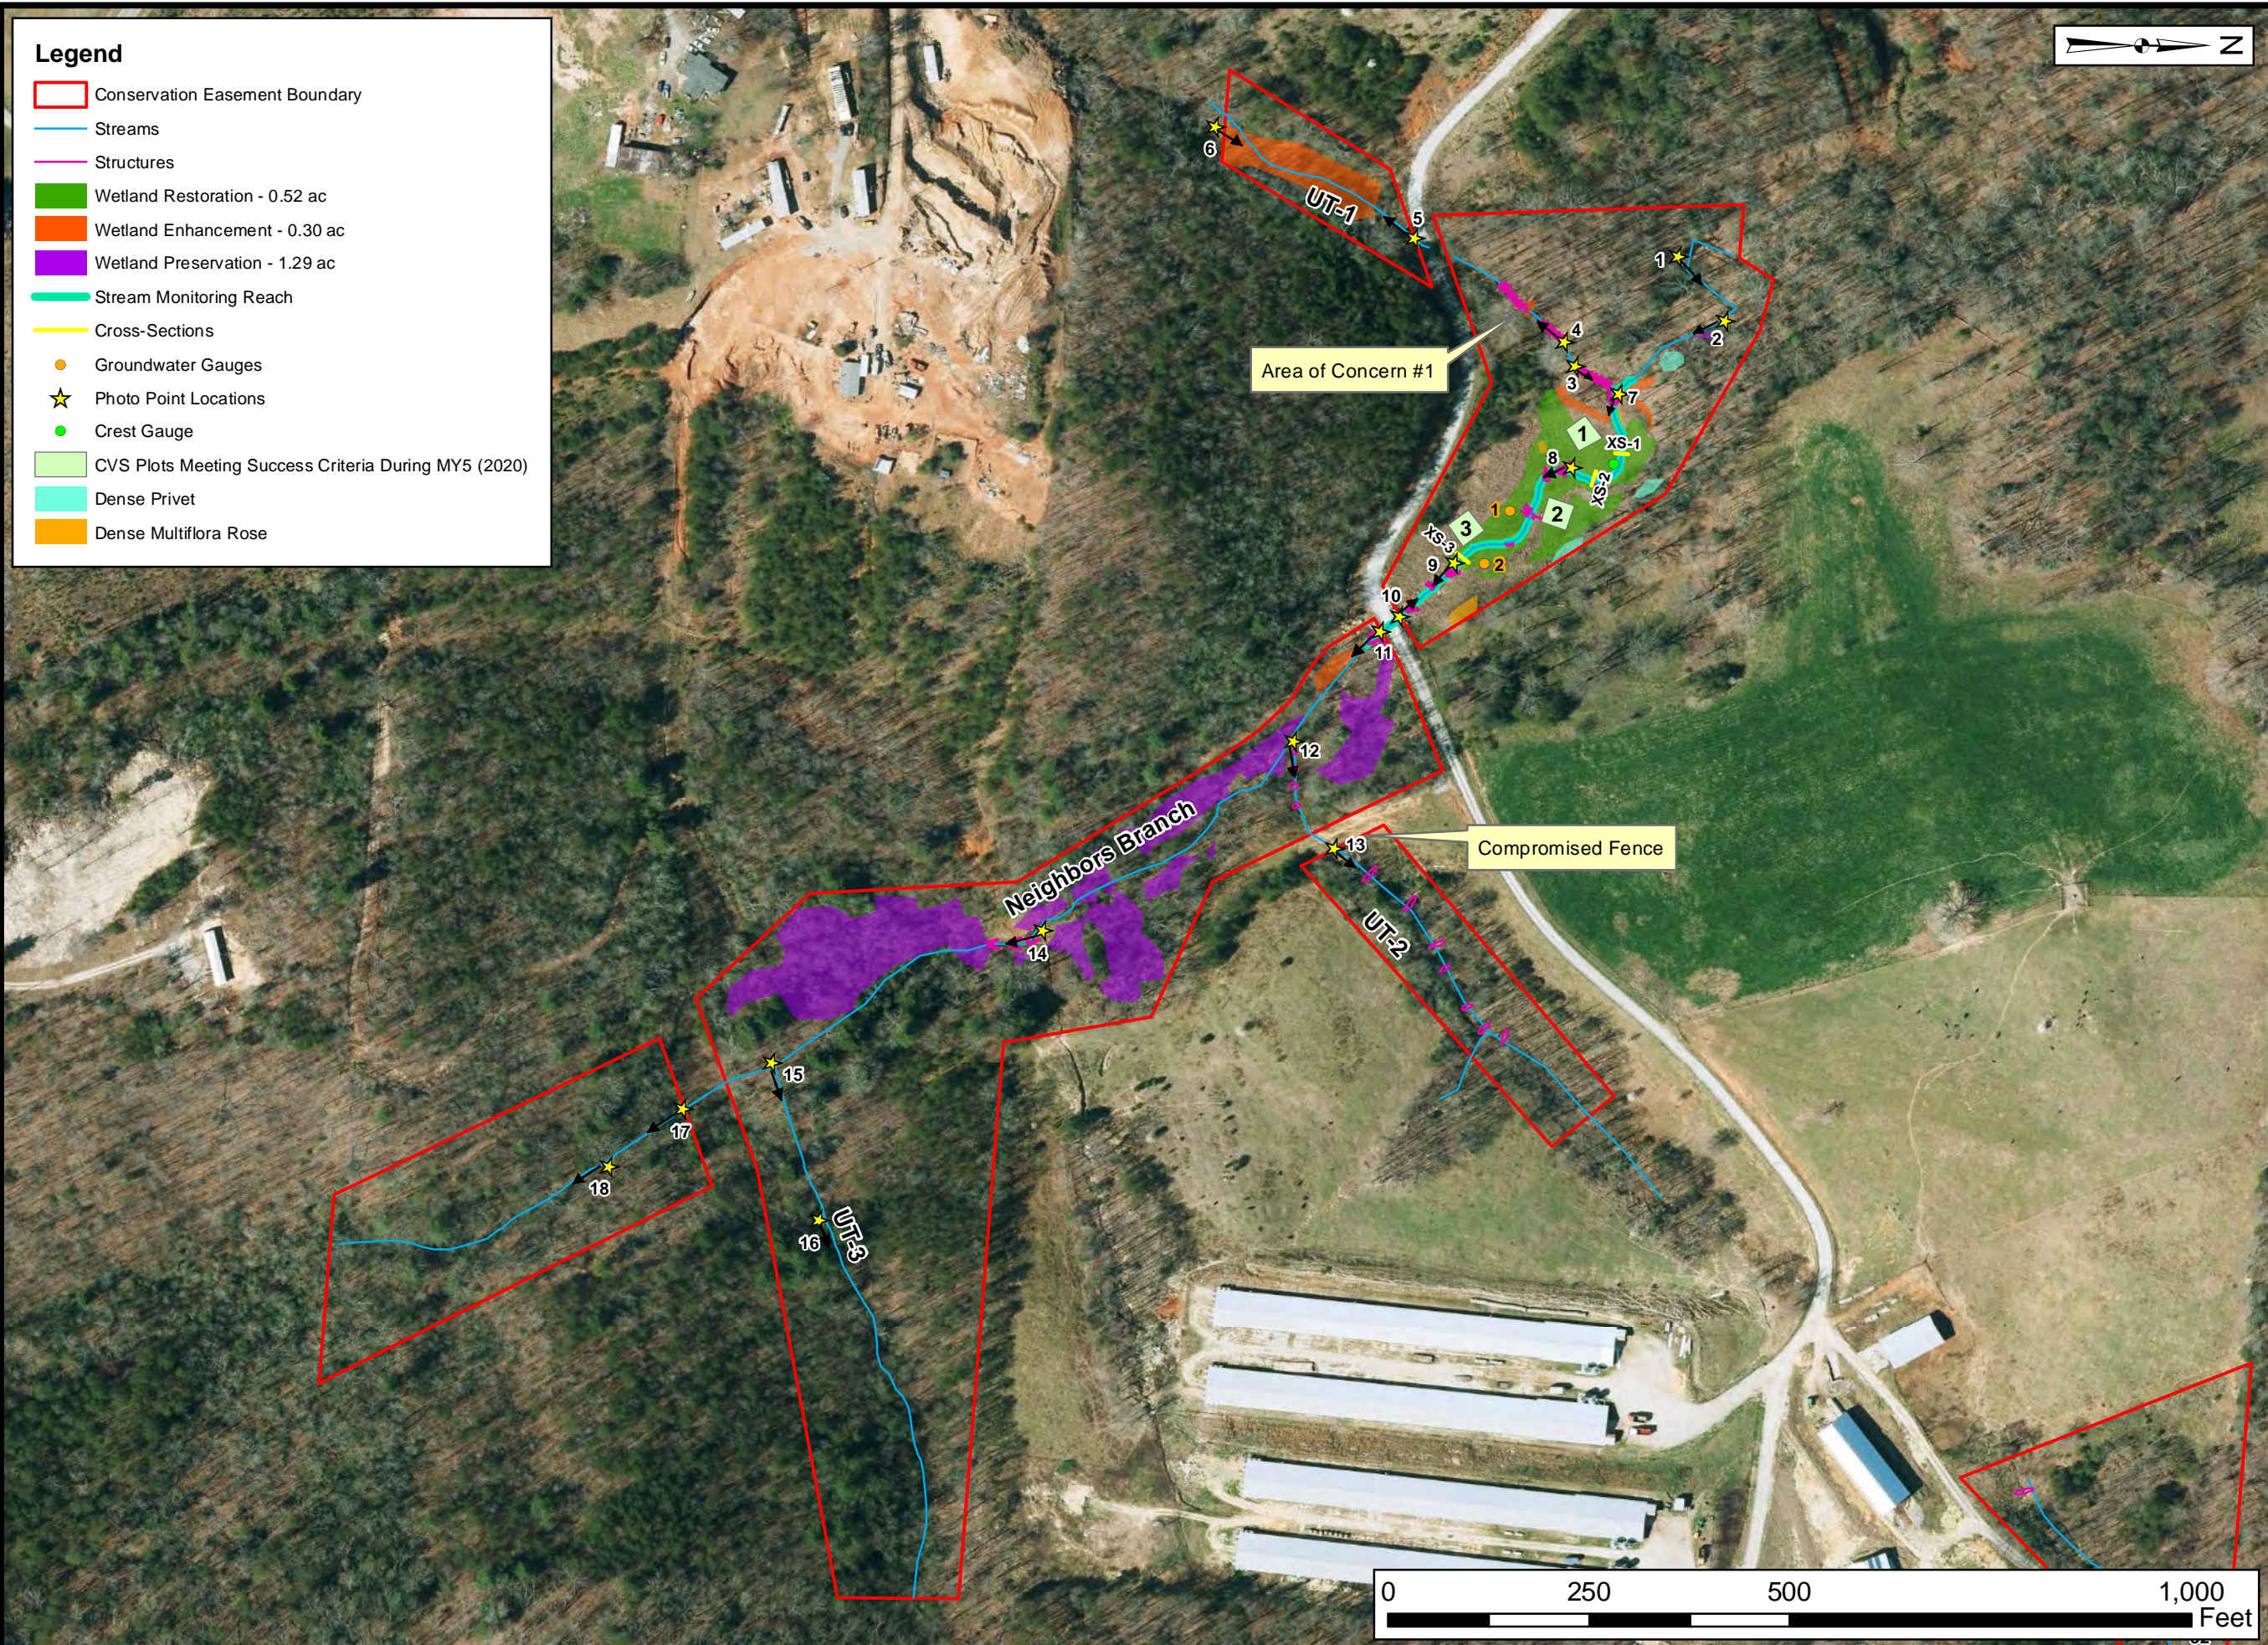
FIGURE
2A

Several dense populations of Chinese privet (*Ligustrum sinense*) and multiflora rose (*Rosa multiflora*) were observed along Neighbors Branch, Walton Crawley Branch, and UT-2 to Walton-Crawley Branch (Figures 2A-B, Appendix B). NCDMS currently has implemented an invasive management plan and is under contract through closeout. During the last site visit invasive treatment areas were closely inspected. Treatments throughout the site have been extremely successful, and populations of invasive species have

Several areas of compromised easement integrity were observed during year 5 (2020). The fence on the northeast side of the crossing over UT-2 to Neighbors Branch has been compromised by large amounts of sediment during several high flow events. DMS has been working with the landowner to repair the downed fence, and some repairs have been made; however, the overall integrity of the fence remains compromised. Additionally, the footpath and foot-bridge identified in MY3 that extends through the conservation easement just north of UT-1 remains. DMS and DEQ Stewardship worked with the landowner to limit the width of the path to a minimum cutting for foot traffic only. Based on visual observations and photo-documentation, the foot path has remained the same width with no additional vegetation disturbed. These areas are depicted on Figures 2A-B (Appendix B).

Two groundwater monitoring gauges were installed to take measurements after hydrological modifications were performed at the Site. Hydrological sampling will occur during the growing season (March 26 to November 5). Approximate locations of gauges are depicted on Figure 2A (Appendix B) and hydrology data can be found in Appendix E.

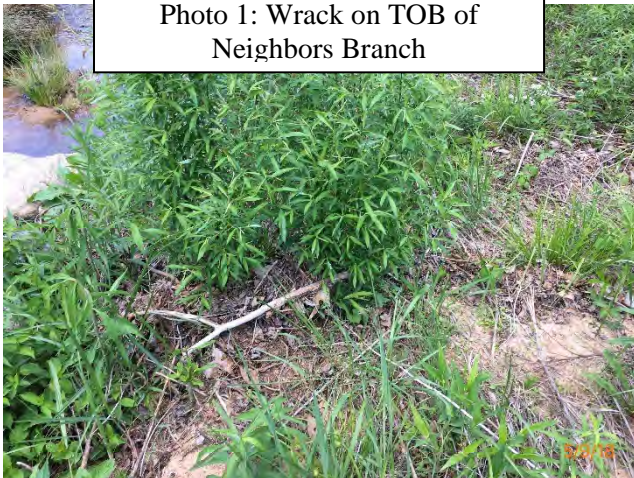
Photo 1: Wrack on TOB of Neighbors Branch

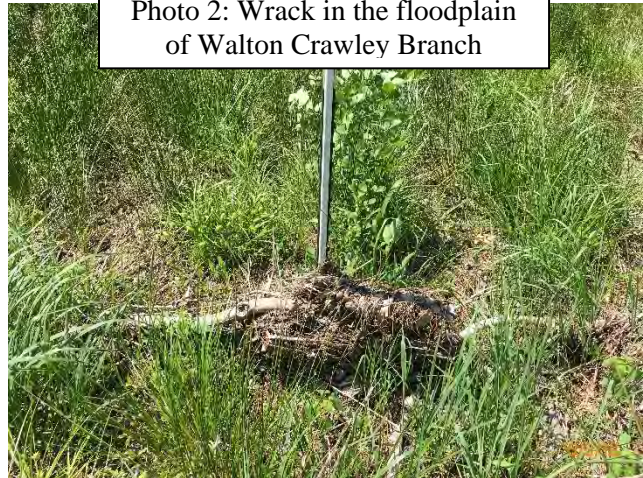
Photo 2: Wrack in the floodplain of Walton Crawley Branch

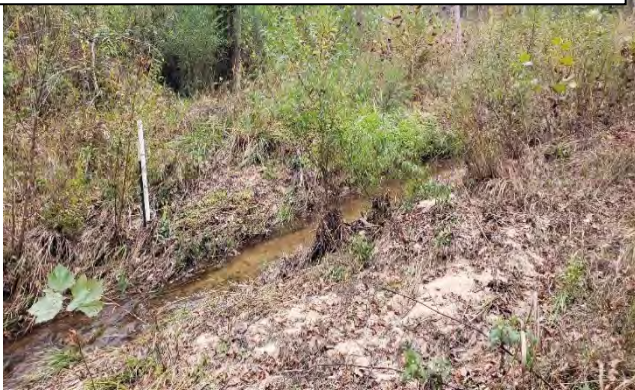
Photo 4: Reclining vegetation in the floodplain of Neighbors Branch

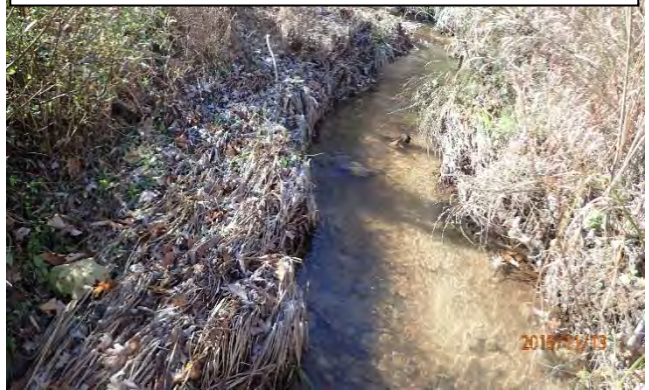
Photo 5: Wrack and laid-back vegetation in the floodplain of Neighbors Branch
