**FINAL
MY1 MONITORING REPORT**

NESBIT SITE

Union County, North Carolina
Catawba River Basin
Cataloging Unit 03050103

DMS Project No. 100121
Full Delivery Contract No. 7868
DMS RFP No. 16-007704 (issued 9/6/2018)
USACE Action ID No. SAW-2019-00832
DWR Project No. 2019-0862

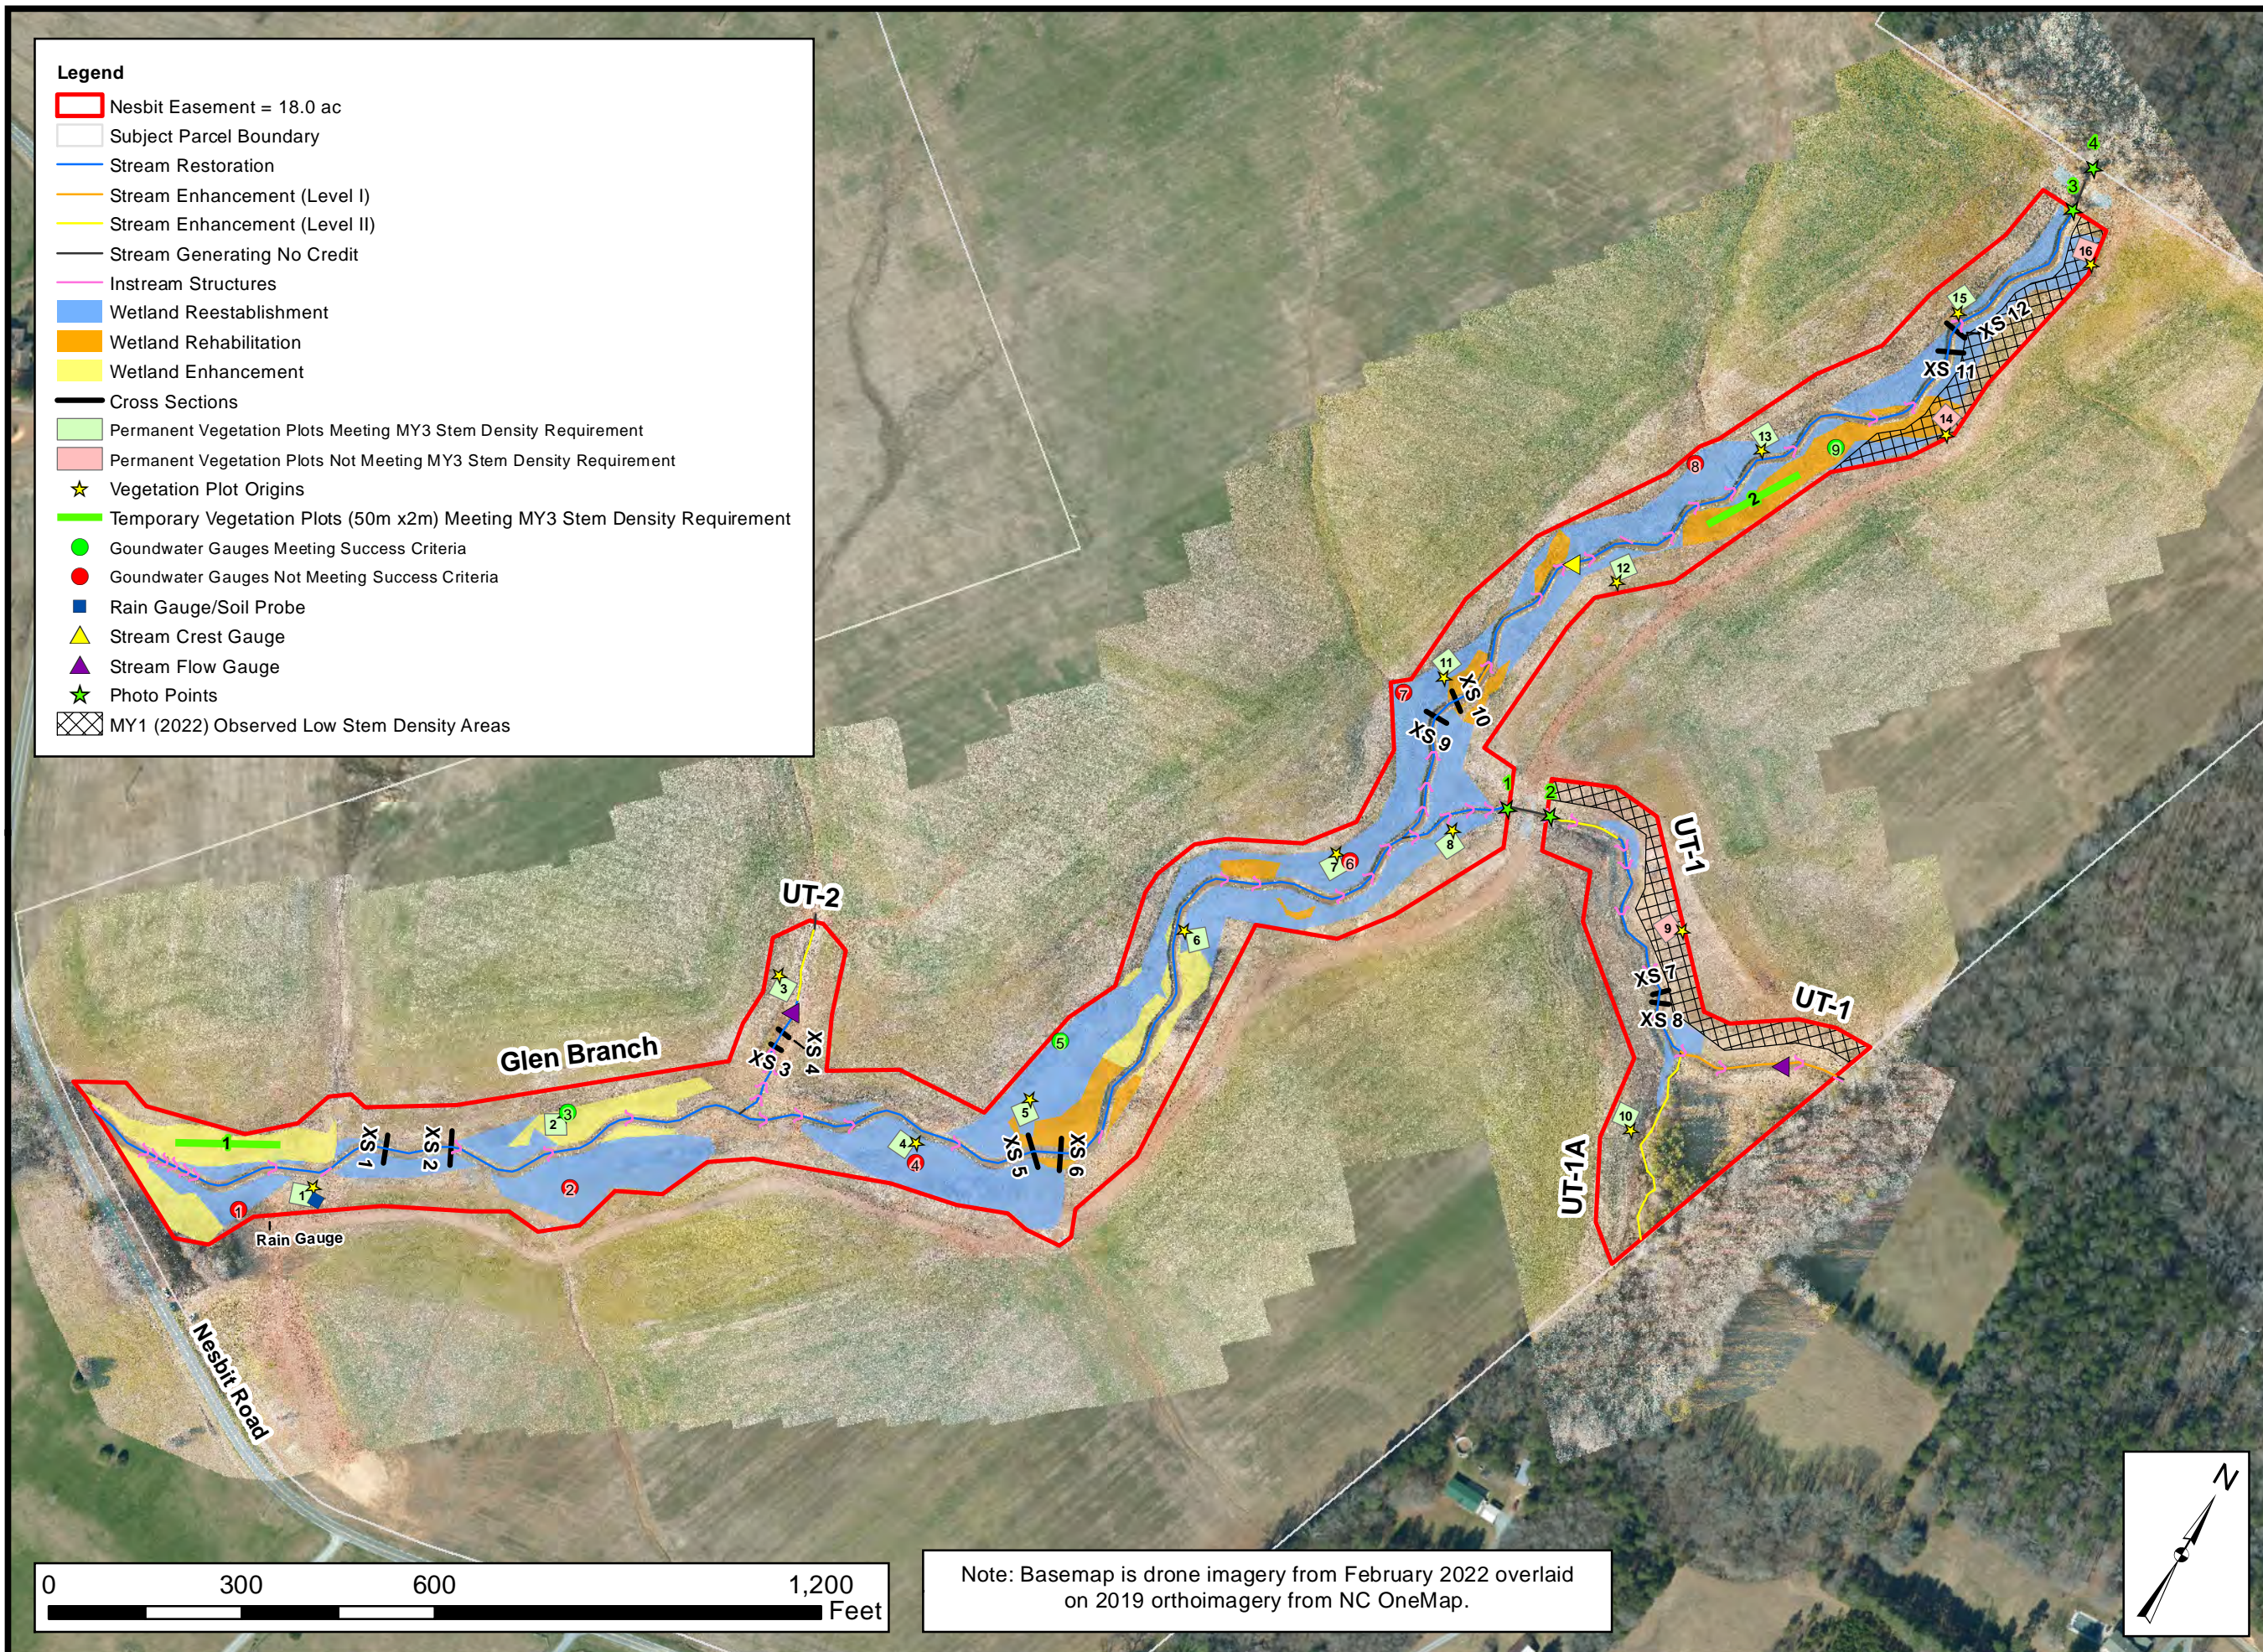
Figure 1. Current Conditions Plan View

- Two areas of observed low stem density were included on the MY1 (2022) CCPV – Figure 1, Appendix 1 near vegetation monitoring plots 14 and 16, and 9 – 1.32 acres total, 8.25 % of the total planted area (16 acres). RS will conduct four vegetation transects within the areas of observed low stem density in the spring of 2023 to determine if additional planting is required.

Two areas of observed low stem density were included on the MY1 (2022) CCPV – Figure 1, Appendix 1 near vegetation monitoring plots 14 and 16, and 9 – 1.32 acres total, 8.25 % of the total planted area (16 acres). RS will conduct four vegetation transects within the areas of observed low stem density in the spring of 2023 to determine if additional planting is required.

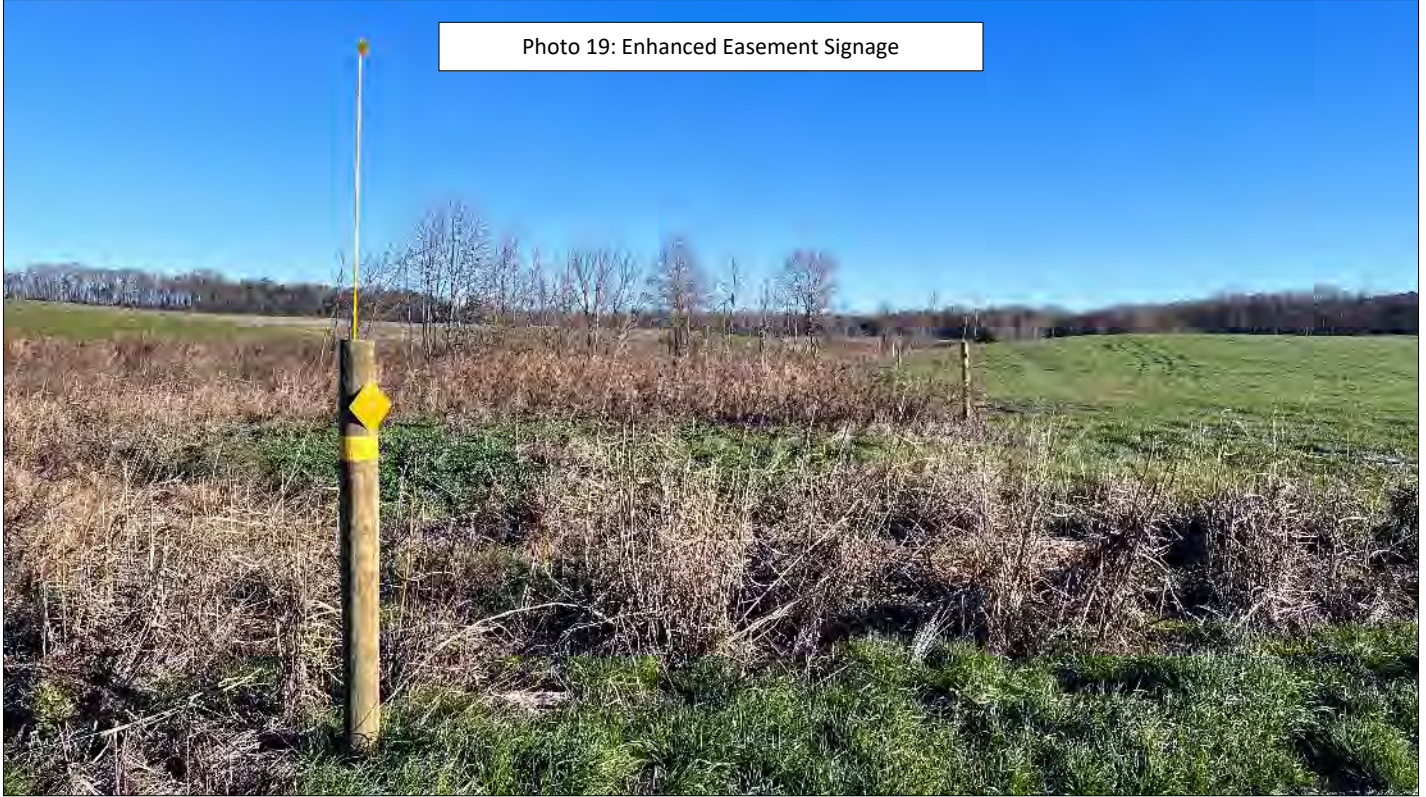
- The easement was marked with 6-inch treated posts upon completion of restoration activities in October/November 2021. Additional marking was added during 2022, and high-visibility flagging was added to all treated post corners to further delineate the easement area.

Photo 19: Enhanced Easement Signage

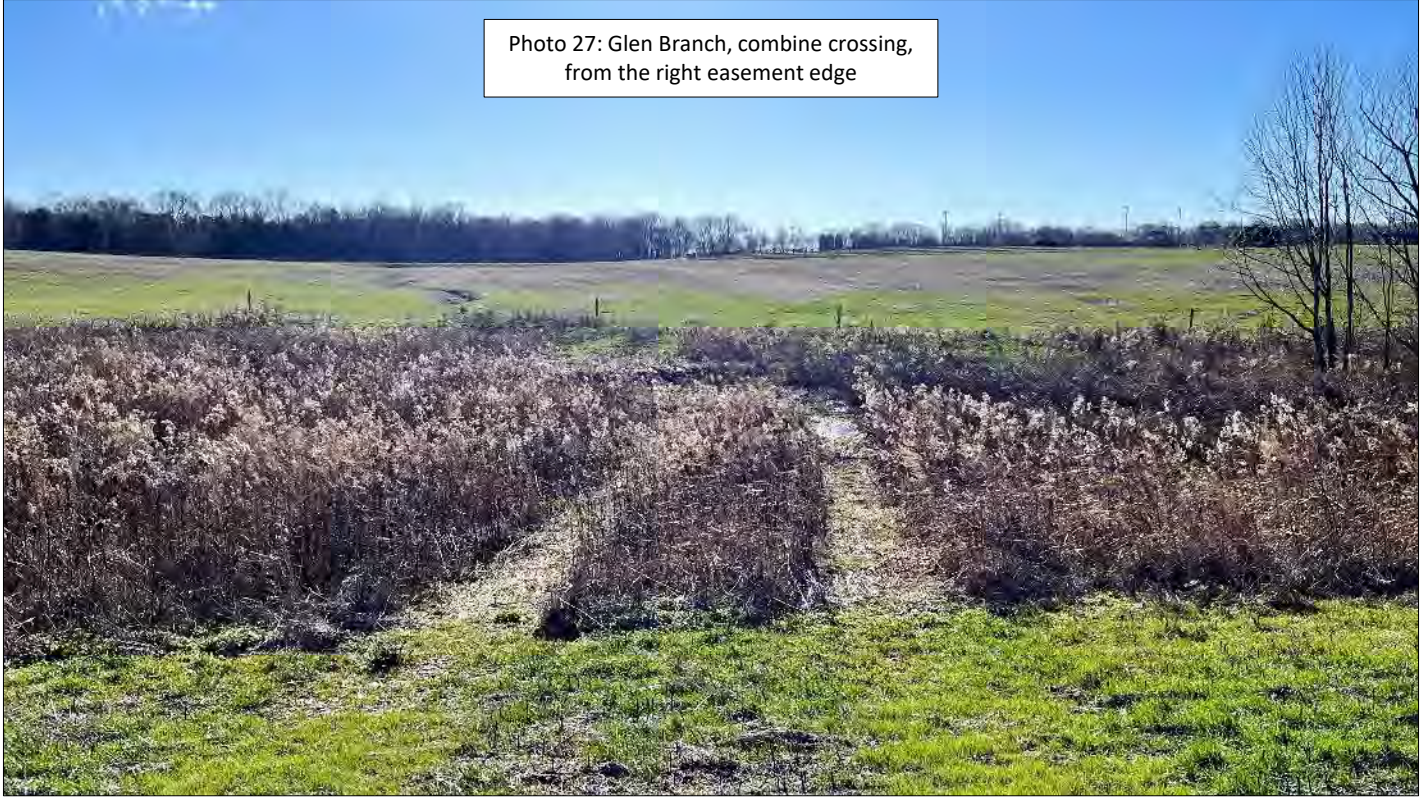
- Minor occurrences of encroachment occurred in Year 1 (2022).
 - Minor areas of scalping occurred along the easement.
 - In 2022, a combine was driven across the project near vegetation plot 1, where a pre-construction crossing once existed. No evidence of impacts to the stream, wetland, or vegetation was observed by RS staff, who investigated the encroachment in late October 2022 (Photo Log, Appendix A).

Photo 27: Glen Branch, combine crossing,
from the right easement edge

- Matthew Harrell, with Restoration Systems, worked with the landowner and his farm operations manager to review the easement footprint where minor areas of scalping occurred to ensure encroachment does not continue (Appendix F).

- The entire easement boundary will be inspected during future monitoring years to ensure that the easement remains well-marked and that no additional encroachment occurs.

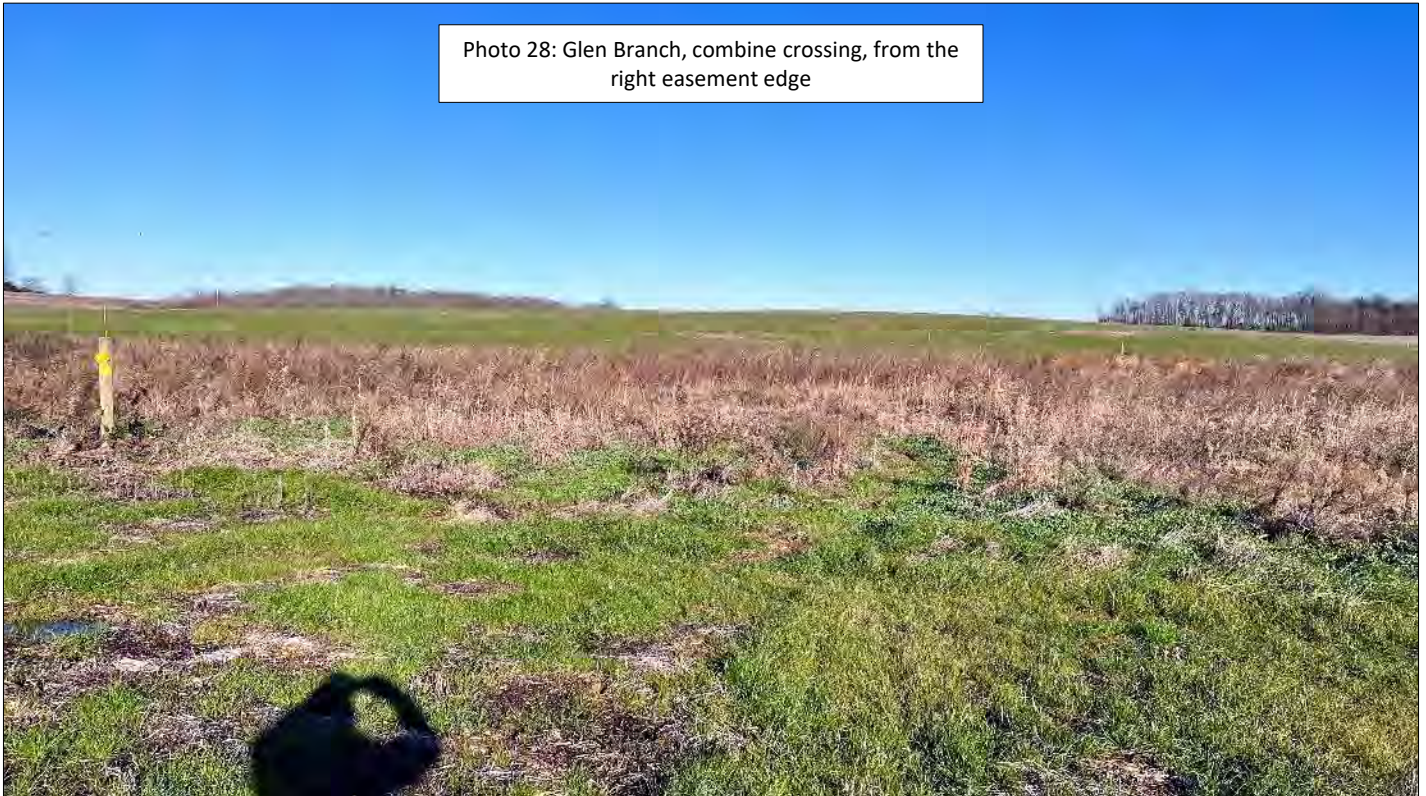
Photo 28: Glen Branch, combine crossing, from the
right easement edge
