**FINAL
MY2 MONITORING REPORT**

NESBIT SITE

Union County, North Carolina
Catawba River Basin
Cataloging Unit 03050103

DMS Project No. 100121
Full Delivery Contract No. 7868
DMS RFP No. 16-007704 (issued 9/6/2018)
USACE Action ID No. SAW-2019-00832
DWR Project No. 2019-0862

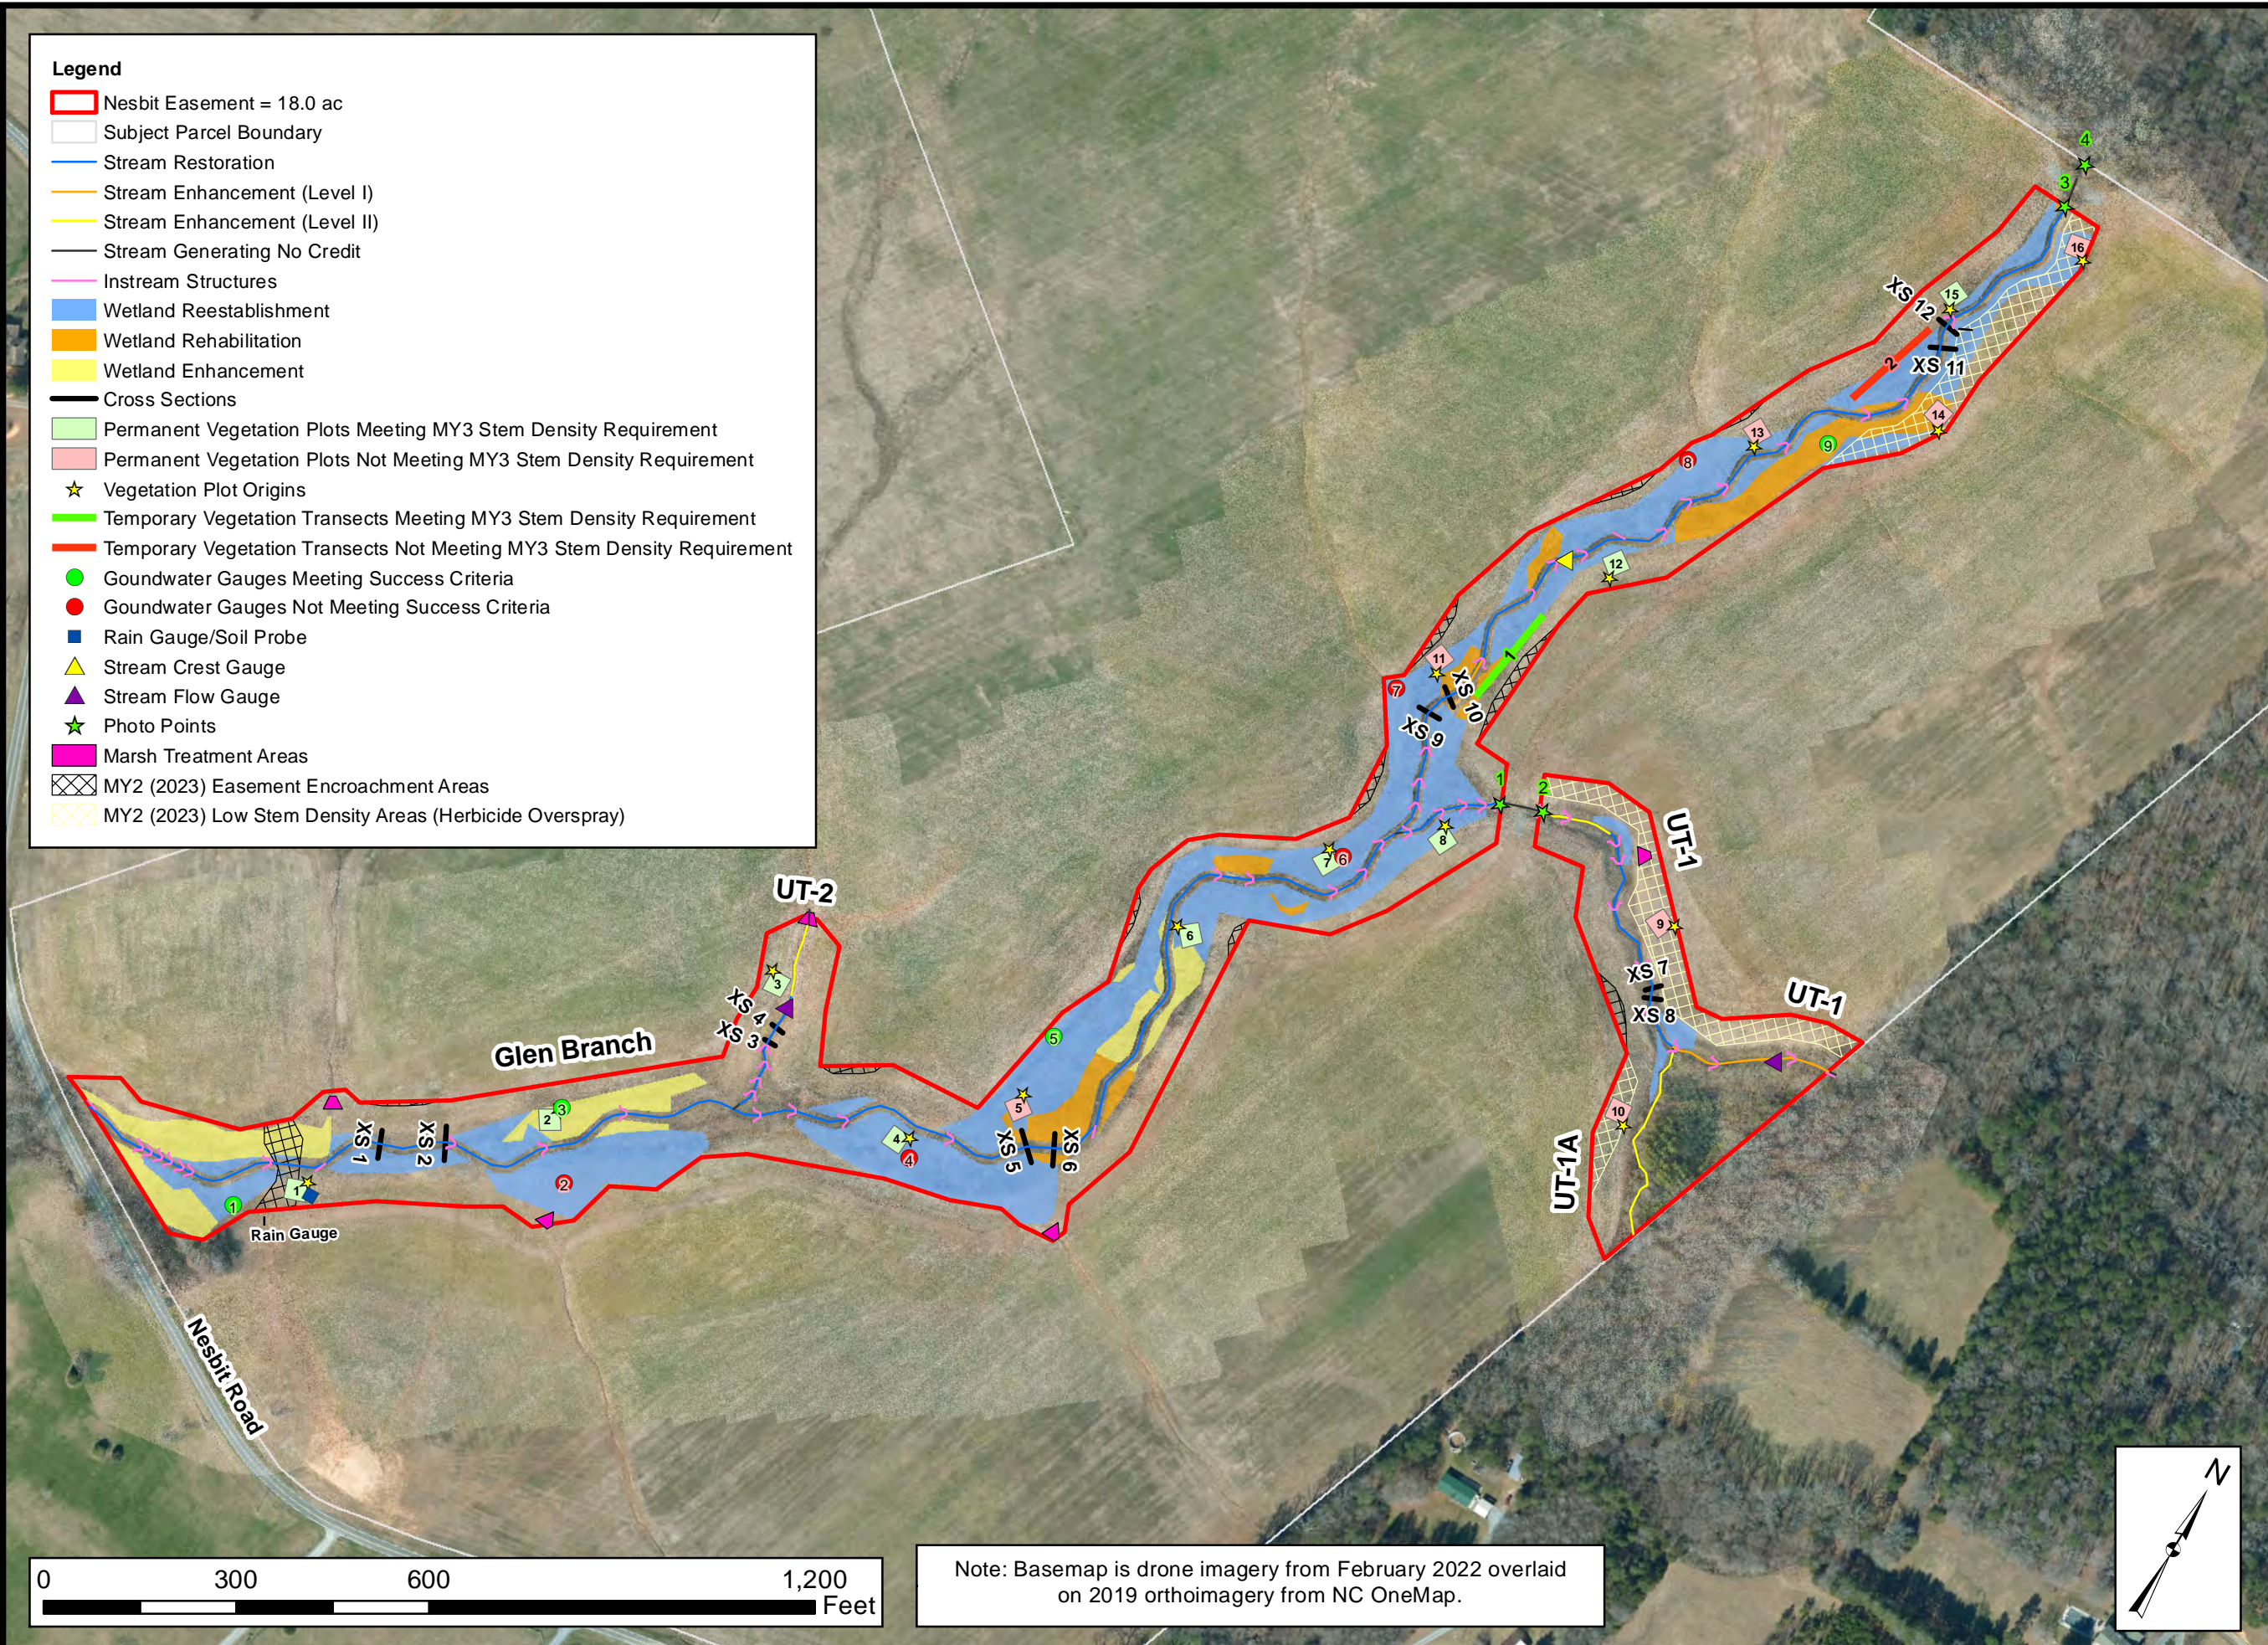
CURRENT CONDITIONS PLAN VIEW

Response: The areas observed to be impacted by herbicide overspray are depicted in yellow cross-hatching. The legend label has been updated to clarify that these are the areas affected by overspray.

- MY2 (2023) Low Stem Density Areas (Herbicide Overspray)

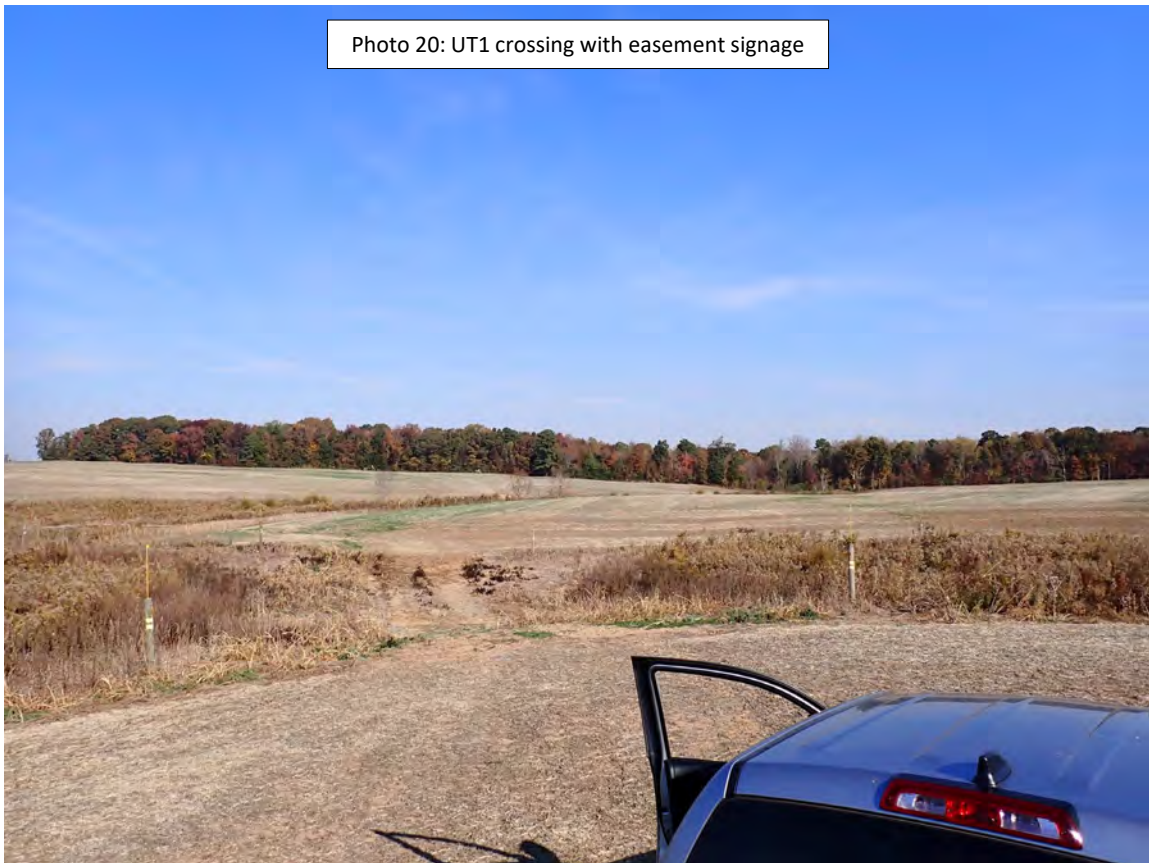
Photo 20: UT1 crossing with easement signage

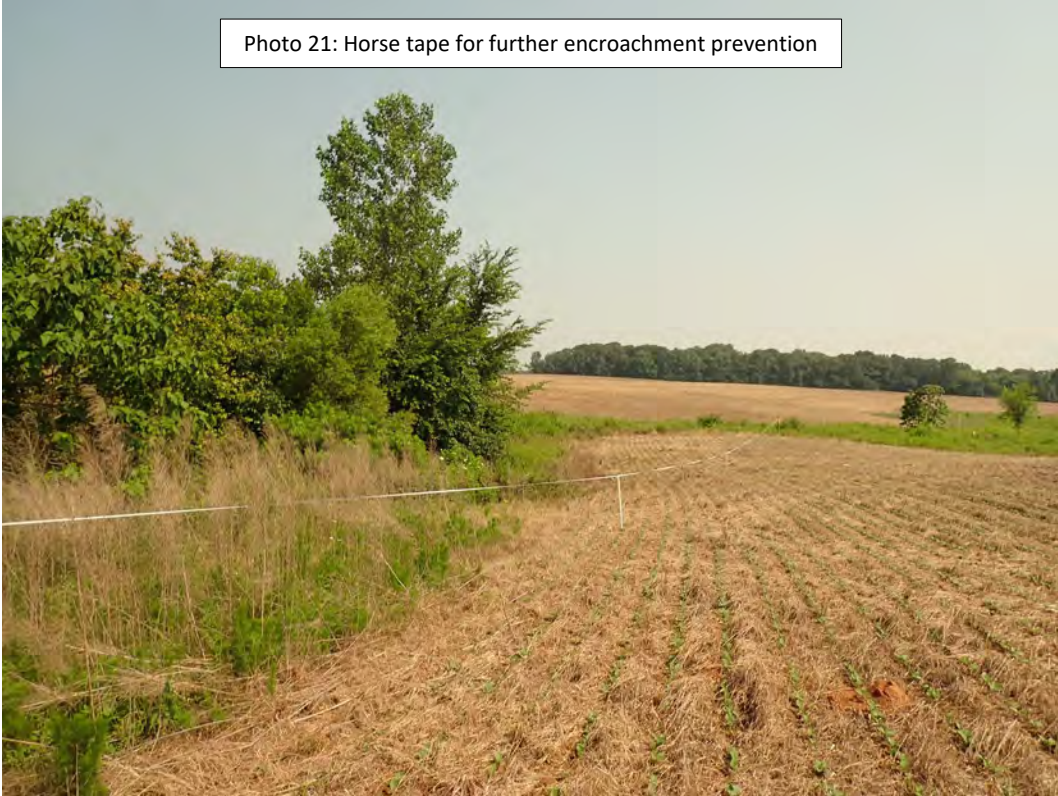
Photo 21: Horse tape for further encroachment prevention

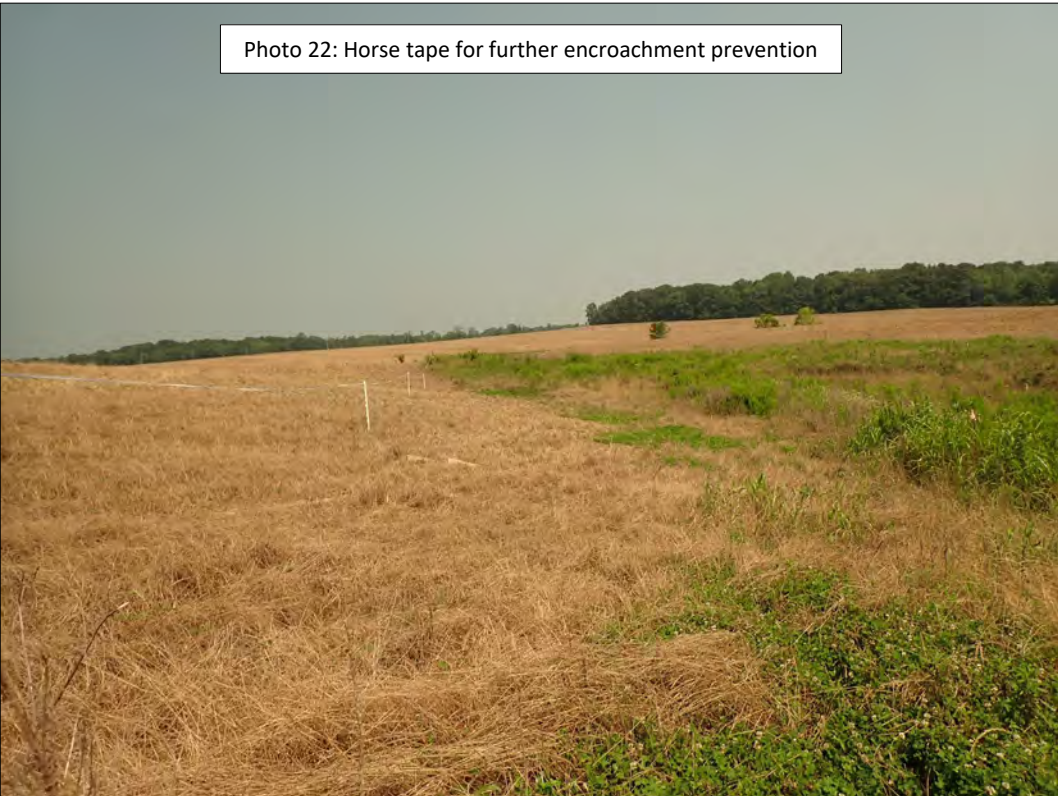
Photo 22: Horse tape for further encroachment prevention

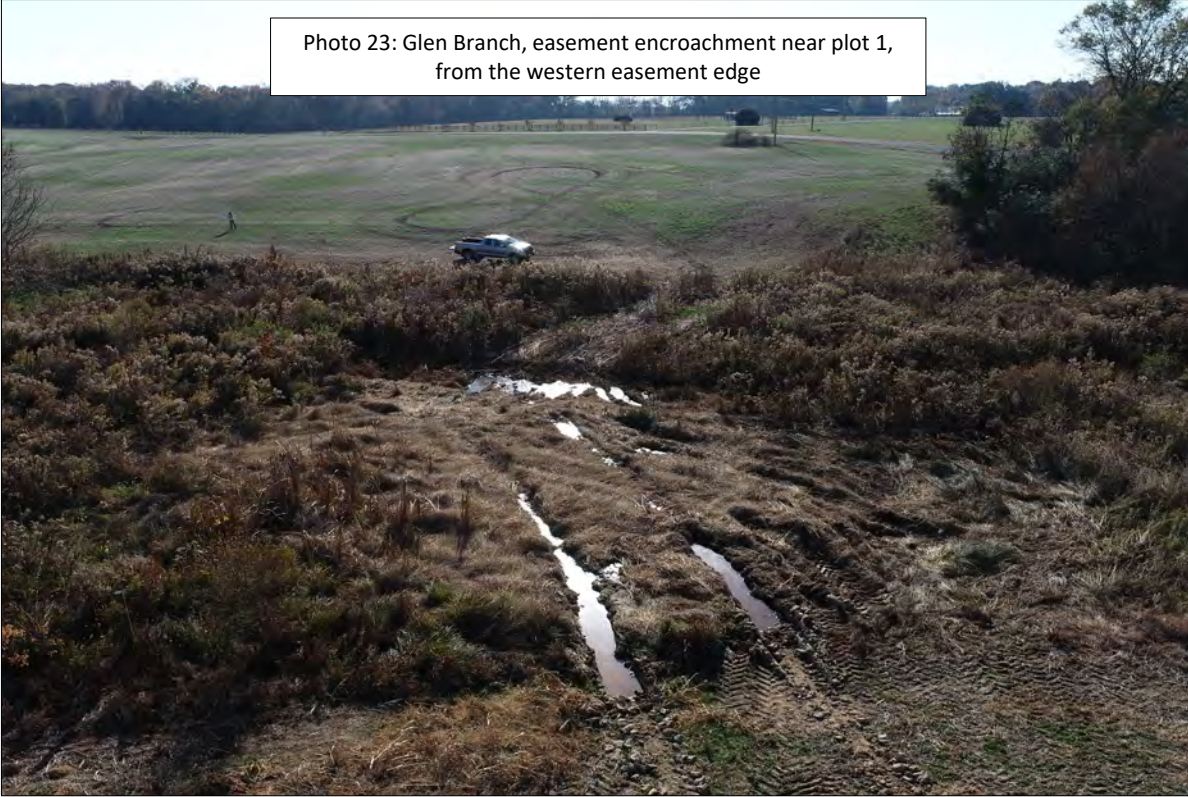
- In late 2023, a combine was driven across the project near vegetation plot 1, where a pre-construction crossing once existed. This was the second occurrence of this type of encroachment in this area; the first occurred in late 2022. No evidence of impacts to the stream or wetland was observed by RS staff, who investigated the encroachment in late November 2023. Vegetation plot 1 was slightly affected by the encroachment. MY3 (2024) vegetation measurements will determine if any planted stems were affected. The landowner was notified, and additional signage added.

Photo 23: Glen Branch, easement encroachment near plot 1,
from the western easement edge

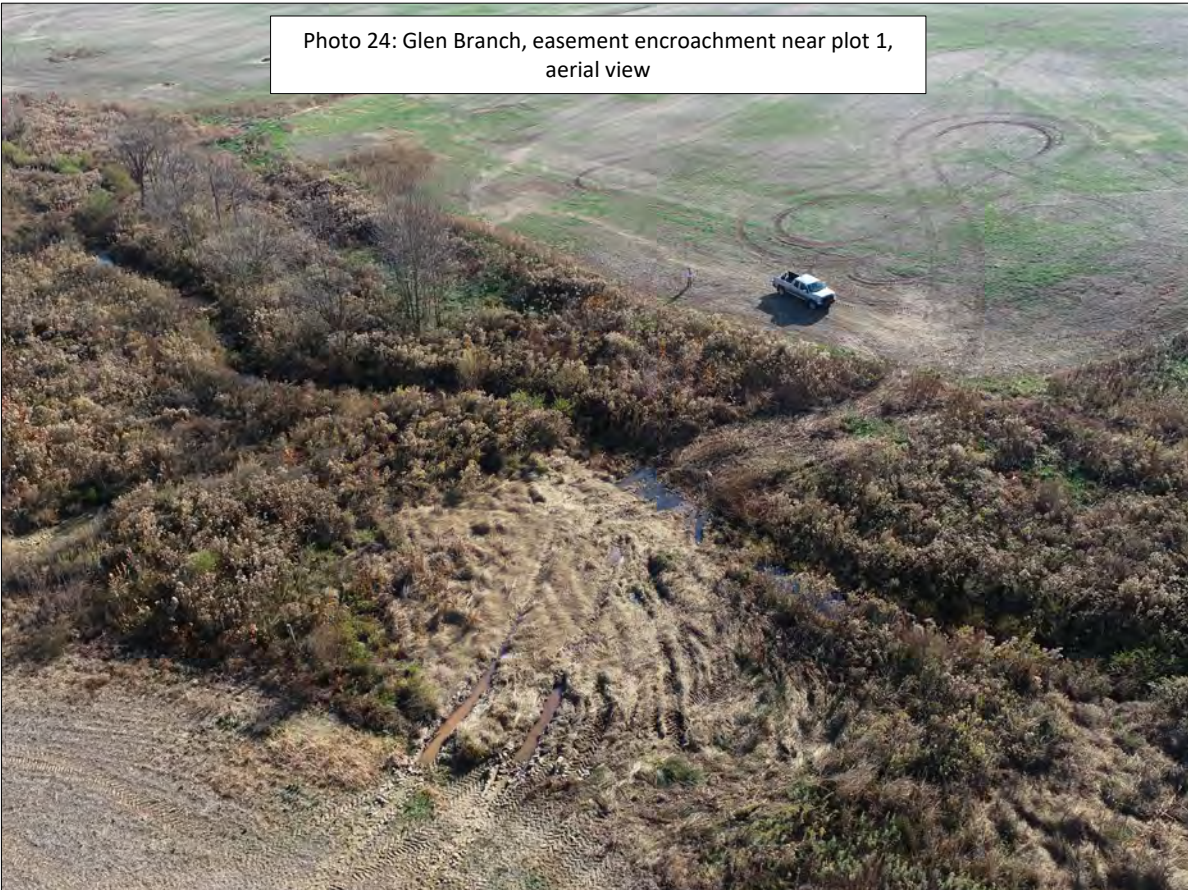
Photo 24: Glen Branch, easement encroachment near plot 1,
aerial view
