Neu-Con Umbrella Wetland and Stream Mitigation Bank

Casey/King Wetland Mitigation Site  
As-Built Report

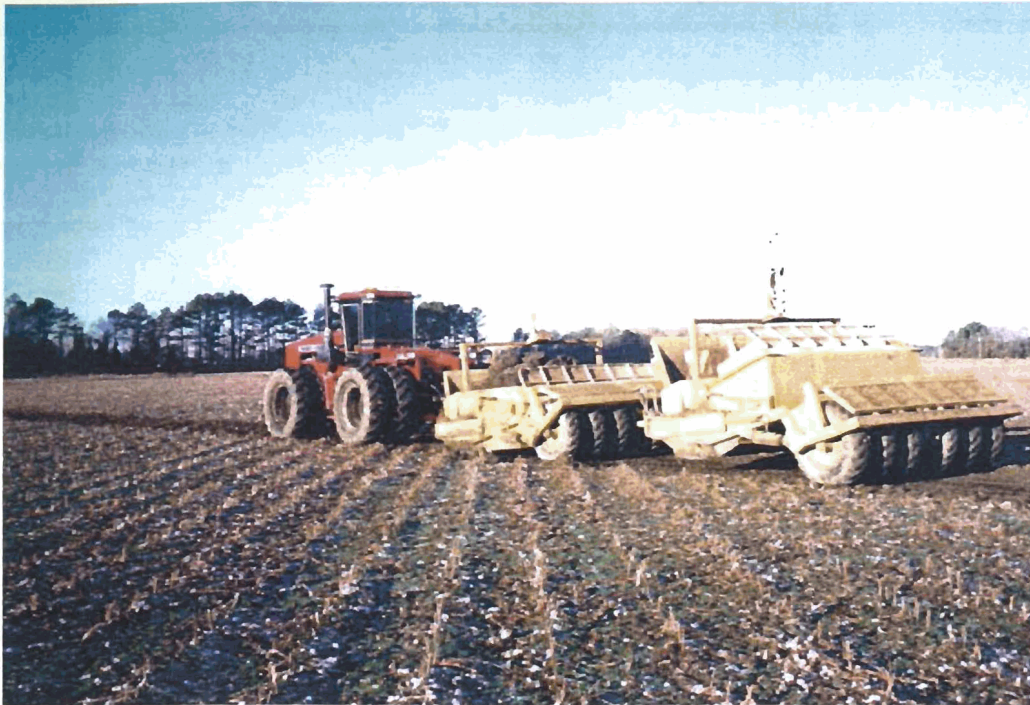
**Photo 1. Site grading with laser level equipped pan excavator.**

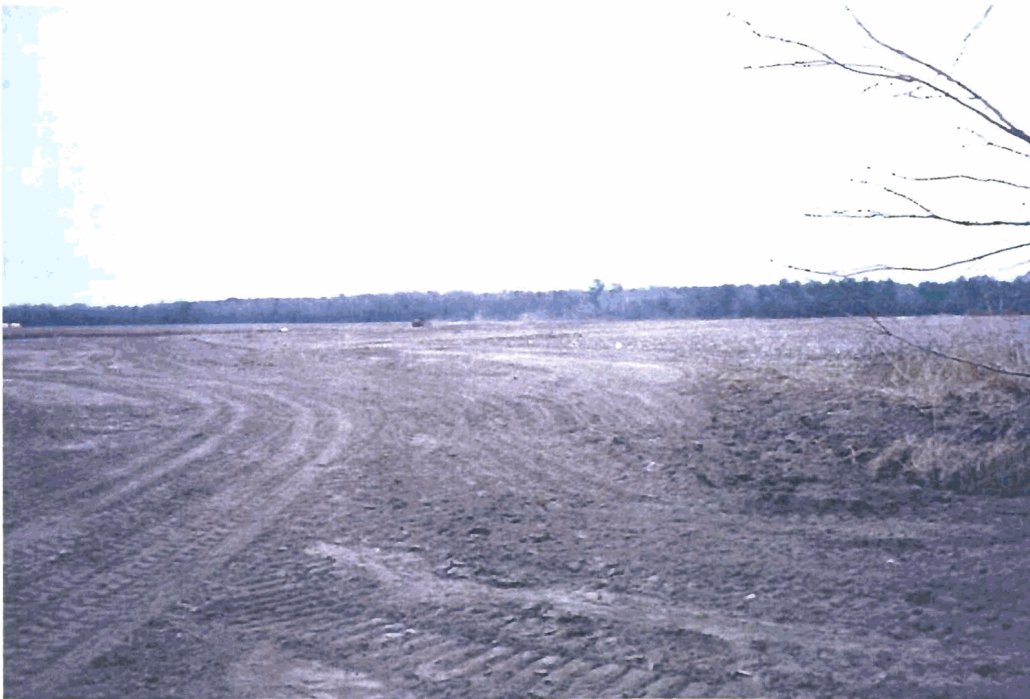
**Photo 2. Completed grading on the west side of the site.**

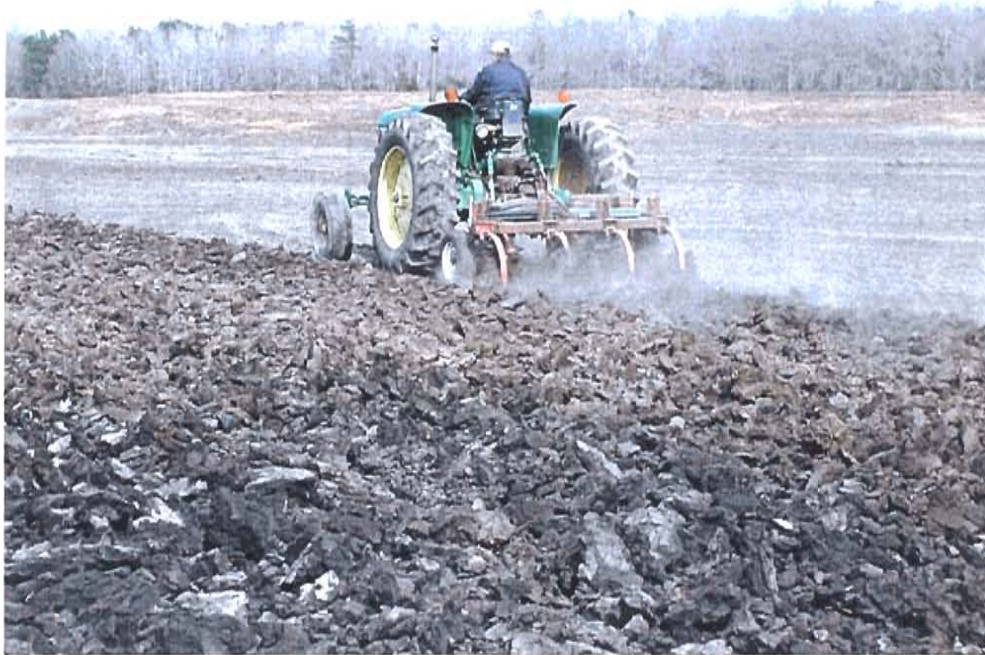
**Photo 3. Breaking the plow pan and increasing surface storage.**

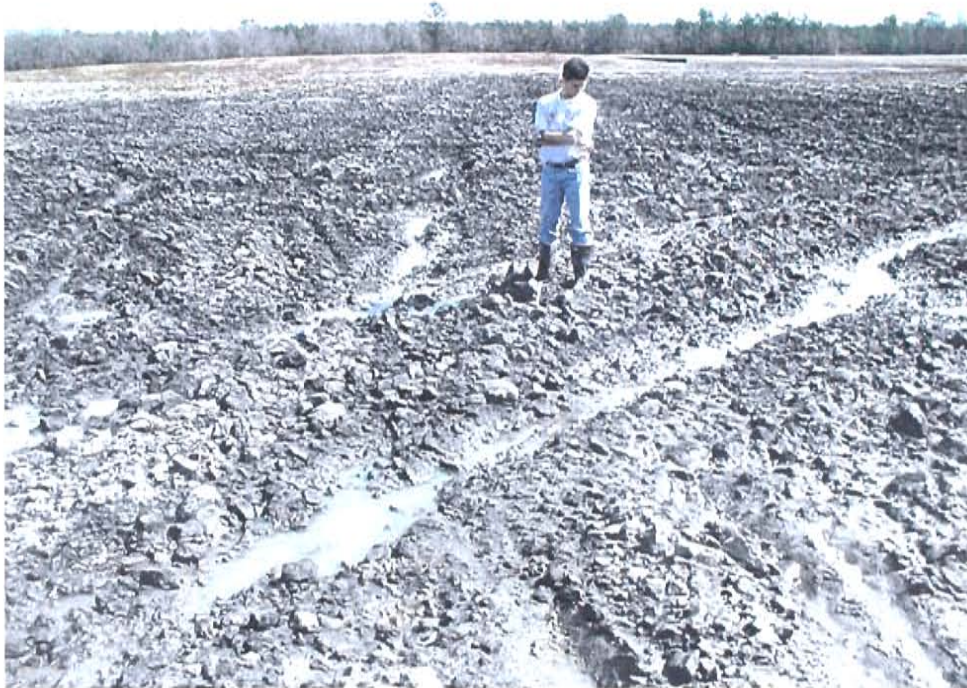
**Photo 4. Restoration area after grading and tillage operations were completed.**

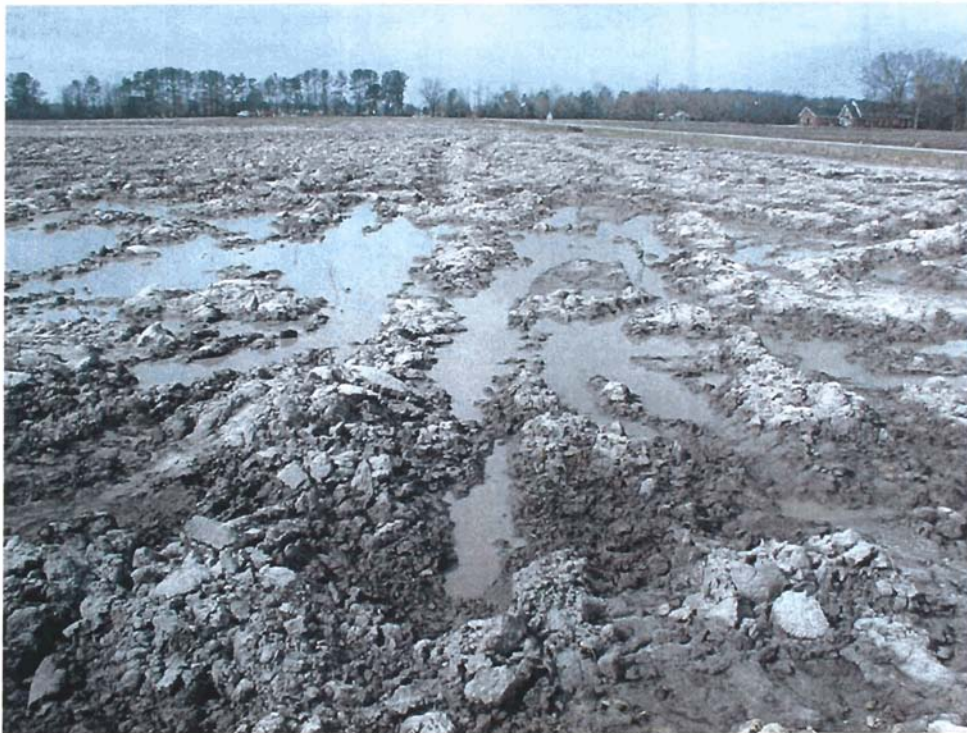
**Photo 5. Restored topography.**

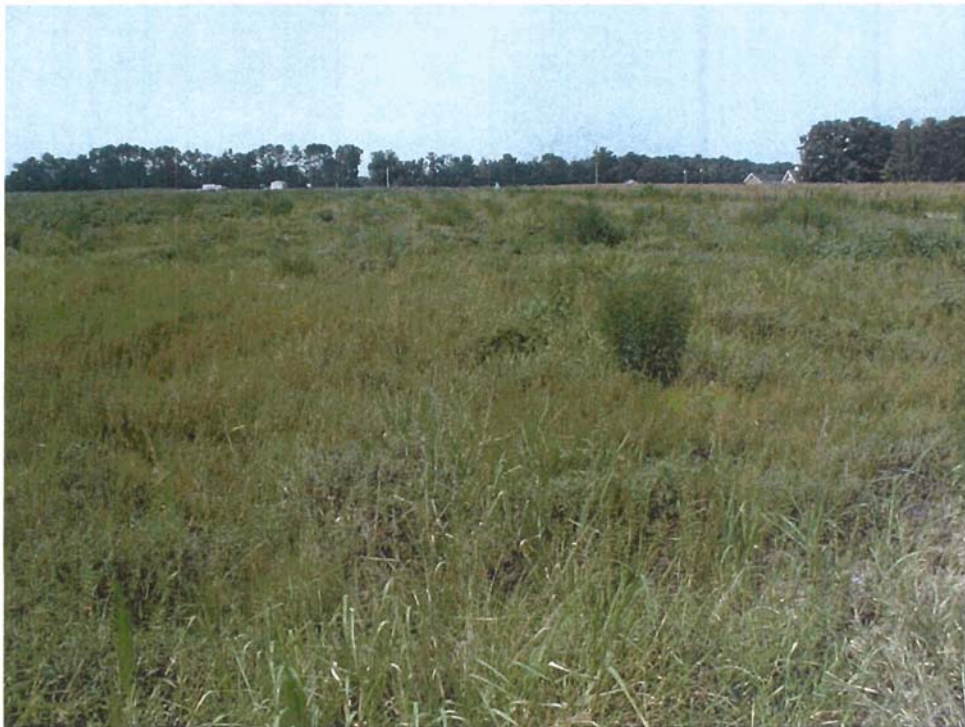
**Photo 6. Same location as Photo 5 on August 24, 2002.**

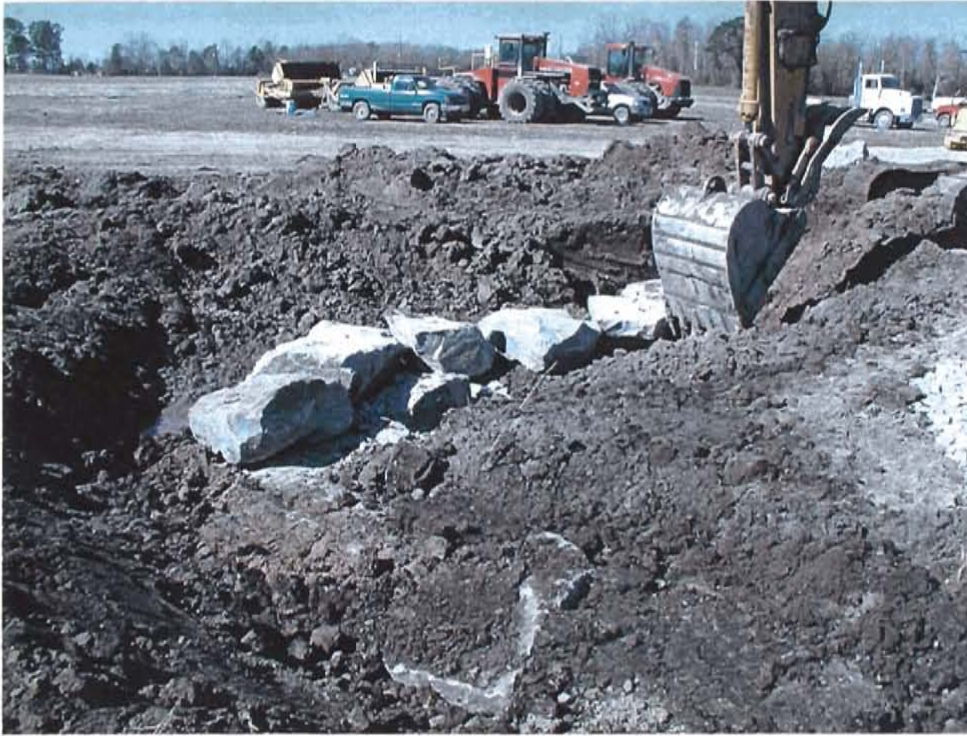
**Photo 7. Cross-vane construction with footer rocks.**

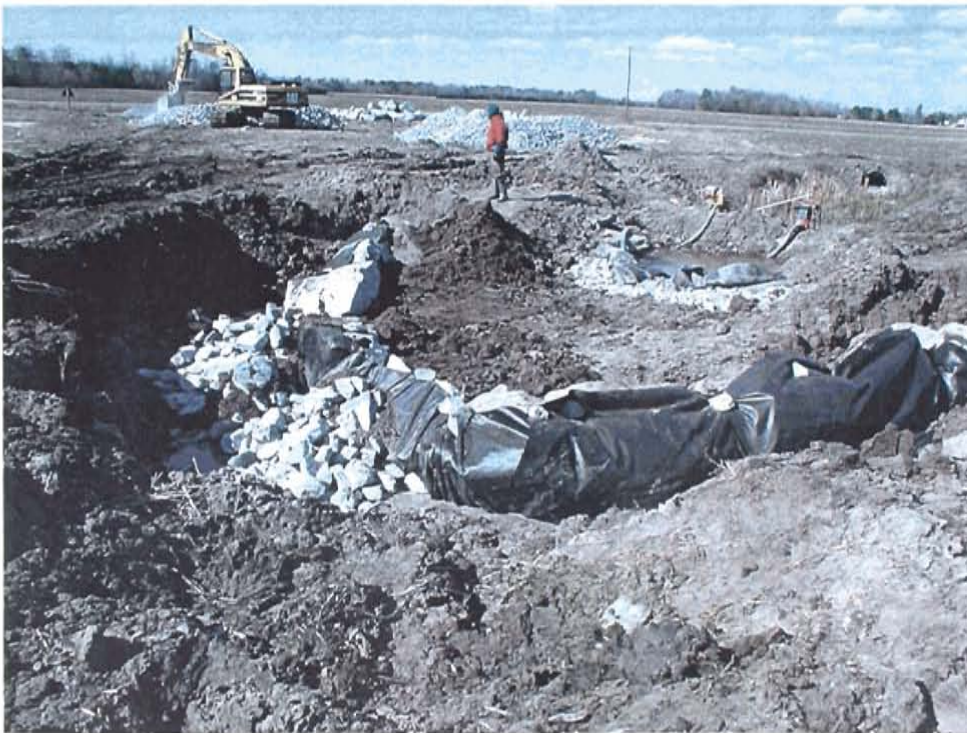
**Photo 8. Sealing of cross-vane structure.**

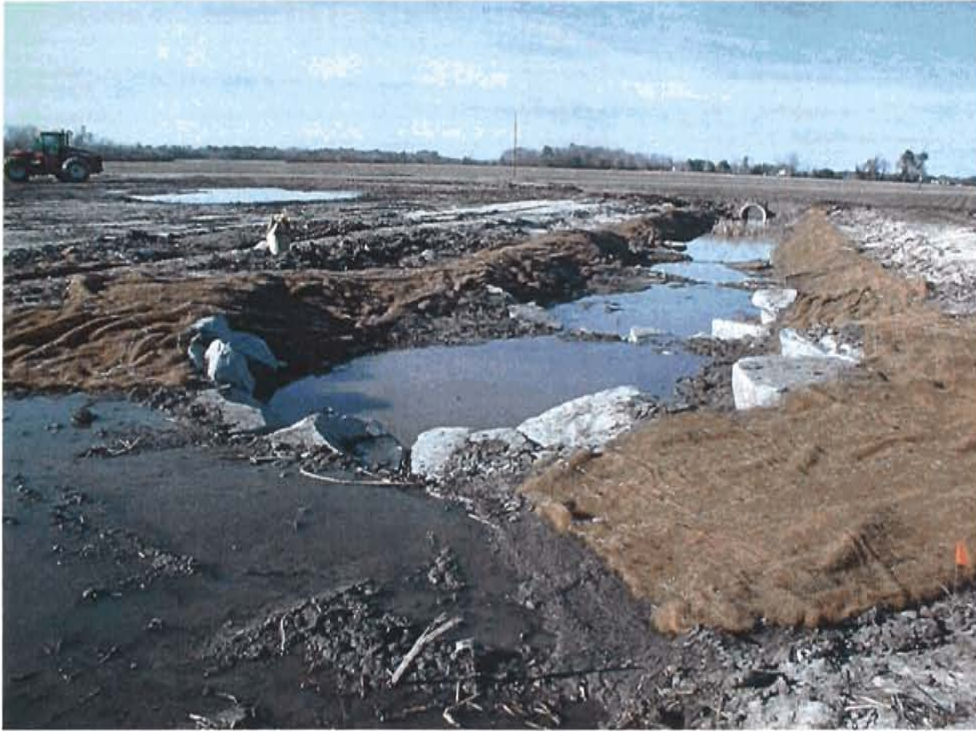
**Photo 9. Completed cross-vanes with protective erosion control matting.**

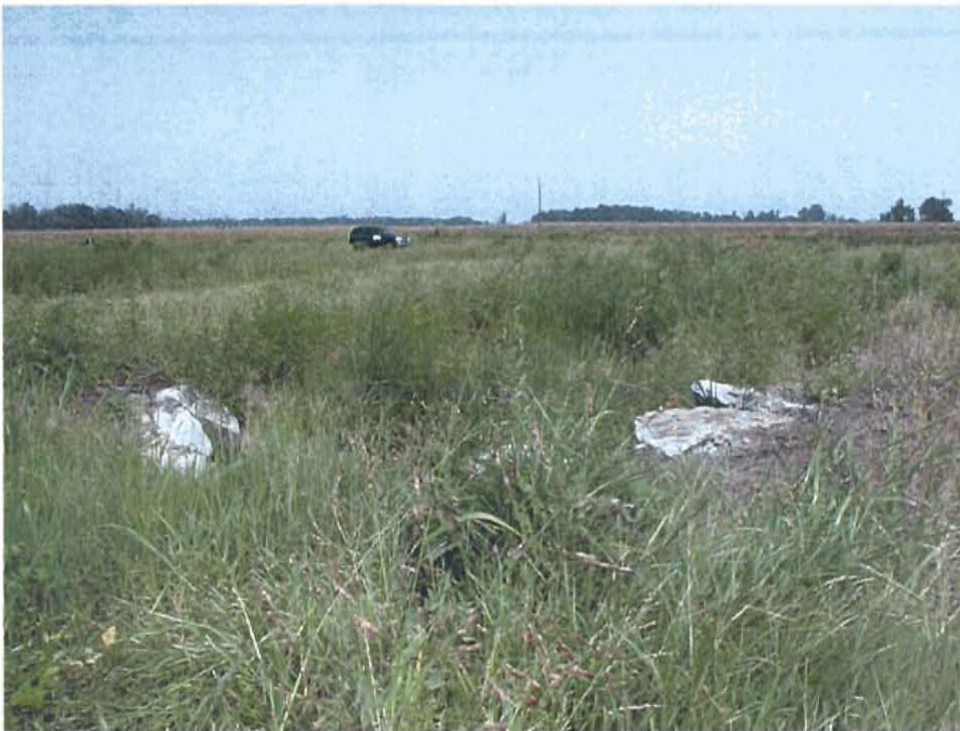
**Photo 10. Same location as Photo 9 on August 24, 2002.**

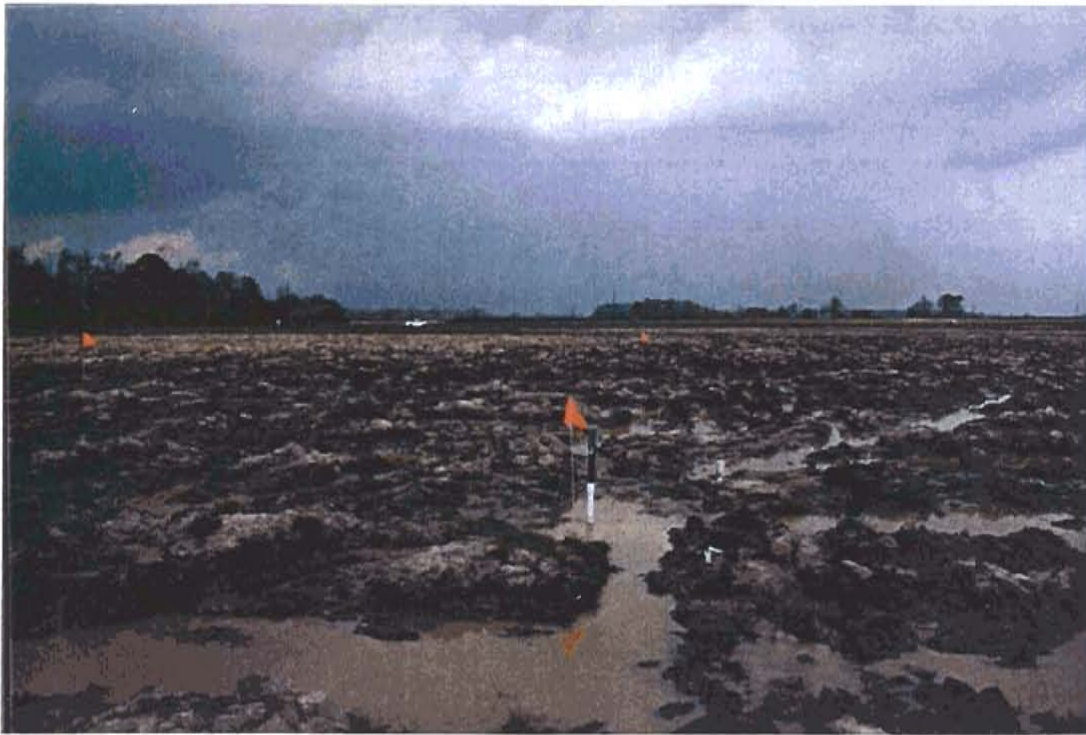
**Photo 11. Monitoring plot #1 on March 20, 2002 after a rainfall event.**

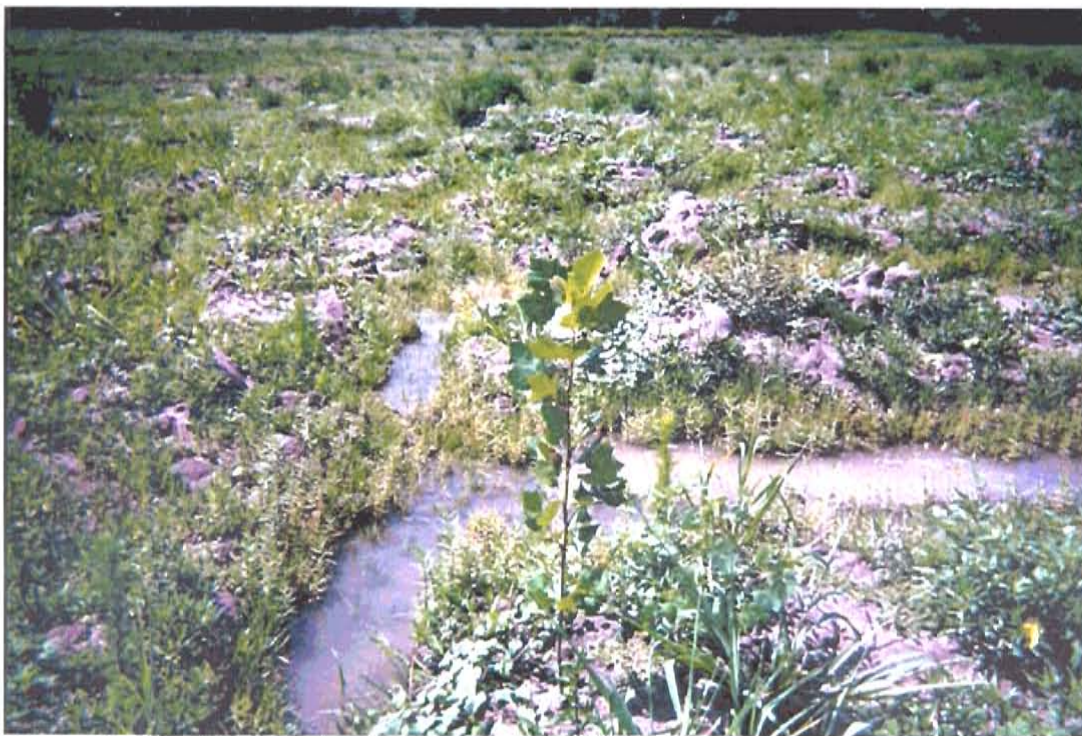
**Photo 12. Monitoring plot #1 on June 24, 2002.**

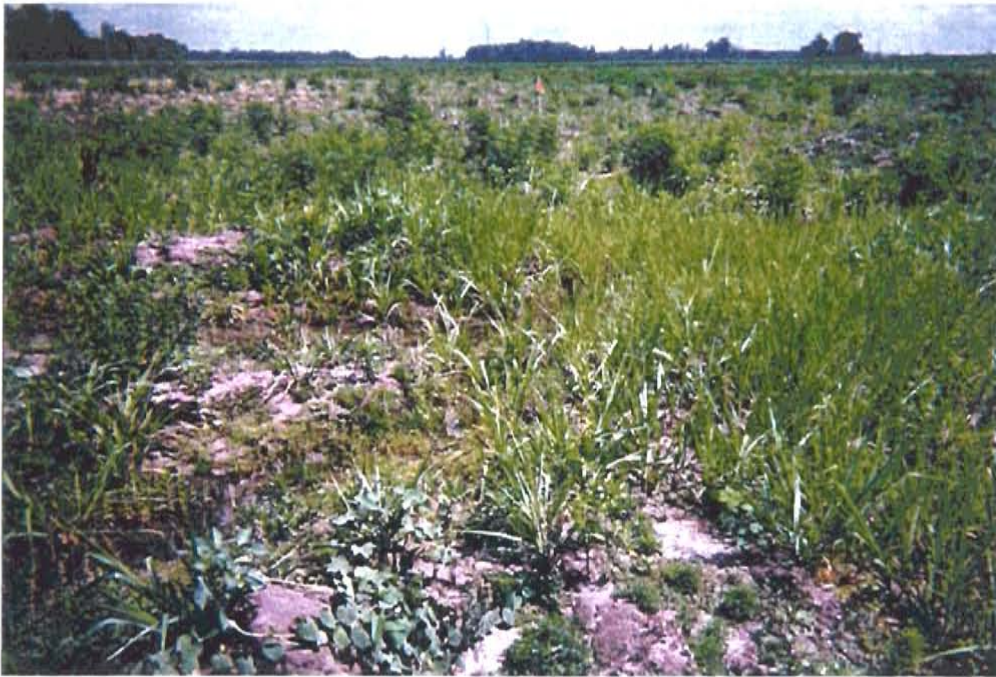
**Photo 13. Monitoring plot #1 on June 24, 2002.**

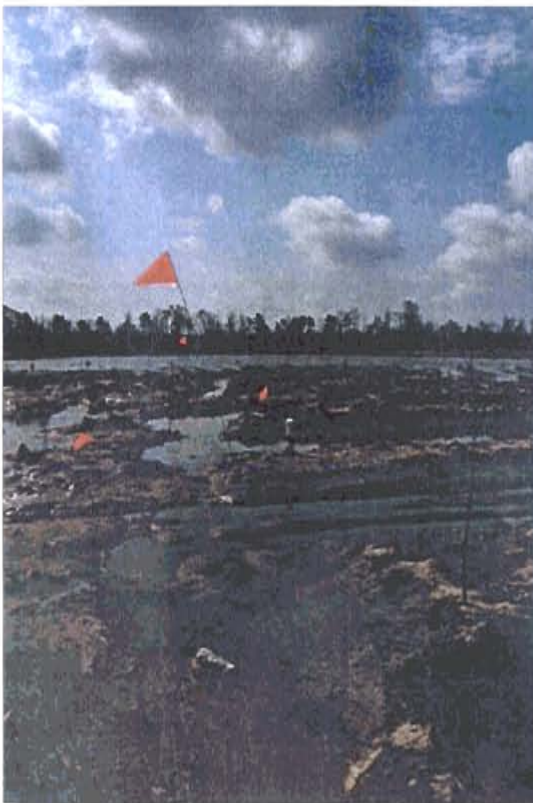
**Photo 14. Monitoring plot #2 on March 20, 2002 after a rainfall event.**

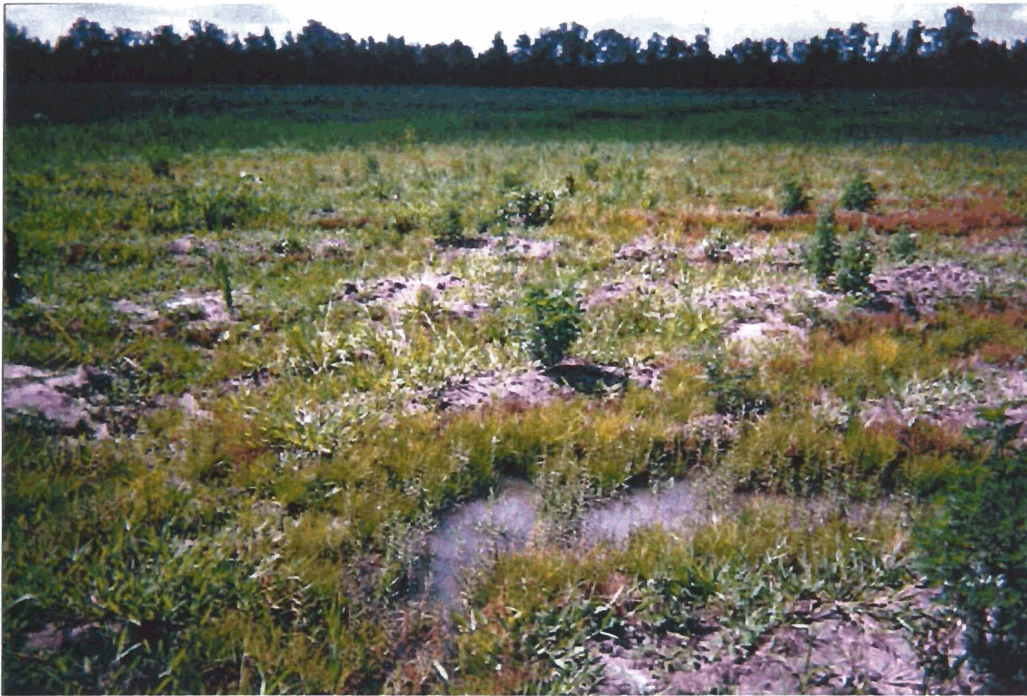
**Photo 15. Monitoring plot #2 on June 24, 2002.**

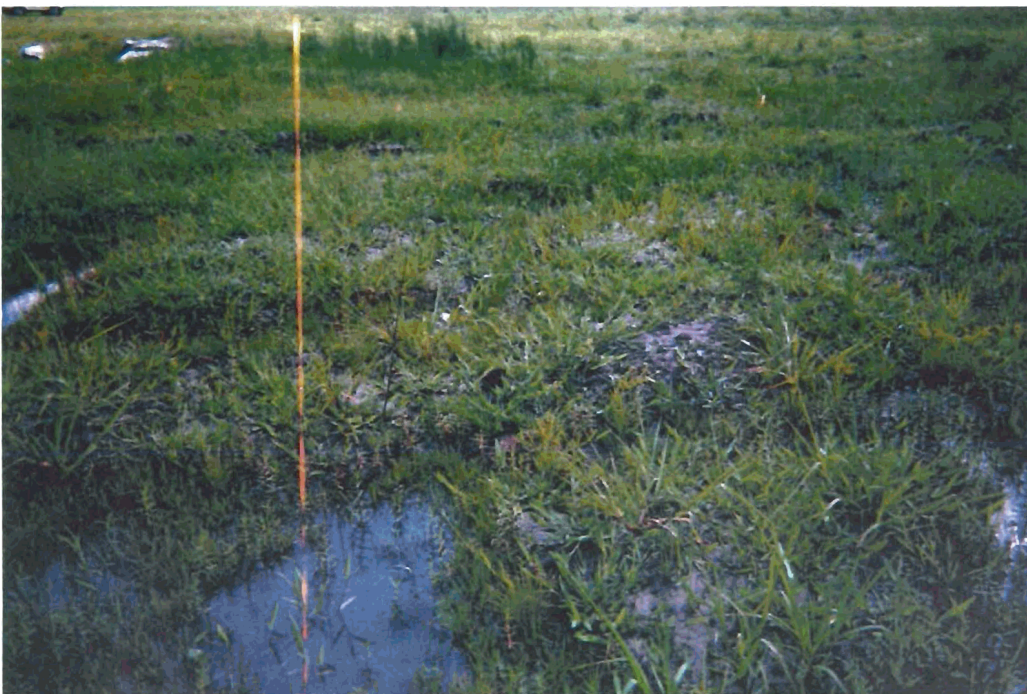
**Photo 16. Monitoring plot #2 on June 24, 2002.**

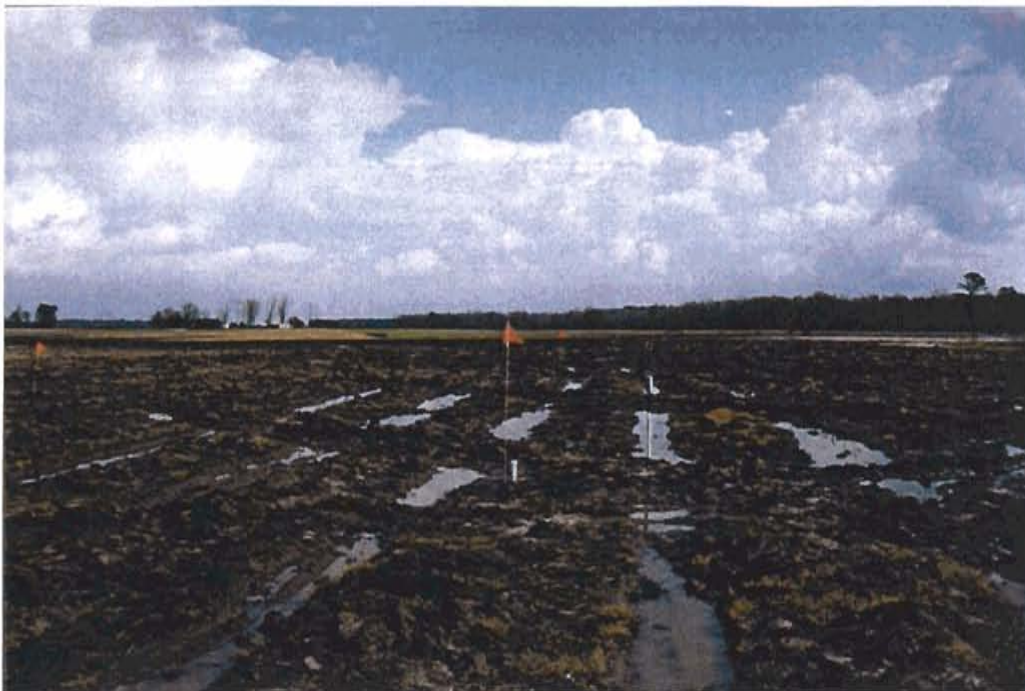
**Photo 17. Monitoring plot #3 on March 20, 2002 after rainfall event.**

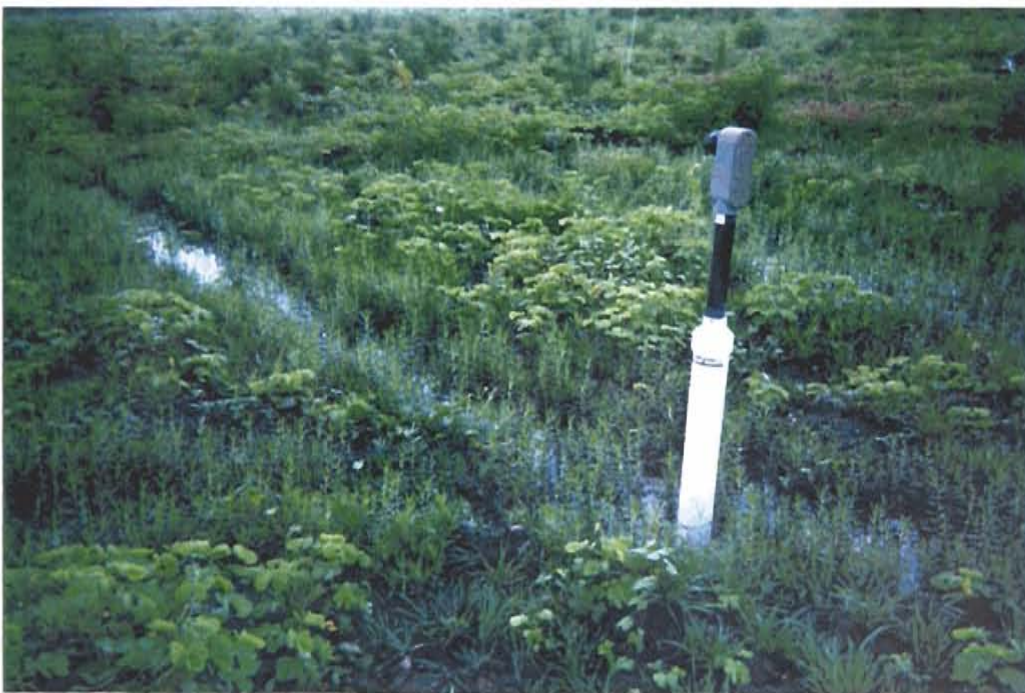
**Photo 18. Monitoring plot #3 on June 24, 2002.**

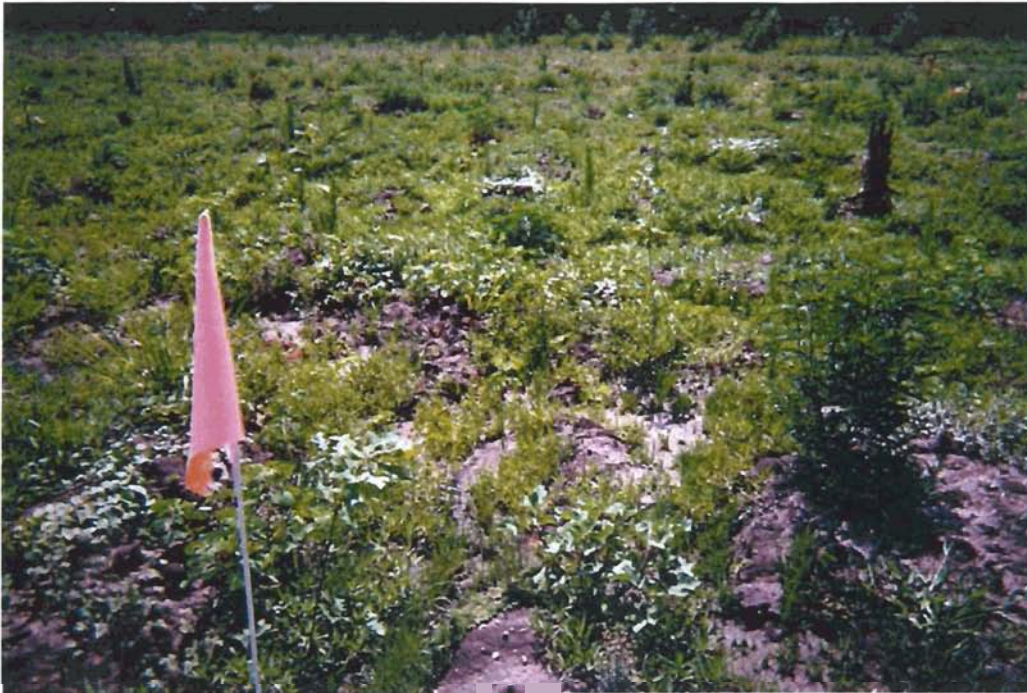
**Photo 19. Monitoring plot #3 on June 24,2002.**

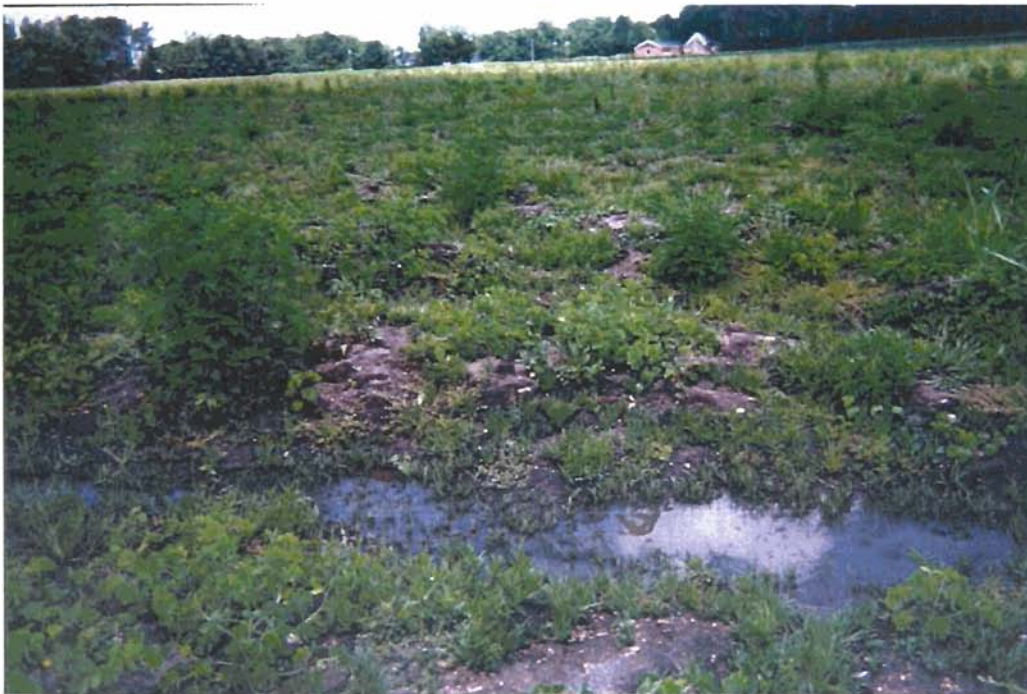
**Photo 20. Monitoring plot #4 on June 24,2002.**

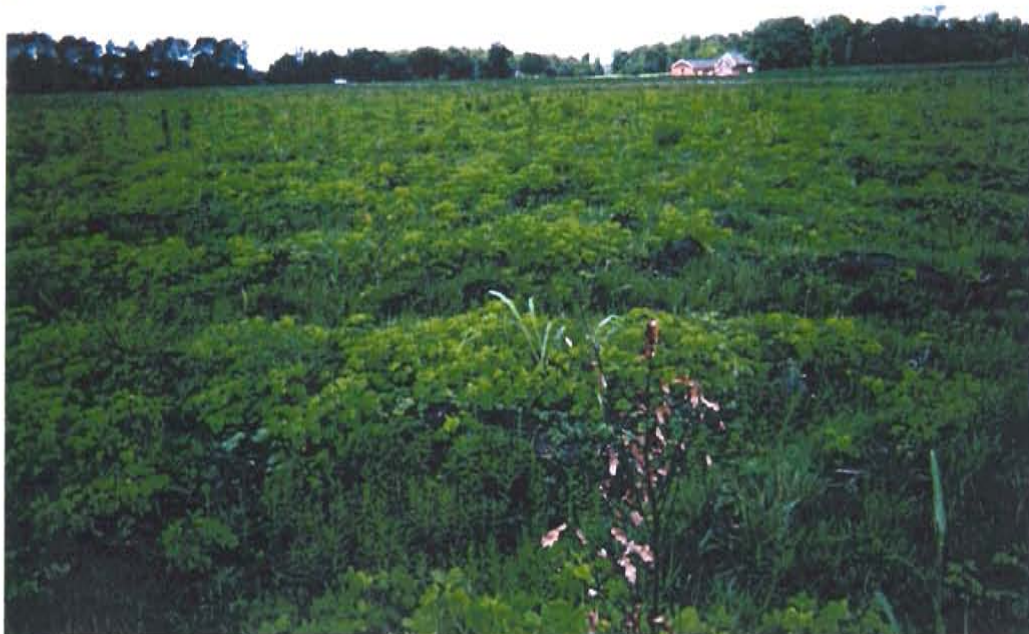
Photo 21. Monitoring plot #4 on June 24, 2002.

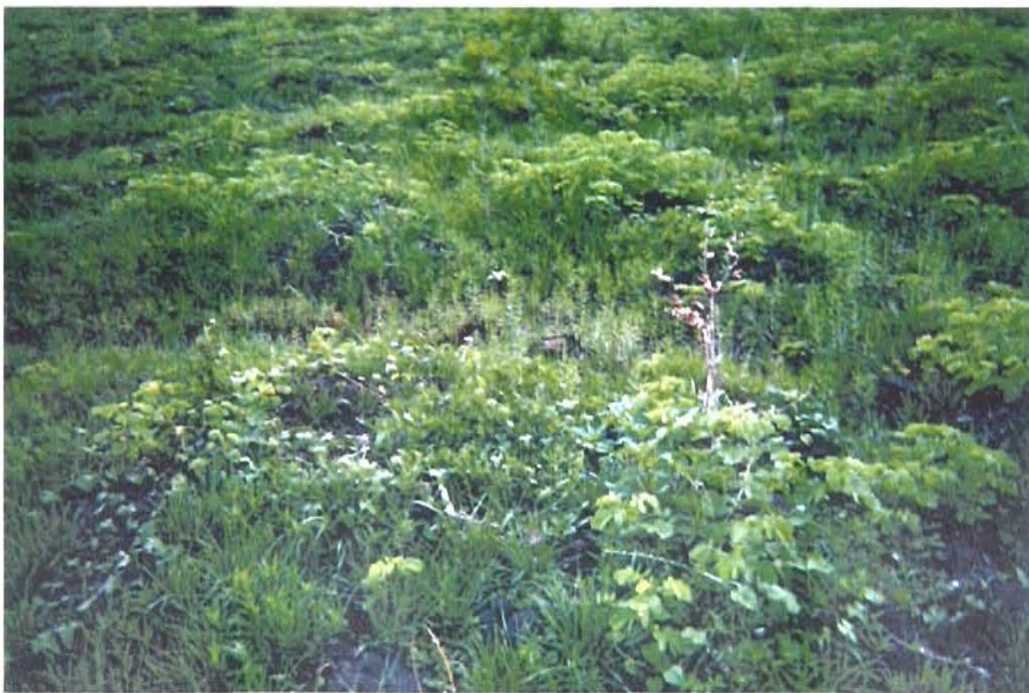
Photo 22. Monitoring plot #5 on June 24, 2002.
